# Characterization of Impact Damage in Composite Plates

Bibi Intan Suraya Murat<sup>1</sup> – Paul Fromme<sup>2</sup> – Marco Endrizzei<sup>3</sup> – Alessandro Olivo<sup>3</sup>

**Keywords:** low-velocity impact, composite plates, X-ray, ultrasonic C-scan, guided waves

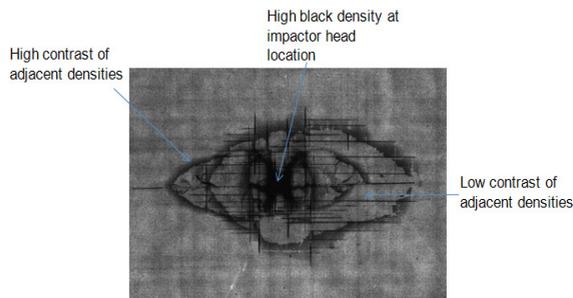
Fig. 1 shows a conventional X-ray image of an impacted cross-ply composite plate, provided by collaborators from the Composite Systems Innovation Centre, University of Sheffield. It should be noted that the X-ray testing was performed on a different, but similar plate to the specimens. The oval shape and the marking out of the damage extremities can be clearly seen. The high black density region is significant compared to other regions, which identifies the location of the impactor head. This could correspond to a small degree of fiber fracture under the impactor head. The high contrast region marked the boundaries between the undamaged and damaged regions, which could be contributed to delamination and matrix cracks. The low contrast regions correspond to the undamaged regions, where no significant changes could be detected. Based on the report by the collaborator, the extended length beyond the impactor-located damage area (15 mm in diameter) were estimated to be approximately 20 mm and 25 mm respectively on the left and right sides, making the total length of the defective region approximately 60 mm (in  $x$ -direction). Due to the oval shape, the widths (minor diameters) varied from 5 mm to 30 mm across the defective region. Unfortunately there was no scale provided on the image.

**Fig. 1.** X-ray images of composite plate impacted at 7.4 J with impact damage; provided by collaborator in Composite Systems Innovation Centre, University of Sheffield

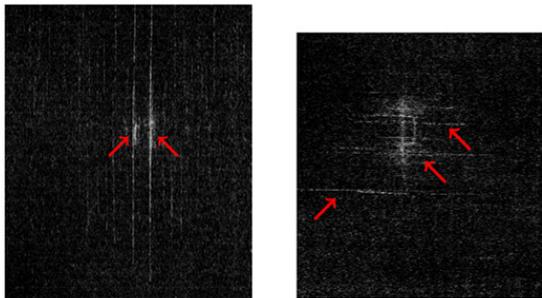
Fig. 2 presents the reconstructed X-ray images on one of the two tested composite plates that are based on the edge-illumination technique, performed in the Department of Medical Physics and Biomedical Engineering, University College London. The method enables dark-field imaging by using incoherent illumination and operates with broadband radiation [11]. The same composite panels were used in their studies and it is expected that these results could provide some extra information about the impact damage. As a preliminary demonstration, the extracted images show a strong differential contrast for the composite plate. The presence of the high contrast of

adjacent densities can be clearly observed from both vertical and horizontal X-ray scattering, which reveal defects inside the plate. The bright lines could indicate local fiber debonding and the two small bright areas which nearly resemble the shape seen in Fig. 2 could probably mark the area of matrix cracks in the plate. This bright area could be used to approximate the size of impact damage in the plate. However, no further information is obtained from the collaborator since this project is still under development. Overall, the damaged region, shape and the extent of the impact damages were observed from the X-ray analysis.

**Fig. 2.** X-ray images of composite plate impacted at 7.4 J with impact damage; a) vertical scattering; and b) horizontal scattering

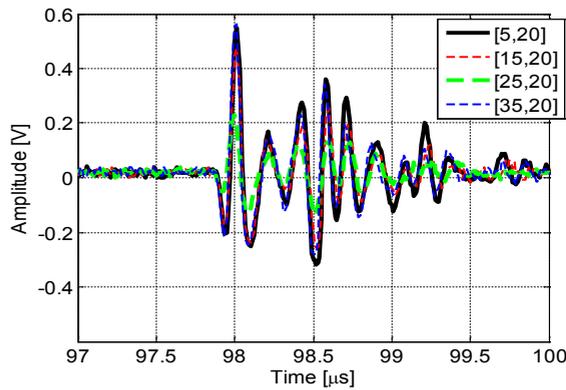
Fig. 3 presents typical received time traces measured from the front surface. The time traces were obtained at four locations, all located at  $y = 20$  mm, but  $x$  positions were varied: 5 mm, 15 mm, 25 mm and 35 mm. The signal monitored at position ( $x = 5$  mm,  $y = 20$  mm) represents a signal collected at the undamaged area. The green dashed line ( $x = 25$  mm,  $y = 20$  mm) corresponds to the reflection from the dented and cracked area (caused by the impact). Measuring the time of flight from the front surface reflection and knowing the thickness and wave speed of the material (approximately 2700 m/s  $\pm 10$  %), one can determine the arrival time of the reflection from the back-wall surface. Since the front surface reflection (first echo) arrived at 98  $\mu$ s, the back-wall reflection was calculated to arrive at approximately 99.5  $\mu$ s  $\pm 10$  %. The time interval of echoes from every layer cannot be detected as the wavelength (0.54 mm) is larger than the nominal thickness of each layer (0.25 mm thick). Fig. 3 shows three groups of reflections that can be observed based on their arrival times. These groups correspond to the reflections from (i) the surface, (ii) within the plate thickness and (iii) back-wall of the plate.

**Fig. 3.** Comparison of response signals at various locations; signal at location  $x = 5$  mm,  $y = 20$  mm corresponds to the undamaged signal; pulse-echo mode; focused; 5 MHz frequency

From Fig. 3, it can be observed that the lowest reflected amplitude (0.2 V) was obtained from the signal measured at the center of the impacted area ( $x = 25$  mm,  $y = 20$  mm). The other three signals have higher amplitudes (0.6 V) of the surface reflection, which described the undamaged and smoother surface. For the second group of the reflections within the plate, multiple peaks of reflections occurred, which can be due to local higher scattering from within the plate. Again it can be observed that the lowest reflection amplitude (0.1 V) was obtained at the impacted area. This shows that the irregular surface (at the impactor location) greatly degraded the normal incident and reflected waves. Meanwhile, the other three signals have inconsistencies in their amplitudes. This may be related to the variations and changes in the interlaminar condition caused by the impact on the surface. What is interesting in this data is that the assumed undamaged signal (based on visual inspection on the surface area) also produced multiple reflections as the other signals. The highest reflected amplitude was observed at  $98.5$   $\mu$ s. Briefly, the arrival time matches approximately to a quarter of the plate thickness. This could indicate the through-thickness location of the delamination as the delamination is normally located in-plane between plies, which produces high reflections. Turning now to the last reflected group (the back-wall reflections), it can be observed that the highest amplitude reflection was obtained from signal monitored at the undamaged area ( $x = 5$  mm,  $y = 20$  mm). This could be due to less wave attenuation and scattering between the plies. Meanwhile, the back-wall reflections from the damaged area are lower than that observed in the undamaged location, which relates to the scattering by the impact damage within the plate.

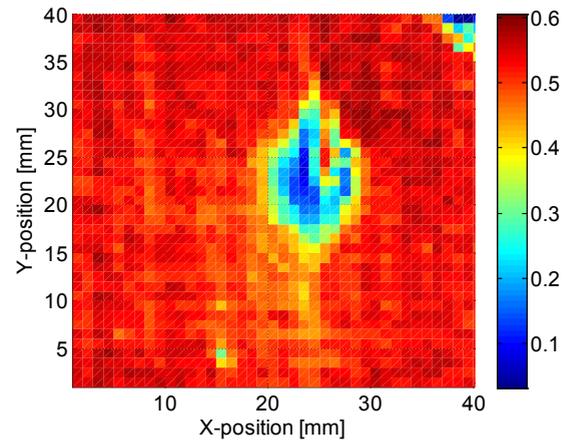
**Fig. 4.** C-scan image of the front surface of the 2 mm cross-ply specimen; 40 mm  $\times$  40 mm scanned area; 5 MHz frequency; 76.2 mm transducer focal length

Fig. 4 shows the C-scan image of the front surface of the test plate (that has a smoother surface compared to the back-wall surface). This image was generated using the maximum peak amplitude of the first reflection. Referring to Fig. 3, the first reflection is mainly a reflection from the plate surface and therefore it is expected not to be sensitive to the internal defects. From Fig. 4, the impact damage is located in the middle of the scanned area. The oval shape region reasonably matches the 15 mm diameter of the hemisphere shaped impactor head. The oval shaped section with lower amplitude region, ranging from 0.1 V to 0.4 V, can be clearly observed with an approximate length of 10 mm ( $x$ -axis) and width of 15 mm ( $y$ -axis). This lower amplitude at the impacted area can be explained by the fact that the incident wave encounters the dented surface, which causes the wave to be reflected back at different angles and causes energy loss due to the scattering at the surface. Meanwhile, the rest of the area has a consistently higher and uniform reflected amplitude within a range of 0.5 V to 0.6 V due to the smooth plate surface.

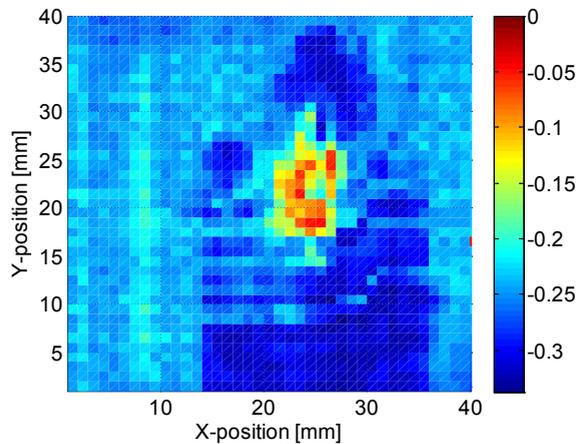
Fig. 5 shows a C-scan image of the same section as Fig. 4, but plotted using the minimum negative amplitude, time gated after the surface reflection. This image represents the internal reflections from within the plate. From the figure, the oval shape with relatively low minimum amplitude (0 V to 0.2 V) as similarly obtained from Fig. 4 can be seen. This shows that the surface indentation not only reduced the normal incident wave but also the reflected wave from within the plate. It also appears there is another large region (half oval shape) with the highest negative amplitude (0.2 V to 0.3 V). This is not observed in Fig.

**Fig. 5.** C-scan image of negative peak amplitude measured from the frontal surface of the 2 mm cross-ply panel; 40 mm × 40 mm scanned area; 5 MHz frequency; 76.2 mm transducer focal length

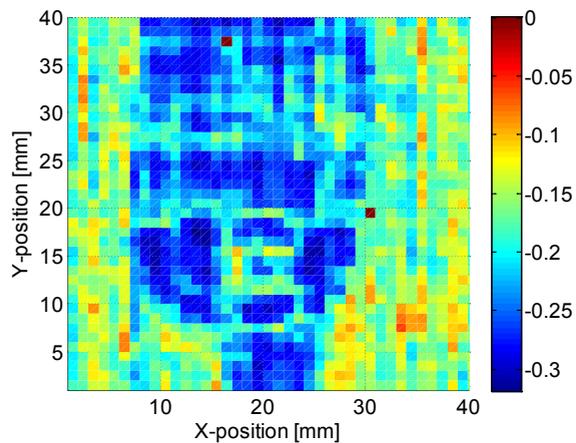
**Fig. 6.** C-scan image of negative peak amplitude measured from the back-wall surface of the 2 mm cross-ply panel; 40 mm × 40 mm scanned area; 5 MHz frequency; 76.2 mm transducer focal length

The same time gating (after surface reflection; negative minimum amplitudes) was also used from the back wall surface (rougher surface compared to the front surface). Fig. 6 shows an approximately similar pattern as obtained in Fig. 5, although the sharp oval shape area (0 V to 0.2 V) was not observed in this figure as the back surface was not dented. The extent of the impact damage (0.2 V to 0.3 V) is reproducible although the surface of the back-wall is rougher. This time gated approach seems to be more sensitive to the extent of the impact damage in the composite laminate. The possible defective area is much larger, about 20 mm and 40 mm in the x- and

y-axis respectively, and the damage level (indicated by different amplitude relative to the neighborhood area) is significant. However, the width of the damaged area could be larger than the scanned area, and may spread in a similar oval-shaped pattern. In relation to that point, Sohn et al. [13] have found that the impact response and damage states in flat composite panels is dependent on the diameter of the spherical impactor head. Although this result does not give full information about damage distribution through the thickness, it has provided a useful approximation of size and depth of the impact damage in the composite plate. It is worthwhile at this stage to use this information for the comparison between the numerical predictions and the experimental results of the guided wave scattering at impact damage.

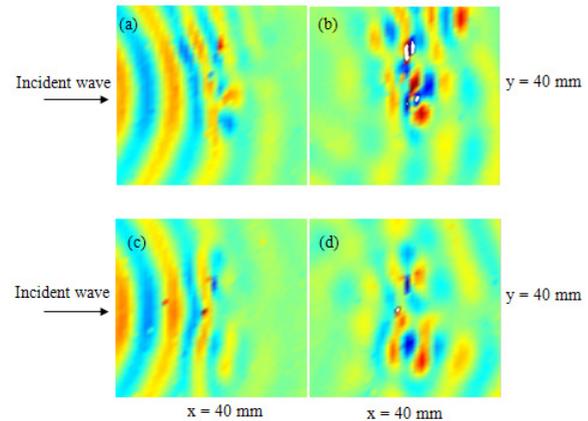
Fig. 7 presents the guided wave fields at various time snapshots, respectively for damaged composite plate 1 and 2. It can be seen that the incident wave interacts with the impact damage and causes scattering within the damaged region. Relatively weak scattering by the damage is present when the incident wave arrives (Figs. 7a and c), then a significant increase of the scattering is apparent when wave has travelled past the damaged area (Fig. 7b and d). Based on the FE study, a significant portion of the waves is also

reflected back from the exit of the impact damage. These reflected waves travel within the damaged region and keep reflecting back at both entrance and exit of the impact damage. As a consequence of these multiple reflections, a considerable amount of guided wave energy is trapped inside the impact damage area. This causes an increase in the amplitude of the wave in that region.

The amplitude of the transmitted waves diminished noticeably after passing through the impacted area. Similar wave behavior was also observed by Sohn et al. [13], where the measurement was performed on a quasi-isotropic composite plate. This finding however is contradictory to some of the FE simulation results [12], where a large amount of transmitted wave can be observed. However, some FE results have demonstrated the reduction in the amplitude past the delamination area. The FE simulations for the delamination placed at 0.5 mm depth is in agreement with this experimental measurement. Comparing both specimens, which were impacted with same 7.4 J impact energy, it can be seen that guided wave scattering in both plates are unique and such variations are expected due to the complexity in the failure mechanism of impact damage.

**Fig. 7.** Guided wave displacement fields in two composite plates; Plate No. 1, snapshot time; a) 20  $\mu$ s and b) 30  $\mu$ s; Plate No. 2, snapshot time; c) 20  $\mu$ s and d) 30  $\mu$ s; 7.4 J impact; 40 mm  $\times$  40 mm scanned area

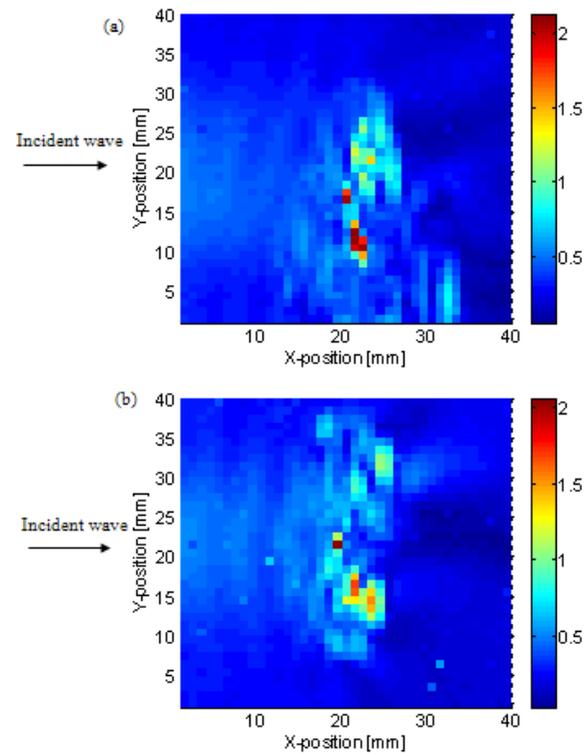
Fig. 8 presents the image of the maximum amplitude of the signal envelope over the damaged areas in both composite specimens. Areas of higher amplitudes can be seen, that occur close to the impact location center ( $x = 20$  mm,  $y = 20$  mm). This indicates the presence of severe damage such as a delamination or fiber and matrix cracking, and matched reasonably well with the visually observed size of the impact damage on the plates as well as the X-ray and C-scan images. Meanwhile, the undamaged area is represented by the low amplitude distribution. From the figure, three different zones can be observed and each zone has its own wave propagation behavior; (i) Zone 1: before the impact damage ( $x < 15$  mm), (ii) Zone 2: across the impact damage ( $15$  mm  $< x < 25$  mm), and (iii) Zone 3: behind the impact damage ( $x > 25$  mm).

The first zone (before damage) shows the incident waves propagating towards the impact damage location. It is also can be seen there were reflected waves propagating back towards the excitation source. Some periodical increase and decrease of the amplitude is visible in the region around  $x = 15$  mm, potentially indicating the interference between the incident and the reflected waves at the impact damage. In zone 2, high amplitudes of the A0 mode signals are visible, which could indicate the multiple reflections

and scattering events within the impact damage area. Meanwhile, in zone 3, the transmitted waves propagating out from the damaged area are seen to be blocked in certain direction with significantly reduced signal amplitudes. Considerable waves transmitted

**Fig. 8.** Maximum amplitudes of guided wave pulse across damaged area of composite plate: a) Plate 1; b) Plate 2; frequency 100 kHz; 40 mm  $\times$  40 mm area with impact location at center ( $x = 20$  mm,  $y = 20$  mm)

across the impact damage indicate that probably little mode conversion occurred as has been observed from the FE simulations. The cross-section of the impact damage in Plate no. 1 can be roughly approximated with length of 10 mm ( $x$ -axis) and width of 20 mm ( $y$ -axis), identified by the higher amplitude maxima. For Plate no. 2, the cross section area of the impact damage can be estimated to be about 10 mm  $\times$  25 mm.
