The April 16 2016 M_w 7.8 Muisne Earthquake in Ecuador – Preliminary Observations from the EEFIT Reconnaissance Mission of May 24 - June 7

G. Franco⁽¹⁾, H. Stone⁽²⁾, B. Ahmed⁽³⁾, S.C. Chian⁽⁴⁾, F. Hughes⁽⁵⁾, N. Jirouskova⁽⁶⁾, S. Kaminski⁽⁷⁾, J. Lopez⁽⁸⁾, N.G. van Drunen⁽⁹⁾, and M. Querembás⁽¹⁰⁾

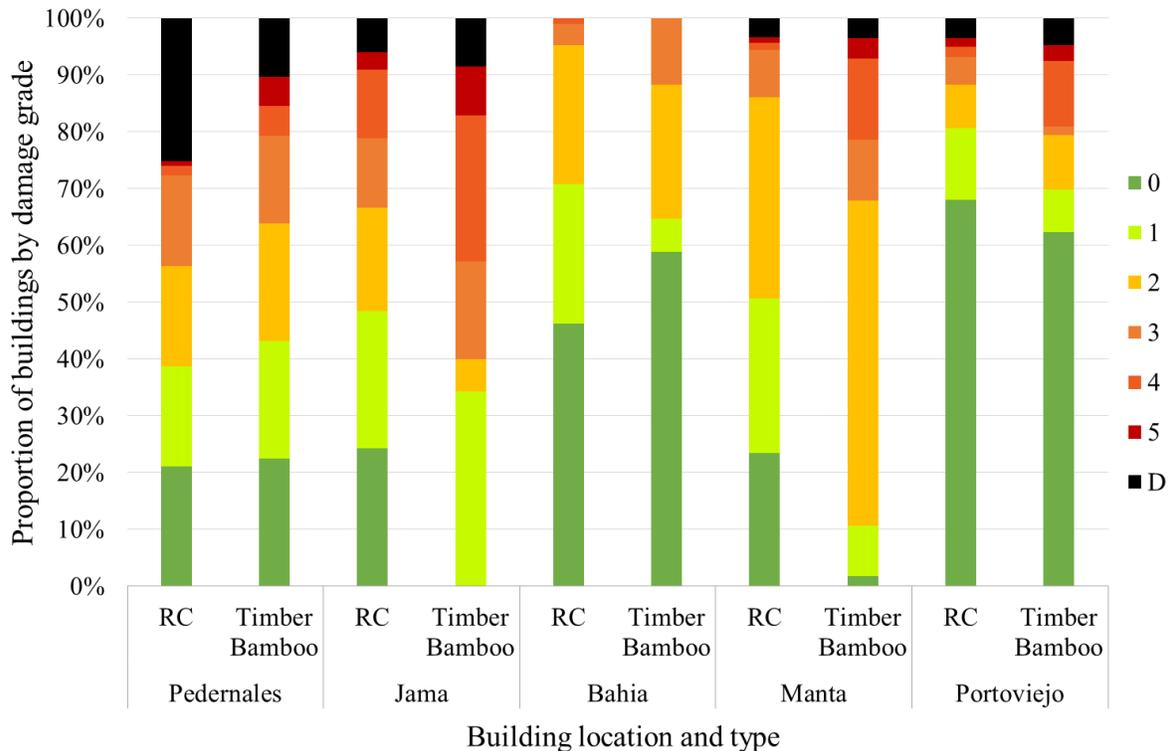
Figure 2 – Damage survey results by area and by EMS-98 damage grade (“D” denotes demolished).

The proportion of buildings surveyed at different damage states is summarised in Figure 2. Even considering the caveats above, Figure 2 indicates that RC buildings experienced greater levels of damage than timber/bamboo buildings, and in addition that Pedernales experienced the greatest level of damage out of the towns the team visited.

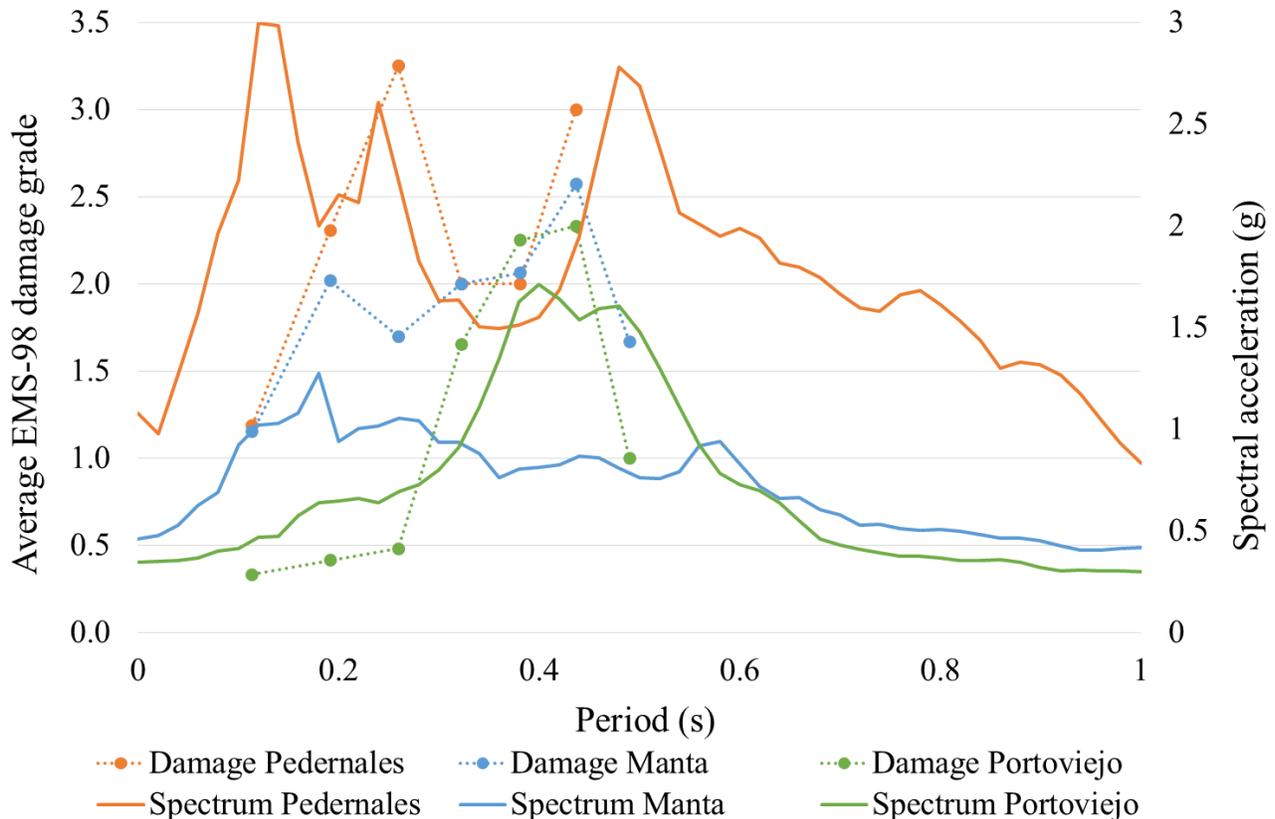
Figure 3 – Relationship between response spectra from recorded ground motions [14] and surveyed damage.

Figure 3 compares the spectral accelerations recorded at stations in Pedernales, Manta, and Portoviejo, with the average damage grades of RC and timber/bamboo structures of different heights surveyed in those locations whose fundamental periods are estimated using Eurocode 8 [15]. In Portoviejo the damage correlates well, and similarly in Pedernales except for the first peak (at just over 0.1s). For Manta, the correlation is weaker although it is difficult to tell without any major peaks in the recorded spectral acceleration. This comparison tends to confirm the expected relationship between shaking frequency and damage to structures of certain height.

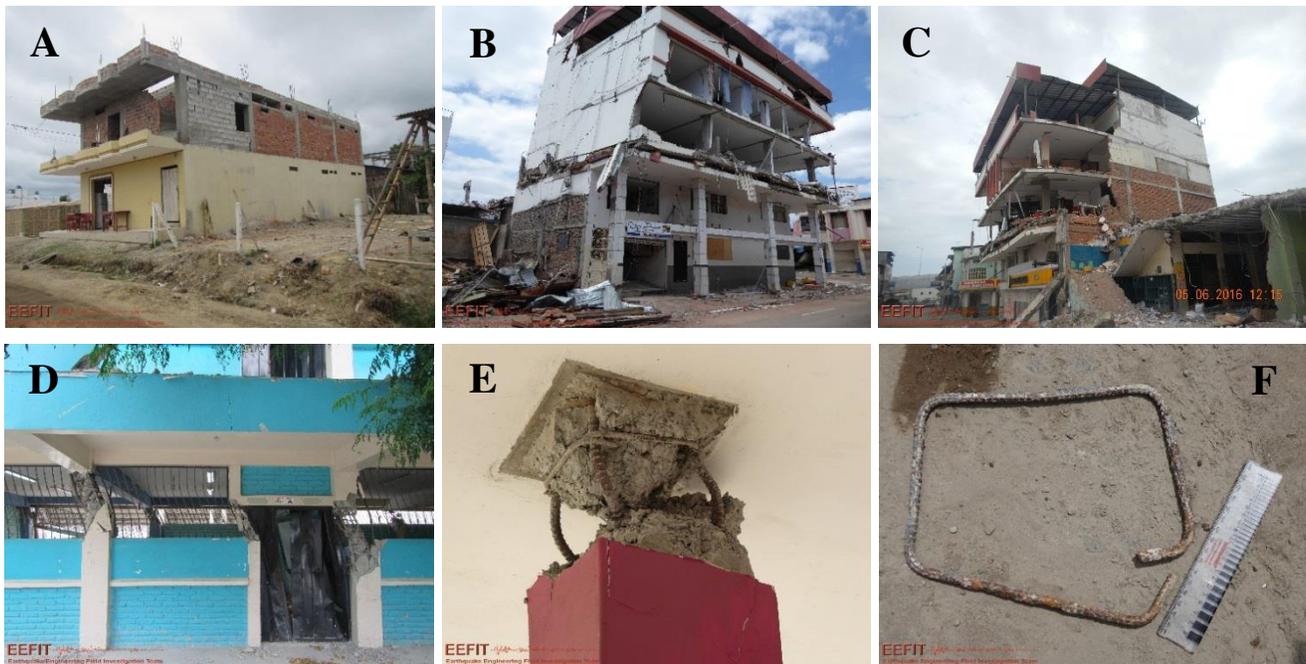
Failure at upper levels: Upper floor soft/weak storey failures were observed in a number of buildings. It is suspected that this could be due to constructing upper floors long after the bottom floors are completed (as extensions of the building when new resources become available or when new needs arise; see Figure 4A). The joints between new and old are typically poorly executed with insufficient lapping of the rebar, resulting in local reduction in capacity promoting failure in these areas (Figure 4B). This localised upper storey damage may also be attributed to all rebar being lapped at one height, resulting from the use of the same length bars in all

columns. Additionally, some upper storey failures could be attributed to changes in plan or elevation at specific levels, resulting in a weak/soft storey.

Inadequate design and detailing of RC moment frames: RC moment frames in seismic areas require several key considerations to ensure they behave safely in an earthquake: 1) Sufficient overall moment and shear capacity, 2) Columns' flexural strength should exceed that of the beams, such that flexural failure occurs first in the beams, 3) Columns and beams should be stronger in shear than in flexure, such that a ductile flexural failure mode occurs before a brittle shear failure mode, and 4) Adequate detailing of the reinforcement in all elements. Damaged RC structures observed generally failed some or all of these requirements (see Figure 4C).

Figure 4 – Two-storey building with columns' rebar left sticking out of roof for future extension (A). Weak/soft storey failure at upper level (B). Inadequate design/detailing of RC frame and infills (C). School building with short column failure (D). Column head failure showing insufficient and poor shear design and detailing (E). Column link with no 135°-bend (F).

Short columns: This failure mode was seen in a number of buildings, with a reoccurring detail of high level windows for the full length of the frame bays (see Figure 4D).

Inadequate design and detailing for shear: In many RC buildings surveyed there was poor detailing of shear reinforcement, with sparsely-spaced links and with poor/no anchorage of these links into the columns (i.e. no 135°-bends in links; see Figures 4E & 4F).

- Improved knowledge and application of basic fundamental structural and seismic design principles
- Better reinforcement detailing, notably detailing of links and rebar overlaps, and increased cover
- Better masonry infill walls and bed joints, better seismic connections to frames, and better materials
- Superior construction quality standards, especially concrete
- Better building maintenance, especially for timber or bamboo structures

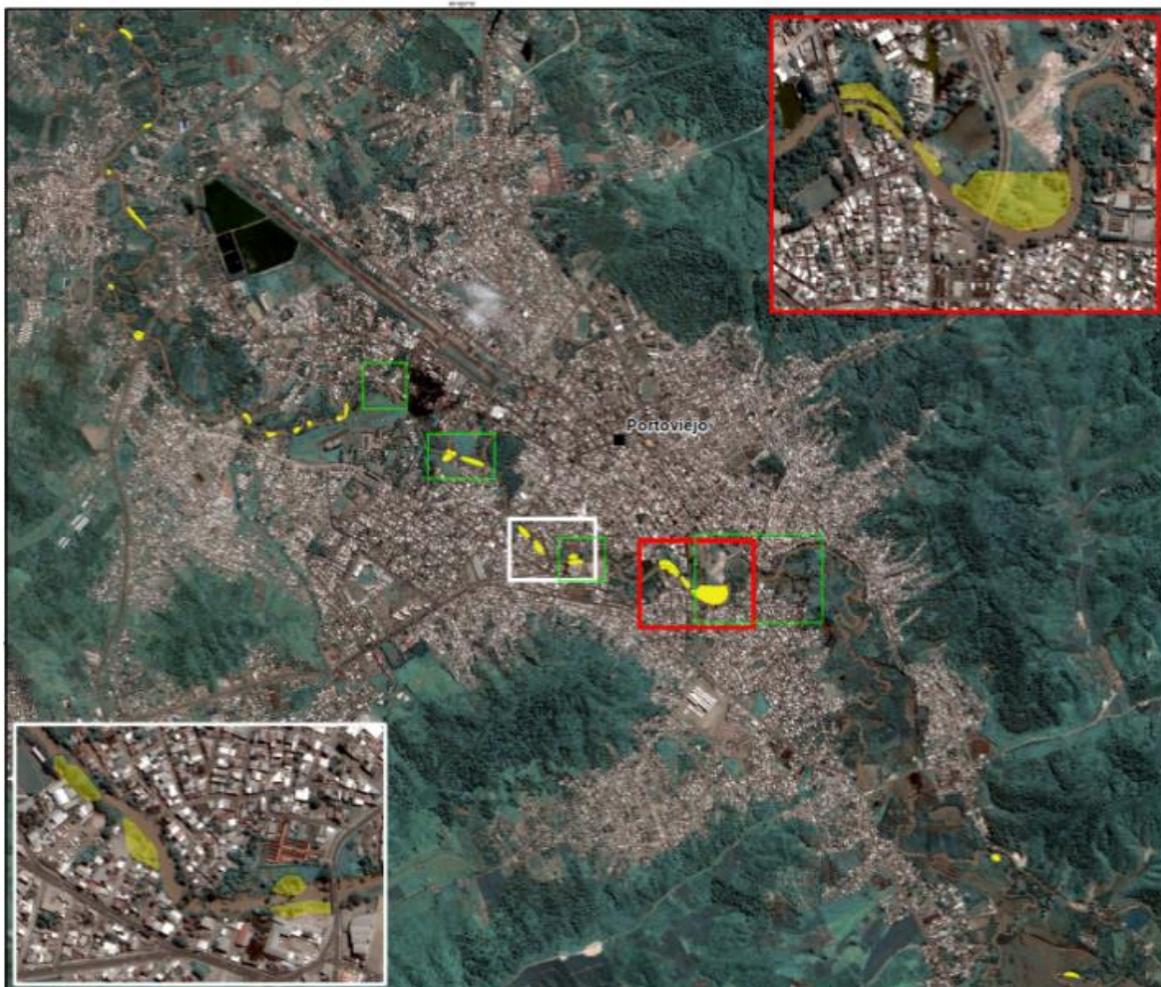
Figure 5 – Portoviejo landslides (in yellow) identified from satellite imagery (British Geological Survey).

As part of the team’s landslide reconnaissance, a ground-truthing exercise was undertaken in collaboration with the British Geological Survey (BGS) to provide field validation for their preliminary landslide assessment, initiated by a request from the UK Department for International Development (DfID) and based on satellite imagery from UNITAR/UNOSAT [17]. Photographic and drone imagery were taken on site and interviews were conducted at locations of identified landslides. 13 sites were surveyed in Portoviejo [18] and 17 in the vicinity of Bahía de Caráquez [19] as part of this exercise. Guided by the BGS satellite images, the team visited these locations and provided observations (see Figure 5 & Table 1 as an example for Portoviejo).

During the survey, the team confirmed that the satellite-imagery interpretation had been mostly successful in correctly identifying landslides in the areas surveyed. A few small-scale additional landslides to those mapped in the rapid co-seismic preliminary assessment were observed and a couple of locations associated to greater uncertainty in the assessment were confirmed not to correspond to landslides after all. On the other hand, satellite-based analysis made it possible to identify extensive landslides attributed to liquefaction mapped along the Chone Estuary, close to Bahía de Caráquez, that were difficult to access due to dense vegetation and instable soil boundaries. Following the map and talking to the local community, the team was able to corroborate the preliminary assessment, observing signs of landslides such as drift of trees in the estuary.
