1 **Enhanced Composite Plate Impact Damage Detection and Characterisation using**
2 **X-Ray Refraction and Scattering Contrast Combined with Ultrasonic Imaging**

3 D. Shoukroun^{1,4}, L. Massimi¹, F. Iacoviello², M. Endrizzi¹, D. Bate³, A. Olivo¹, P. Fromme⁴

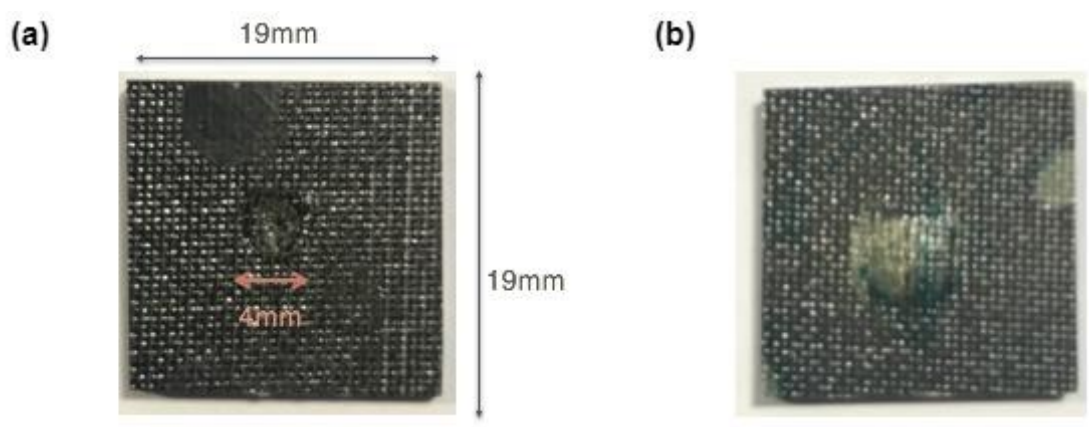
500 **Figure 1**

120 A 2 mm thick, 19 mm x 19 mm carbon fibre/epoxy resin cross-ply laminate sample
121 containing severe impact damage was imaged. The 16 plies were measured to be
122 approximately 150 μm thick, and the top and bottom laminae had a woven structure.
123 The sample contained an indent induced by impact, approximately 4 mm in diameter
124 and 1.2 mm in depth, which resulted in a small protrusion on the back of the plate,
125 approximately 5.5 mm in diameter and 0.5 mm thick, as shown in Fig. 1.

466 **Figure 1:** Photograph of specimen: (a) impact damage on front surface; (b) protrusion
467 on back surface.

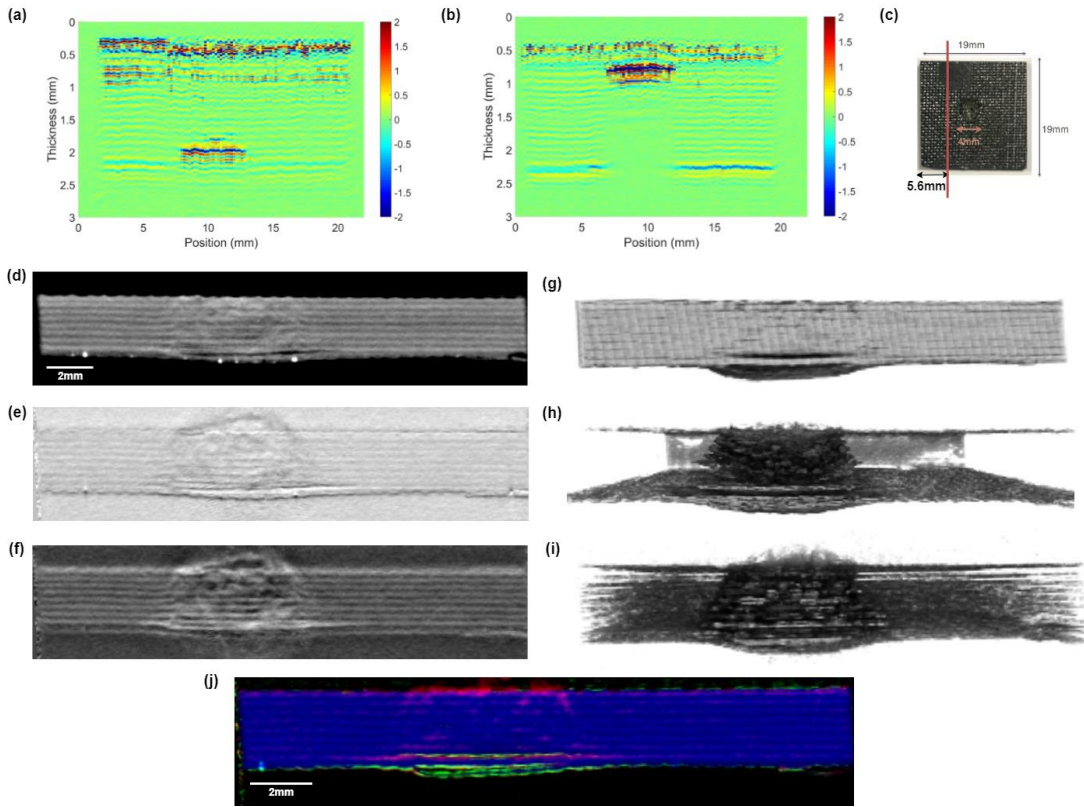
231 Figure 6 shows a cross-section about 5 mm from the impact center, where no
232 indent can be observed. Delamination is detected by the ultrasonic B-scan and X-ray
233 images close to the bottom of the sample. The delamination was localized between plies
234 14 and 15 from the X-ray images, in agreement with the ultrasonic B-scan images, as the
235 first reflection from the delamination in both scans was found to be approximately 0.3
236 mm from the back surface of the sample, which corresponds to the thickness of the two
237 plies. In the B-scans, a strong reflection was observed (Fig. 6a/b), characteristic of a
238 delamination [9]. From the X-ray retrievals, the delamination length at that location was
239 measured to be approximately 5 mm in length from the absorption and refraction
240 images. This was in good agreement with the measurement of approximately 5.5 mm
241 from the ultrasonic B-scan, considering the system resolution (0.2mm step size).

242 In the slices and the 3D rendering of the X-ray images, the delamination is visible
243 in all three retrievals, with the absorption images showing a separation between the
244 plies (Fig. 6d, with stretched contrast in Fig. 6g). A strong signal is observed in the
245 refraction retrieval (Fig. 6e/h) due to the interface created between the delamination
246 and the neighbouring plies. A strong scattering signal is also observed around the
247 delamination (Fig. 6f/i), indicating the presence of the sub-pixel damage. Identification
248 of the features observed in the scattering signal is not directly achievable, but it could
249 indicate that either the delamination (ply-separation) extends further than observed in
250 the absorption and refraction signal (Fig. 6j), or additional micro-damage e.g.
251 debonding, micro-matrix cracks, or fibre damage. These features are better visible in the

252 3D renderings shown in Fig. 6h/i with enhanced contrast to highlight the interfaces of
253 the delamination in the refraction signal and the surrounding damage in the scattering
254 image, respectively. These micro-features are unique to the scattering signal and offer
255 a more accurate representation of the possible damage extent, which could not be
256 observed in the other signals due to the scale of those features. The complementarity
257 of the scattering signal allows to observe features of different magnitudes and nature
258 and thus to better understand the defects present in the sample. The 2-dimensional cuts
259 through the 3D rendering of the X-ray signals (Fig. 7) shows that the delamination is not
260 complete, but is shaped as a ring around the impact damage which pushed the central
261 part of the specimen downwards and caused the protrusion. The refraction and
262 scattering renderings show in addition to the main delamination towards the back of

479 **Figure 6:** Delamination: ultrasonic B-scan with (a) front surface (indent) and (b) back
480 surface (protrusion) facing the transducer (colour scale signal voltage in volts); (c)
481 position of B-scans and cross sections within the sample; cross-section of retrieved X-
482 ray (d) absorption, (e) refraction, (f) scattering CT reconstructions; 3D rendering of the
483 sample for retrieved (g) absorption, (h) refraction, (i) scattering; (j) superposition of the
484 retrieved EI XPCi CT images with absorption (blue), refraction (green), scattering (red).

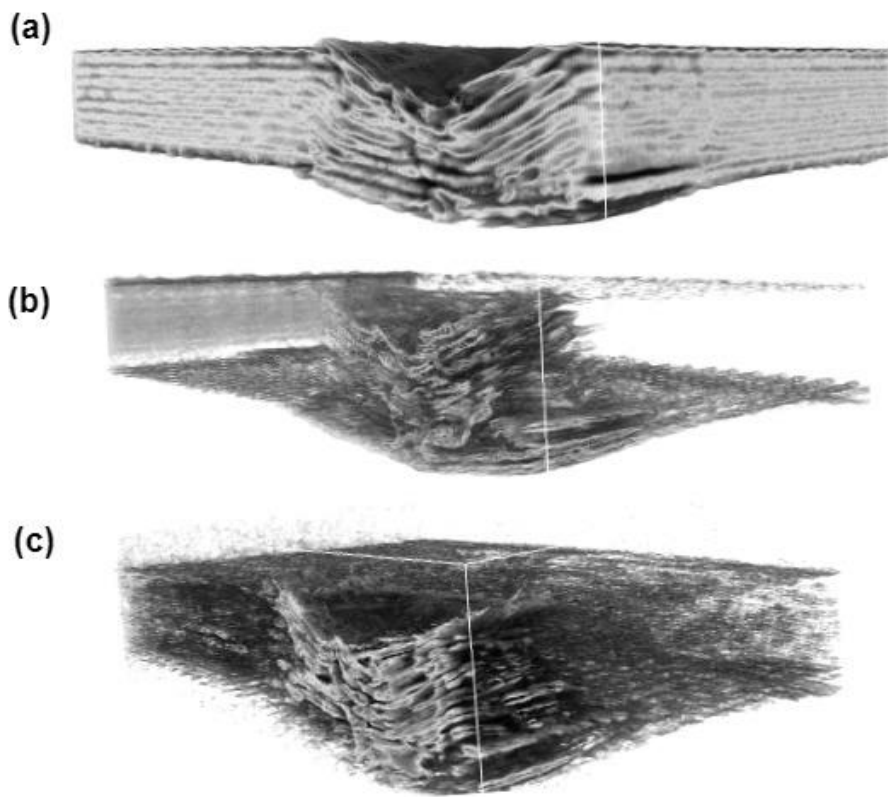
515 **Figure 7**

263 the specimen, smaller interfaces and delaminations within the protrusion.

485 **Figure 7:** 2-directional cut through 3D rendering showing shape of delamination around
486 the main impact damage in the retrieved X-ray (a) absorption, (b) refraction, and (c)
487 scattering signals.

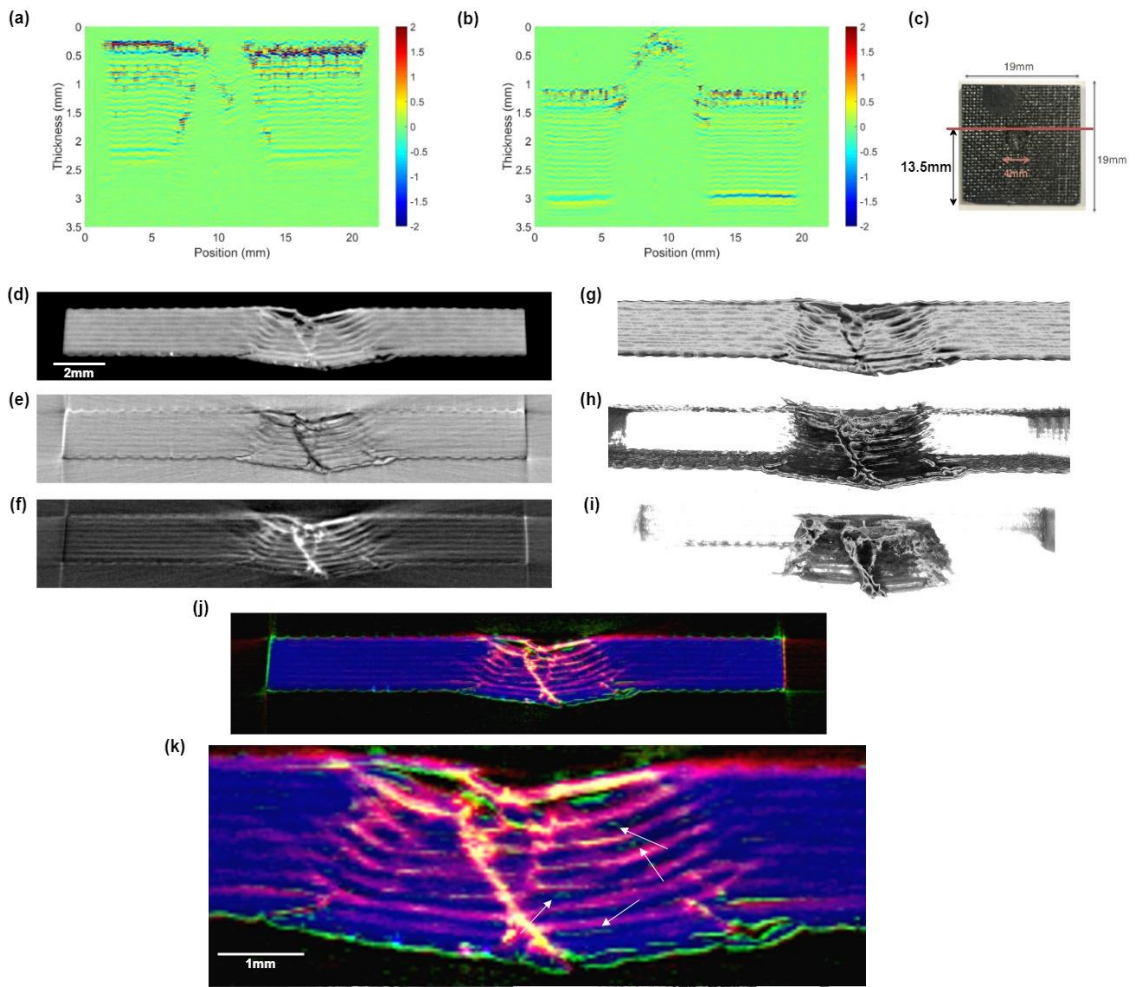
518 **Figure 8**

266 The impact caused damage across the sample, as can be seen from both the
267 ultrasonic B-scans (Fig. 8a/b), and the X-ray images across the impact center. The
268 ultrasonic B-scans exhibit one of the limitations of ultrasonic testing for damage
269 detection in composite plates. The indented front surface and protrusion cause strong
270 reflections and scattering, with potentially unobserved internal defects due to lack of
271 signal past the damage closest to the surface. An example of such a situation is observed
272 here, where a crack across the thickness of the sample was only observed in the X-ray
273 images (Fig. 8). The macro-crack was observed in all three X-ray retrievals, however they
274 indicate different features; the absorption CT slice (Fig. 8d) shows clear damage in the

275 sample, with the crack and further damage better visible with enhanced contrast (Fig.
276 8g). The refraction signal (Fig. 8e/h) highlights the interface of the crack through the
277 sample, whereas the scattering signal (Fig. 8f/i) indicates further micro-damage in the
278 sample surrounding the crack. This level of accuracy in the measurement of the damage
279 extent is unachievable using ultrasonic imaging or conventional attenuation-based CT
280 alone, represented here by the retrieved absorption images (Fig. 8d).

281 Moreover, a clear scattering signal can be observed throughout the damaged
282 area of the sample. The presence of signal in the different retrievals indicates the
283 presence of different types of damage (Fig. 8j). The signal in the refraction images is due
284 to the small voids created by the separation of plies in the inter-ply area originating from
285 the material being displaced when the damage occurred, as shown in Fig. 8k. The
286 scattering signal is due to the micro-damage that occurs within the plies due to the
287 material displacement. The multimodal imaging of the sample, as well as the
288 superposition of all three retrievals in an RGB image, as shown in Fig. 8j/k, thus allows
289 to locate and clearly visualise the damage, as well as identify the scale of damage
290 involved and have a more accurate representation of the extent of the damage from the
291 refraction and scattering images to complement the absorption and ultrasonic images.

488 **Figure 8:** Center of damage: ultrasonic B-scan with (a) front surface (indent) and (b) back
489 surface (protrusion) facing the transducer (colour scale signal voltage in volts); (c)
490 position of B-scans and cross sections within the sample; cross-section of retrieved X-
491 ray (d) absorption, (e) refraction, (f) scattering CT reconstructions; 3D rendering of the
492 sample for retrieved (g) absorption, (h) refraction, (i) scattering; (j) superposition of the
493 retrieved EI XPCi CT images with absorption (blue), refraction (green), scattering (red);
494 (k) zoom impact damage.

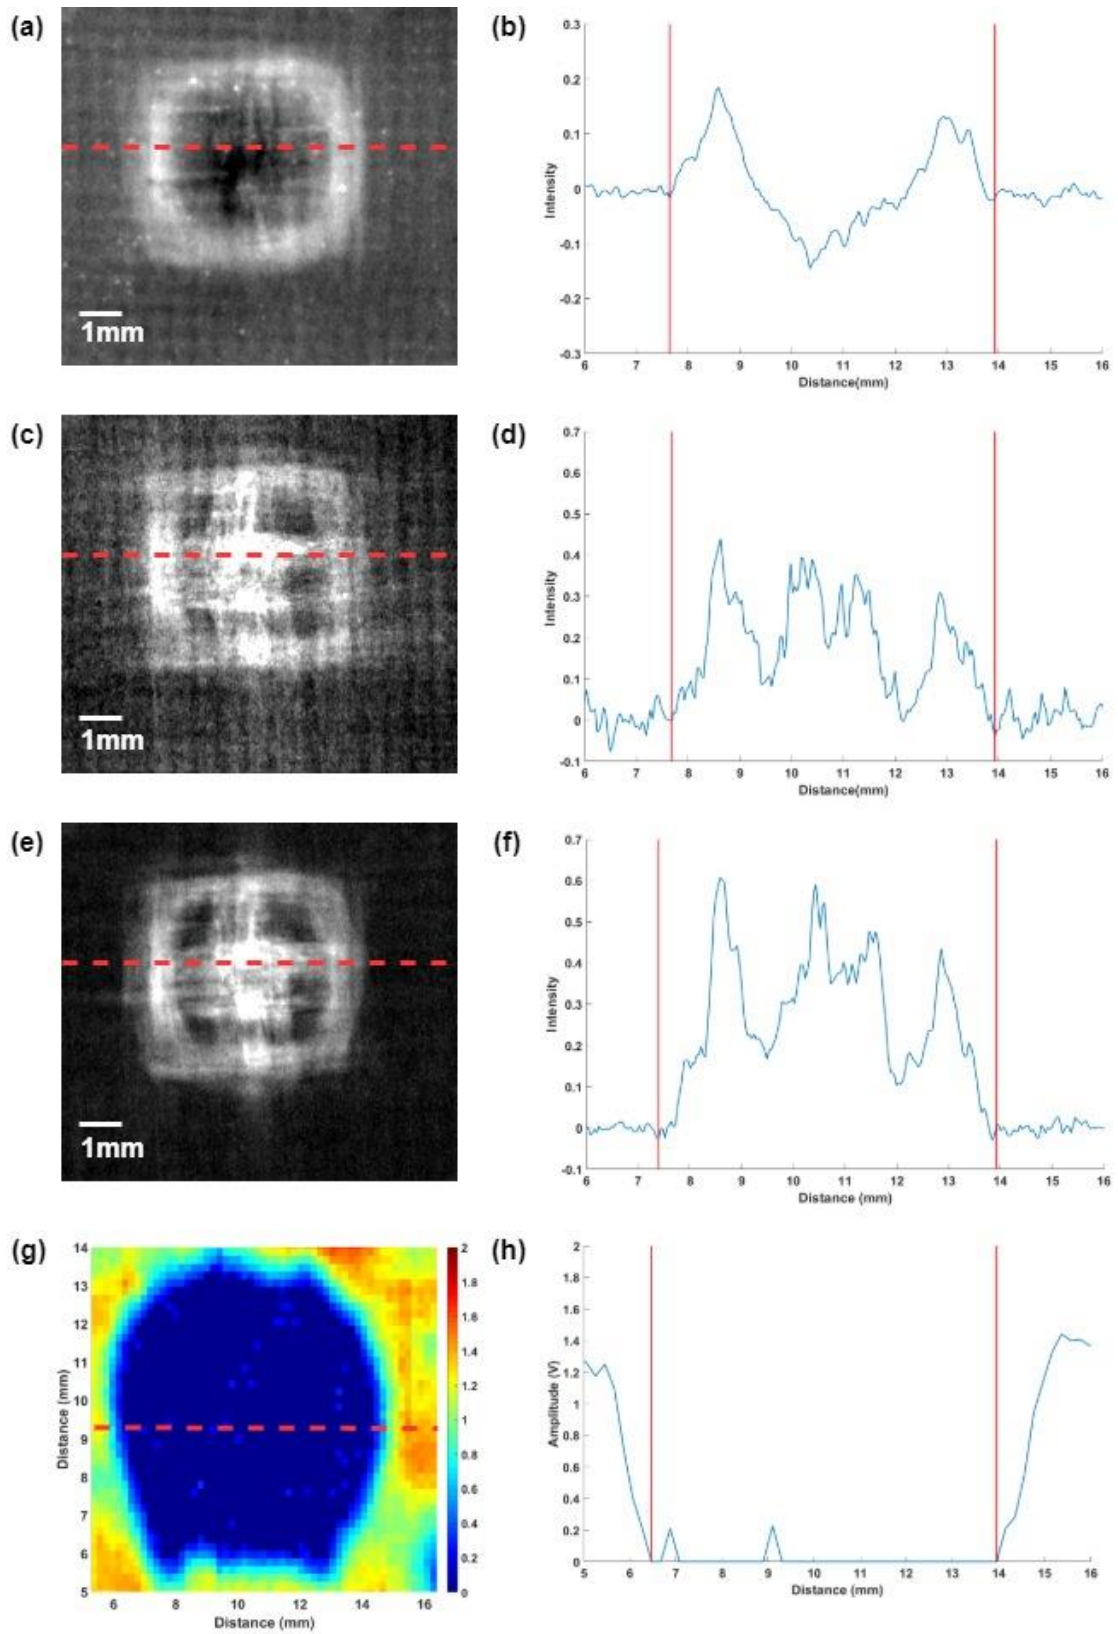
521 **Figure 9**

298 in the absorption 2D projection (Fig. 9a) the damage appears round-shaped, similar to
299 the shape observed in the double through transmission ultrasonic C-scan (Fig. 9g).
300 However, the refraction and scattering signal show a more square-shaped damage
301 indication (Fig. 9c/e), due to the types of defects observable in these signals. Profile
302 plots were taken across the 2D projections of the sample in order to assess the damage
303 extent across the damaged area of the sample. Examples of such profile plots are shown
304 in Fig. 9b/d/f/h, corresponding to the red lines in the 2D projections. A simple
305 thresholding method was used to assess the extent of the damage. It was measured to
306 be approximately $5.9 \times 5.4 \text{ mm}^2$, $5.9 \times 5.7 \text{ mm}^2$ and $6.6 \times 7.3 \text{ mm}^2$ for the absorption,
307 refraction and scattering signals, respectively. As expected, the scattering signal

308 indicates a larger damage extent than the absorption and refraction signals, due to its
309 sensitivity to sub-pixel features. The dimensions observed in the double-through
310 transmission C-scan of the sample were calculated to be approximately $6.7 \times 7.1 \text{ mm}^2$,
311 comparable to the size obtained from the scattering signal.

Figure 9: Horizontal profile plots taken across 2D projections of CT retrievals (red line on
images) for (a-b) absorption, (c-d) refraction, and (e-f) scattering signals; (g-h) ultrasonic
double-through transmission C-scan.

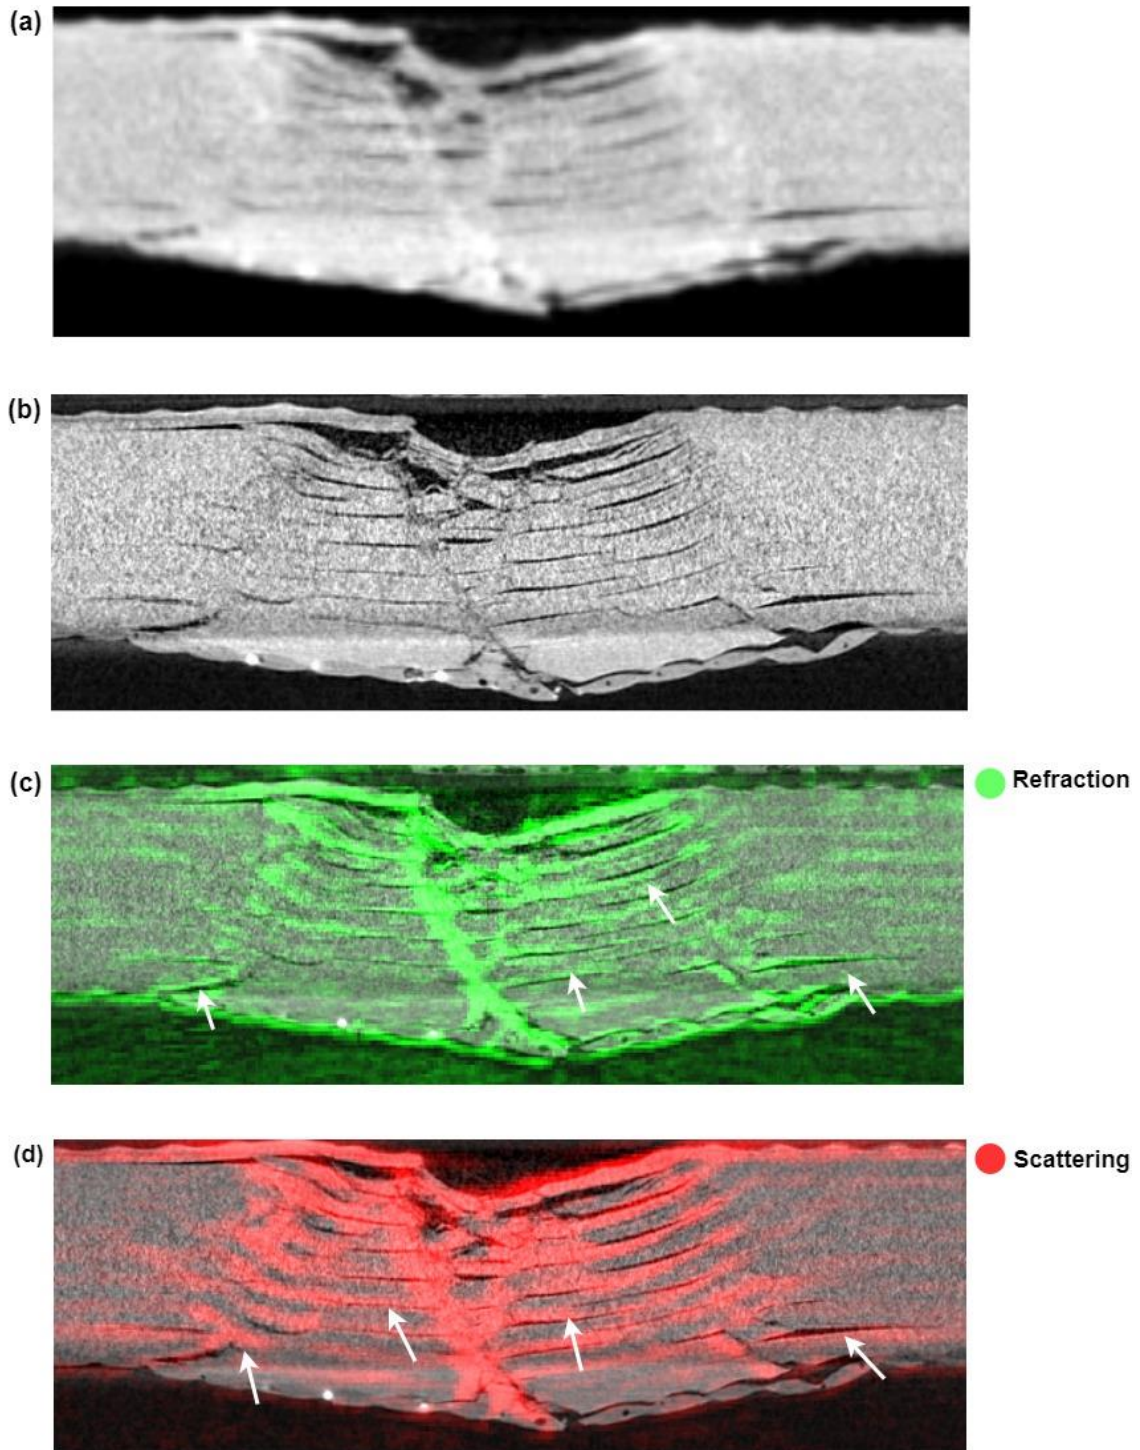
312 The features observed in the EI XPCi signals were compared to a high resolution
313 X-ray CT scan performed using a commercial system with voxel size of $(14\mu\text{m})^3$. The
314 higher resolution absorption scan (Fig. 10b) confirms the features observed from the
315 lower resolution absorption (Fig. 10a), refraction, and scattering signals. This is more
316 clearly visible in Fig. 10c/d, where the respectively the refraction and scattering signals
317 were superimposed on the high resolution absorption scan. The interfaces observed in
318 the refraction signal are confirmed by the high resolution scan (Fig. 10c arrows). The
319 presence and extent of those interfaces confirms our interpretation as to the nature of
320 the refraction signal. Small voids created between the plies, not visible in the low
321 resolution absorption scan (Fig. 10a), became visible in the high resolution absorption

322 scan (Fig. 10b), and match the superimposed scattering signal (Fig. 10d). The scattering
323 signal extends beyond the damage visible in the high resolution scan in certain areas,
324 suggesting that an even higher resolution scan would be needed to observe these
325 features. This confirms our hypothesis that the scattering signal indicates micro-damage
326 at a scale below the resolution of the imaging system.

495 **Figure 10:** Comparison of crack observed in the sample for (a) low resolution absorption
496 scan; (b) high resolution absorption scan using commercial system; superposition of the
497 high resolution absorption scan with (c) low resolution refraction signal (green) and with
498 (d) low resolution scattering signal (red).
