# The Collapse of World Trade Center 7: Revisited

Mhd Anwar Orabi<sup>1</sup>, Liming Jiang<sup>1,\*</sup>, Asif Usmani<sup>1</sup>, Jose Torero<sup>2</sup>

<sup>1</sup>*Research Centre for Fire Safety Engineering, Department of Building Environment and Energy Engineering,  
The Hong Kong Polytechnic University, Hong Kong*

<sup>2</sup>*Department of Civil, Environmental, and Geomatic Engineering, University College London*

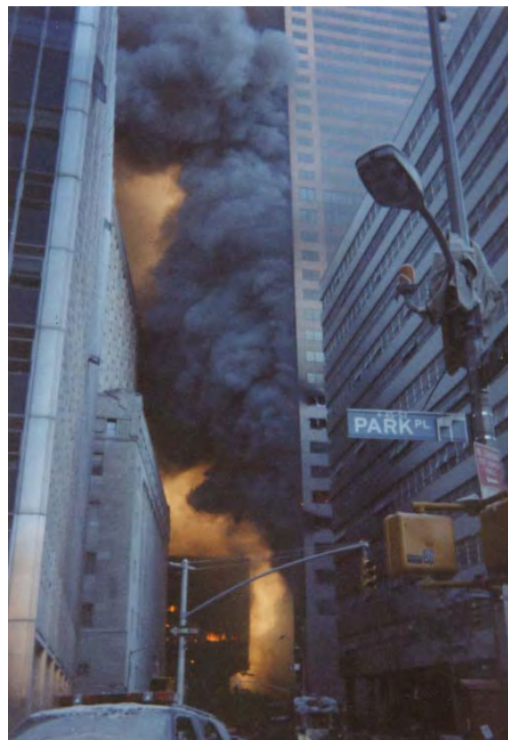
by Mowrer [20] that dark smoke indicative of hydrocarbon combustion was observed in the videos and witnessed by first responders after 3:30 PM just outside the northeast corner of the building as seen in Fig. 3 [19]. This may potentially have been smoke exhausted due to a fire in the mechanical room.

Fig. 3. Smoke outside the northeast corner of WTC7 between 4:15 and 4:38 PM. From [20]

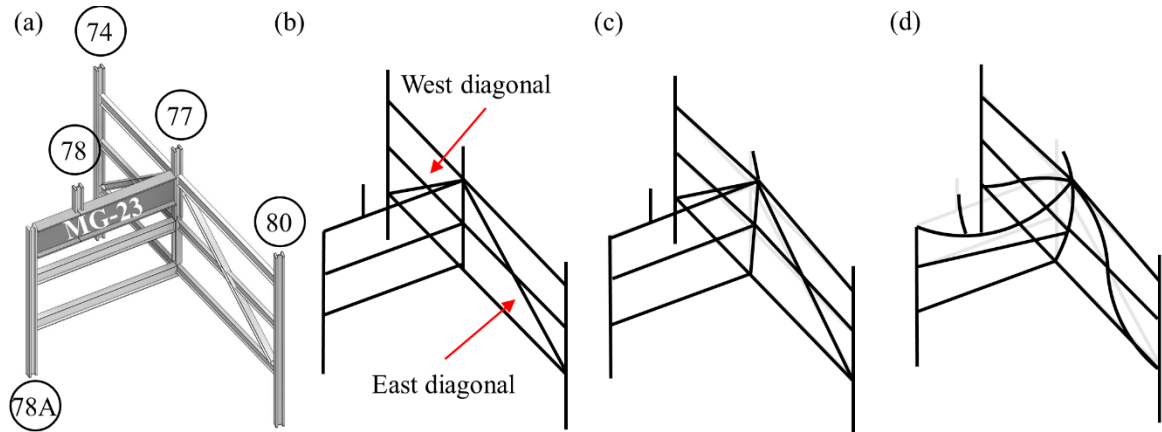
This is particularly important because the mechanical room contained a portion of Truss 2, one of the two major transfer structures in the east of the building. Truss 2, as shown in Fig. 4 (a), supported two core columns and had a large built-up girder (MG-23) framing into it from the south. Fig. 4 (b) through (c) shows a potential failure mechanism that may have been induced by heating of the truss. As the diagonal members are under high compressive loading due to restrained thermal expansion, the heated girder MG-23 applies out-of-plane load to the truss. Unable to sustain the loads, the truss may fail and affect the overall stability of the building. The hypothesis that the fire may have compromised the transfer structure which would in turn affect global stability will be investigated in the coming sections.

Fig. 4. The potential collapse of Truss 2 (a) Truss 2 column and girder designations, (b) Truss 2 line representation, (c) As MG-23 heats up it pushes on Truss 2 out-of-plane, and (d) due to P- $\delta$  effects Truss 2 diagonals buckle and vertical support is lost to columns 77 and 78

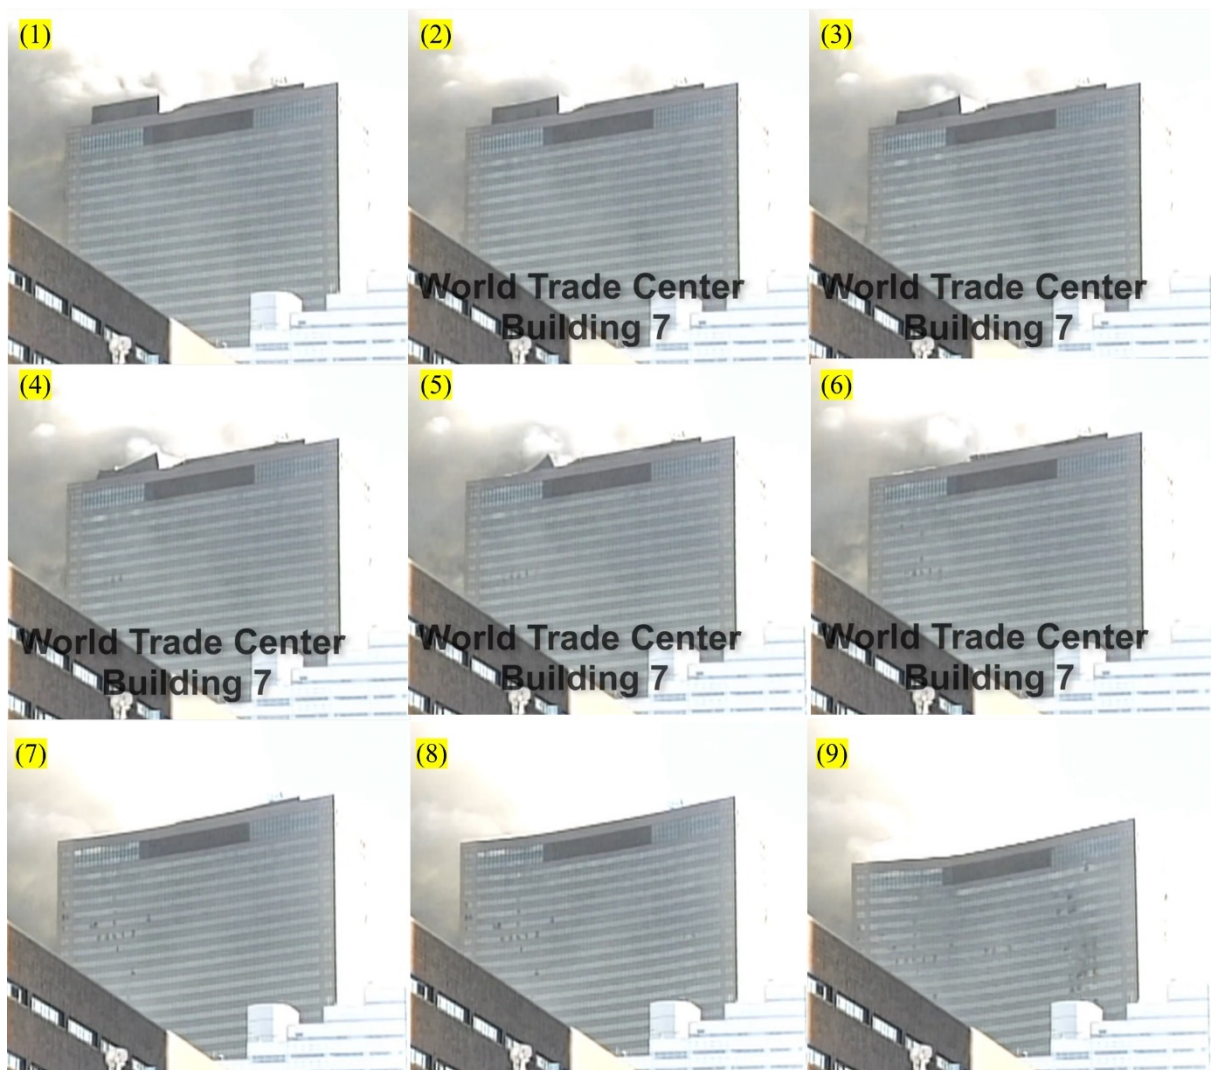
The failure of WTC7, as shown in Fig. 17, appears to have begun somewhere in the north-east part of its internal structure. This is commonly characterised by the distinct ‘kink’ that appeared in the edge of the east section of the penthouse on the roof as shown in the 3<sup>rd</sup> frame of Fig. 17. The eastern part of the penthouse completely sinks into the structure by the 6<sup>th</sup> frame followed by the remaining portion which has disappeared from view by the 8<sup>th</sup> frame. After the penthouse has completely sunk into the building, the remaining structure progressively collapses. Another kink is observed in the edge of the building as it failed and is clearly visible in the 9<sup>th</sup> frame. The entire collapse of the 47-storeyed tower happened in less than 14 seconds, and had begun somewhere in the lower floors [14].

Fig. 17. Early stages of the collapse of WTC7. From NIST video [56] showing the North face of the building

The buckling would likely begin with columns 80 or 79 as they were carrying the heaviest load, and their failure starting on any of the fire floors would rapidly manifest as the kink seen on the east penthouse and shown in frame 3 of [Fig. 17](#). Indeed, one of the few points of consensus among the investigation teams is that the failure of column line 79-80-81 would manifest itself as a kink in the penthouse structure. The initialisation of the failure to the west of the middle of the east penthouse caused by the failure of Truss 2 then results in the sinking in of the entire east penthouse as was clearly observed in frames 4 and 5 of [Fig. 17](#). Without columns 79 through 81, and with the penthouse already sinking into the structure, the building begins to fail. The failure of column line 79-80-81 and the floors they once supported would nullify the damping effect of the upper floors that had resulted in the low deflection rate in Model 2. The absence of load-carrying capacity of columns 78 and 77 should then manifest in the collapse of WTC7 accompanied by a kink in the building edge, which was indeed clearly visible in frames 7 through 9 of [Fig. 17](#).
