# Exposure and Susceptibility of Inactive and Abandoned Tailings to Flash Floods in Chile

## ABSTRACT

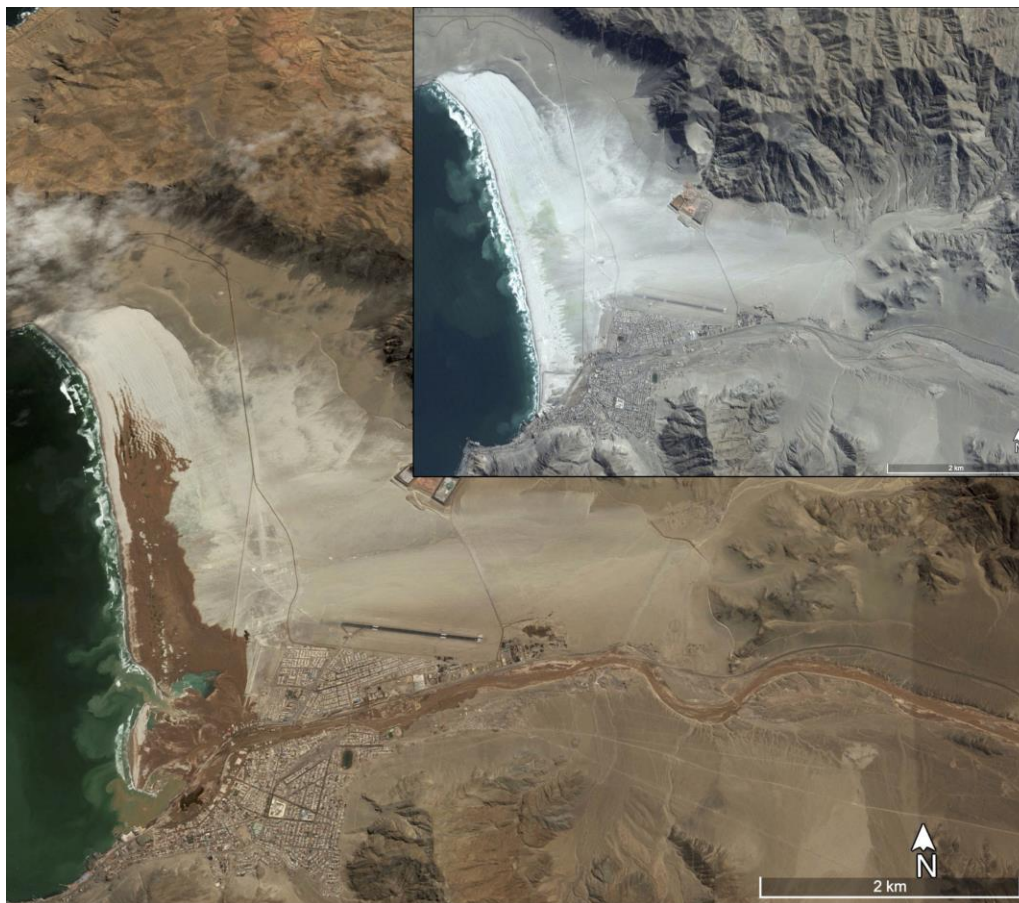
Chañaral beach in the Atacama Region lies immediately north of the small coastal city of Chañaral at the mouth of the Salado river (Figure 1). Between 1938 and 1974, around 150 million tonnes of untreated tailings were discharged directly into the Salado river and transported in suspension to Chañaral bay (Castilla, 1983). An artificial beach formed as a consequence, which in 1982 was about 5 km long, 0.4 km to 0.9 km wide and 1 m to 5 m deep (Castilla, 1983). From 24–26 March 2015, intense rainfall and flooding events affected the Atacama Desert (mean annual precipitation in the driest parts is less than 5 mm), with the Salado river basin being most affected: total rainfall up to 80 mm over 51 hours, flood peak discharge of about 1000 m<sup>3</sup>/s and flood depths over 4.5 m in Chañaral (Wilcox et al., 2016). Flood water from the Salado river carved two clearly defined pathways across Chañaral beach, eroding tailings into the ocean, and deposited brown sediment on top of a large area of the beach (Figure 1).

**Figure 1** Google Earth images showing the Salado river, Chañaral and Chañaral beach before (23 July 2013, inset) and after (05 April 2015) the 24–26 March 2015 flood event

The area of Chañaral tailings beach eroded was estimated to be 675 000 m<sup>2</sup> (Stile, 2020). If 1.8 m is taken as the maximum erosion depth, then the greatest volume of tailings eroded would have been

1 215 000 m<sup>3</sup>. This figure is expected to be an overestimate, but suggests that at least several 100 000 m<sup>3</sup> of tailings were scoured from the beach and transported into the ocean.

The primary erosion mechanism at Chañaral beach was scour caused by the flood water flowing down the Salado river. Along the Marquesa section, it appears that flood water eroded and undercut the toes of tailings deposits, causing the material above to detach along steep to vertical brittle failure surfaces and fall or topple (Figure 3). Such brittle behaviour implies that the tailings acted as bodies of cemented sand and silt, which is consistent with the maturity of the deposits. These proposed mechanisms for the Marquesa section are hypotheses at this stage and could be tested through site investigation, additional image analysis and eye-witness accounts.

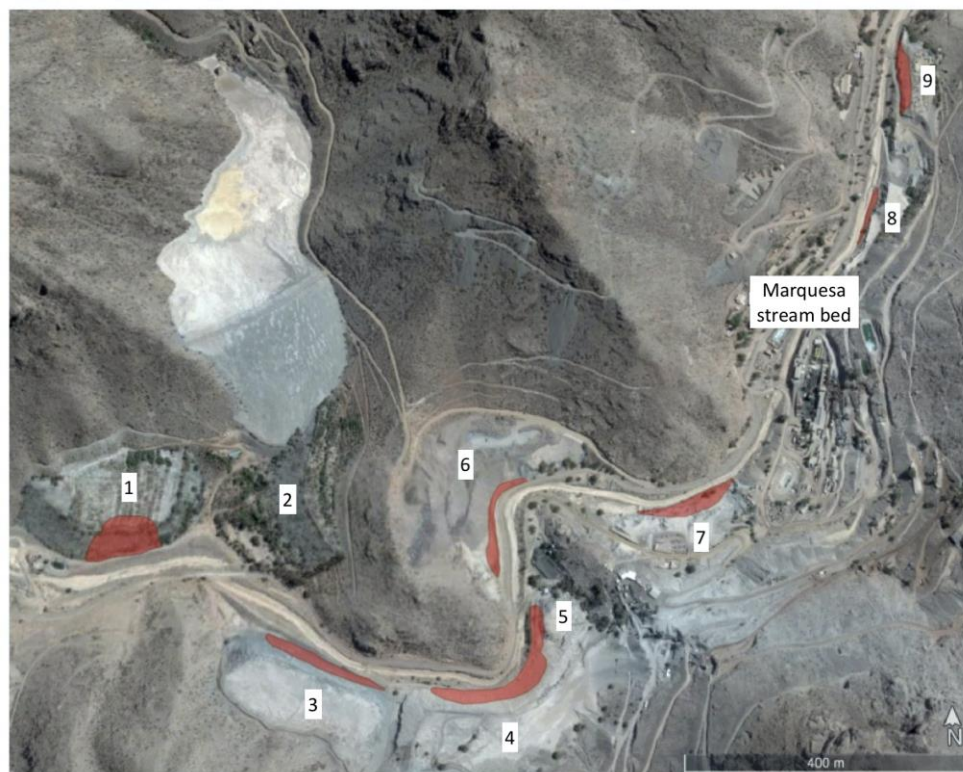
**Figure 2** Google Earth image from February 2017 showing the nine inactive and abandoned tailings studied along the Marquesa valley bottom, with approximate zones of tailings eroded in May 2017 shaded red

The results of the two methods for estimating the Marquesa tailings losses are presented in Table 1 and compared to the estimates reported by Falcón (2017). Despite reasonable agreement in the totals, there is significant discrepancy between several of the individual estimates. Without access to the tailings sites, it is not possible to ascertain which results are most accurate. If the lowest and highest values are taken for each facility, the total loss lies between about 77 000 m<sup>3</sup> and 150 000 m<sup>3</sup>. Overall, the results suggest something of the order of 100 000 m<sup>3</sup> of tailings were lost.

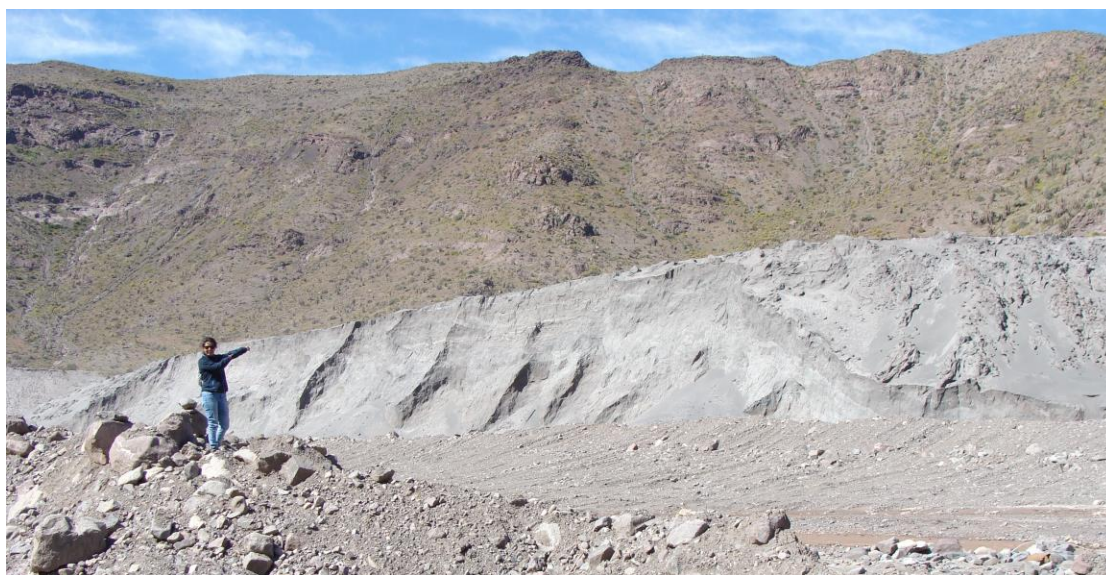
**Figure 3** Eroded section of tailings deposit 3 (Figure 2) in the Marquesa valley photographed in September 2017 and showing the steep slope left after failure, which reveals internal stratification of tailings
