Seismic screening and structural investigation of heritage buildings for adaptive reuse: a survey study at Iloilo City, Philippines

To cite this article: Richard De Jesus *et al* 2022 *IOP Conf. Ser.: Earth Environ. Sci.* **1091** 012008

Richard De Jesus^{1,5}, Andres Winston Oreta¹, Mary Earl Grio², Rodolfo Mendoza, Jr. ¹, Lessandro Garciano¹, Rhodella Ibabao³, Giacomo Sevieri⁴ and Carmine Galasso⁴

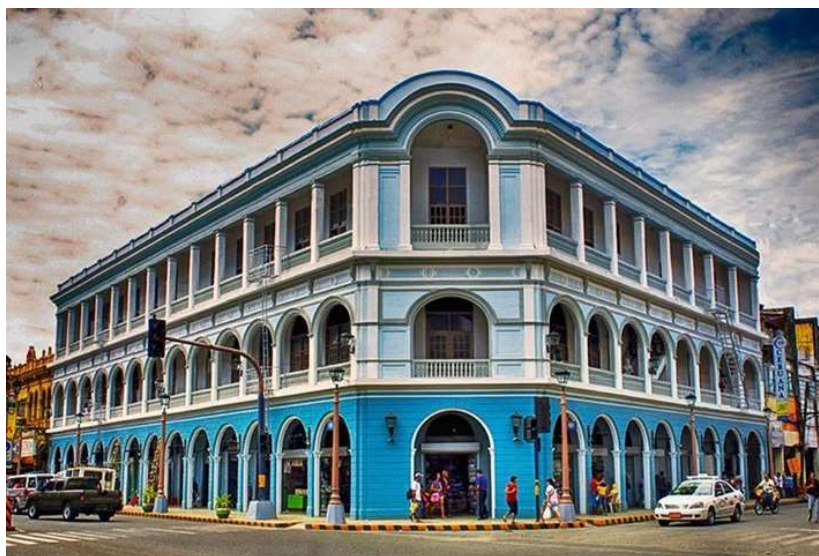
Figure 2. Villanueva Building (01-008), one of the CH structures in Calle Real

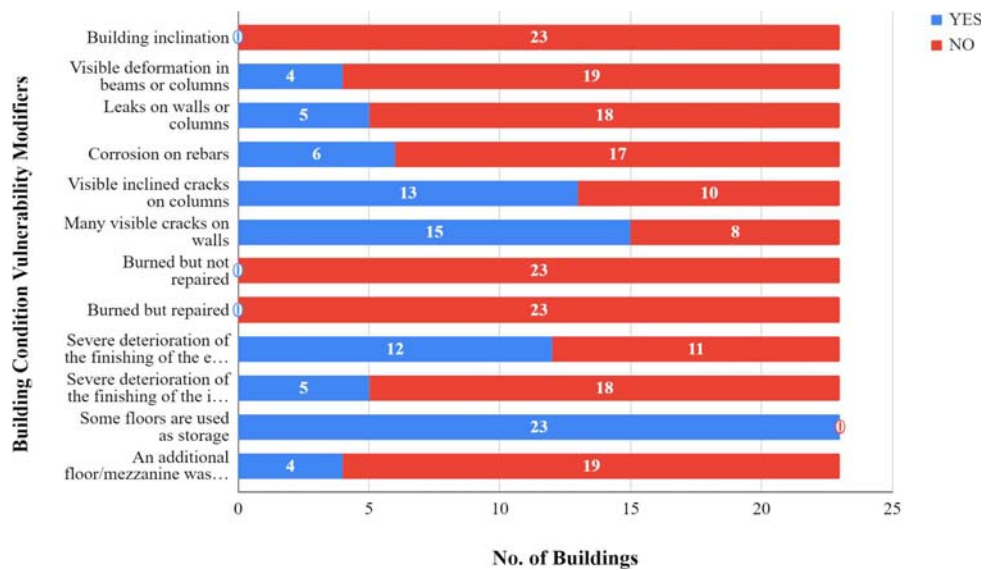
Figure 5 shows the statistics for seismic vulnerability modifiers. All buildings did not exhibit significant inclination as judged through a street survey. Also, all twenty-three (23) buildings had not been exposed to fire. However, all buildings somehow had used the whole or a portion of flooring for storage. Many of the structures had visible deformations, had shown leaks on walls and columns, and had exhibited cracks on structural members. Severe deterioration can also be observed from the finishing of both the exterior and interior parts of the structures. Finally, many of these structures had installed an additional floor/mezzanine for additional storage.

Figure 5. Building Condition Modifiers.

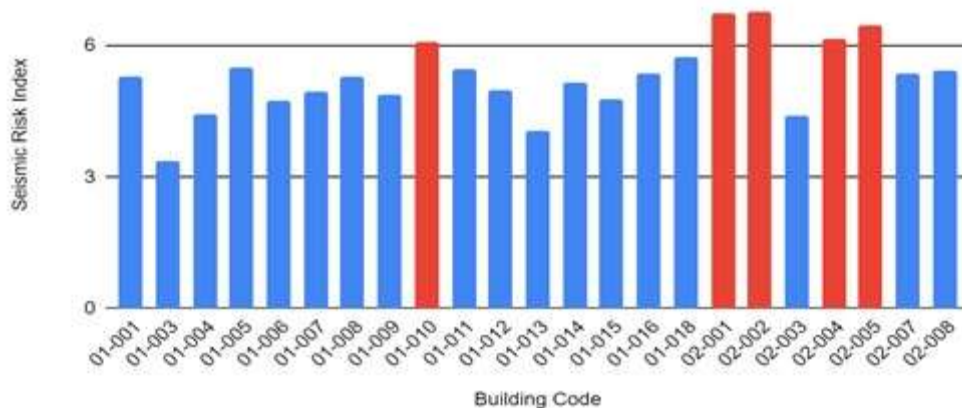
In the seismic risk index of figure 6 and seismic risk map in figure 7, it is seen that the 02-002 Villanueva is the most at-risk building with a seismic index of 6.78 classified under high risk. On the other hand, the building with the lowest risk as its index is only 3.38 is the 01-003 Pilar building classified as medium risk.

Figure 6. Seismic risk index.

Among the 23 assessed buildings, five (5) heritage structures are at high risk while the rest (18) are at medium risk. The seismic risk index ranges from 3.38 to 6.78. Five buildings that are found to be at high risk shared the same highest rating criteria which is the structural system material (V6). Twenty-one (21) out of twenty-three (23) buildings scored 0.44 or medium risk since the beams, columns, and girders of the buildings are mostly made up of reinforced concrete. This is estimated to contribute to 21.89% of the average vulnerability rating.

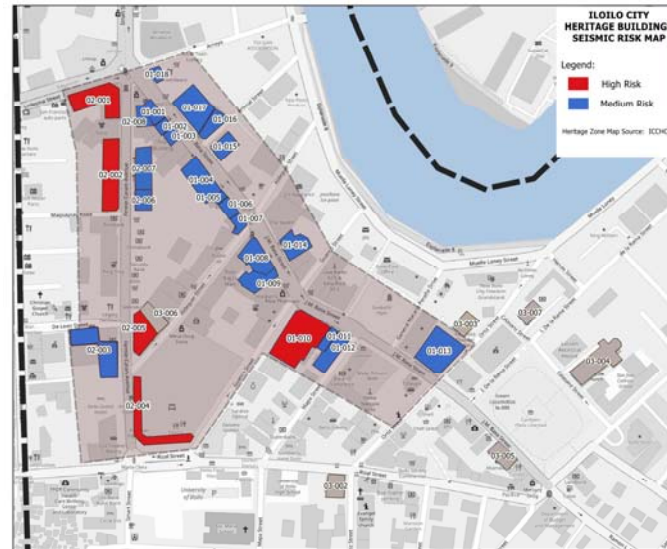
Figure 7. Seismic Risk Map of Calle Real

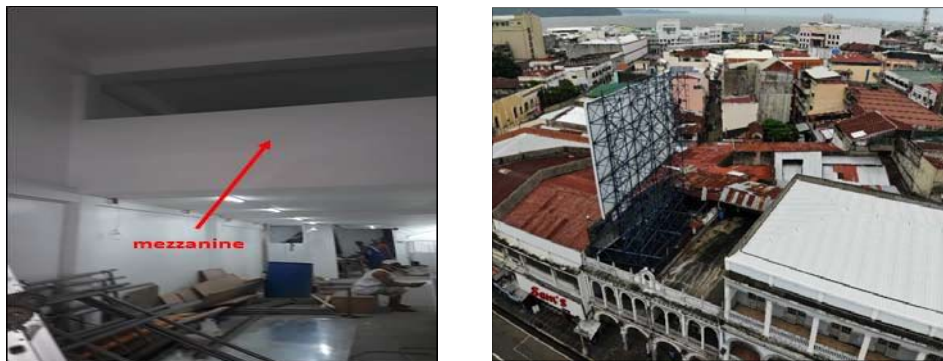
During the site survey, several functional and structural issues were found in cultural heritage structures in Calle Real. Structure owners, to maximize earnings from their property with the least expense, put their property up for commercial lease based on the as-is condition of the structure. Since Calle Real is one of the busiest commercial areas in Iloilo City, rental fees are significantly high and as a result, tenants have imposed modifications on the structure to maximize the usable commercial space of the structure. Some of these modifications are conversion of spaces for storage, installation of the mezzanine for additional storage area (figure 8a), removal of a building component (e.g., column) to increase

commercial space, installation of billboards on top of the structures (figure 8b), conversion of entire 2nd floor to storage, and cutting off a portion of roof for other purposes.

Figure 8. (a) Installation of mezzanine; (b) installation of billboards on top of the structure

Issues about structural integrity were also discovered during the site survey. Based on the preliminary survey, although a truss system was installed to provide support for the billboard structure placed on the roof deck of the building, no evidence is seen on the improvement of the structural elements of this building to carry the additional load. Roof alterations were also observed in some structures to accommodate the installation of a water supply tank. Other structural integrity issues found in some buildings are the conversion of entire floors as storage spaces and also the installation of mezzanines for additional storage. These building use alterations have caused excessive sagging of the floor due to excessive weight brought about by stored supplies.
