The Application of Thermal Imaging as a Nondestructive Test in Historic Buildings

As a case study, David house¹² has been chosen for structural and thermal investigations through infrared thermal imaging. The building envelope in David house consists of adobe structure and clay façade. In some parts, the clay façade has been replaced by brick. There are several openings in building envelope.

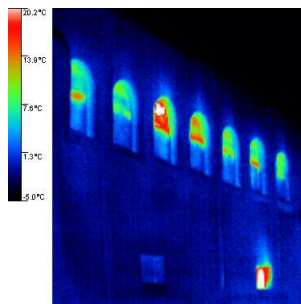
Thermography of David house indicates that the most important thermal bridges of the envelope were single glazed windows. Figure 5 and Figure 6 Show thermal bridges in David house. The red parts in the windows represent thermal loss through single glazed windows, which are considered as thermal bridges. In order to resolve thermal defects through windows, their glasses should be double glazed or another frame should be added in front of the old window from inside or outside the envelope. The decision making on double glazing the existing window or adding another frame depends on the structure of window in terms of bearing the load of a new material and historic preservation theories.

Figure 5. Thermal bridges in thermal images of David house, Isfahan, Iran.

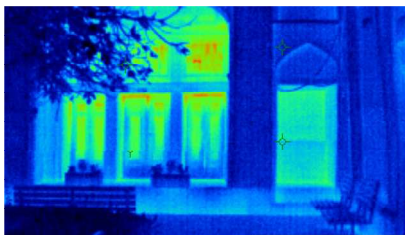
In David house, locations of air leakage in building envelope are mostly loos conjunctions between openings and the rest fo envelope. Figure 7 shows the heat loss from top of the wooden doors through their conjunction. In most cases, in historic buildings, the loos conjunction occurs when the framing materials have lost their initial shape. In most cases, airleakage problems are solved through repairing the framing parts for giving them their initial shape and injection of some materials such as polystyrene foams in their gaps.

Figure 7. Heat loss from wooden doors through their conjunction, David house, Isfahan, Iran.
