# Impact of Moisture Decay on Seismic Vulnerability: Haiti’s Wood-Framed Vernacular Buildings

## 1. Structural Damage to Wood-Framed Buildings following the 14 August 2021 Mw7.2 Haiti Earthquake

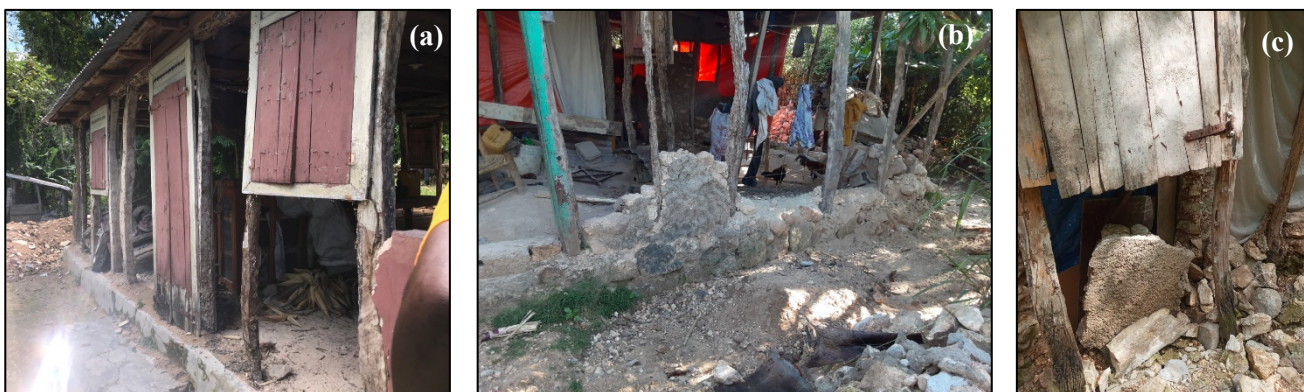
During the damage assessment process, we identified moisture-related problems decreasing the resilience of the typology: weathering, insect attack, rising damp, and moisture decay on wooden posts, which then manifest as significant section losses lessened adhesion between framing and infill, and loss of connections adversely impacting on structural performance under seismic loading as demonstrated by more than a third of severely damaged buildings (57/154). Figure 2 displays some of the severe damage cases that moisture decay observed in the framing. In both (a) and (b), longitudinal posts seem to have been rotten due to moisture, which prominently affects the quality of wood and connection. On the other hand, the affected section of posts in (c) is at the foot, which has traces of rising damp.

Figure 2. Examples of moisture decay were observed in wooden frames (Earthquake-induced structural damage is severe for each).

Key post-disaster messages in light of these observations include that the vernacular buildings detailing should be amended such that the contact between wooden posts and ground moisture is cut, for example through a masonry base. Additionally, precautions against moisture brought on by precipitation should be taken through the surface waterproofing of wood-frames. Consequently, it is important to enhance not only the seismic but also climatic resilience of such vernacular typologies, and this perspective should be implemented in the reconstruction/built-back-better efforts.
