## HYBRID EEFIT MISSION TO FEBRUARY 2023 KAHRAMANMARAŞ EARTHQUAKE SEQUENCE

**Abstract:** *The southwestern part of Türkiye was hit on 6 February 2023 by an Mw 7.8 (epicentre: Pazarcık) and then an Mw 7.5 earthquake (epicentre: Elbistan). The event was followed by tens of thousands of aftershocks including the Mw 6.3 event on 20 February (epicentre: Uzunbağ). This paper reports on the preliminary findings of the mission organised by the UK's Earthquake Engineering Field Investigation Team (EEFIT) to the Kahramanmaraş Earthquake sequence of February 2023. This mission followed a hybrid model, combining field and remote investigation techniques, to investigate the characteristics of the earthquake sequence, its impact on buildings and infrastructure, as well as the efficacy of relief, response and recovery operations. The key messages include that the building stock is hard to categorise which brings along difficulties with damage assessment, that the recovery and reconstruction require multi-sectoral engagement of key stakeholders, and that the auditing and quality control mechanisms within the construction industry need revisiting in the way forward for better disaster resilience i

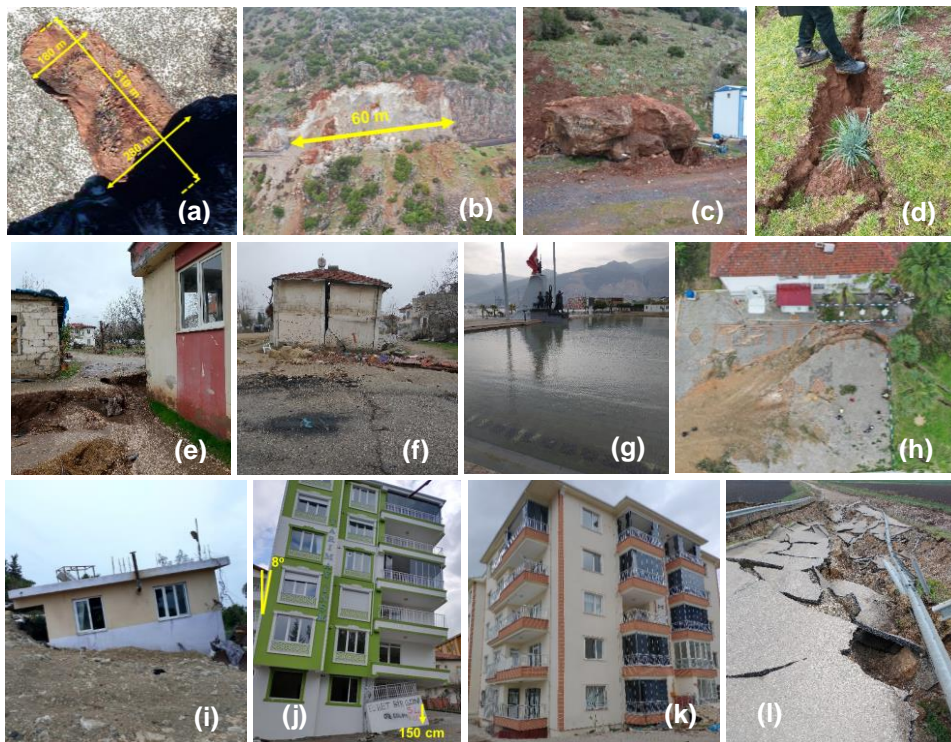
Landslides and rockfalls were identified in an area around Islahiye. Upstream of Değirmencik, a large landslide had taken place, which blocked the local road as well as a stream that passed through the valley (Figure 2a). A large reservoir had formed behind this landslide, which acted as a natural dam for the blocked stream. Piping was visible through it and the local authorities were alerted to its existence. Between Fevzipasa and Türkbağçe, a landslide initiated on a rock cut

had blocked approximately 60m along the rail line (Figure 2b). In the same area, multiple rockfalls were observed, which disrupted electricity, communication, and water lines. An example is shown in Figure 2c, where a large rock hit both an electricity tower and a water line. The fault surface rupture was mapped by the virtual reconnaissance team over a length of about 300km. Surface rupture was investigated by the field team at two locations around Islahiye and in the area of Gölbaşı, Adıyaman. Around Islahiye, the surface rupture was mapped both on the plains, as a continuous rupture and on a hill, where multiple parallel features were observed (e.g. Figure 2d). In Gölbaşı, Adıyaman, surface rupture features were observed within the town, where they interacted with shallow-founded structures. When a surface crack interacted with structures with stiff shallow foundations, it was diverted, wrapping around the foundations before continuing (e.g., Figure 2e). When surface cracks met structures with a weak foundation that could not provide a sufficient kinematic constraint, they continued through the structure, imposing differential displacements and causing structural damage (e.g., Figure 2f).

*Figure 2. Geotechnical observations from the EEFIT mission (a) Landslide upstream of Değirmencik, (b) Landslide north of Türkbahçe blocking the rail line (c) Rockfall north of Türkbahçe hitting both an electricity tower and a water line (d) Surface rupture on a hill (e) Interaction of surface crack with a stiff, strong foundation (f) Interaction of surface crack with a weak foundation (g) İskenderun Anıt Meydanı square subsidence (h) Lateral spreading at the school of Demirköprü (i) Shallow-founded structure at an area of liquefaction (j) Building with a shallow foundation and high aspect ratio in Gölbaşı (k) Building with a shallow foundation and low aspect ratio in Gölbaşı, and (l) Embankment failure close to Çöçelli*

Liquefaction was identified in three main locations visited: the seafront of İskenderun, around the Orontes River to the northeast of Antakya, and in the town of Gölbaşı, Adıyaman. The soil surface around the seafront of İskenderun, an area that is largely reclaimed, displayed several signs of liquefaction. The seawalls moved towards the sea, a settlement was observed behind them and ejected sandy material was visible at some locations in close proximity. Cracks related to lateral spreading were visible all along the inspected waterfront. Cumulative displacements of more than 40cm towards the sea were measured at multiple locations. Extensive subsidence was observed along Atatürk Boulevard in the districts of Yenişehir and Çay, large parts of which were underwater at the time of inspection (e.g., Figure 2g). Manholes were observed to “float” relative to their surrounding pavement, which had subsided. Finally, liquefaction-related settlement of structures was observed to the south of Atatürk Boulevard in the Çay district. Multiple locations of liquefaction manifestation were identified along the Orontes River. In Demirköprü, lateral spreading was observed along the river (e.g., Figure 2h). Structures with shallow foundations within the zone that liquefied and moved towards the river suffered excessive settlement and rotation. An example is shown in Figure 2i, where the depicted structure settled by 180cm and accumulated a rotation of 14°. Finally, a plethora of structures affected by liquefaction were

inspected in Gölbaşı. Most of the affected structures were founded on stiff raft foundations. Structural damage was limited, indicating a rigid-body-like response, which was facilitated by the raft foundations. Many structures experienced more than 1m of settlement. Structures with a high aspect ratio (height of structure over the width of the foundation's narrowest dimension) exhibited significant tilting (e.g., Figure 2j), while structures with a lower aspect ratio settled but exhibited limited tilting (e.g., Figure 2k). Bridges and approach structures were also inspected. Bridges along the Orontes and Karasu rivers displayed damage due to the spreading of the banks, leading to abutments rotating and piers tilting and forming plastic hinges at their connections with foundations. An approach structure close to Çöçelli village was also visited, which was founded on soft clay and suffered a major slope stability failure (Figure 2l).

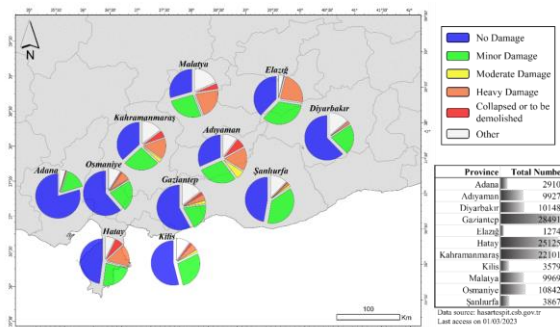
Before the field mission, (social) media and other web-based data sources and remote sensing products were used to gather preliminary information and effectively plan site visits. As part of the pre-fieldwork studies, the EEFIT team also assessed the damage dataset provided by Türkiye's Ministry of Environment, Urbanisation, and Climate Change (TMoEUCC). This extensive undertaking involved a team of over 7,000 experts, primarily comprising the ministry's technical staff, engineers representing vocational chambers, and academics. The Ministry's public dataset, accessed through [hasartespit.csb.gov.tr](http://hasartespit.csb.gov.tr), was last updated on March 1, 2023. Figure 3 illustrates the damage state per province, involving a total of over 1.28M buildings. Hatay, Kahramanmaraş, Adıyaman, and Elazığ were provinces with the highest proportion of collapses and heavy damage. Considering the seismotectonic characteristics of the sequence, it is seen that the structural damage was concentrated within/around the fault ruptures of the two MW7+ events.

Figure 3. Distribution of damage in the 11 provinces within the disaster region as per the damage assessment data by the TMoEUCC as of 1 March.

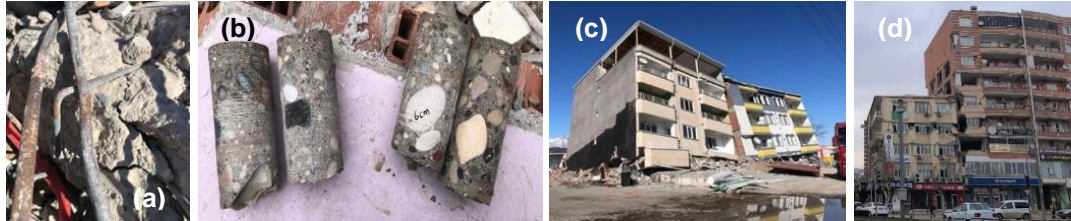
zoning amnesties have made pre-2000 RC buildings the most vulnerable group in the building stock. Consequently, these buildings suffered from problems such as inadequate reinforcement, abnormal granulometry in concrete, design issues like short column effects, soft/weak stories, pounding effects, and soil-structure problems (Figure 4).

Figure 4. Damage representations from the earthquake-affected cities (a) Plain round rebars and 90° hooks at the end of stirrups, (b) Abnormal granulometry, (c) Soft/weak story, and (d) Pounding effects

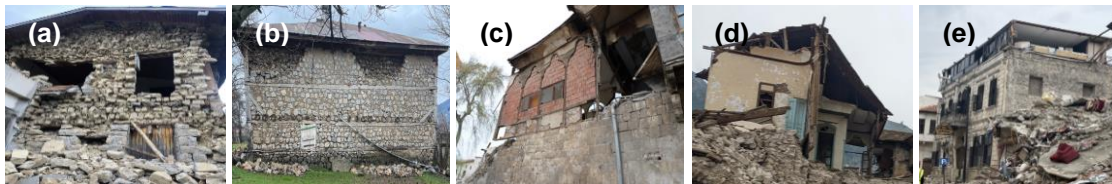
**Traditional Buildings:** Traditional buildings typically have 1-3 stories and can be classified into three categories: (1) Unreinforced Masonry load-bearing walls (URM), (2) Timber reinforced masonry; and (3) *Himiş*, a hybrid typology combining masonry ground floor, and wooden framed upper floors with masonry infill or cladding (Aktas, 2017). In big cities, these typologies are more often built with cut or irregular stones using lime mortar, while villages commonly used earth blocks and local stones with mud mortar. Many village houses lack regular maintenance. They exhibit a wide range of flooring options, including timber flooring, masonry vaults, and reinforced concrete (RC) slabs, and supported by steel I beams. One of the major failures observed in URM is the loss of integrity in the wall leaf composed of irregular stones. These issues can lead to various types of failures, which include roof collapse, localised out-of-plane (OOP) failure of individual spandrels and piers, global OOP failure of entire façade, failure at corners, separation of quoins that are unable to strengthen the connections between walls and failure of the gable. Alterations, such as adding extra floors or replacing original floors with heavier RC slabs, were observed to result in failures of entire floors or roofs, as evidenced by on-site observations. Pounding is commonly observed in traditional structures with varying heights, constructed using different structural systems, and at different times (Figure 5).

Figure 5: (a) URM (separation wall-leaf); (b) timber reinforced stone masonry (arch failure); (c) *Himiş* (OOP of bearing wall), (d) gable failure, and (e) addition of a storey

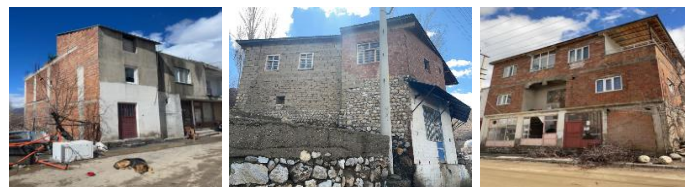
Figure 6: Examples of non-engineered buildings

**Modern Non-Engineered Buildings:** In villages, there is a prevalence of non-engineered 1/2-storey buildings made of RC. These isolated structures have demonstrated satisfactory performance during seismic events due to their low rise and lack of attachments to other buildings. In addition, there is a notable prevalence of hybrid systems in villages, which are built with a variety of materials like adobe, clay bricks, stone, and different structural systems such as RC frames and URM load-bearing walls (Figure 6). These constructions often lack engineered design, resulting in irregular structural systems with discontinuous beams and columns that disrupt the regularity of the structure and introduce complexity. Current building codes are insufficient for evaluating non-engineered and hybrid structures, hindering earthquake resistance assessment.

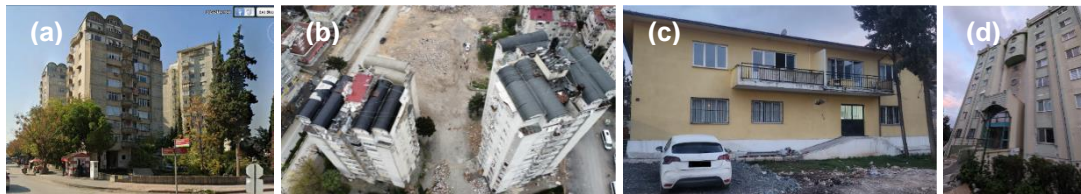
***Retrofitted Buildings:*** Although many buildings collapsed or sustained significant damage during the earthquake, there were also buildings that performed well compared to regular structures. For example, retrofitted buildings and those constructed by TOKI (governmental mass housing management unit) exhibited satisfactory performance and life safety levels. During our field mission, we visited some of these buildings and investigated the effectiveness of various strengthening techniques, including carbon-fiber reinforced polymer, shear walls, and masonry infills. These retrofit methods demonstrated that even with affordable techniques, buildings that do not meet code criteria can be significantly improved and collapse prevention can be achieved. Additionally, TOKI buildings, which constitute approximately 3-5% of residential buildings, achieved operational or immediate occupancy performance levels due to their high percentage of shear walls. Our observations showed that these buildings sustained mostly non-structural or minimal structural damage and remained occupiable after the earthquake sequence (Figure 7).

Figure 7: (a) 3-building complex before (b) and after the earthquake; (c) Masonry building with carbon-fibre-reinforced polymer retrofit; (d) TOKI building with minor damage.
