1 **Damage to monumental masonry buildings in Hatay and Osmaniye following the 2023 Turkey earthquake sequence:**
2 **the role of wall geometry, construction quality and material properties**

16
17 **Abstract** This paper reports on the findings of an investigation on 29 historic stone masonry buildings located in the cities of
18 Hatay and Osmaniye following the 2023 Turkey earthquake sequence. The earthquake couplet on 6 February (with moment
19 magnitudes 7.8 and 7.5) and the following events (including another earthquake which occurred on 20 February with a moment
20 magnitude of 6.3) resulted in significant damage to the buildings. To understand why, the examined buildings were assigned an
21 EMS-98 damage level (ranging from 1 to 5) and descriptive response categories (masonry disaggregation, local mechanism and
22 global response). Overall damage statistics indicated that masonry disaggregation was common and coterminous with local
23 mechanism response. Wall geometry and construction quality indices were then investigated to explore why these were the
24 dominant damage mechanisms. Wall geometry indices highlighted insufficient amount of walls to resist the local seismic

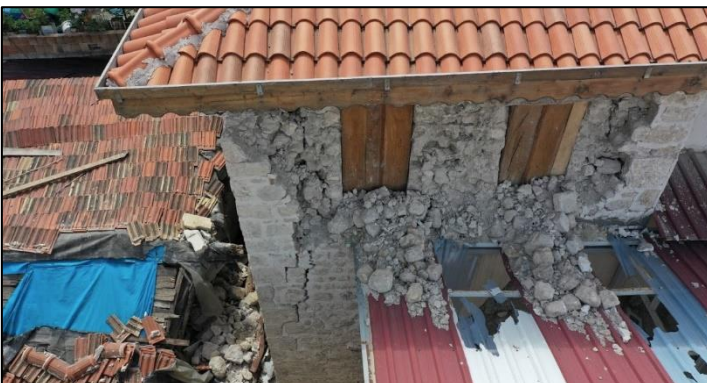
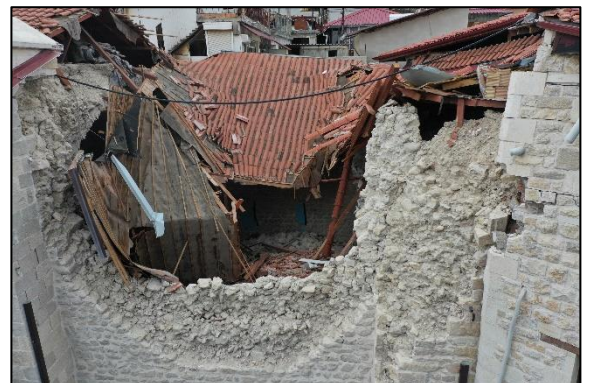
For the buildings examined, multiple response types had to be assigned as disaggregation was often observed alongside local or global response mechanisms. Fig.2a shows an instance where a local response mechanism involving the separation of building façades is seen alongside disaggregation. In Fig. 2b, the upper part of the disaggregated and leaning wall appears to have initiated a local response leading to vault collapse due to spreading supports. The EMS-98 DG and building response type are listed in Table 2.

Fig.2 Partially disaggregated masonry walls and local response mechanisms from a) R1 and b) C8.

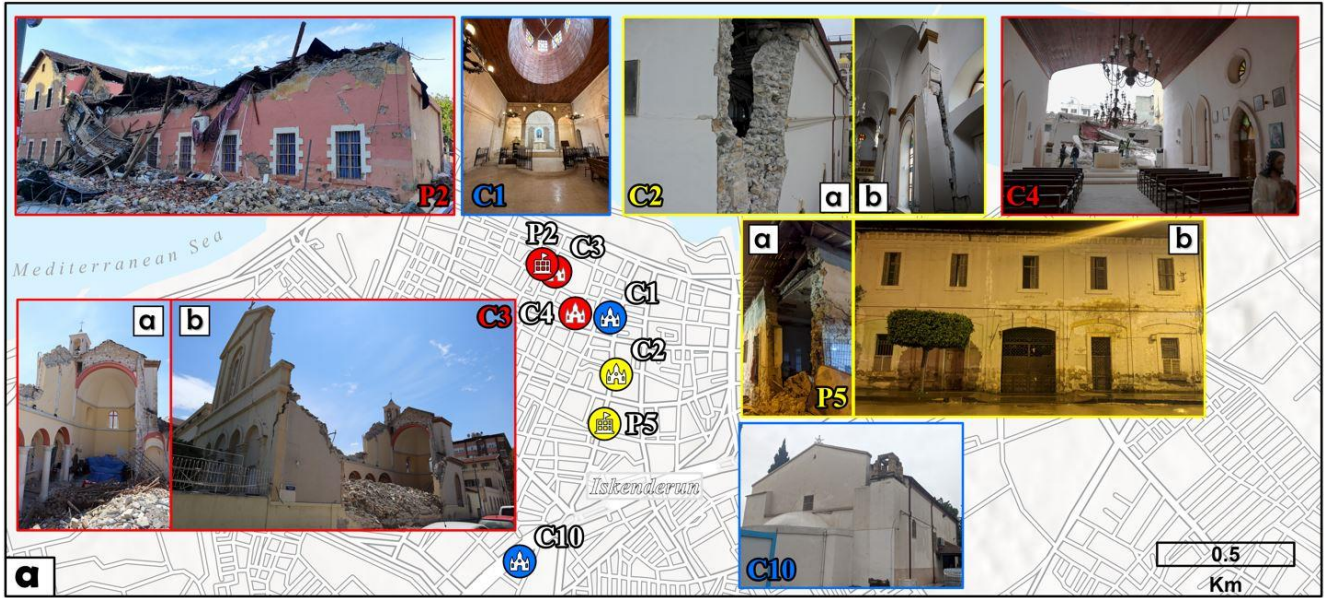
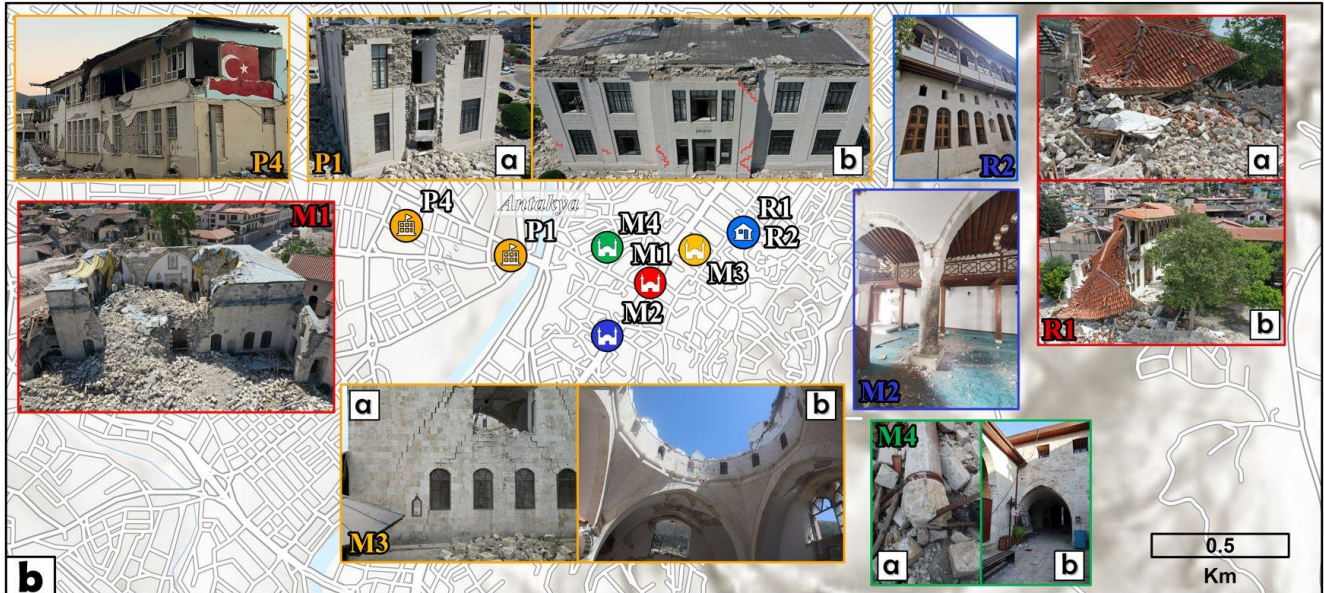
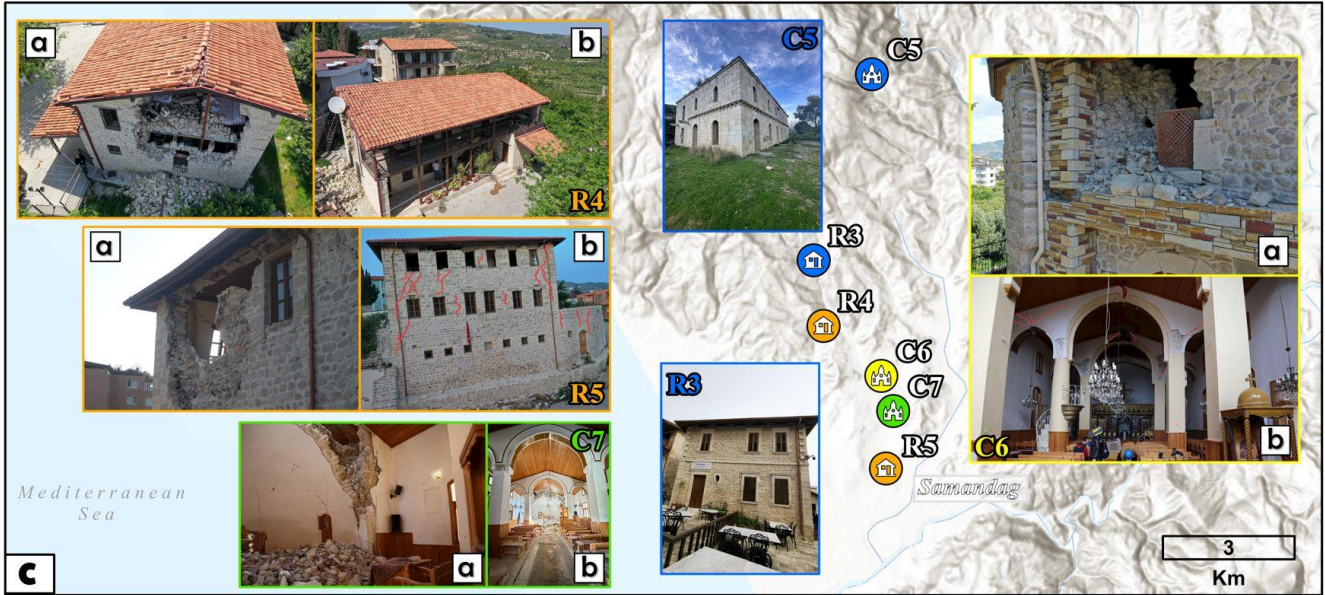
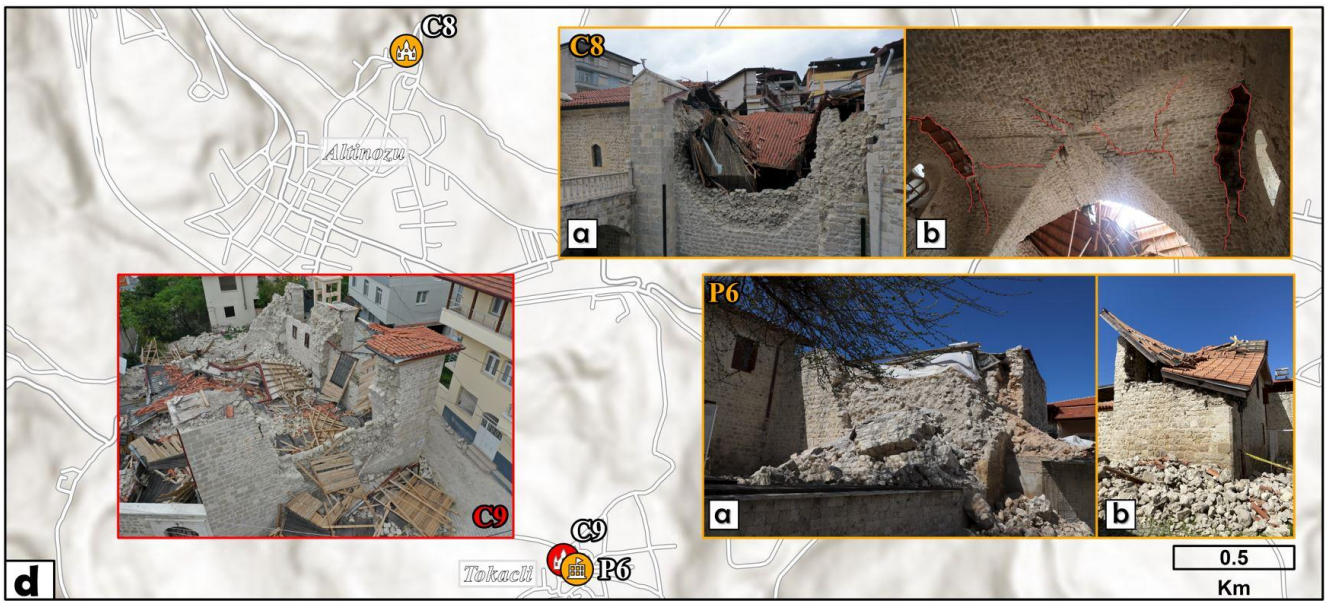
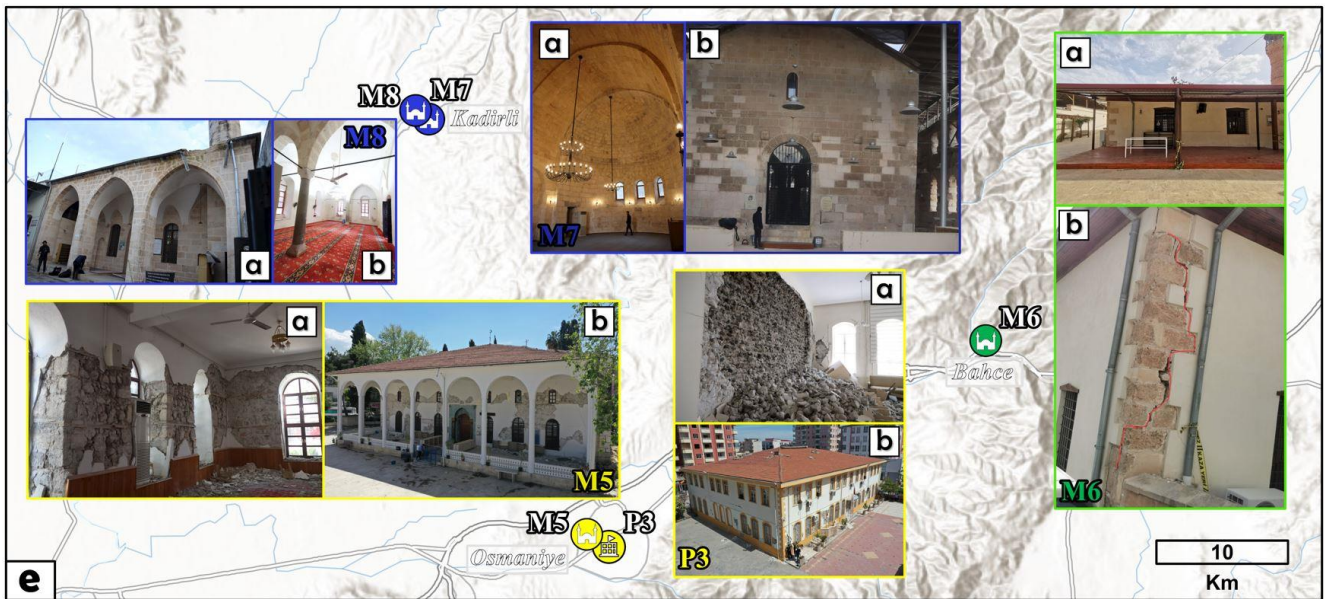
131 Fig.3. Location, EMS-98 DGs and photographs of the investigated buildings from a) İskenderun b) Antakya c) Samandağ d)
132 Altınözü e) Osmaniye

237 (including C3, M1 and P2) was due to local mechanism formation and out-of-plane motion of walls in the building transverse
238 direction (see Fig. 3). To evaluate the vulnerability of walls to overturning instability during out-of-plane motion, Fig.4d explores
239 the relationship between λ_o and PGA. According to Fig.4d, only 5 of the buildings have unsafe walls, indicating that the walls of
240 structures were, in general, sufficiently thick to prevent out-of-plane instability. However, several building walls in the safe zone
241 of Fig.4d (including C3, M1 and P2) collapsed in the out-of-plane direction. While the indices of only a small number of buildings
242 are discussed in the text for brevity, the numerical values of seismic indices for each building can be found in the Appendix (see
243 Table A2).

319 The data in Table 4 is useful to explain contradictory observations from Section 3. There, it was observed that several
320 collapsed buildings (e.g. M1, P2 and C3) were located in the safe zone of the out-of-plane seismic index λ_o . In other words, the
321 out-of-plane seismic index λ_o indicated that the total thickness to height ratio in these buildings should have been sufficient to
322 resist overturning instability. However, the MQI category of these buildings are either “*C*” or “*B*” and the wall internal connection
323 criteria *WC* are not fulfilled (“NF”). These results indicate that leaves may have separated during the earthquakes, reducing the
324 effective thickness of the wall in Eq.(3), and rendering it unsafe against overturning. For M1, separation of internal and external
325 leaves can be observed in Fig.7b. This disaggregation may have been responsible for the subsequent collapse of the mosque

326 dome (see Fig.3b). There are 11 buildings in Table 4, where the λ_o safety criteria is “Safe” but disaggregation is observed.

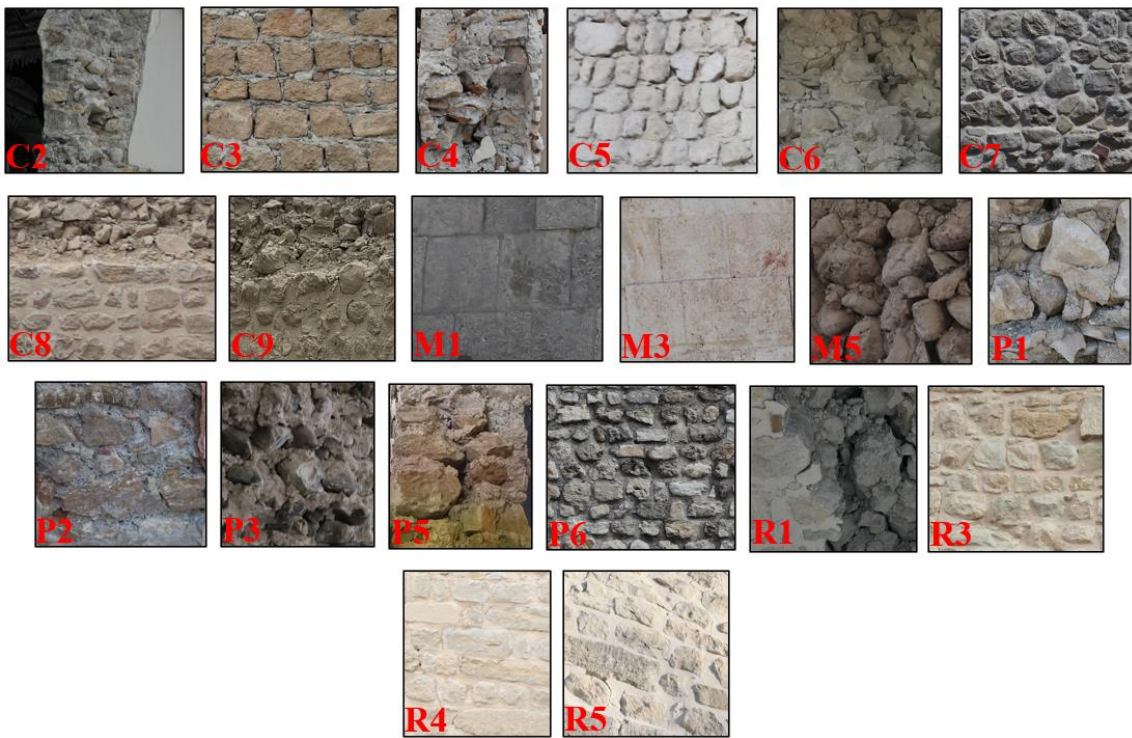
Fig.5. Representative zoom-in views of typical walls investigated in Table 4

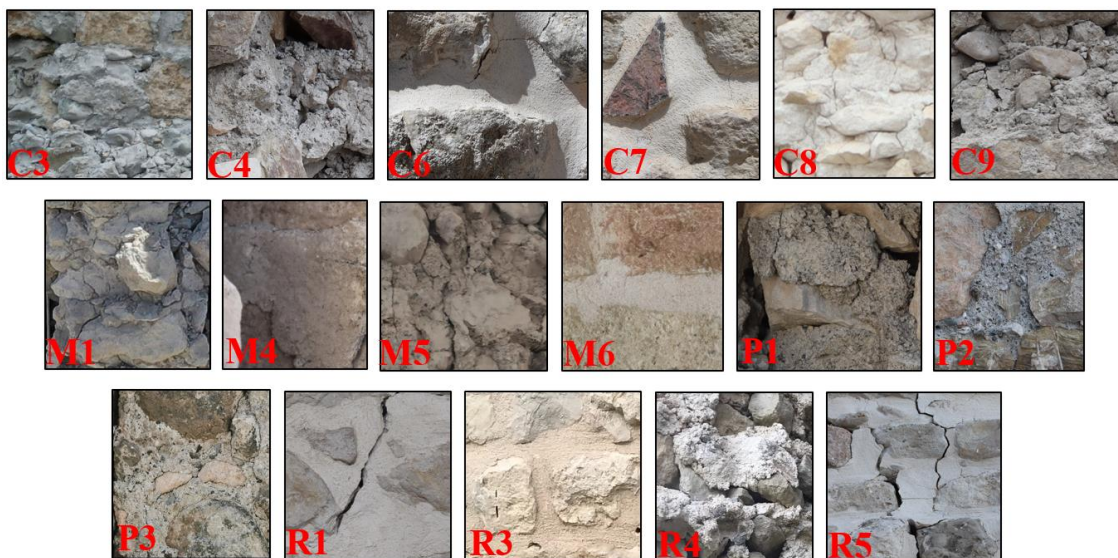
Fig.6. Representative zoom-in views of mortars investigated in Table 7

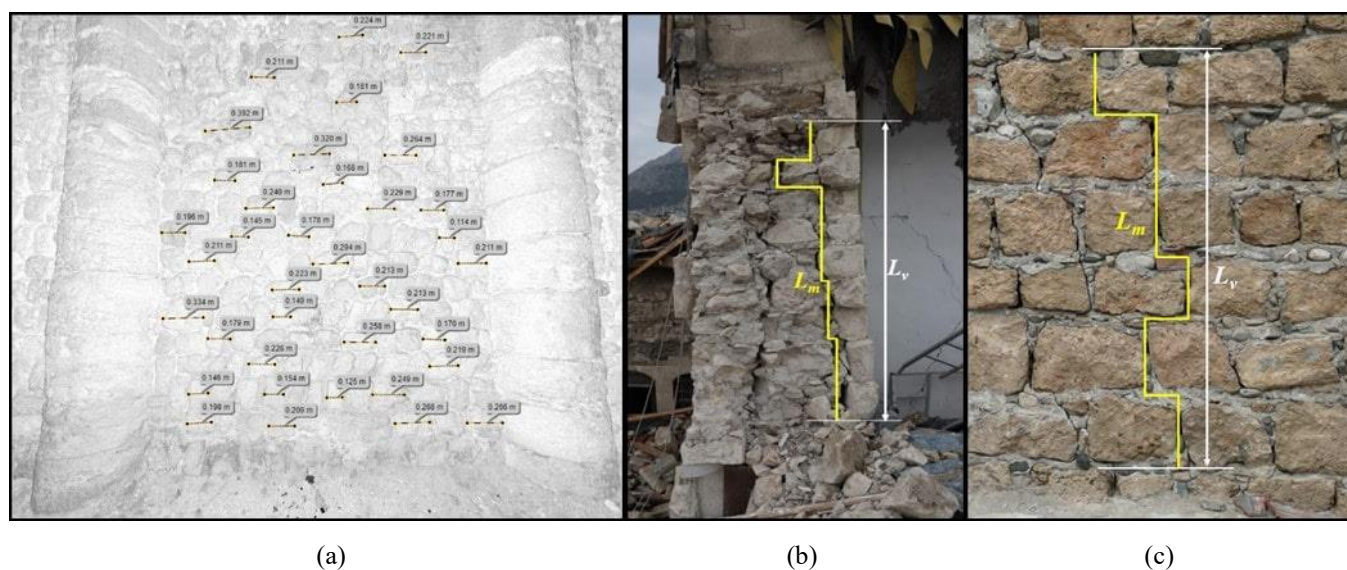
Fig.7. a) Stone dimension measurements from a point cloud (Building: C5), b) photograph of a through thickness cross-section of a disaggregated wall used for *WC* calculation (Building: M1), and c) an exposed wall surface used for *VJ* calculation (Building: C3)
