# INVESTIGATION OF STONE MASONRY CONSTRUCTION TECHNIQUES AND MATERIAL PROPERTIES IN HATAY AND OSMANIYE AFTER THE 2023 TURKEY-SYRIA EARTHQUAKES

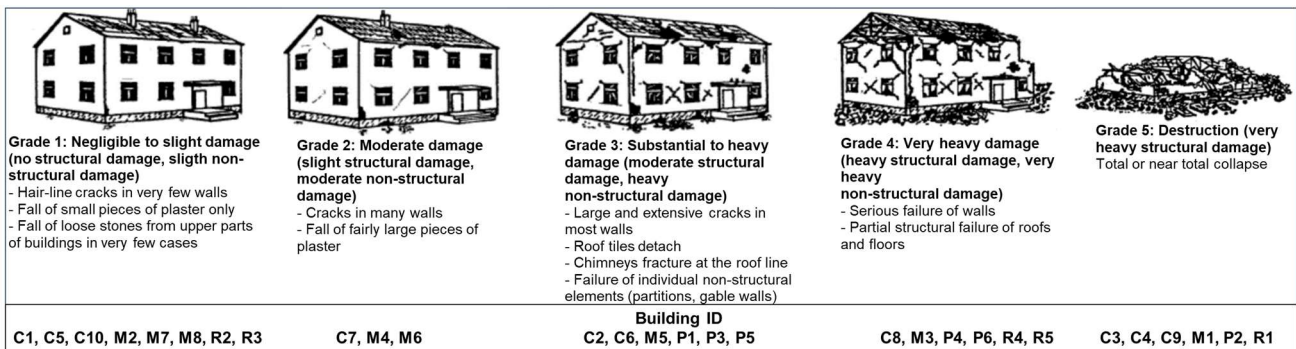
A damage level was assigned to each building. For this purpose, damage grades (DGs) from EMS-98 (Mavroulis et al. 2019) were used. Figure 1 represents the DG definitions of EMS-98 (Grünthal and Levret, 1998). Although DG definitions in Figure 1 consider damage in both structural and non-structural elements in the classification, damage assignments in this study were done considering structural damage to walls only. This enabled consistent comparisons between different building typologies which may have different structural and non-structural components. For instance, arched porch structures, domes or minarets in mosques were not considered in the DG assignment; damage was evaluated solely from the structural walls. This enabled like for like comparisons with damage in church, public and residential building walls.

Figure 1. EMS-98 damage classifications (Grünthal and Levret, 1998) and assignment of DGs to the investigated buildings

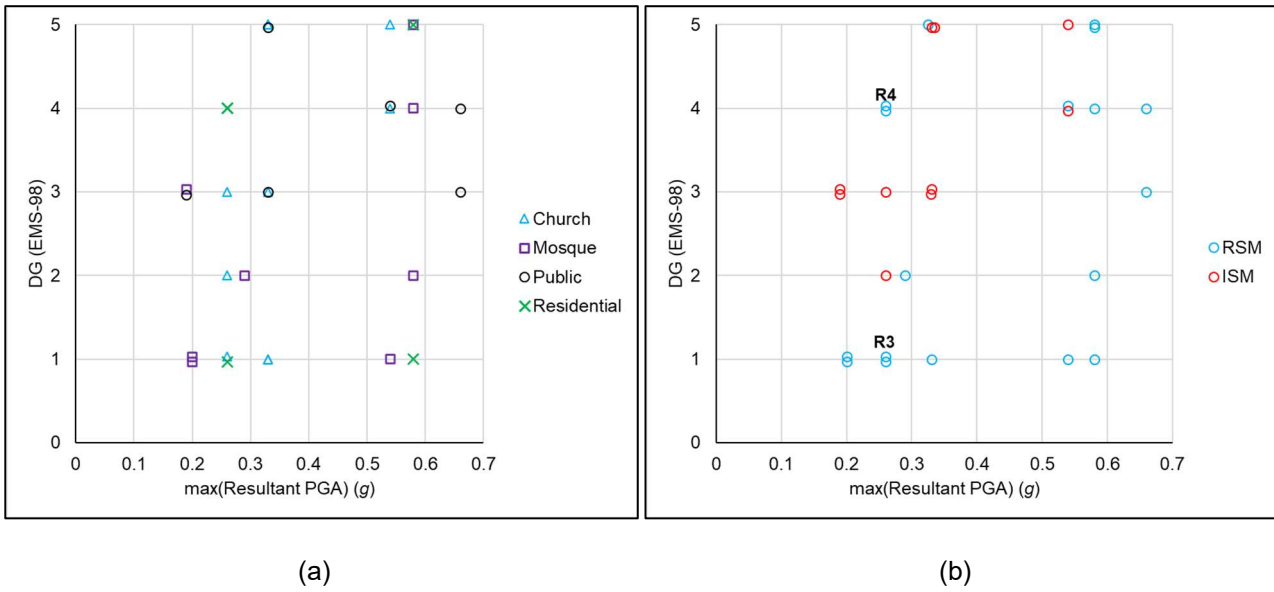
Figures 2a-b show the relationship between the maximum resultant PGA and the DG for each building. There is no obvious relationship between the seismic demands and damage. In Figure 2a, individual markers are coloured according to the use of the buildings (e.g. church). Although the public buildings appear to be associated with high DGs (3-5), the sample size is small and no clear trend can be established between damage and building use.

In Figure 2b, markers are coloured according to the wall construction type (e.g. RSM or ISM). In general, ISM buildings appear to have experienced lower seismic demands and high damage. Except for one, all ISM buildings are assigned DG3 or more. This observation is consistent with the well-known vulnerability of this construction type to earthquakes.

In Figure 2b, there is a wider range of seismic demands for RSM buildings. Half of the 18 RSM buildings were subjected to resultant PGAs higher than 0.5g and experienced damage ranging from DG1 to 5. The remaining 9 RSM buildings were subjected to resultant PGA values lower than 0.4g. These buildings were classified either with DG1-2 (up to moderate damage), DG4 (heavy damage) or DG5 (near or full collapse). In particular, the building R4 (highlighted in Figure 2b) experienced out-of-plane collapse while R3 (also highlighted in Figure 2b) showed no signs of damage under similar seismic demands. It is noteworthy that the buildings R3 and R4 are two-storey residential buildings, with similar structural configurations.

Figure 2. EMS-98 DGs vs maximum resultant PGA values considering a) wall construction types b) purpose of the buildings

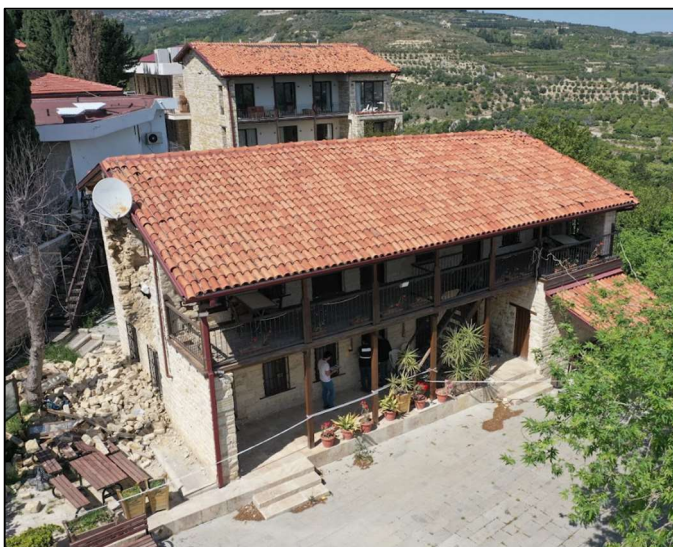
(a)

To understand why similar buildings may have experienced different damage levels under similar seismic demands, it is useful to examine their damage patterns. Borri et al. (2020) proposed a classification which categorises buildings according to the presence of masonry disaggregation. Masonry disaggregation refers to disintegration of walls under strong ground motions with diffuse detachment between stones and mortar. In ISM walls, disaggregation occurs when weak mortar is used alongside irregularly shaped and sized stones. In RSM walls, it typically occurs when wall leaves have weak connections and separate from each other. According to Table 1, 70% of the investigated buildings were subjected to masonry disaggregation. Masonry disaggregation is evident in how the building leaves have separated in R4 due to a lack of diatons (see Figures 3a-b); a similar separation is not observed for the building R3 in Figures 3c-d). It is thought that masonry disaggregation may have facilitated the formation of the out-of-plane collapse mechanism in R4, leading to the DG4 assignment of this building.

Figure 3. a) General view and b) disaggregated wall in R4 c) general view and d) a vertical crack around corner stones in R3

Half of the RSM buildings are categorized as class “B” while the rest are categorized as “C”. All class “C” RSM buildings experienced disaggregation, including R4 (see Figures 3a-b). About half of the class “B” buildings did not experience disaggregation. This includes R3 (see Figures 3c-d). However, the buildings M1, M3 and R1, which are categorised as “B”, unexpectedly experienced disaggregation. A possible reason for disaggregation in these class “B” walls, is their unfulfilled WC criteria; this indicates that their wall leaves may have separated, leading to disaggregation and out of plane collapse. An example of wall leaf separation is shown in Figure 4b and this aspect is discussed in detail elsewhere (Bozyigit et al., 2023).

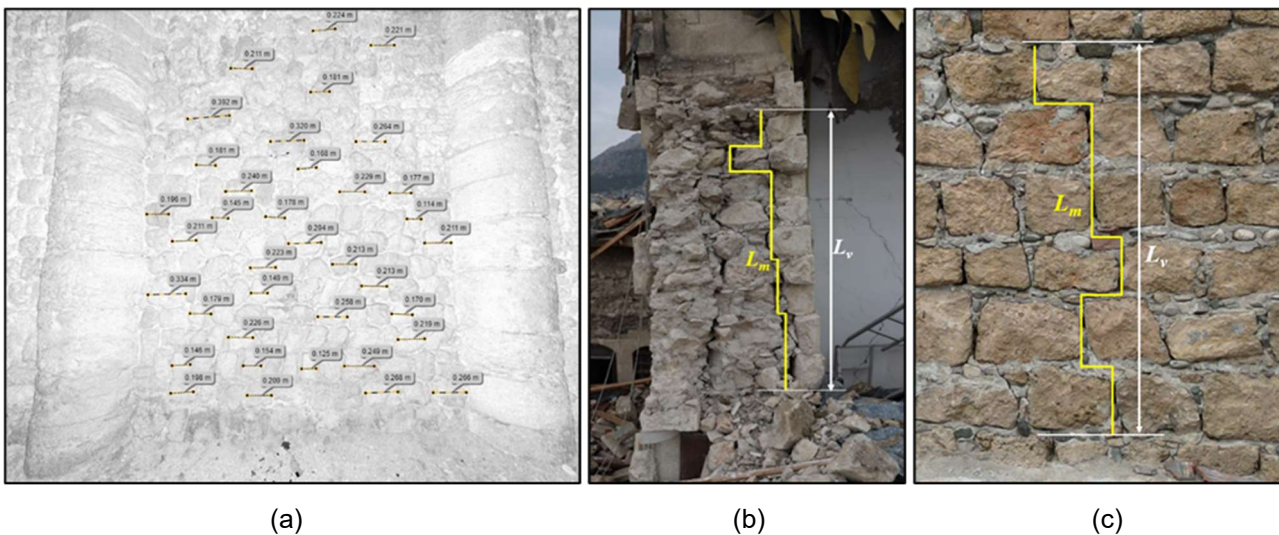
Figure 4. a) Stone dimension measurements from a point cloud for C5, b) photograph of a through thickness cross-section of a disaggregated wall used for WC calculation (Building: M1), and c) an exposed wall surface used for VJ calculation (Building: C3) (Bozyigit et al. 2023)
