PRELIMINARY FIELD OBSERVATIONS OF TUNNEL-FORM BUILDING DAMAGE FROM THE FEBRUARY 2023 TÜRKİYE EARTHQUAKES

S. Dede¹, F. Gutiérrez-Urzúa², T. Rossetto³, F. Freddi⁴, U. Hancılar⁵

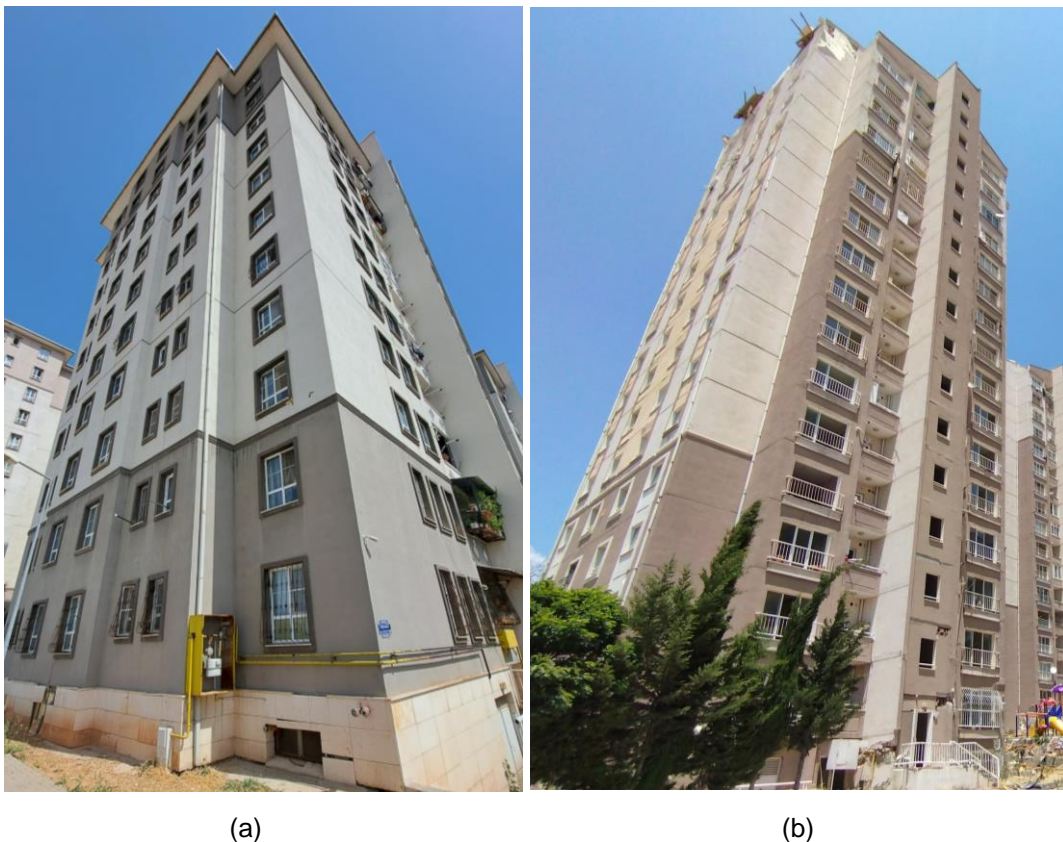
Figure 2. Tunnel-form buildings in the investigated mass housing sites
a) Building in Nizip, Gaziantep b) Building in Antakya, Hatay.

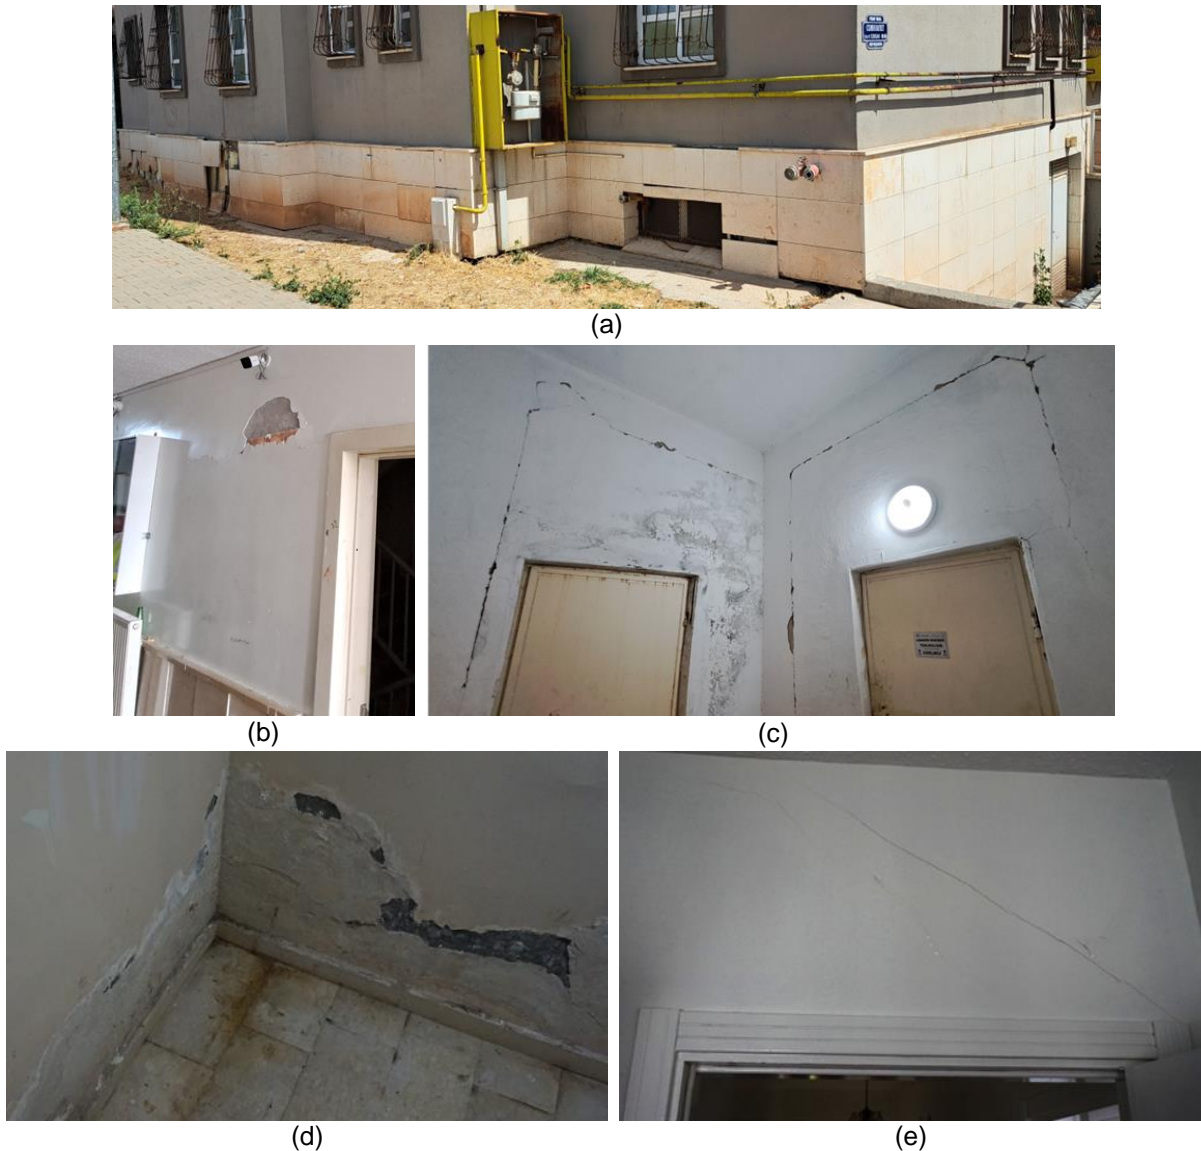
Tunnel-form buildings on this site are 13 storeys including basement floors surrounded with rigid basement walls. The case study site was constructed in 2014 and is located in the eastern part of Nizip. External observations revealed separations between the building and the surrounding ground. Figure 4(a) shows the impact of this separation and the damage to the façade elements, particularly at the ground level, causing breakages in decorative tile elements. Figure 4(c) shows the separations between the infill walls and structural elements. Additionally, spalling of plaster on the shear walls was noted as shown in Figure 4(b). This observation, however, was mainly limited to lower floors. Figure 4(d) shows the moisture observed in the basement floors. The penetration of the moisture into the shear walls could adversely affect the structural performance and is expected that the shear walls' reinforcements at this level were significantly compromised.

Coupling beams are key elements densely used in this structural typology. Figure 4(e) shows an example of the onset of diagonal cracks observed in coupling beams in Nizip. Nonetheless, such damage was predominantly found in coupling beams on the middle floors. No further damage to structural members was detected in Nizip.

Figure 4. Damage patterns of high-rise tunnel-form building in Nizip. a) Damage to the façade elements; b) Spalling of plaster; c) Separations between the infill walls and structural elements; d) Damp in the basement floors; e) Onset of diagonal cracks in a coupling beam.

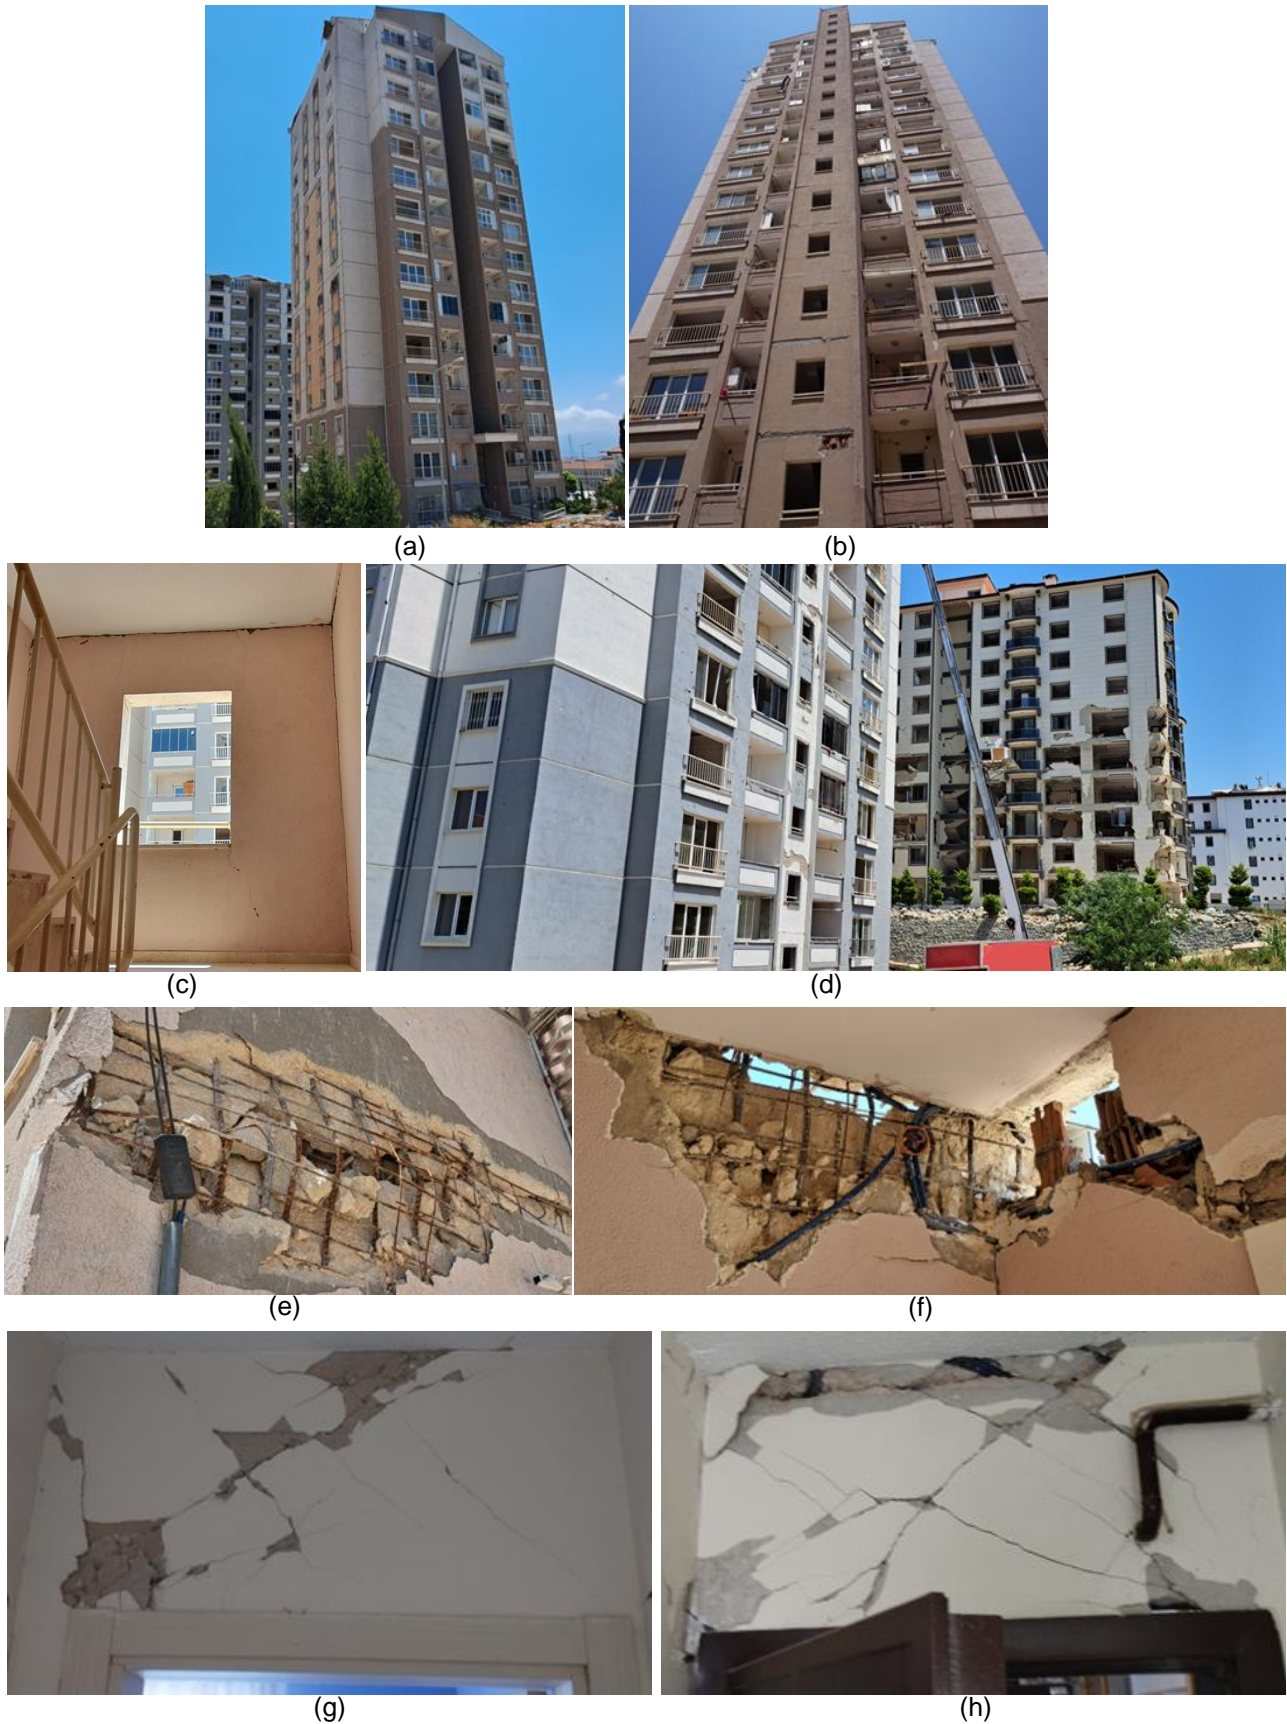
Tunnel-form buildings in the investigated site are 17 storeys including basement floors surrounded with rigid basement walls. The case study site was constructed in 2012 and is located in the south of Antakya. Figure 6(a)-(b) presents the exterior view of the buildings showing the non-structural and structural damage suffered during the February earthquakes. It remains unclear which earthquake caused the specific portions of the damage. Extensive cracks were observed in the infill walls, particularly concentrated at the edges of the door and window openings. Furthermore, extensive cracks were also observed in the infill walls adjacent to the structural members that suffered significant structural damage. Figure 6(c) displays another common damage feature that is the separation of the infill walls from the structural system. Out-of-plane failure of infill walls was also observed although it was not widespread along the height of the building. Nevertheless, compared to the RC frame buildings in the nearest vicinity as depicted Figure 6(d), non-structural damage was less severe and limited in the distribution throughout the building height. Significant damage was observed in the shear walls at the ground level. Concrete crushing, reinforcement buckling, and fracture were evident in multiple shear wall sections. This damage, as presented in Figure 6(e)-(f), extended into the web of the some shear walls, coupled with observation of substantial concrete crushing. Figure 6(g)-(h) shows extensive diagonal cracks, that were mainly concentrated at the mid-levels. Additionally, as a flaw of the local construction practice, pipes passing through the coupling beams caused local weaknesses. In coupling beams with light damage, the damage was concentrated in this area, while in severely damaged ones, localisation of cracks were observed around the holes.

Figure 6. Damage patterns of high-rise tunnel-form building in Antakya. a) Front of the building; b)Rear of the building; c) Separation of the infill walls from the structural system; d) Damage to infill walls in a nearby tunnel-form building and an RC frame; e) Damage to shear wall, exterior view; f) Damage to shear wall, interior view; g) Diagonal cracks in a coupling beam; h) A commonly observed construction flaw.
