Lessons Learnt From the 2009 Padang Indonesia, 2011 Tōhoku Japan and 2016 Muisne Ecuador Earthquakes

Keywords: earthquakes, Padang, Tōhoku, Muisne, buildings, foundations, landslides, geospatial tools

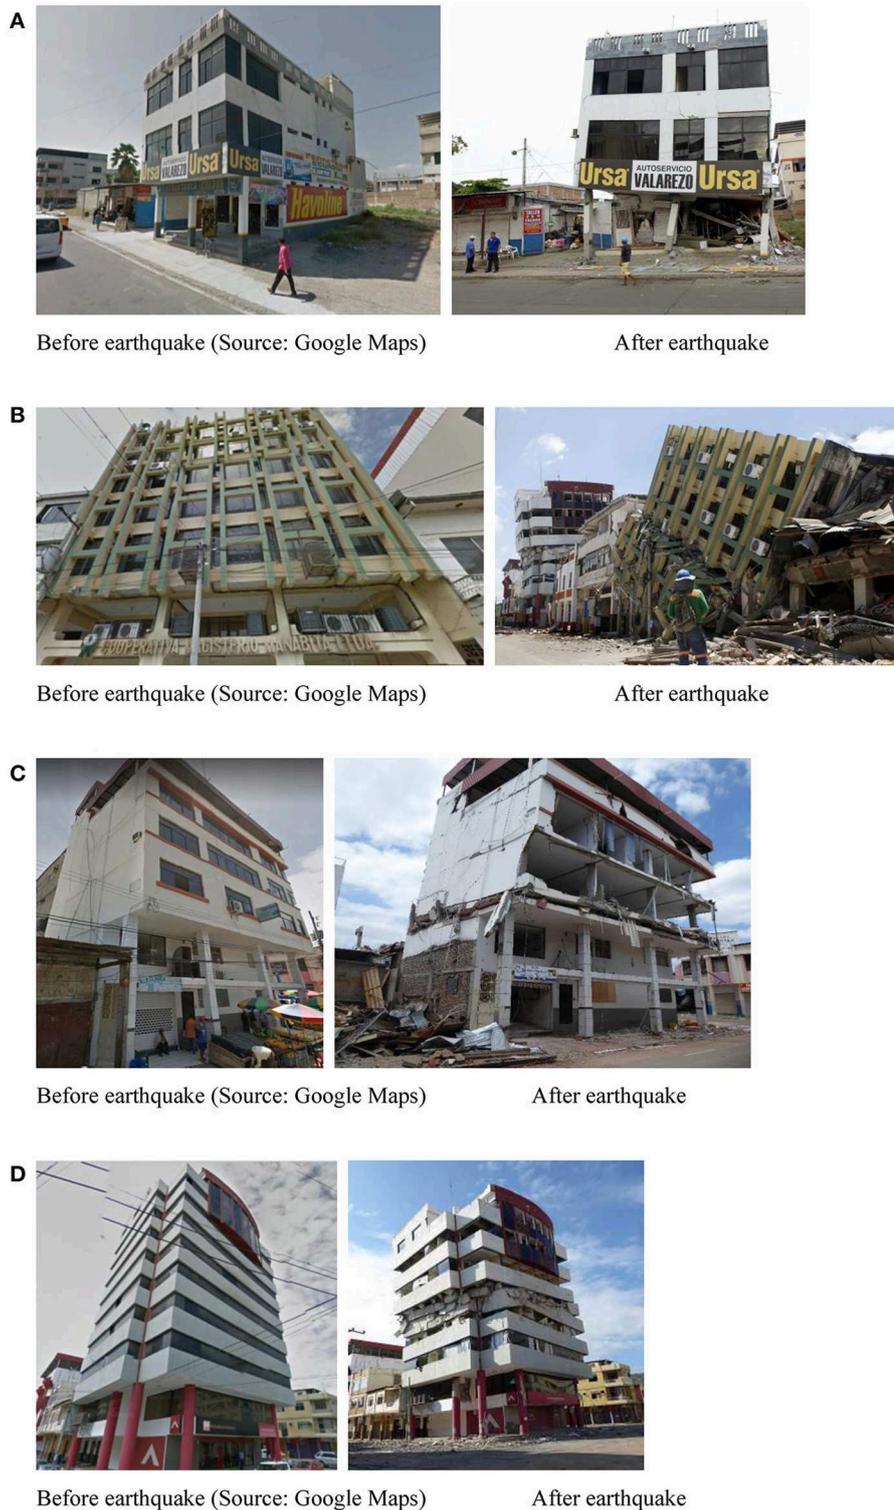
Most seismic induced soft-story collapse failures occur particularly at the ground level where there exist columns with minimal infill walls or simply due to higher loadings transferred from upper stories. Such typical soft-story failures, alike to those observed at Padang and Tōhoku, were observed as shown in **Figure 8A**. However, in contrast, there were also observations of upper floor soft-story failures in a number of buildings following this Muisne earthquake. Change in stiffness of the story or plan was one of the key factors leading to such occurrence of upper-story collapses. Examples include the Magistrate building and a commercial building in Portoviejo and Manta, respectively, where discontinuity of stiffness was observed, as shown in **Figures 8B,C**. There were however occasions where upper soft-story collapse occurred on buildings without obvious change in structural stiffness, plan or story height (e.g., **Figure 8D**). Further investigation appeared to confirm that such failure could be due to extension of the building long after the bottom floors

FIGURE 8 | Soft story collapse following the Muisne earthquakes. **(A)** soft story collapse at ground level of car garage at Manta. **(B)** Upper story collapse at the Magistrate building at Potoviejo due to change in stiffness at 1st floor. **(C)** Upper story collapse at commercial building at Manta due to change in stiffness at 2nd floor. **(D)** Upper story collapse at Mutualista Pichincha building in Portoviejo.

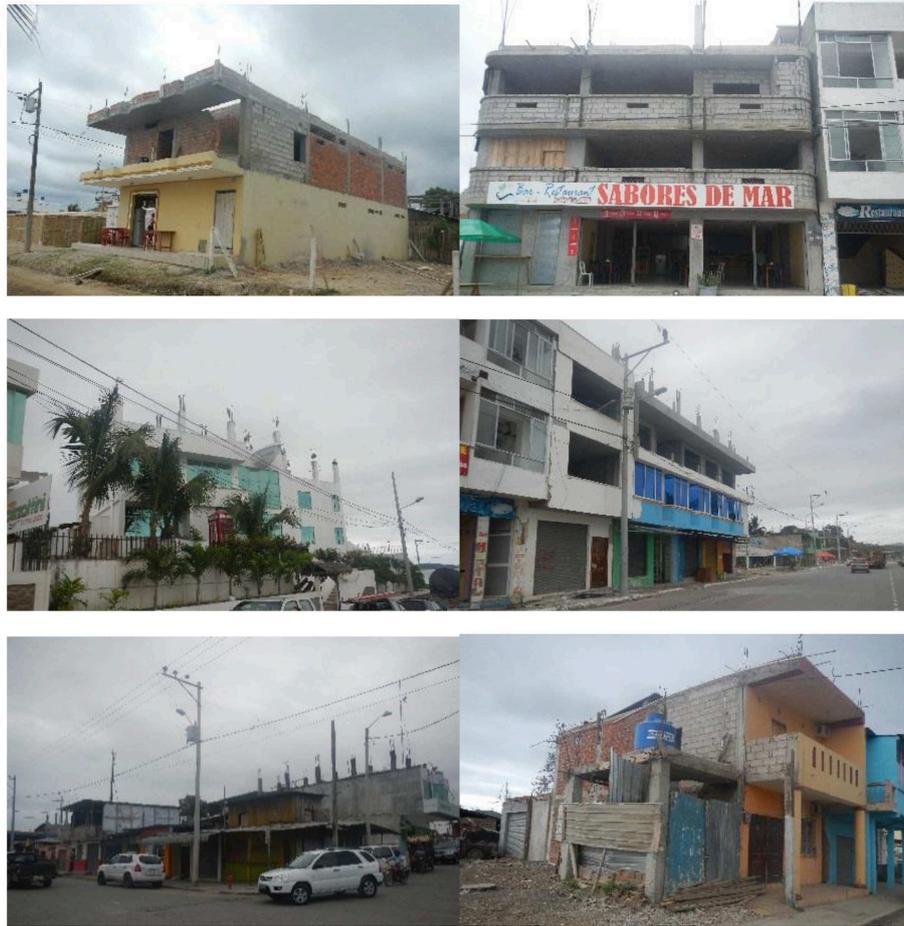
were completed. Such practice appears to be rather prevalent in these towns (see **Figure 9**), although several other countries do have similar practices such as the *Beşkats* in Turkey and in Greece. The joints between new and old were typically poorly executed with insufficient lapping of the rebar, resulting in weak and brittle connection with local reduction in capacity, hence promoting failure in these areas. Such findings are alike to failures observed in post-earthquake reconnaissance to Turkey and Greece (Earthquake Engineering Field Investigation Team (EEFIT), 2003; Pomonis et al., 2011). In addition, the reinforcement bars often left out for many years can experience surface corrosion, which weaken their bond to the new concrete during casting. Such localized upper-story damage may also be attributed to all rebar being lapped at one height, resulting from the use of the same length bars in all columns. The increased axial loads would also cause more severe problems for the bottom floors.

FIGURE 9 | Exposed reinforcement for future extension of building observed in various affected towns in Ecuador.

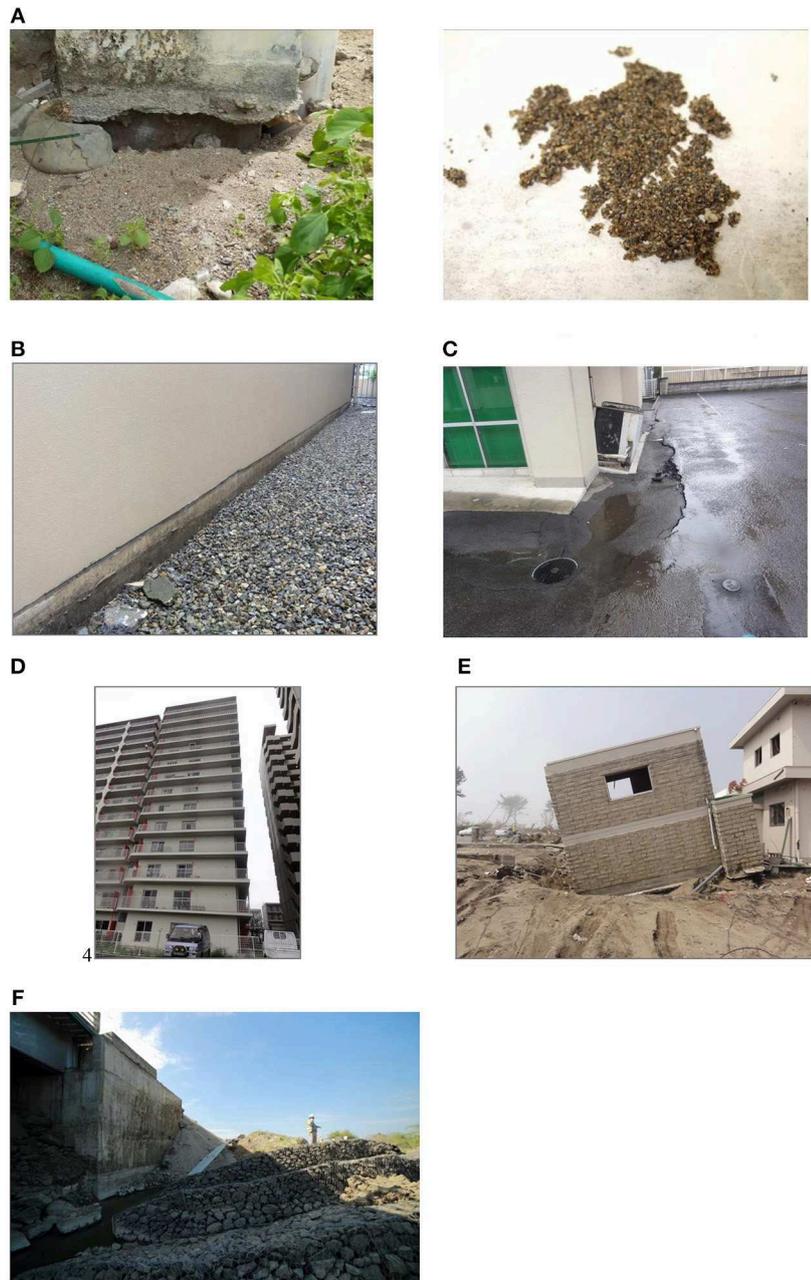
Similar observations were made in the Tōhoku earthquake, particularly in Sendai city where it is closest to the Mw9.0 epicenter. RC buildings found on deep pile foundation suffered lower settlement relative to the surrounding ground

(**Figure 12B**). Foundations of a handful of lower rise buildings of expectedly shallower foundation penetration depth sank relative to the surrounding ground level (**Figure 12C**). Other attributing factors could be due to soil liquefaction as evident with occurrence of sand boils and ground settlement measuring as much as 70 mm nearby. In the affected areas, ground settlement caused tilting of high rise buildings (**Figure 12D**) and affected the use of external staircases and roadways leading to carparks. In some cases, differential settlement rendered apartment buildings unsuitable for occupancy and had to be demolished. Overturning of buildings due to impact of the tsunami mainly occurred to buildings with shallow foundation or slender piles. Soil liquefaction can allow piles to be pulled out of the soil more easily. Scouring due to fast-flowing tsunami waves around buildings also reduces ground bearing support which led to tilting of buildings as shown in **Figure 12E**. Coastal subsidence of more than 0.5 m in numerous coastal towns and cities also caused these shorelines to suffer frequent tidal flooding.

foundation suffered excessive settlement and lateral spreading at the southern road entrance of the bridge. The location of bridge was along the narrow channel of young sediment deposit extending northwest to Crucita based on the geological map. Ground settlements of up to 1.1 m and lateral spreading as much as 3 m of the road embankment were observed. At the time of the survey, the surface of the approaches had been repaired, although sizeable settlement and rotation of the gabions on the river bank on the south west side of the bridge were observed (see **Figure 12F**). Heavy rain and flooding in the region during the days leading up to the earthquake could have raised the ground water table level, making ground more susceptible to liquefaction.

FIGURE 12 | Foundation and ground failures following Padang, Tohoku and Muisne earthquakes. **(A)** Settlement of ground around column where sand was found in the proximity. **(B)** Ground settlement around building at Sendai. **(C)** Sinking of building relative to surrounding at Sendai. **(D)** building tilt due to differential settlement at Sendai. **(E)** loss of soil bearing due to scour at sendai. **(F)** settlement and rotation of gabions on the river bank Mejia bridge.

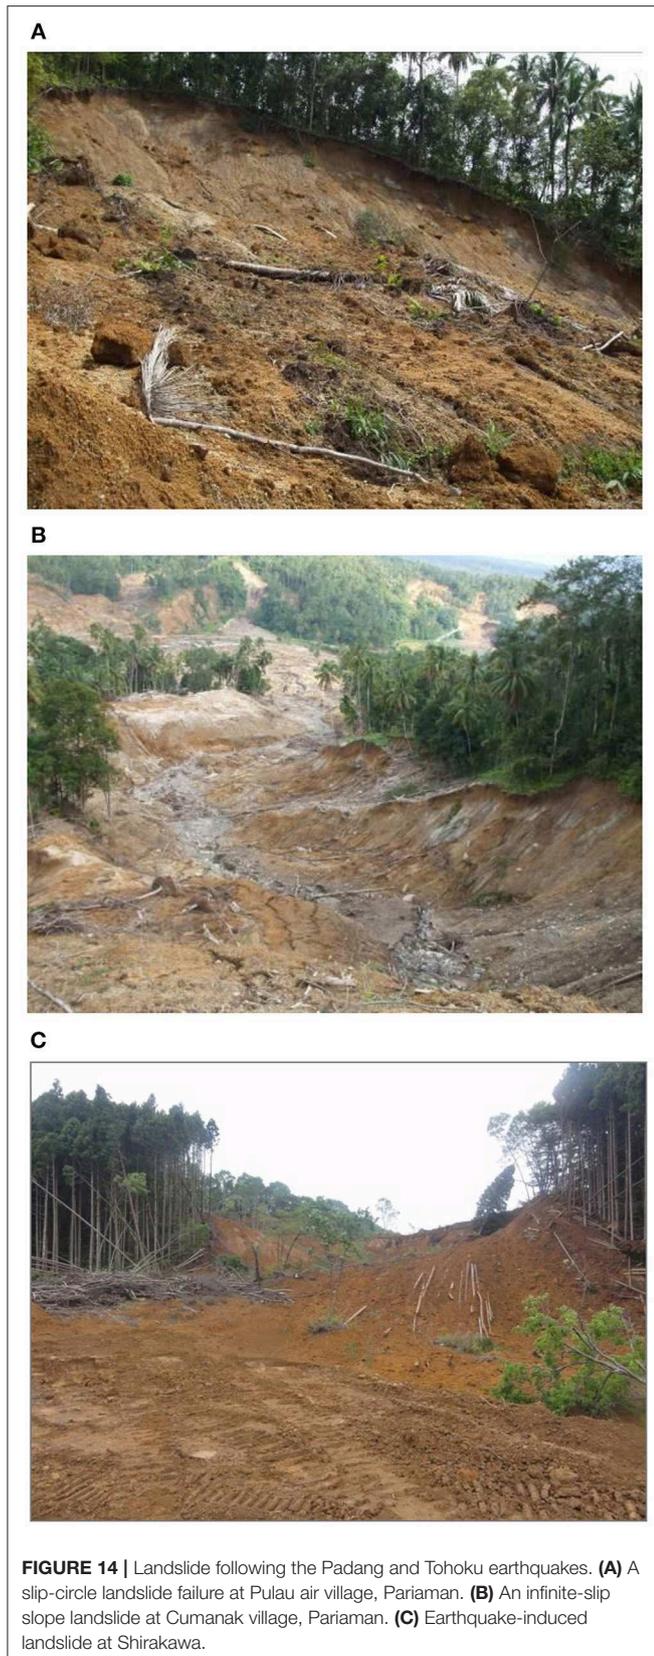
Landslides at Padang were widespread in the mountainous topography landwards of Pariaman. **Figures 14A,B** show two of the several landslide sites visited in the worst-affected district of Nagari Tandikek in Pariaman. Two villages, Pulau

Air and Cumanak, were severely affected by these landslides. Roads perpendicular to the landslide runoff were buried which disrupted rescue operations. The landslide site at Kapalo Koto, a part of the Pulau Air Village, was buried by the landslide. The concrete slab foundation and brick and timber debris of the destroyed Kapalo Koto elementary school were the only remains in the site. Located near Mount Tandikek, a dormant volcano, the agriculturally-intensive Cumanak Village experienced the largest landslide with the highest number of casualties. A contributing factor to the large landslides was the heavy rainfall on the morning of the landslide. The infiltrated rainfall led to slope instability due to the reduced effective shear strength of the

and houses at the foot of slopes, resulting in traffic disruption, property losses and 13 casualties in Shirakawa as shown in **Figure 14C**. In Ecuador, numerous landslides were observed along the coast between San Vicente and Canoa, where the Northern Bahia Fault is mapped. These slope instabilities, also present along the southern coastal cliffs close to Bahia and in many places in the estuary, were attributed to excavation of steep slopes for road construction. The San Isidro section of the Canaveral Fault may also have aggravated the damage in the region following the earthquake. Other contributing factors leading to greater severity of slope instability include: (1) greater saturation of water in soil due to heavy rainfalls leading up to the time of earthquake, (2) lateral spreading from liquefaction of soft alluvial soil layers causing slippage at weak interfaces near the surface of slope, (3) lack of stabilization at man-made cut slopes, (4) river bank management leading to increased stream velocities which loosen or erode earth embankments, and (5) flood plains next to vulnerable man-made slopes (e.g., Portoviejo).

Following lesson learnt from these events, the effects of landslides could be alleviated by: (1) mapping landslide risk in the region for planning of urgent slope stabilization works, (2) installing drainage systems to avoid high pore water pressure build-up, (3) implementing stabilization techniques with vegetation, shotcrete or anchors, and (4) active monitoring of unstable slopes particularly after rainy seasons so as to provide timely mitigation measures. Subsequent section of this paper would discuss further with an example on the use of geospatial tools for mapping landslide risks.
