RECONNAISSANCE OBSERVATIONS BY CIGIDEN AFTER THE 2015 ILLAPEL, CHILE EARTHQUAKE AND TSUNAMI

Abstract

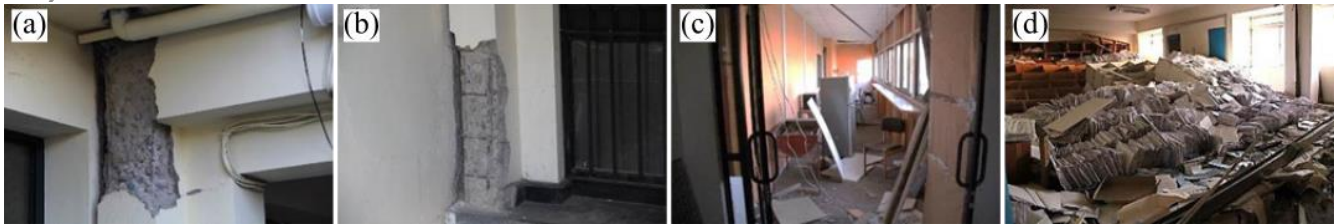
From the survey, it was observed that all public hospitals of the Coquimbo Region, but the one in Vicuña (Fig. 2), experienced slight structural damage including diagonal cracks in some RC and masonry walls and spalling of concrete cover in a limited number of elements (Fig.3a and b), while non-structural damage was observed in all facilities. Falling of contents was the most common form of non-structural damage, together with damage in glazing and in partition walls (Fig.3c). The inpatient ward was the most affected service in all facilities, and was often closed or relocated due to damaged glazing. The largest number of physical areas affected in services was reported in Combarbala and Salamanca. In the Coquimbo hospital, hardcopies of several medical records were lost after the collapse of shelves; most of these records were not digitally backed up (Fig.3d). Due to its importance within the healthcare network, a military field hospital was installed at the hospital in Coquimbo during 5 months to partially restore its ability to address emergencies and regular medical appointments. With regards to the electrical supply, the backup generators required over 30 minutes to start in Salamanca. In the Combarbala and La Serena hospitals, the generators supplied electricity only for critical units, thus reducing the capacity of the facility and its functionality.

Fig. 3 – (a, b) Concrete spalling at Illapel hospital; (c) non-structural damage at Coquimbo hospital; and (d) shelves collapse with medical records at Coquimbo hospital

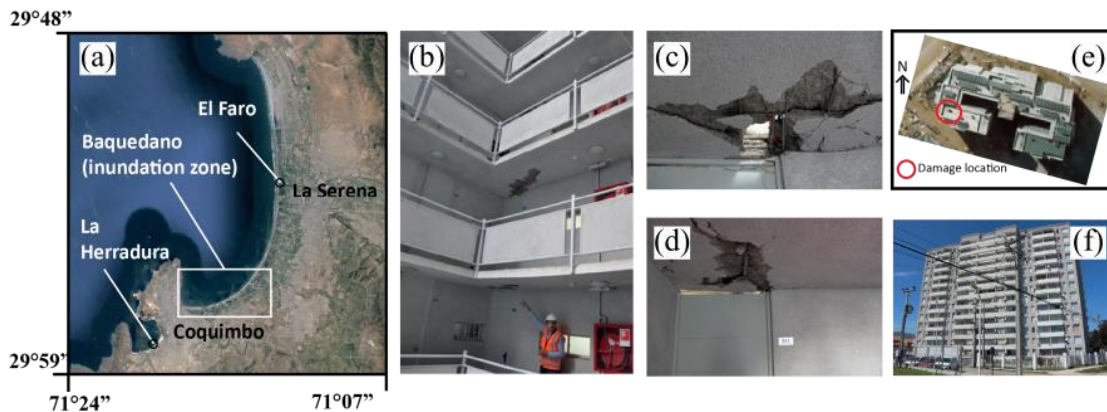
Fig. 4 – (a) Geographic location of surveyed sectors; (b) structural damage in a building in La Herradura; (c) and (d) detail of structural damage in RC slabs in building in La Herradura; (e) floor plan configuration and damage location; and (f) view of the north façade of the building

In general, no significant damage was observed in the surveyed coastline buildings; only small cracks in concrete cover and a low degree of ground settlement was observed in some cases. A single medium-rise RC building located in La Herradura (Fig.4b through f) presented severe structural damage, characterized by significant concrete crushing in the slabs at their intersection with shear walls in stories 3 and above (Fig. 4b, c and d). The building presented a C-shaped floor plan configuration (Fig. 4e) and had a single diaphragm with no construction joints. Severe damage was observed in the south west corner of the building (Fig. 4e), while minor damage was found in the north west corner. The observed damage was probably the result of large bending and shear forces induced in the floor diaphragms, aggravated by the horizontal irregularity of the building, the small slab thickness, and the absence of lintels. Probably, this building considered a rigid diaphragm model and the actual stresses during the earthquake exceeded those estimated by the flexural slab action during the design process.

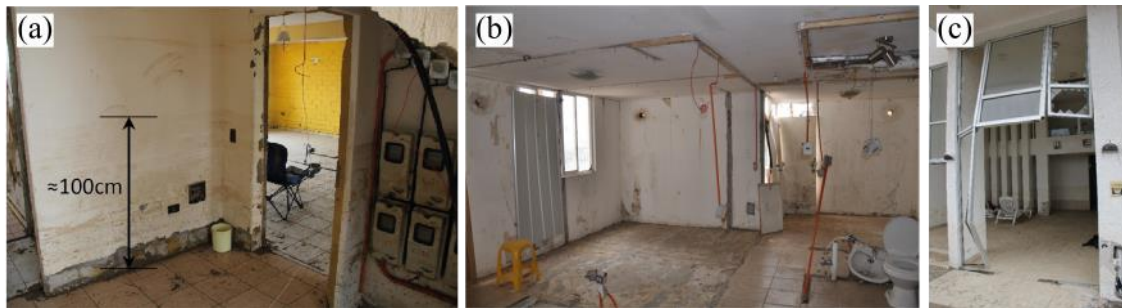
Approximately ten RC buildings with 8 or more stories were inundated by the tsunami. In all cases, non-structural elements in the first story were completely swept off by the sea waves as seen in Fig.5a and 5b. On the other hand, no evidence of structural damage was observed as a result of ground shaking or hydrodynamic forces; only a series of very narrow vertical and diagonal cracks ($\epsilon < 0.2$ mm) were observed in some RC walls and slabs. Unlike these buildings, two RC buildings next to the coastline had been designed using the recommendations for constructions within tsunami flood risk areas developed after the 2010 Maule earthquake and tsunami [14]. These buildings were characterized by a high-rise first story used for common areas and storage, electrical and emergency equipment located above the first story, and a layout that allows water flow (Fig.5c). Furthermore, the common areas of the buildings were insured against tsunami inundations. With these considerations, these buildings performed better than anticipated, and the economic impact for the residents was minimized.

Fig. 5 – (a) Run-up marks left on the walls; (b) non-structural elements washed away in first story housing units; and (c) non-structural damage in first story common areas

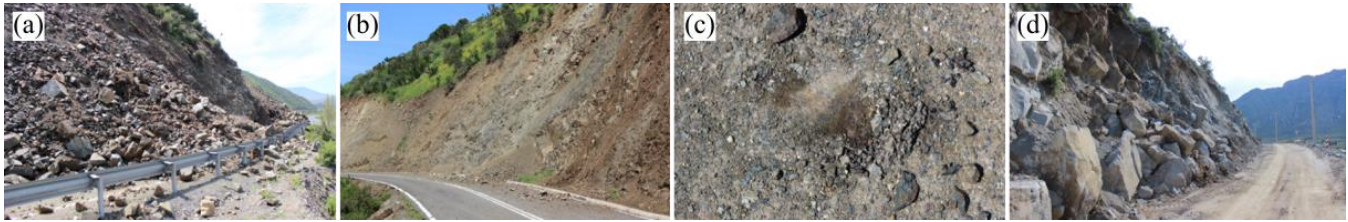
The secondary and tertiary road networks also evidenced several problems that interrupted the connectivity of the Coquimbo Region. Road D-75, connecting the cities of Huentelaquen and Illapel through the north rim of Choapa River, was affected by a massive rockfall in km 11 generating permanent closure of the road (Fig.8a). Road D-75 presents a double treated surfacing and low-volume traffic, constituting an alternative route connecting Route 5 with the city of Illapel. Two weeks after the earthquake, the road remained closed in this point. The road is located in the river canyon, presenting steep cut-slopes with slope angles greater than 30° starting from km 9. The slopes are made of weakly cemented rocks, sedimentary rocks and soils, with native vegetation present in the natural soil on the top of the slope. Minor rock falls were also observed starting from km 9 (Fig.8b), causing partial blockage of the road after the main shock. The material was plowed off and traffic was restored until km 11. The pavement in this area suffered permanent local surface deformations similar to punch-outs caused by rock-fall (Fig.8c).

time the field evaluation was performed, with the exception of road D-71. This road was permanently plowed in three points, where partial closures were observed and only one lane was operating. Road D-81 connecting the cities of Illapel and Salamanca through the north bank of the Choapa River was also assessed (Fig.2). By the time of the evaluation, minor landslides were already plowed given the importance of this road as it connects the large copper mine Los Pelambres with the coast. An alternative route through the north bank of the river is road D-825, which is an unpaved low-volume traffic road. The road presented major rockfall, where rocks of considerable size obstructed the road (Fig.8d). At the time of the reconnaissance, the road was already cleared, requiring the detonation of major rocks and plowing of oversized material to the road side and down the hill to the river.

Fig. 8 – (a) Massive rockfall on km 11 of road D-75; (b) raveling on steep cut slopes of road D-75; (c) punch-outs on road D-75; and (d) plowed rockfall on road D-825

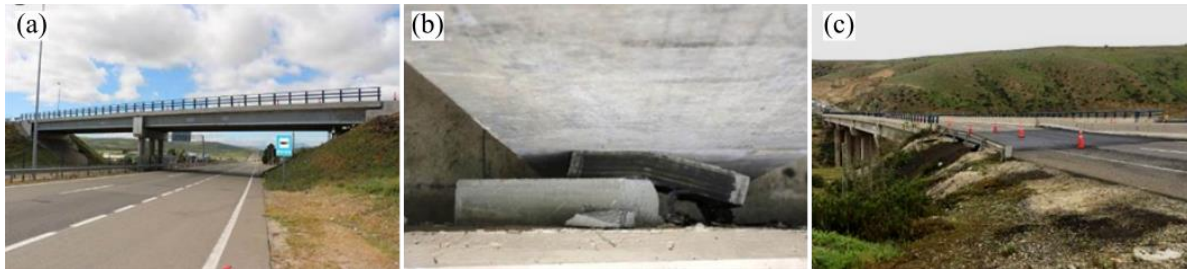
Eight bridges suffered damage without losing its functionality. Six of these bridges were on Route 5 (Fig.2), and one of them corresponded to a pedestrian bridge. The other 2 bridges were located in secondary roads. The observed damage was displacement and/or rotation of the superstructure due to sliding of elastomeric bearings, settlement of the bridge approach, and damage in bridge joints of the superstructure due to impact with the abutments. The largest residual displacement of the superstructure (16 cm) was observed in the west span of the Talinay underpass (km 346) as a result of the rotation of the superstructure (Fig.9b). Apparently, the hold downs or “seismic bars” used to connect the deck slab with the abutment and bent cap did not prevent lateral displacement of the superstructure. This sliding behavior increases energy dissipation and limits the shear forces transferred to the piers and abutments.

Similar rotations of the superstructures have been observed in previous earthquakes [18], but mostly in skew bridges. Settlement of the bridge approach was observed in El Teniente bridge (Route 5, km 334), which presented a settlement of about 20 cm in the embankment of its southern access (Fig.9c). A similar performance was observed in the Illapel II Bridge, located in Illapel. The two abutments settled 10 cm, and the abutment slopes suffered minor raveling [19]. No damage was observed at the Amolanas bridge (Route 5, Km 309), the highest highway bridge in the country (100.6 m the tallest pier). This bridge is a 273 m continuous steel box girder connected to three piers and end abutments, and is equipped with two viscous dampers at each abutment in the longitudinal direction. Evidence of liquefaction was observed in the river bed of La Cebada Bridge (Route 5, km 339) located 66 km north of the epicenter. However, no settlement was observed in the bridge approach. Besides the aforementioned problems, the pavements suffered additional distresses such as cracks and potholes due to the impact of the rocks and gravel that fell into the roads.

Fig. 9 – (a) Talinay underpass; (b) creeping and 16 cm residual displacement of the elastomeric bearings on the superstructure of Talinay underpass; and (c) temporary asphalt ramp on the south access of Teniente Bridge
