To appear in: *Building and Environment*

**Assessment of Wind-driven Rain Impact, Related Surface Erosion and
Surface Strength Reduction of Historic Building Materials**

Dr. Aykut Erkal ^a, Dr. Dina D'Ayala ^b, Mr. Lourenço Sequeira ^c

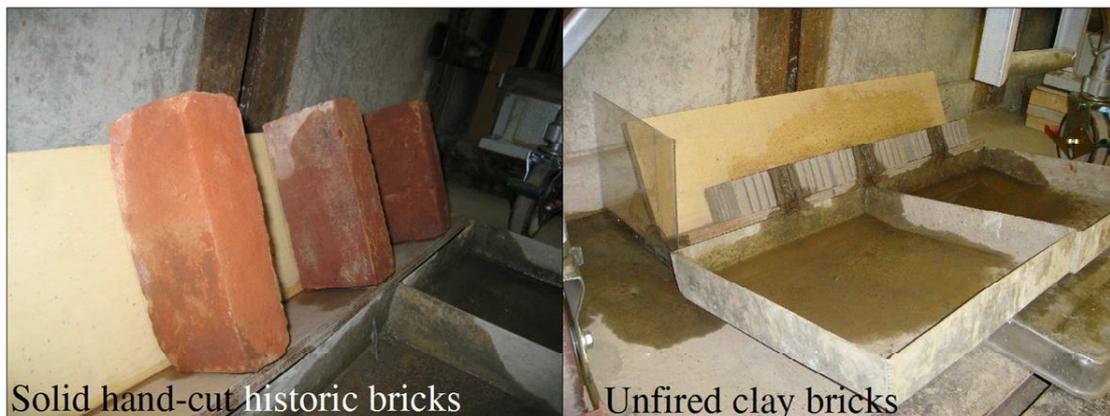
- Fig. 6.** Water drop stains on the tested masonry materials after impact
- Fig. 7.** Laser scanning for surface roughness determination and resultant roughness profile of solid hand-cut historic clay brick

Solid hand-cut historic bricks

Unfired clay bricks
