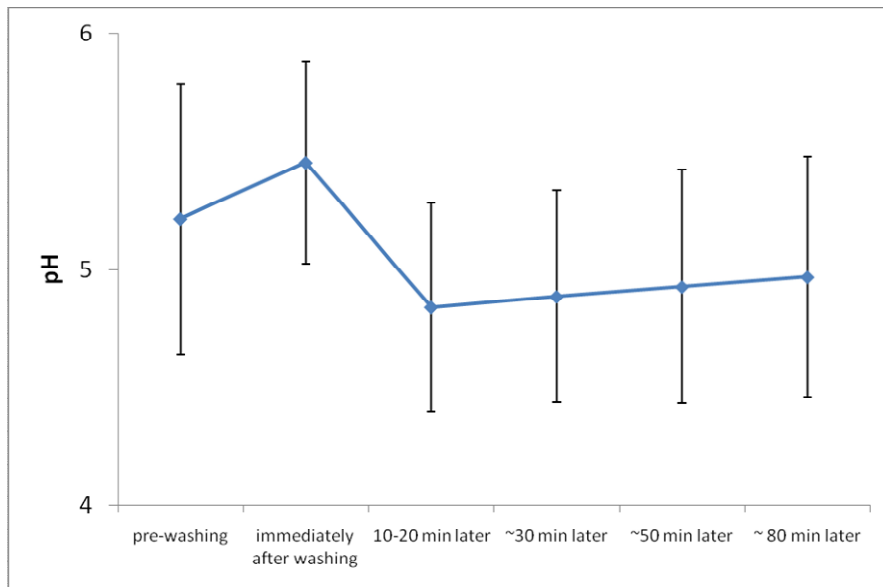
Figure 1 Change in nail plate surface pH upon washing and subsequently with time. The latter is given as an approximation, rather than a definite value as the time varied slightly for each volunteer and for each nail, depending on the durations of pH measurements. Reproduced with permission from [7].

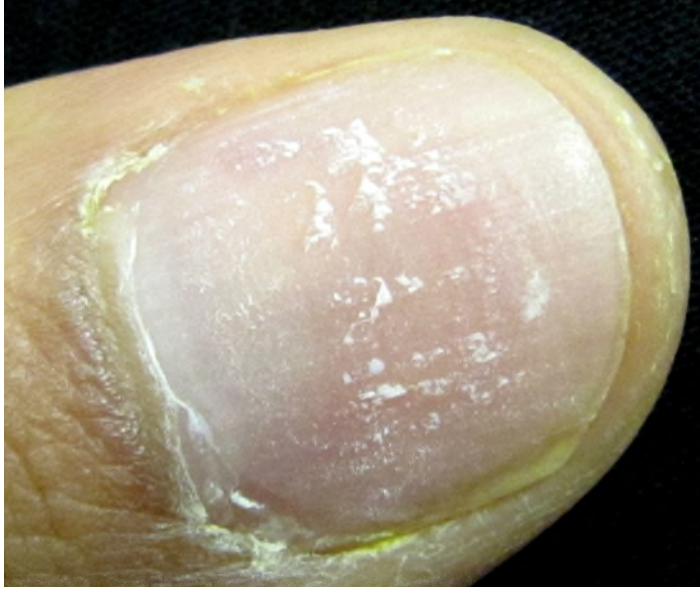
Figure 2: The 'flaky' appearance of the nail plate surface after tape stripping. This volunteer received a total of 15 tape strips, at which point he felt discomfort and tingling. Reproduced with permission from [7].
