# Seismic Vulnerability Reduction of Load Bearing Masonry School Buildings in Nepal

Rohit Kumar Adhikari, Department of Civil, Environmental and Geomatic Engineering  
 rohit.adhikari.15@ucl.ac.uk  
 Supervisor: Prof Dina F. D'Ayala

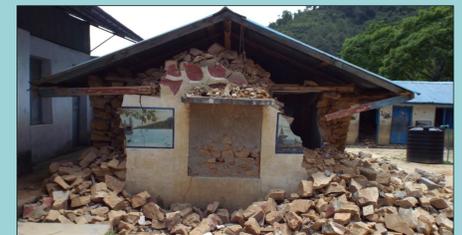
Figure 2: A stone in mud masonry school building damaged due to the 2015 Gorkha earthquake.

- Caused the loss of life of nearly 9,000 people (2).
- About 7,000 school buildings either collapsed or were significantly damaged (see Fig. 2).

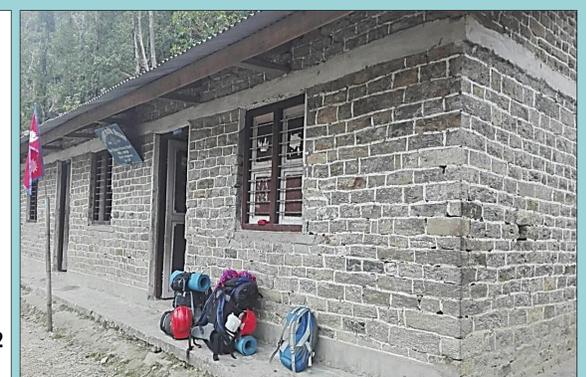
Figure 5: A dressed stone in cement mortar URM school building with a lintel level band beam.

- Traditional Nepalese LBM school buildings [i.e. (a), (b) and (c)] present **high seismic vulnerability**.
- Vulnerability of traditional dressed stone in cement mortar masonry **with lintel band beam** (Fig. 5) is comparatively low [(d)].
- Modern masonry construction types such as **confined and reinforced masonry** [i.e. (e) and (f)] show significantly low vulnerability i.e. very good seismic performance.
