NUMERICAL SEISMIC PERFORMANCE ASSESSMENT OF PRE-EARTHQUAKE STONE MASONRY RESIDENTIAL BUILDING TYPOLOGY IN LIGHT OF 2015 NEPAL EARTHQUAKE

Rohit Kumar ADHIKARI¹ and Dina D'AYALA²

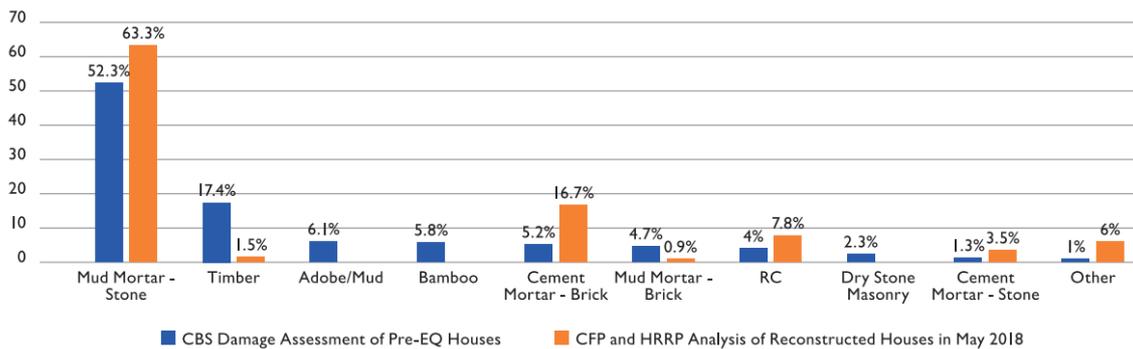
Figure 3. Comparison of the prevalence of pre- and post-earthquake housing typologies in the affected districts. (HRRP, 2018).

Figure 4 presents a comparison of construction typologies in the 31 earthquake affected districts before and after the 2015 earthquake (HRRP, 2018). It should be noted that the percentage of pre-earthquake housing typologies shown in the figure is computed over the entire population of houses that existed, which was collected during post-earthquake survey by the Central Bureau of Statistics (CBS), Nepal for identifying reconstruction and retrofit grant beneficiaries. However, the data related to post-earthquake typologies is based on a sample of about 500 newly constructed houses in different districts. Nevertheless, Figure 4 provides an indicative comparison of the pre-earthquake and post-earthquake housing typologies and the primary construction type in the affected districts both before and after the earthquake remains the SMM which constitutes as much as half of the total houses. This is mainly due to the problem of transportation of modern construction materials such as cement or steel in rural areas; availability of stone, mud etc. and the skilled masons for traditional construction as well as the lower cost of construction compared to other typologies (Bothara et al., 2018a). The reason for many households choosing SMM typology in reconstruction can also be linked to the amount of financial grant (approximately 3,000 USD in total) provided by the government for each household for house reconstruction. RC framed construction represents a low proportion of the total building population.

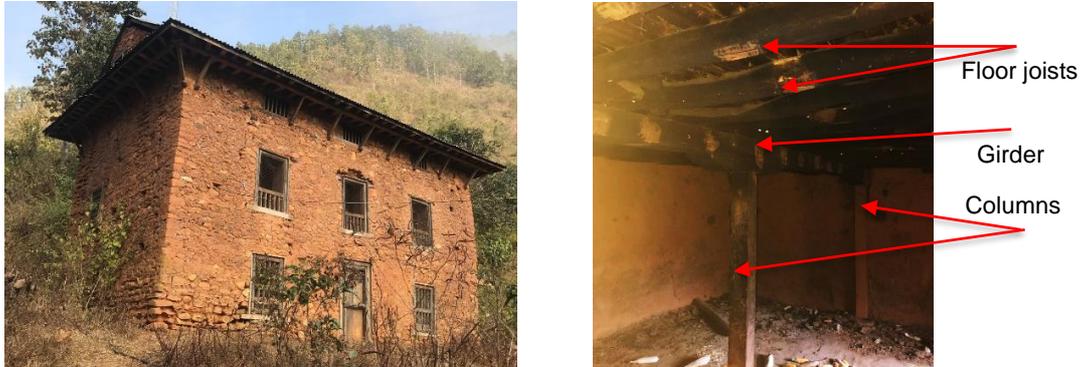
Figure 4. Photograph of a typical PRE- SMM building in Sindhupalchowk district (left) and timber framing structure (right).

Most of the SMM buildings constructed before the 2015 earthquake (named hereafter as PRE-SMM) are unreinforced, often built with random rubble stone in mud mortar thus displaying poor tensile and shear strength. The rubble stone masonry walls are usually thick (400 mm – 600 mm) and have three wythes which are not properly inter-connected using through stones (Bothara et al., 2018b). However, the cross-wall connections are usually made stronger by providing fairly rectangular shaped corner stones. Figure 4 presents a photograph of a typical house in the rural mountainous districts and the same is used as a case study building in the present study. These are usually two-storied buildings with an attic floor covered in multi-pitched timber roof structure. Besides the SMM walls, the vertical load bearing structure consists of a timber frame centrally placed in the longitudinal direction, see Figure 4. The longitudinal girder, resting over the short walls, at each floor level supports a number of transverse joists that span in the transverse direction, resting on the long walls and providing the support for the mud-timber floor structure.

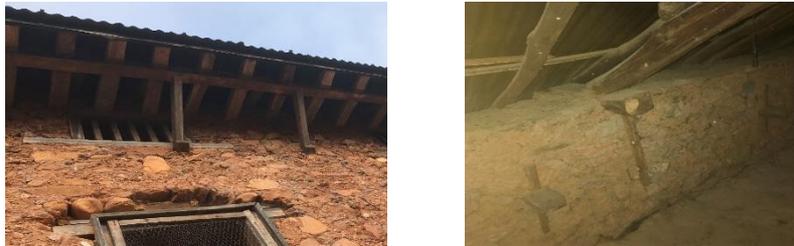
Figure 5. Timber roofing system with timber keys and compression struts: outside view (left) and inside view (right).

The timber roof structure is supported by a system of compression struts locked to the masonry by timber keys as seen in Figure 5 which improves the floor-wall connections and provides in-plane stiffness at the attic floor level.

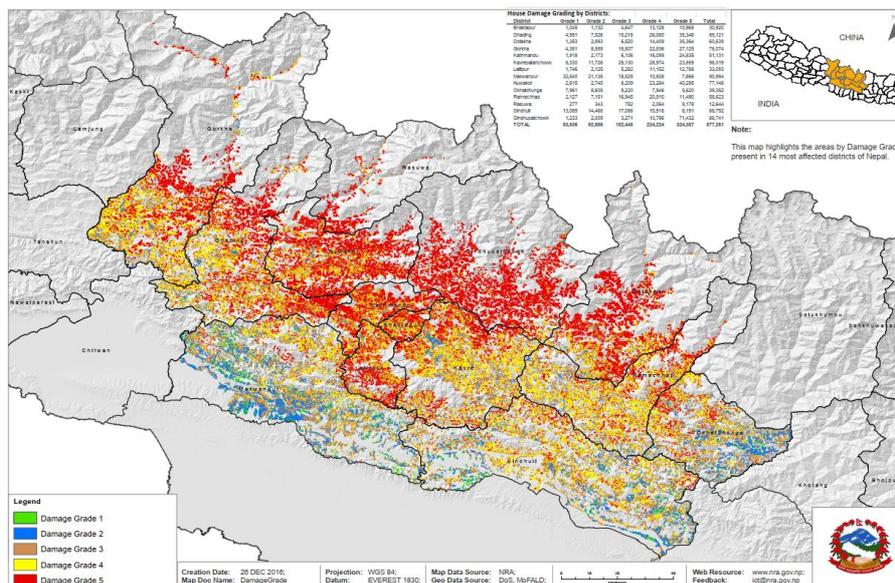
Figure 6. Damage grade distribution of structures in 14 most affected districts (NRA, 2016b).

The damage suffered by the PRE-SMM typology during the 2015 Nepal earthquake was extensive and contributed significantly to both economic and human loss due to the earthquake. Figure 6 shows the damage grade distribution in the building structures due to 2015 earthquake in the 14 most affected districts. High concentration of red dots i.e. building collapse lies in the north part which is mostly mountainous region where PRE-SMM was the most frequent typology.

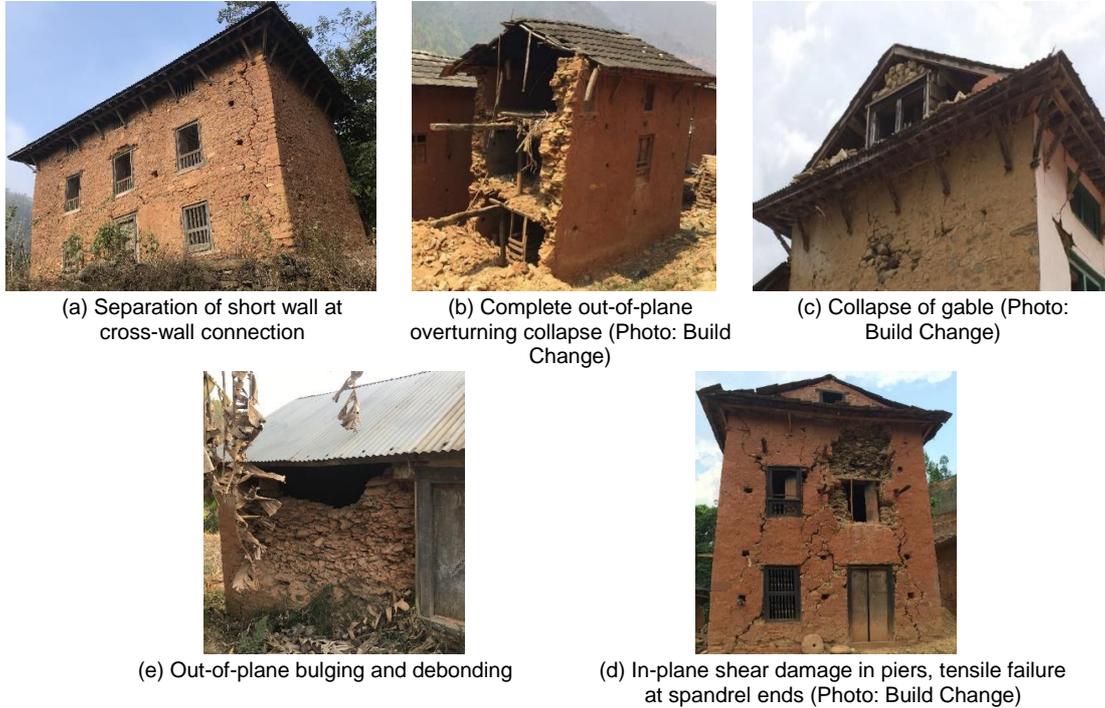
Figure 7. Main failure mechanisms of PRE-SMM typology observed in 2015 Nepal earthquake.

Figure 7 presents the main damage patterns experienced by this typology during the 2015 Nepal earthquake: vertical separation of wall, complete out-of-plane overturning collapse, gable collapse, out-of-plane bulging and delamination, shear cracks in the in-plane walls etc.

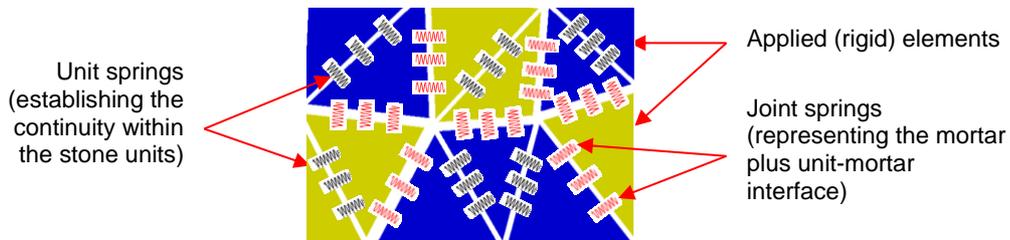
Figure 8. Schematic of simplified micro-modelling of stone masonry using AEM. Blue or yellow coloured cluster represents individual stone unit.

Extreme Loading for Structures (ELS) software (ASI, 2018), based on applied element method (AEM), is used in the present study (Figure 8). Two types of springs are used, 'unit' or 'element' springs connecting the applied elements of the units, and 'joint' springs connecting the individual applied elements to represent the equivalent properties of mortar and mortar-unit interface. In this

study, to account for the random irregular shape of rubble stone, triangular elements are used rather than rectangular elements. A detailed overview of the formulation, constitutive laws, failure criteria etc. for masonry modelling in AEM can be found in Malomo et al. (2018).

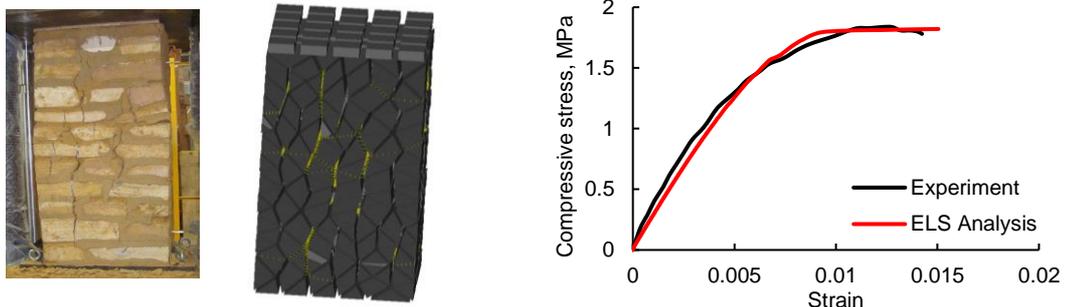
Figure 9. Experimental and ELS analysis comparison: Crack patterns at failure (left) and stress-strain diagrams (right).

For the validation of the proposed numerical modelling strategy using AEM method, numerically obtained compressive and lateral behavior of SMM walls are compared against experimental tests results. Figure 9 compares the numerical crack patterns and the stress-strain diagrams to the experimental results of a SMM pier subjected to vertical compression and Figure 10 for a SMM wall subjected to vertical bending under a four-point bending test (Pun, 2015). Under both loading cases, the experimental and numerical results are in good agreement. These results confirm that AEM can be effectively used for the gravity and lateral load analysis of SMM structures.

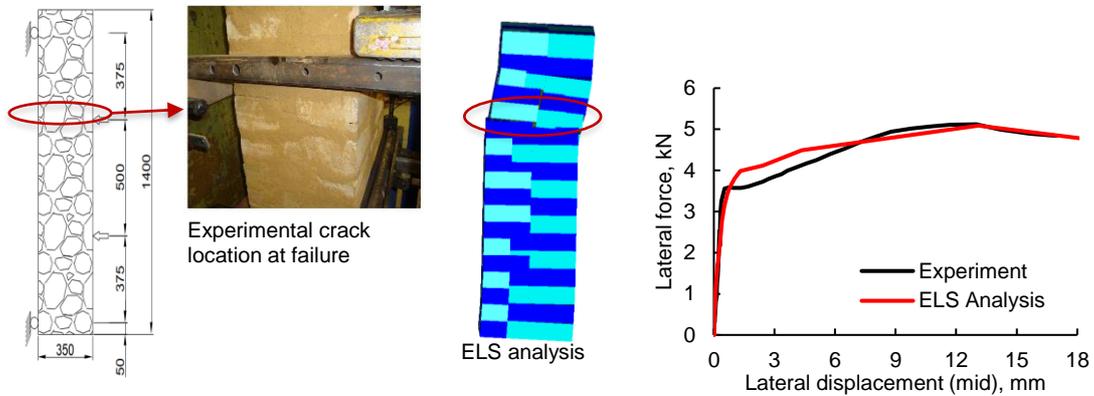
Figure 10. Experimental and ELS analysis comparison: Crack patterns at failure (left) and force-deformation curves (right).

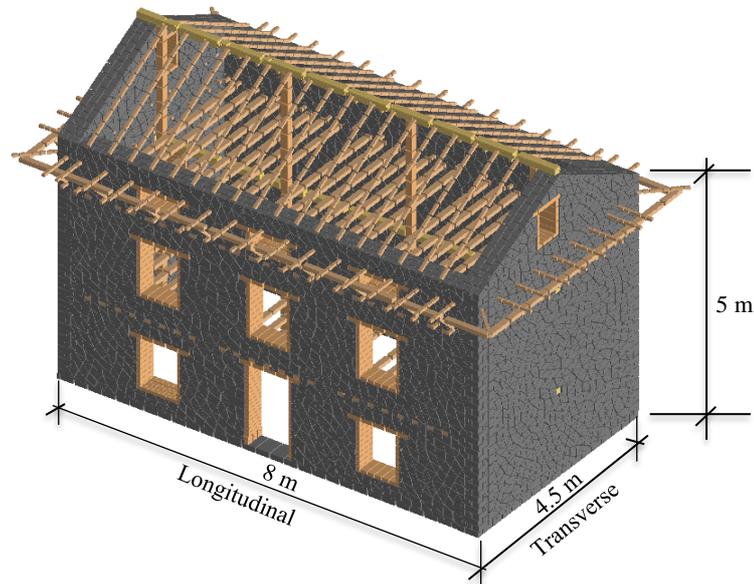
Figure 11. Numerical model of an index building of the PRE-SMM typology created in ELS.

In ELS, a 3-D numerical model (Figure 11) of an index building of the PRE-SMM typology is created using the strategy discussed in the previous section. For computational efficiency, stone units are modelled as rigid elements i.e. the cracks are assumed to develop through the mortar joints only. For the joint springs, a failure criterion is defined by specifying a separation strain, 0.025 for this particular model. This parameter is obtained from the calibration study reported in the previous subsection. Once this strain limit is exceeded in a spring, this has no further tensile or shear capacity, however contact can occur between the adjacent applied elements depending on the loading condition. The timber lintels above the openings as well as the timber frame

elements around the openings are modelled as elastic elements. The timber framed roof structure, including the keys and compression struts are also modelled to reproduce a realistic model. Foundation are assumed to be fixed. It is worth noting that the building is non-symmetric in the longitudinal direction due to the typical distribution of opening.

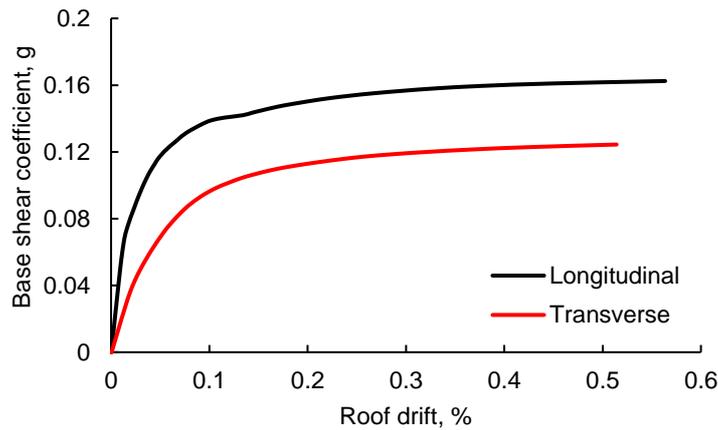
Figure 12. Capacity curves for the PRE-SMM typology in two principal directions.

Figure 12 compares the capacity curves of the PRE-SMM index building in the longitudinal and transverse directions. The peak lateral capacity attained by the building is 0.16g and 0.12g in longitudinal and transverse direction, respectively. An analytical study on similar construction types of Turkish two-storey SMM buildings by D'Ayala and Kishali (2012) also found typically low lateral capacity (0.07g - 0.19g) for such buildings. Due to the poor strength of mortar as well as the randomness of the stone, the non-linear response starts at a drift as low as 0.05% and the ultimate drift capacity is only about 0.5% in both principal directions. Bothara et al., (2018b) also obtained a similar level of yield and ultimate drift values for similar SMM buildings from Nepal.

The shake map from the 2015 Nepal earthquake (USGS, 2015b) estimated a PGA range of 0.3g - 0.8g in the most affected districts which is far more than the lateral seismic capacity of the PRE-SMM typology (Figure 12). However, due to the lack of site-specific seismic records, no direct comparison of the actual and numerical seismic performance of the case study building, for example using capacity spectrum approach, could be made.

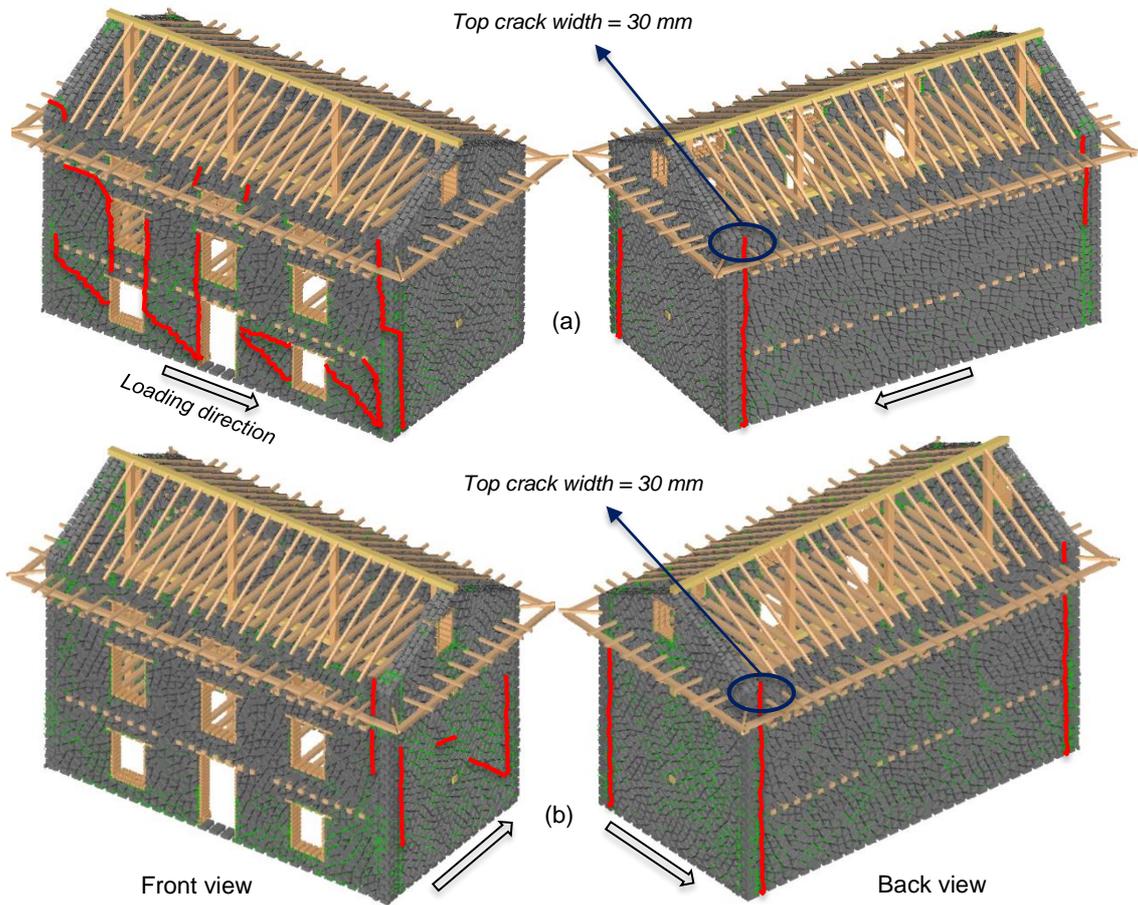
Figure 13. Ultimate failure mechanisms obtained from pushover loading in (a) longitudinal and (b) transverse directions. Green coloured cracks represent tensile and shear cracks of width up to 3 mm while red coloured cracks represent major cracks of width more than 3 mm.

The ultimate crack patterns developed in the building when loaded in the two principal directions are shown in Figure 13. The most dominant failure mode includes continuous vertical separation cracks at the cross-wall connection triggering the overturning of the out-of-plane loaded walls. The long in-plane loaded wall with windows suffers diagonal shear cracks in the lowermost piers as well as tensile damage in the spandrels. Piers also tend to separate from the wooden frames around the openings. These damage patterns compare well with the actual damage observed in the case study building due to the 2015 earthquake (Figure 14) in which major vertical separation cracks in both direction walls can be seen.

Both in the numerical analysis as well as in the observed damage, excessive out-of-plane overturning of the walls is restricted to some extent, and the ultimate failure includes the collapse mechanisms involving damage in both in-plane and out-of-plane walls. This indicates that the timber floor system and the roof system, including the arrangement of timber keys and struts, provide sufficient level of stiffness for the diaphragm action.

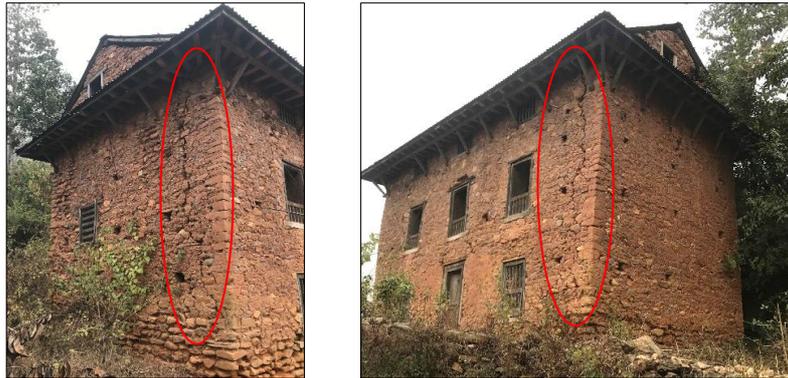
Figure 14. Actual damage due to the 2015 earthquake in the case study building from Sindhupalchowk district. Vertical separation cracks have a maximum width of about 25 mm.
