# **Full-scale fire testing to collapse of steel stiffened plate structures under lateral patch loading (Part 1) – without passive fire protection**

The aim of this paper is to present a fire test database on the collapse of a full-scale steel stiffened plate structure without passive fire protection under lateral patch loading. Steel plate panels of a 1,900 TEU containership in compliance with test facility in a maximum size and capacity were considered as a reference structure, with principal dimensions of 7 m long and 4.8 m wide fitted with two transverse frames and seven longitudinal stiffeners. Lateral patch loading was applied using two loading actuators at the centre of each transverse frame. A fire test was conducted in a furnace fuelled by liquefied petroleum gas, where the maximum gas cloud temperature inside the furnace was increased up to 800 °C during testing. Time history of the lateral deformations of the test structure was measured with the focus on a critical period of time until the structure reached the ultimate limit state (or collapse) after the fires started. Details of the test database are documented, which will be useful for validating computational models

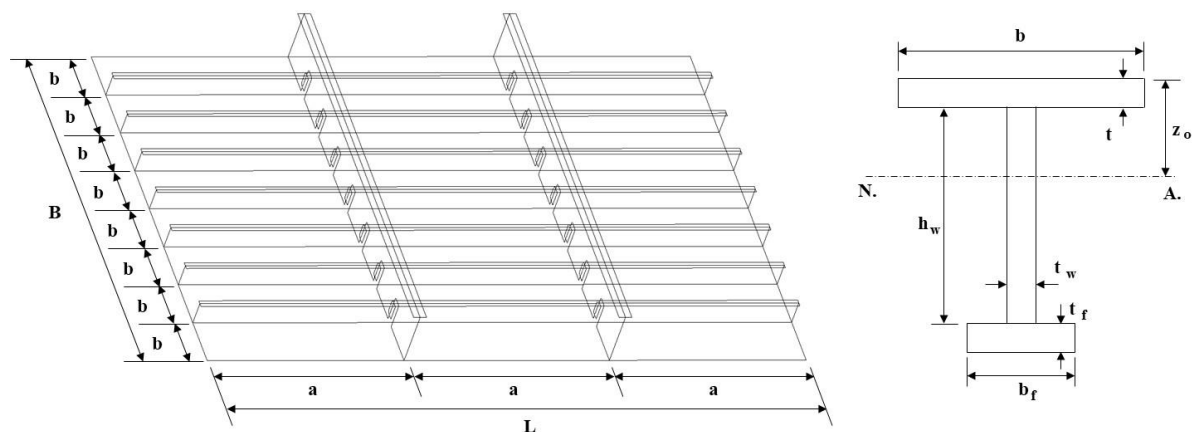
**Figure 2.** Nomenclature of the test structure.

Figure 1 shows steel plate panels of an as-built containership carrying 1,900 TEU, selected as a reference ship in compliance with test facility in size and capacity. Figure 2 denotes the nomenclature of the test structure. Properties of plate panels are characterised by the plate slenderness ratio,  $\beta$  and the column slenderness ratio of longitudinal stiffeners with attached plating,  $\lambda$ , as follows.

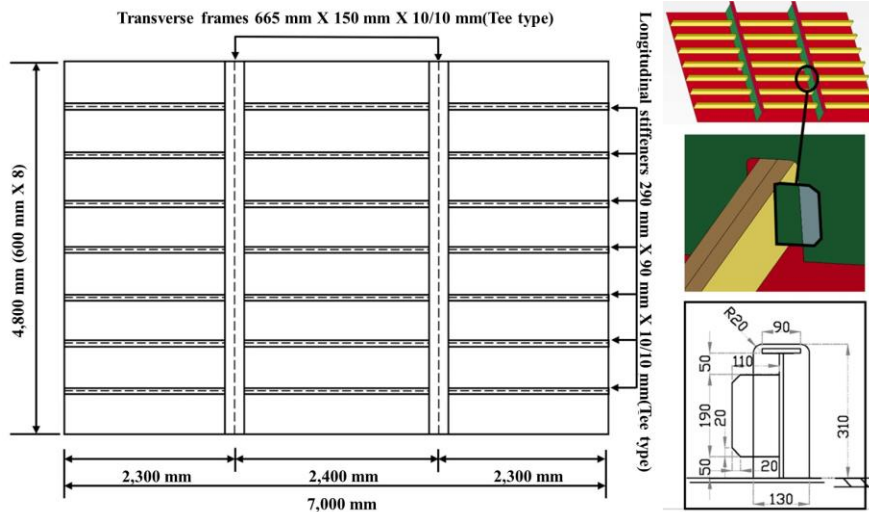
**Figure 3.** Plan view drawing of the test structure design, with detail of the longitudinal stiffener and cut out.

The scantlings of the test structure, which is made of high tensile steel with grade AH32, were determined. Figure 3 shows the plan view drawing of the test structure design. Table 1 compares the geometric properties for a reference plate panel versus the test structure.

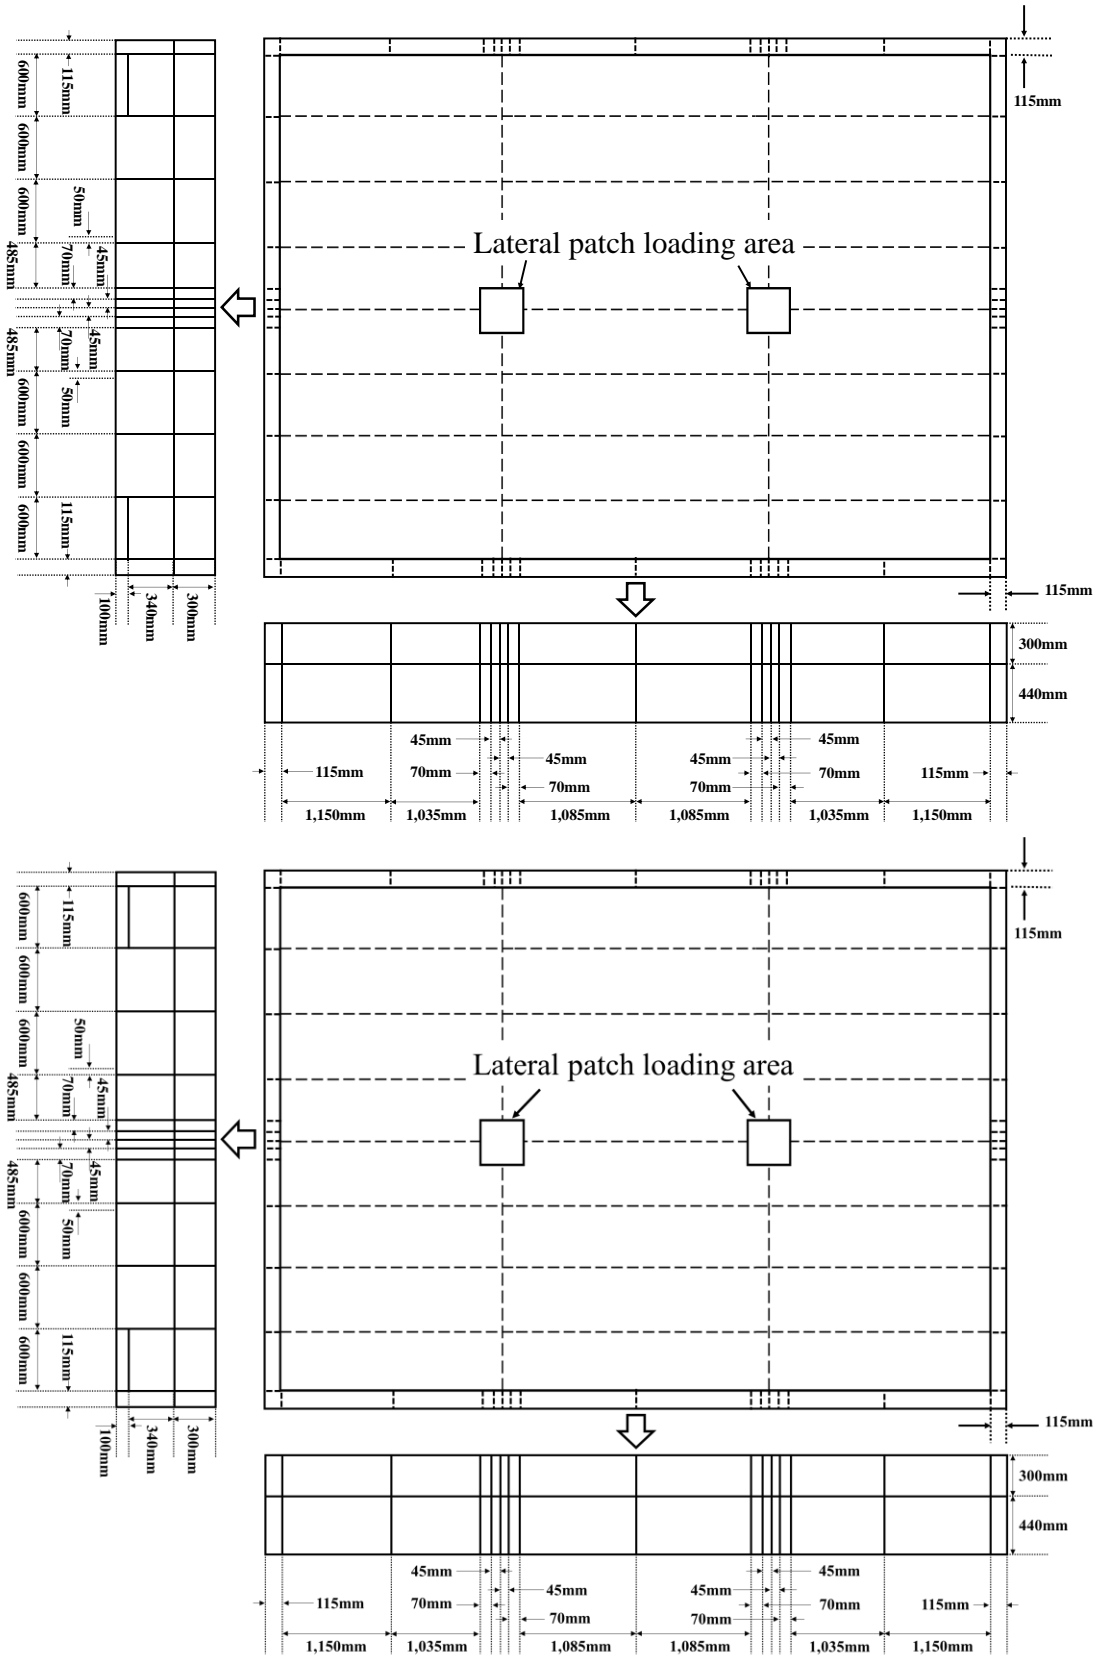
**Figure 4.** Plan and profile drawings of the test structure together with supporting jigs along the four edges.

To attain a strong support condition along four edges (boundaries) of the test structure associated with the furnace facility, support jigs were also designed and constructed. Figure 4 shows the plan and profile drawings of the support jigs which were made of the same high tensile steel with grade AH32 as for the test structure. The support jigs may represent a fixed boundary condition for the structural failure analysis using computational models.

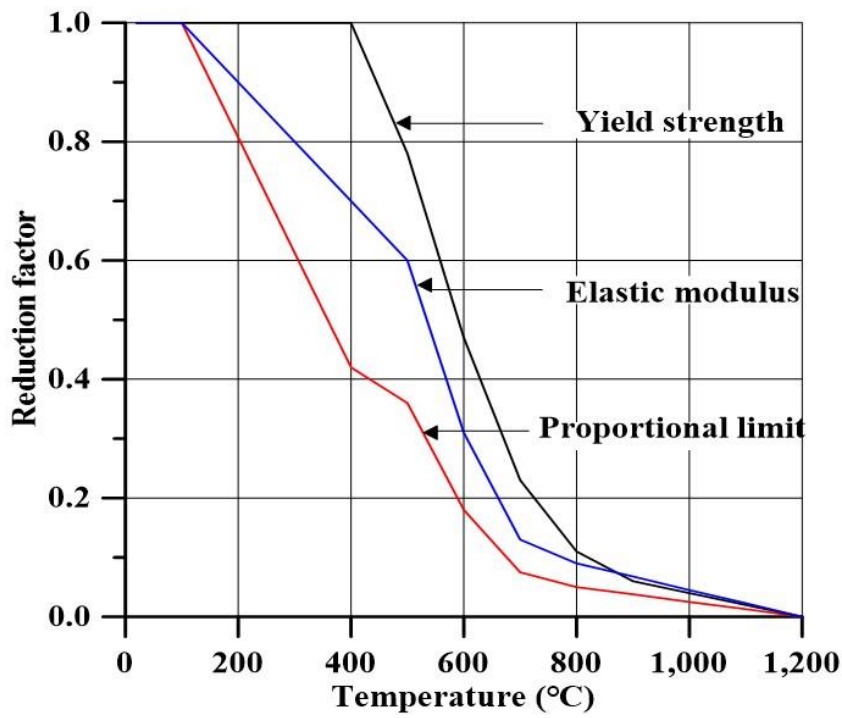
**Figure 5.** Effect of elevated temperatures on mechanical properties of steel (EN 1993-1-2 2005).

A high tensile steel with grade AH32 was used to fabricate the test structure and support jigs. Material procurement was conducted under the responsibility of a shipyard in Busan, South Korea which fabricated the test structure as described in Section 4. The nominal values of mechanical properties for AH32 high tensile steel at room temperature (20 °C), provided by the steel maker, are indicated in Table 2. Figure 5 presents the effects of elevated temperatures on mechanical properties of steel (EN 1993-1-2 2005).

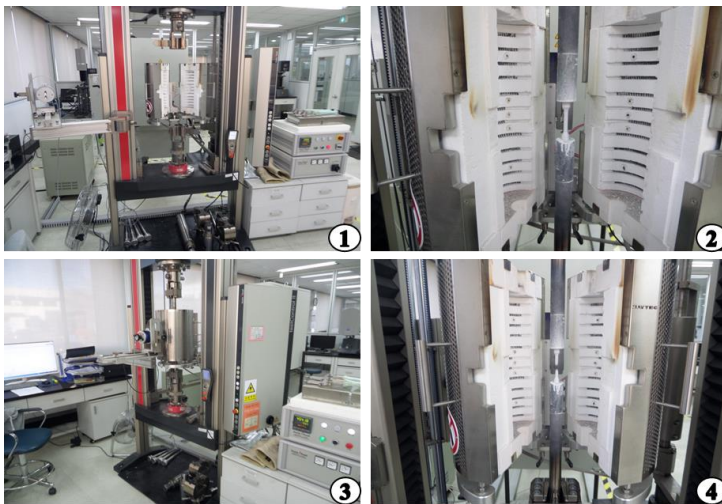
**Figure 6.** Tensile material test set-up using universal testing machine with an elevated temperature control chamber.

Figure 6 shows a tensile material test set-up at an elevated temperature using the test facility at the ICASS/KOSORI in Yangsan, South Korea ([www.icass.center](http://www.icass.center)). Figure 7 presents the engineering stress-engineering strain curves of the high tensile steel AH32 obtained from the tensile testing. It is observed that neither upper nor lower yield point appears at 400 °C until the ultimate tensile strength is reached. In this case, the yield strength was defined as a stress at the intersection of the stress-strain curve and a straight line through an offset point strain, equivalent to the proof stress at 0.2% strain (Paik 2018). Table 3 summarises the obtained mechanical properties of the AH32 steel, with varying elevated temperatures associated with fires.

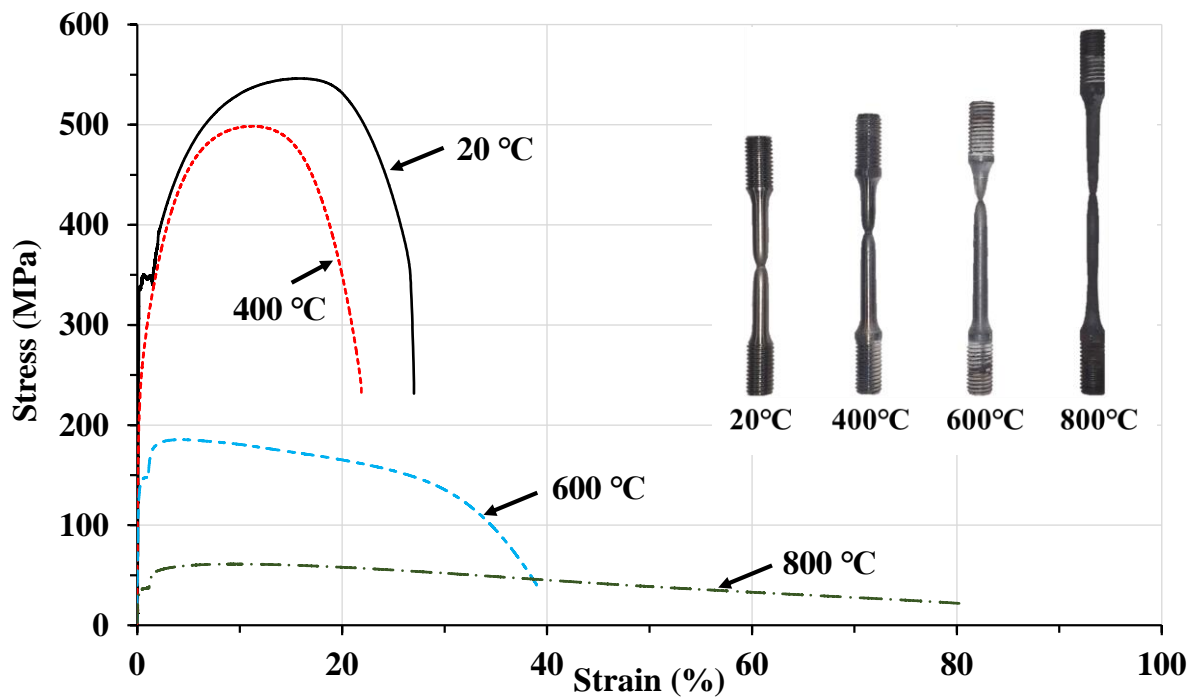
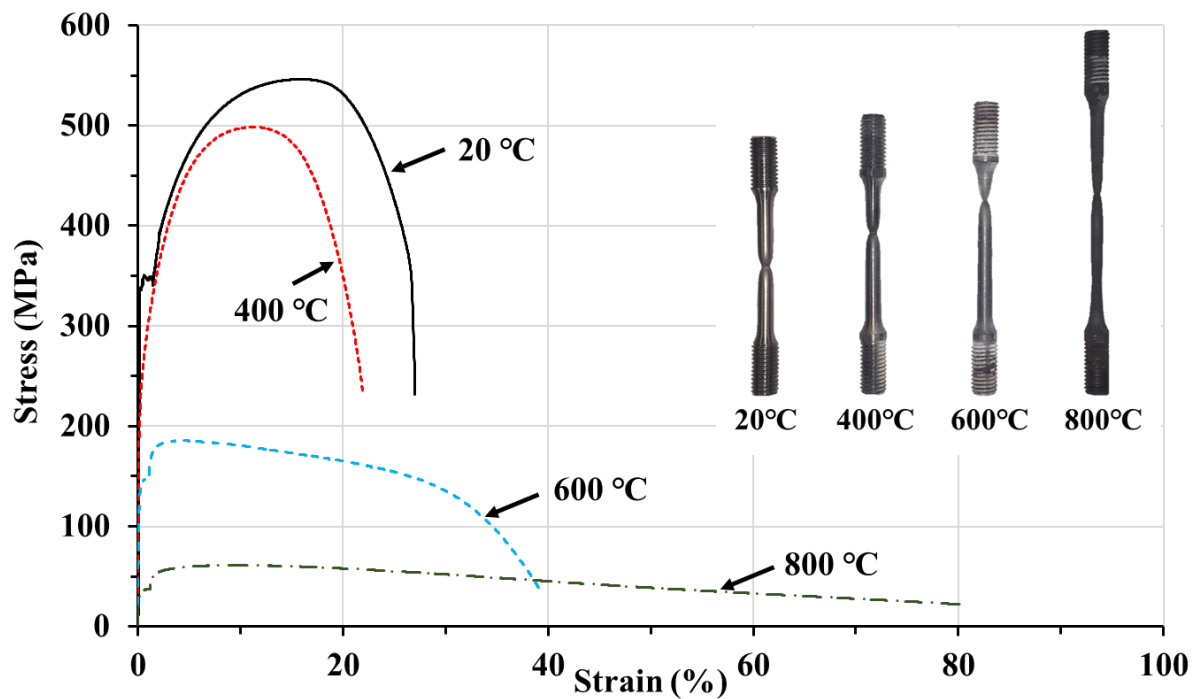
**Figure 7.** Engineering stress-engineering strain curves of high tensile steel AH32 at different temperatures, obtained from tensile tests.

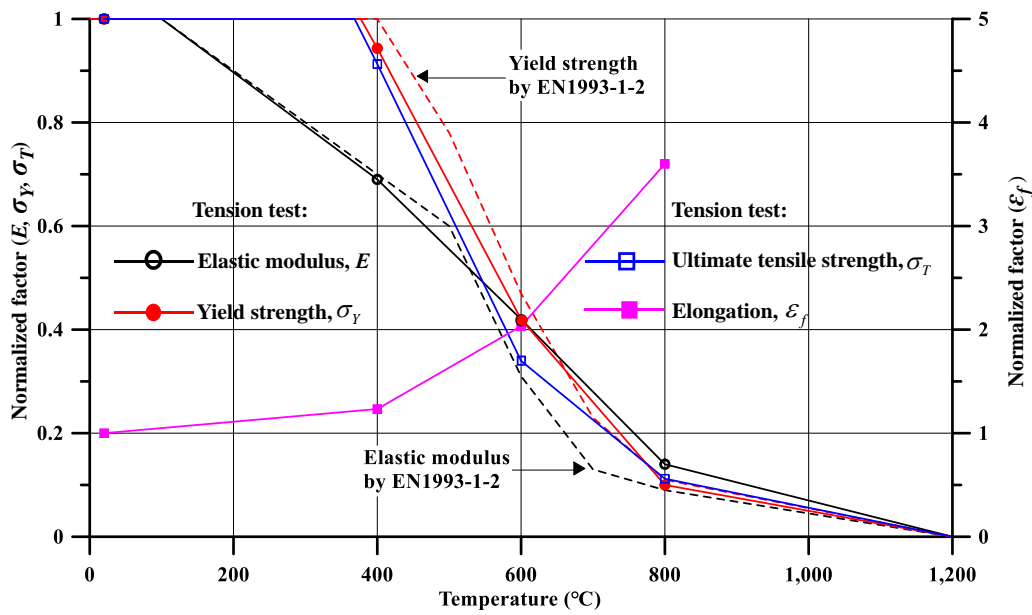
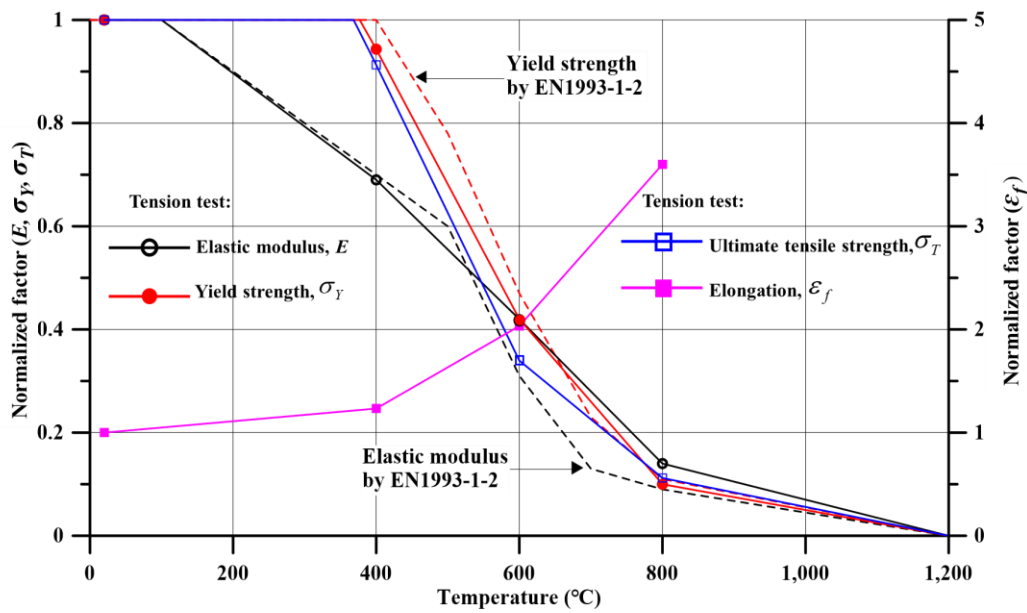
**Figure 8.** Comparison of material properties between tension tests and EN 1993-1-2 for AH32 high tensile steel.

Figure 8 shows a comparison of material properties between tension tests and EN 1993-1-2 (2005), where the nominalised factor indicates a ratio of the corresponding parameter at an elevated temperature to that at room temperature. It is confirmed from Figure 8 that the EN 1993-1-2 curve generally provides a reasonable guideline to

characterise the effects of elevated temperatures on mechanical properties of steel, as it is in a good agreement with tension tests. New data for ultimate tensile strength and elongation obtained from the present study are also presented. The reduction trend of ultimate tensile strength is quite similar to that of yield strength, but the elongation significantly increases with increase in temperature.

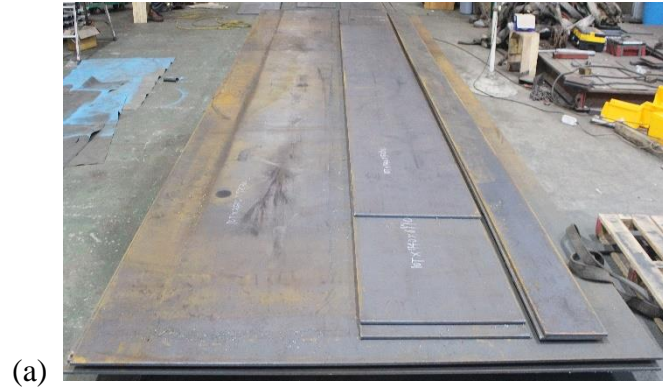
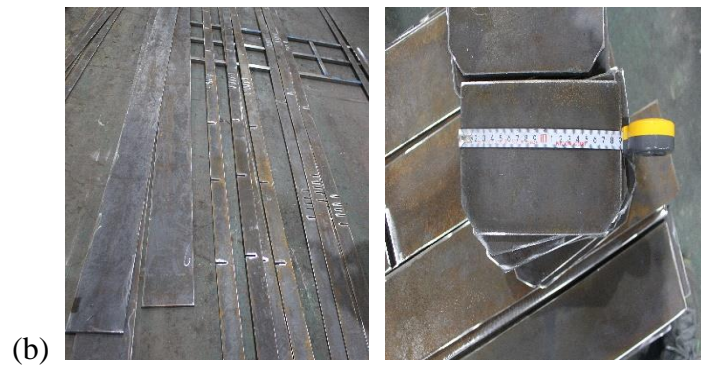
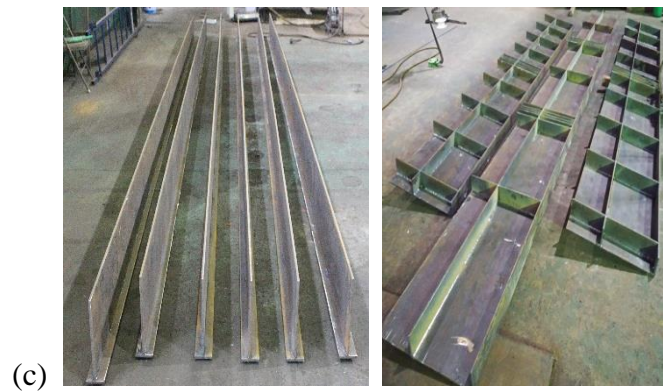
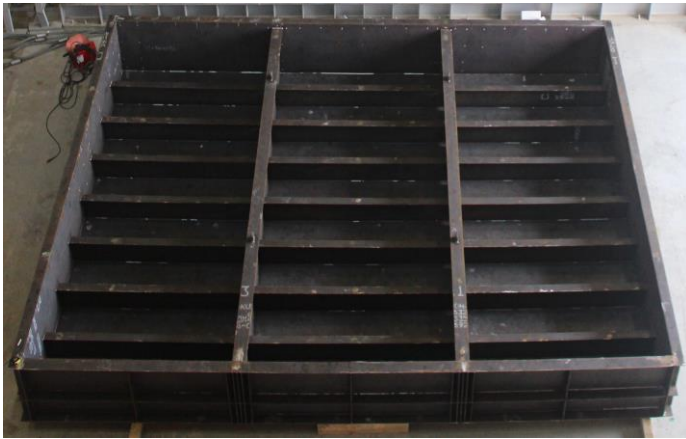
**Figure 9.** The fabrication process at the shipyard: (a) raw plate sheet, (b) plate cutting, (c) assembly of support members and support jigs, (d) completion of the test structure.

Table 4 summarises the welding conditions applied for fabricating the test structure. To minimise welding-induced initial imperfections, the plating of the test structure was entirely made of an identical steel sheet by avoiding butt welds to connect pieces of steel sheets. All longitudinal stiffeners and transverse frames were attached by continuous fillet welding following the welding requirements of DNV GL (2018). The flux-cored arc welding (FCAW) method was applied. Figure 9 shows a flow of the fabrication process.

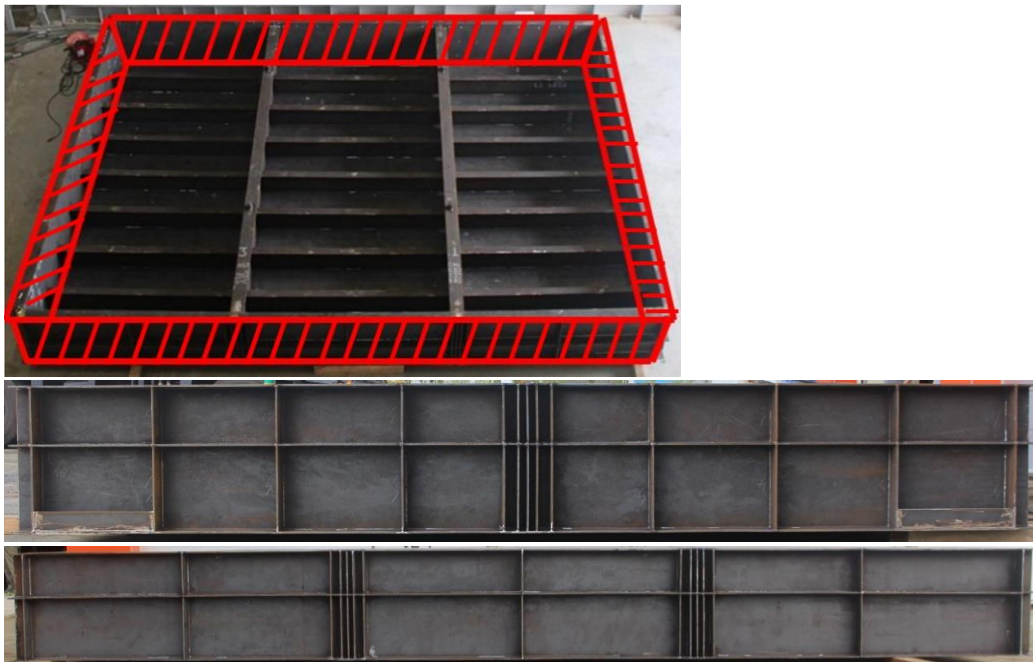
**Figure 10.** Fabrication of support jigs along four boundaries of the test structure.

Support jigs were welded to the test structure along its four edges as shown in Figure 10. The test structure was transported from the shipyard to the test site at ICASS/KOSORI ([www.icass.center](http://www.icass.center)) in Hadong, South Korea.

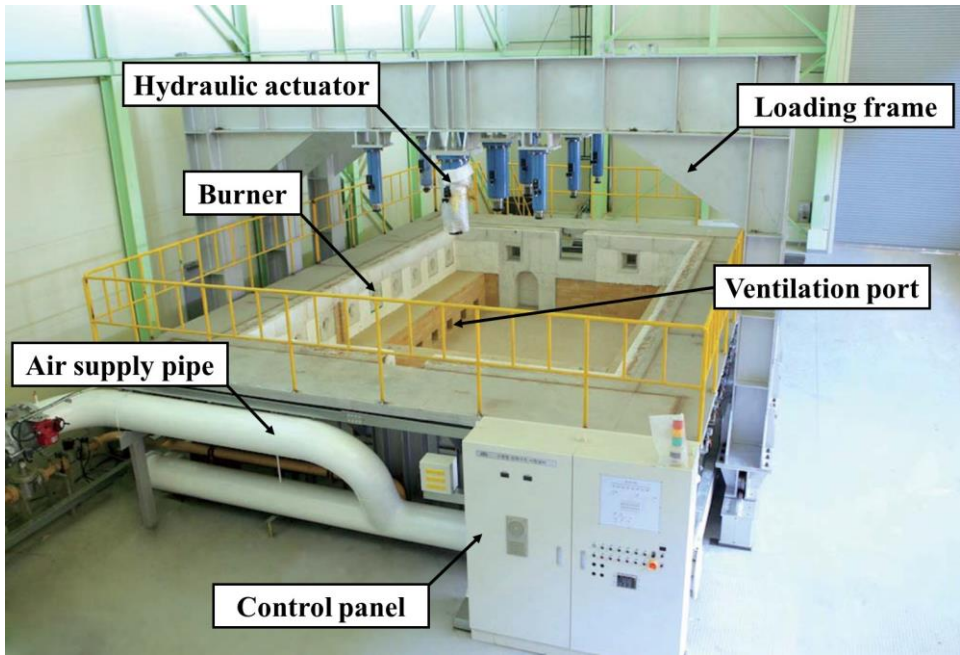
**Figure 11.** Horizontal type fire test furnace facility of the ICASS/KOSORI in Hadong, South Korea.

The testing was conducted in a horizontal type furnace at the test site of the ICASS/KOSORI in Hadong, South Korea ([www.icass.center](http://www.icass.center)). Figure 11 shows this type fire furnace test facility. The space inside the furnace is 6,500 mm long, 4,500 mm wide and 1,730 mm deep. The test structure was positioned horizontally to cover up on top of the furnace, while burners supplied by liquefied petroleum gases were used to raise ambient temperature inside the furnace. The maximum gas cloud temperature that can be applied in the test facility is 1,430 °C. Figure 12 shows a target curve of increasing gas cloud temperatures with time as per the ISO 834 fire curve (ISO 834 1999), which presents a guideline of predicting the time history of ambient temperatures for engineering structures in fires. It can be expressed in the following equation:

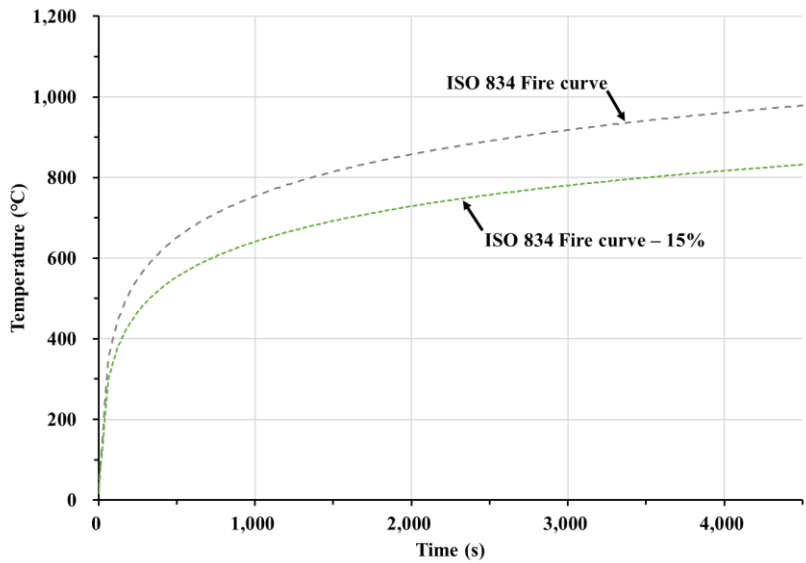
**Figure 12.** A target curve of increasing temperatures with time as per the ISO 834 fire curve.

$$T = 20 + 345 \log(8t + 1) \quad (3)$$

where  $T$  is the gas cloud temperature in °C and  $t$  is the time in minute. Figure 12 also shows the ISO 834 curve 15% below the original curve, which was applied for the present test.

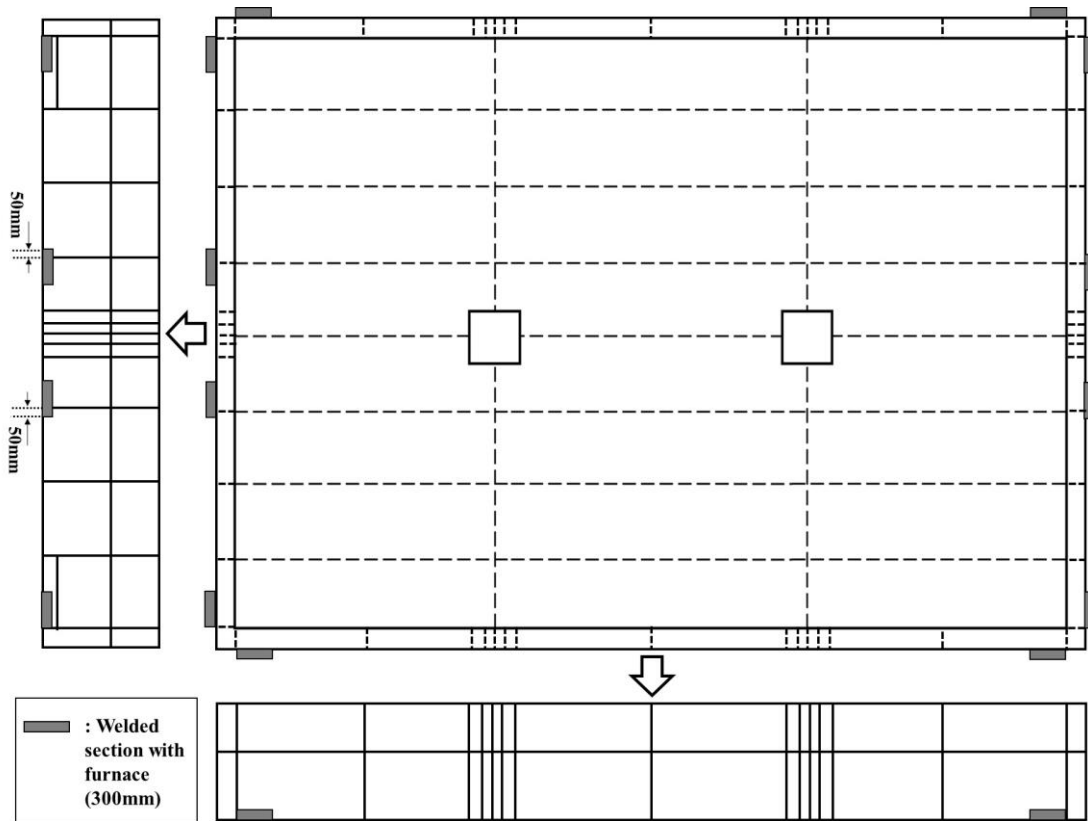
**Figure 13.** Plan and profile views showing the welded locations between supporting jigs and the furnace.

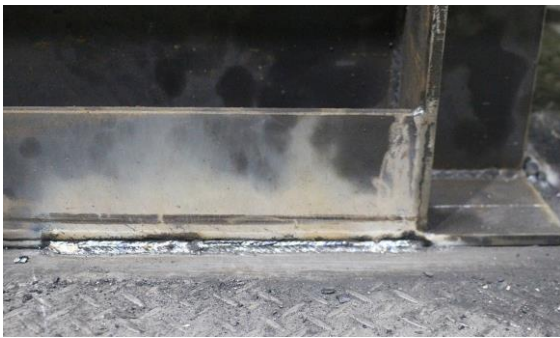
**Figure 14.** A 300 mm long welding of a supporting jig along part of the furnace boundary.

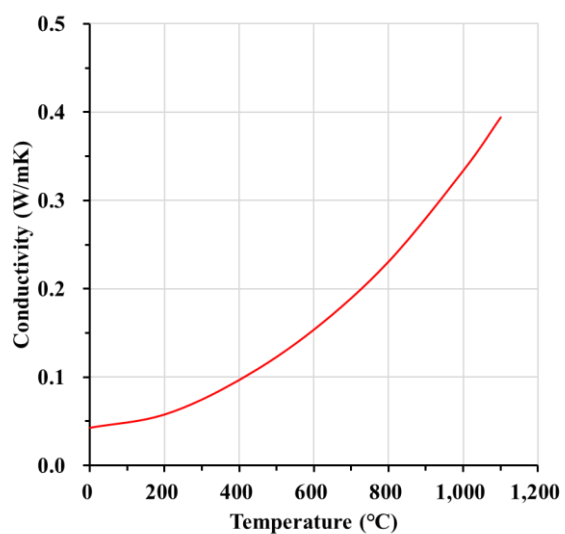
**Figure 15.** Thermal conductivity of cerawool (DIFK 2014).

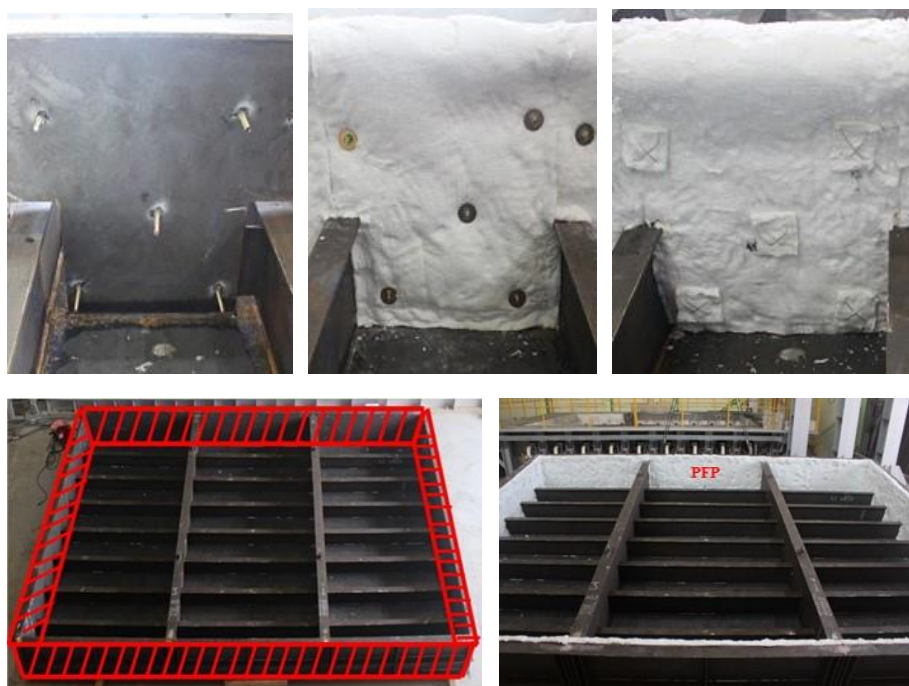
**Figure 16.** Insulation with passive fire protection material along the four boundaries of the test structure.

The boundaries of the furnace should be fully shielded to prevent elevated temperatures inside the furnace from flowing outside the test structure, and thus all the four boundaries were insulated by fire protection material, called cerawool, which can achieve an ultra-high temperature-resistant and fireproof condition by lowering thermal conductivity with melted and fiberised high purity silica (sand) and alumina. Table 5 and Figure 15 present the nominal values for the properties of cerawool (DIFK 2014). Figure 16 shows the insulation with fire protection material along the four edges of the test structure. Figure 17 shows the completion of the test set-up including loading and sensors of test data acquisition that will be described later.

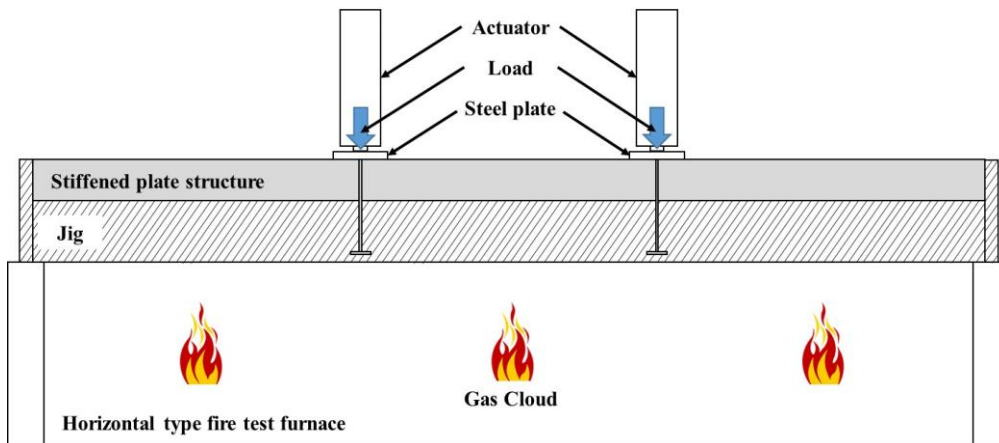
**Figure 18.** Set-up for applying lateral patch loads at the centre of transverse frames.

Two out of the three hydraulic loading actuators were used for the tests, where lateral patch loads were applied at the centre of each transverse frame as shown in Figure 18. Multiple layered steel plates including one plate insulated with passive fire protection were inserted between the loading actuator tip and the patch area of the test structure, as shown in Figures 19 and 20, to apply the patch loads uniformly over the patch area and also to protect loading actuators from heat. To prevent the transfer of high temperature from the heated test structure to the loading actuators, which may cause a malfunction, they were insulated by fire protection material with cerawool as shown in Figure 21.

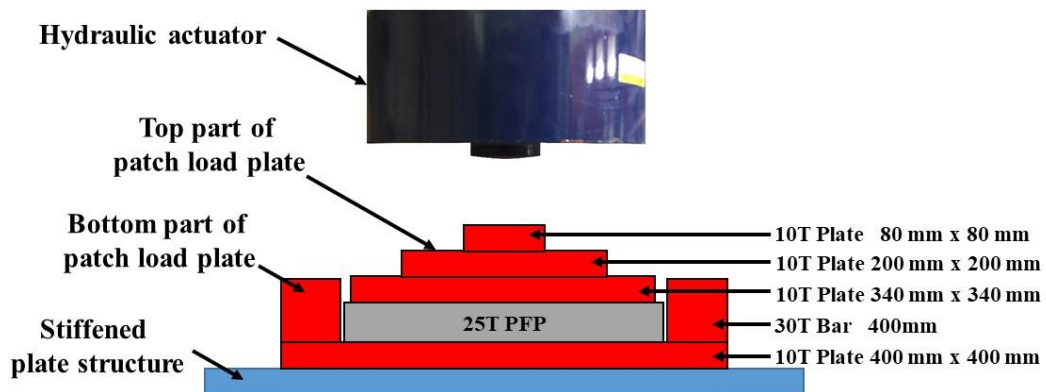
**Figure 19.** Multiple layered steel plates between the loading actuator and the patch loading area (side view).

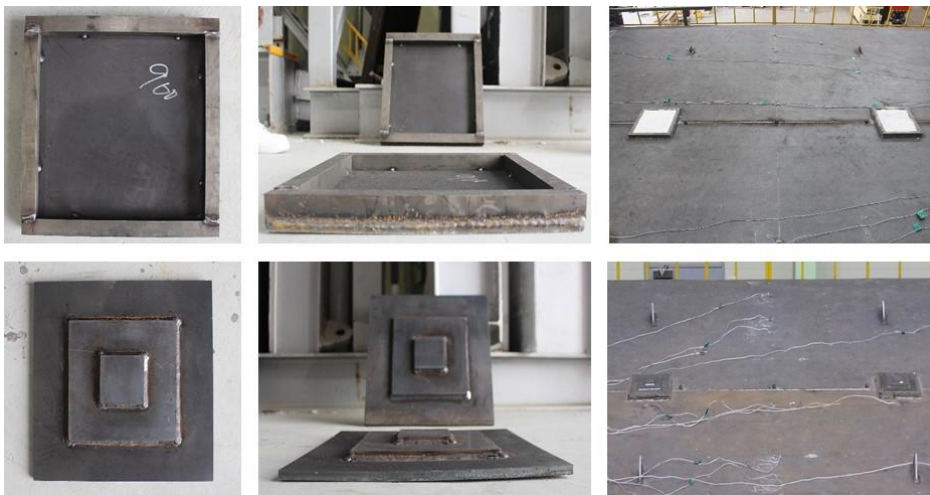
**Figure 20.** Manufactured and installed patch load plates.

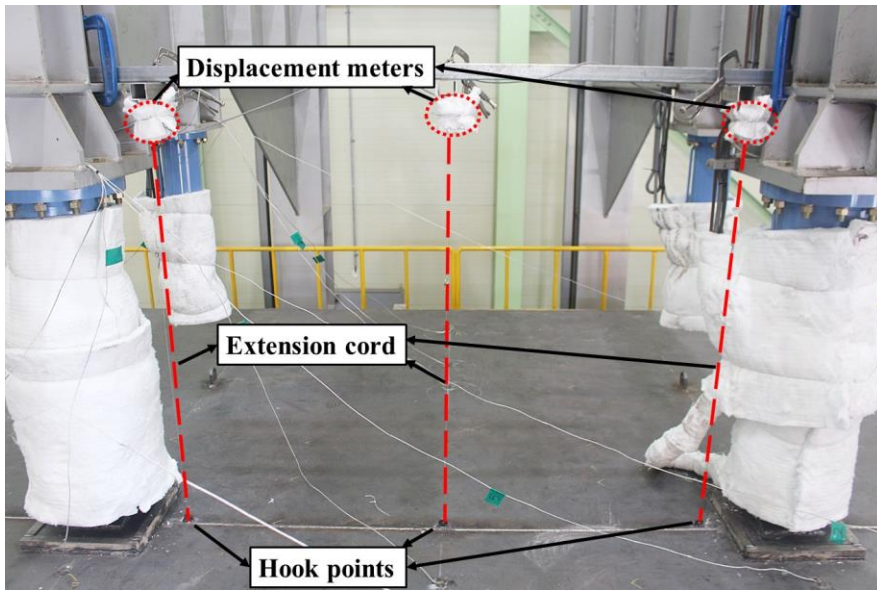
**Figure 18.** Insulation of passive fire protection for loading actuators to prevent them from heat transfer.

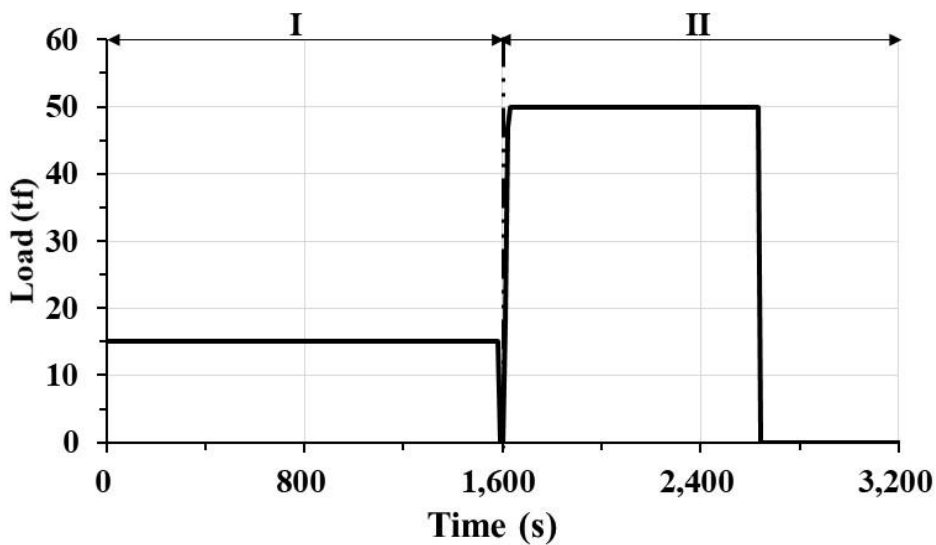
**Figure 22.** Measured profile of lateral patch loads at two steps associated with each loading actuator.

Lateral patch loads were applied in two steps as shown in Figure 22, where 15 tf were applied at each loading point and maintained for 1,580 seconds in the first step, and 50 tf were applied at each loading point after fully unloading of the first load step at 1,630 seconds and maintained until the test ended by structural collapse at 2,630 seconds. At each loading step, the magnitude of load application was kept constant, where the stroke of hydraulic loading actuator was automatically controlled so that the applied loading was considered as a “dead load”. A computer system in the control room was used for this purpose.

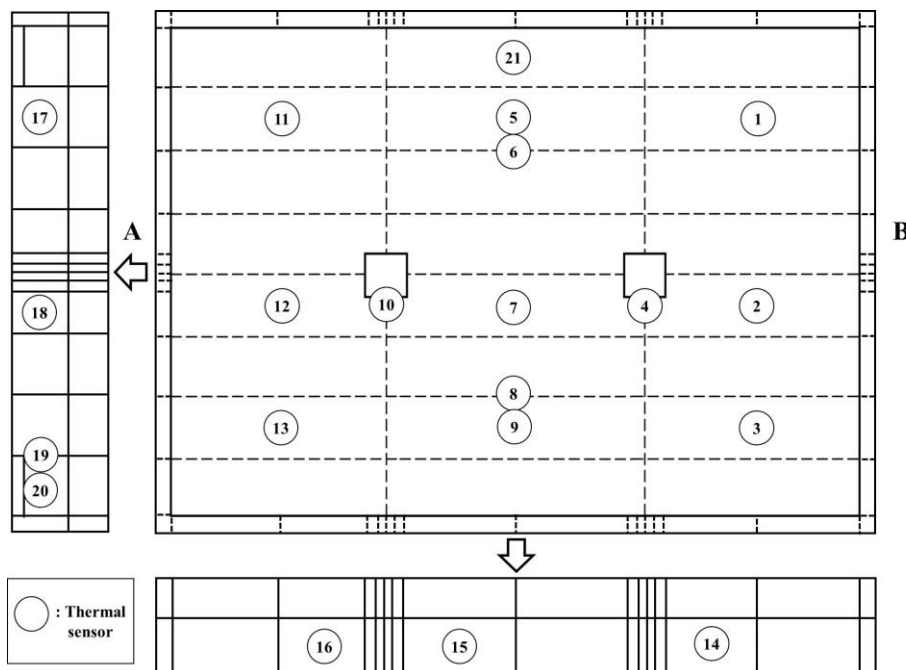
**Figure 24.** Locations of the 20 monitoring points to measure steel temperatures (top view).

Gas cloud temperatures were transferred to the steel structure, and the time history of the steel temperatures of the test structure was measured at a time interval of 10 seconds for 14 monitoring points (Nos. 1-13 and 21) using the thermo-electric couple sensors which are a different model from those used to measure gas cloud temperatures as indicated in Table 6. Also, a total of 7 locations (Nos. 14-20) were monitored to measure steel temperatures of supporting jigs insulated by fire protection materials, which could be used to assess their support effectiveness against fires. The sensors Nos. 1-20 were allocated to measure steel temperatures at plating of the test structure outside the furnace. On the other hand, one sensor (No. 21) was used to measure steel temperatures of the test structure inside the furnace. Figure 24 shows the locations of the monitoring points to measure steel temperatures. The thermos-electric sensors were attached by spot welding to avoid the detachment at very high temperatures, as shown in Figure 25.

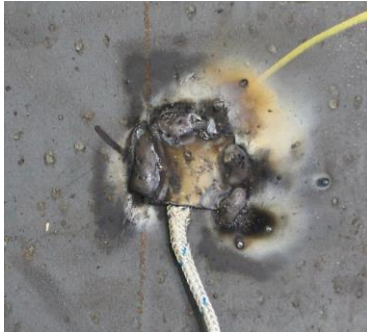
**Figure 25.** Spot welding to attach thermo-electric couple sensors.

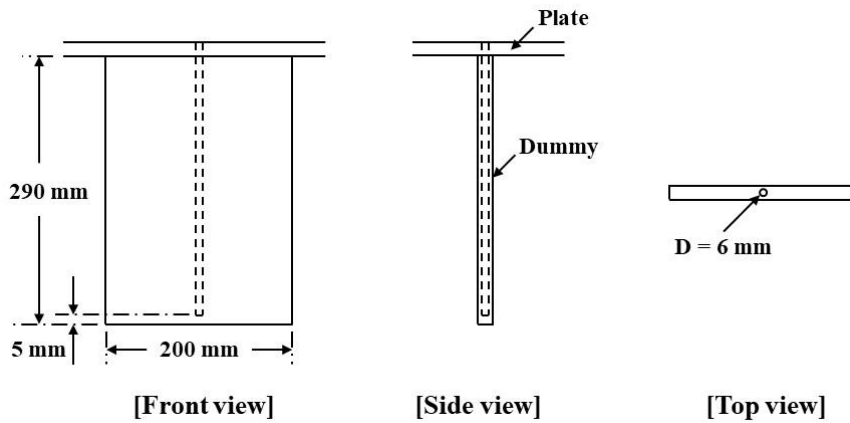
**Figure 26.** Design of the dummy steel plates.

To attach a sensor (No. 21) for measuring steel temperatures inside the furnace, a hole with a diameter of 6 mm was made at the centre of the test structure to pass wire through. Two dummy steel plates with a size of 200 mm × 290 mm were attached to the test structure inside the furnace, and they were placed in overlap with a thickness of 5 mm together with a ceramic tube with a diameter of 4 mm, which is enough to pass the insulated wire of the sensor through. Figure 26 shows the design of the dummy steel plates, and Figure 27 shows the installation of the sensor into the dummy steel plates.

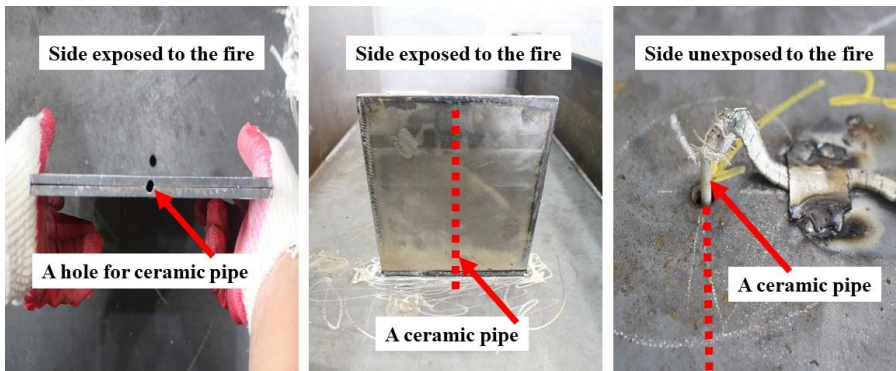
**Figure 27.** Installation of the sensor (No. 21) into the dummy steel plates.

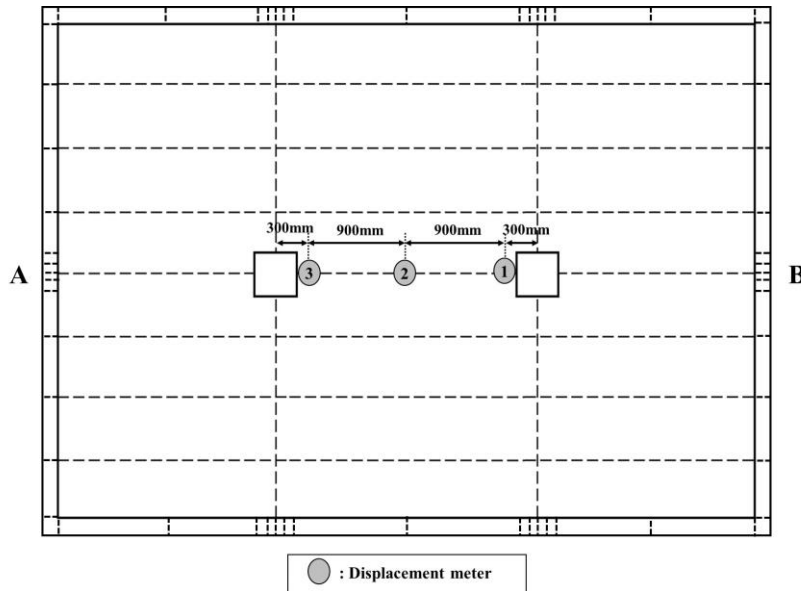
**Figure 28.** Locations of the three displacement meters.

interval of 1 second for three monitoring points using displacement meters as indicated in Table 6. Because of the loading actuators, two displacement meters were placed 300 mm away from the centre of the patch loading points, as shown in Figure 28, while the last displacement meter was positioned on exactly the central point of the test structure. Figure 21 shows the set-up of displacement meters at the three monitoring points.

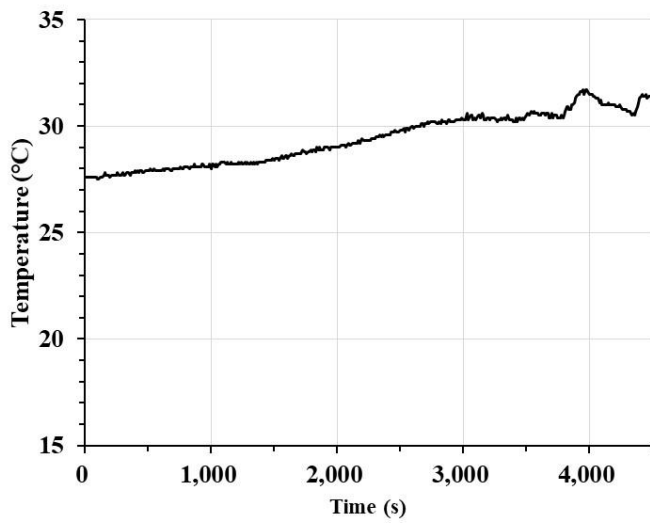
**Figure 29.** Ambient temperature outside the furnace around the test structure.

Figure 29 presents the change of ambient temperatures around the test structure outside the furnace. The room temperature was 27.6 °C before heating, and it was increased to 30.6 °C after an hour, implying that the room temperature was almost constant.

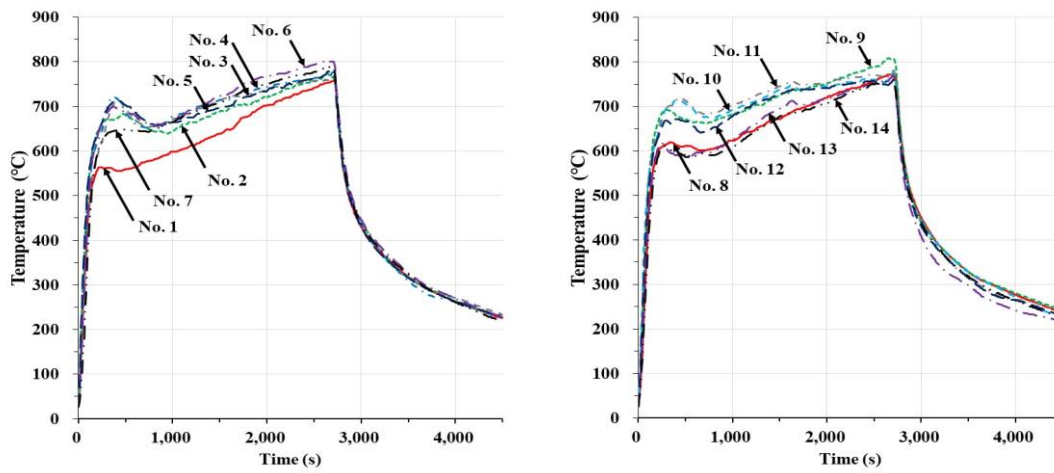
**Figure 30.** Gas cloud temperatures at monitoring points inside the furnace.

Figure 30 presents the time history of the gas cloud temperatures measured at monitoring points inside the furnace. The average gas cloud temperature reached 600 °C at 180 seconds after the start of the gas burning, and it remained at 700 - 800 °C after 1,450 seconds, until the structure collapsed. From 2,720 seconds after the collapse of the structure, the temperature was drastically decreased as the gas burner was shut down.

Monitoring points 1, 7, 8 and 14 were located away from the centre of the test structure, and the gas cloud temperatures at these locations are slightly lower than other points close to the centre. However, it is proposed that the gas cloud temperatures are almost uniform inside the furnace. Figure 31 compares the time histories of the gas cloud temperatures between the measurements and the ISO 834 fire curve. It is seen from Figure 31 that the average gas cloud temperature is about 15% lower than the ISO 834 fire curve.

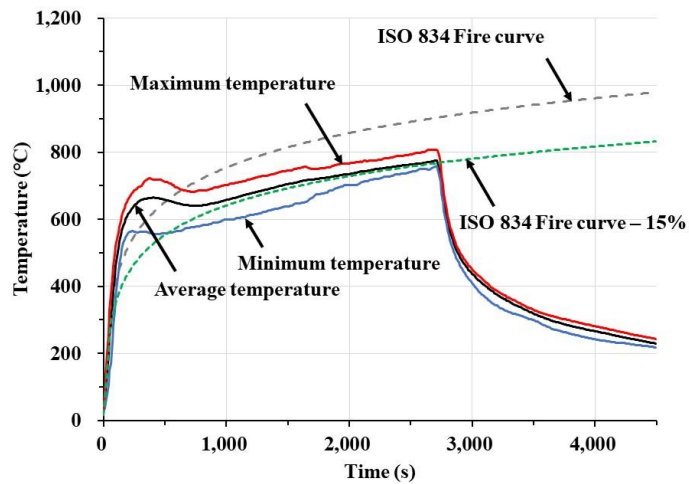
**Figure 31.** Comparison of gas cloud temperatures with the ISO 834 fire curve.

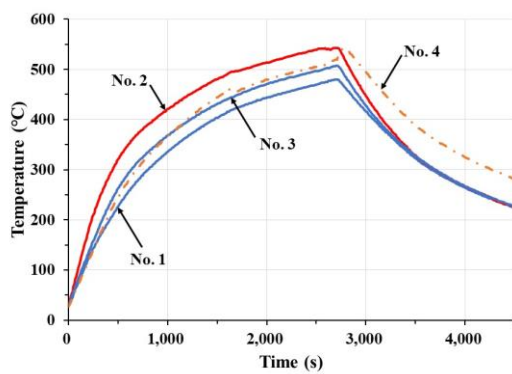
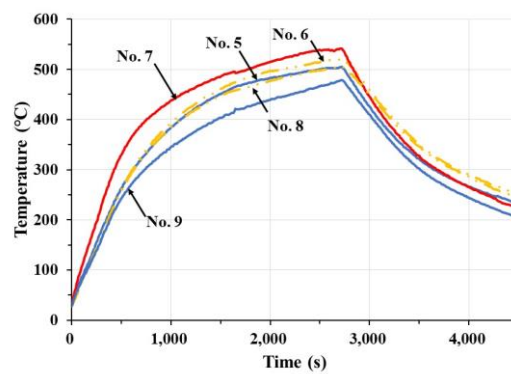
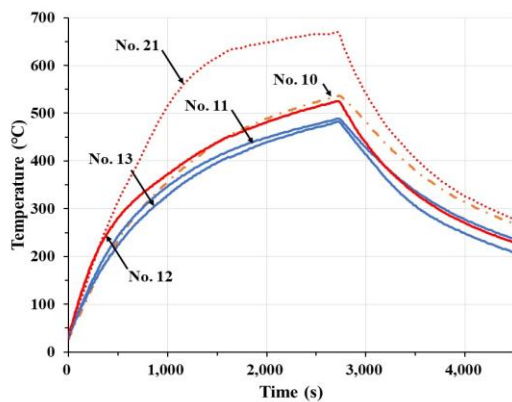
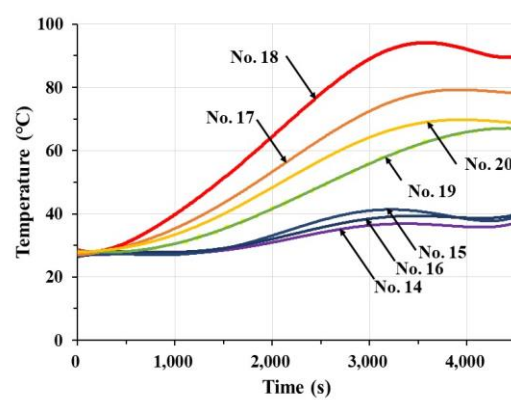
(a) Sensors 1 to 4

(b) Sensors 5 to 9

(c) Sensors 10 to 13 and 21

(d) Sensors 14 to 20

**Figure 32.** Steel temperatures measured at the monitoring points.

Gas cloud temperatures are transferred to the steel structures. Figures 32(a)-(c) present steel temperatures measured at a total of 14 monitoring points of the test structure. Comparing steel temperatures in Figure 32 and gas cloud temperatures in Figure 30 reveals that the former is of course lower than the latter. Steel temperatures measured for supporting jigs are shown in Figure 32(d), showing that the maximum temperature is at most 94 °C. This confirmed that the fire protection material almost fully insulated the supporting jigs and the fixed conditions along the boundaries of the test structure were secured.

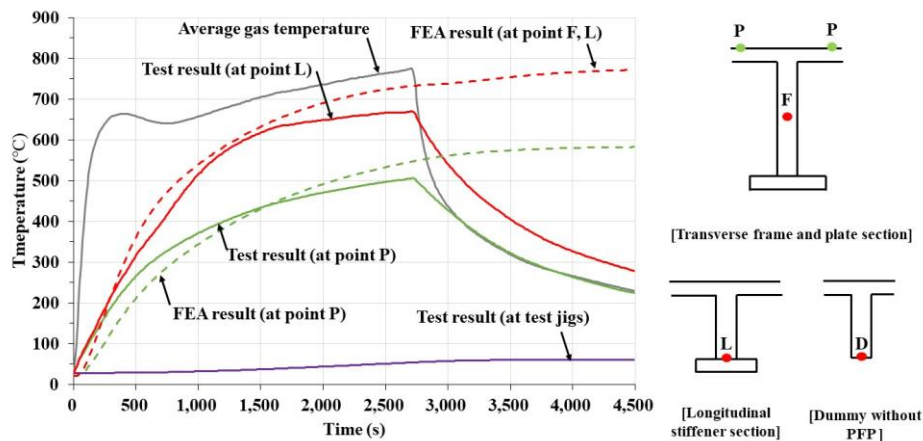
**Figure 33.** Comparison of steel temperatures between the measurements and the finite element method calculations by heat transfer analysis.

It is recognised that the heat transfer analysis using the finite element method is useful to predict steel temperatures, refer to Chapter 12 of Paik (2019). Figure 33 shows a comparison of steel temperatures between the measurements and the predictions, while details of the heat transfer analysis are presented in a separate paper (Ryu et al. 2020). It is seen from Figure 33 that the heat transfer analysis is in a good agreement with the measurements until 2,710 seconds when the gas burner was shut down as the structure entirely collapsed.
