# **Full-scale fire testing to collapse of steel stiffened plate structures under lateral patch loading (Part 1) – without passive fire protection**

The aim of this paper is to present a fire test database on the collapse of a full-scale steel stiffened plate structure without passive fire protection under lateral patch loading. Steel plate panels of a 1,900 TEU containership in compliance with test facility in a maximum size and capacity were considered as a reference structure, with principal dimensions of 7 m long and 4.8 m wide fitted with two transverse frames and seven longitudinal stiffeners. Lateral patch loading was applied using two loading actuators at the centre of each transverse frame. A fire test was conducted in a furnace fuelled by liquefied petroleum gas, where the maximum gas cloud temperature inside the furnace was increased up to 800 °C during testing. Time history of the lateral deformations of the test structure was measured with the focus on a critical period of time until the structure reached the ultimate limit state (or collapse) after the fires started. Details of the test database are documented, which will be useful for validating computational models

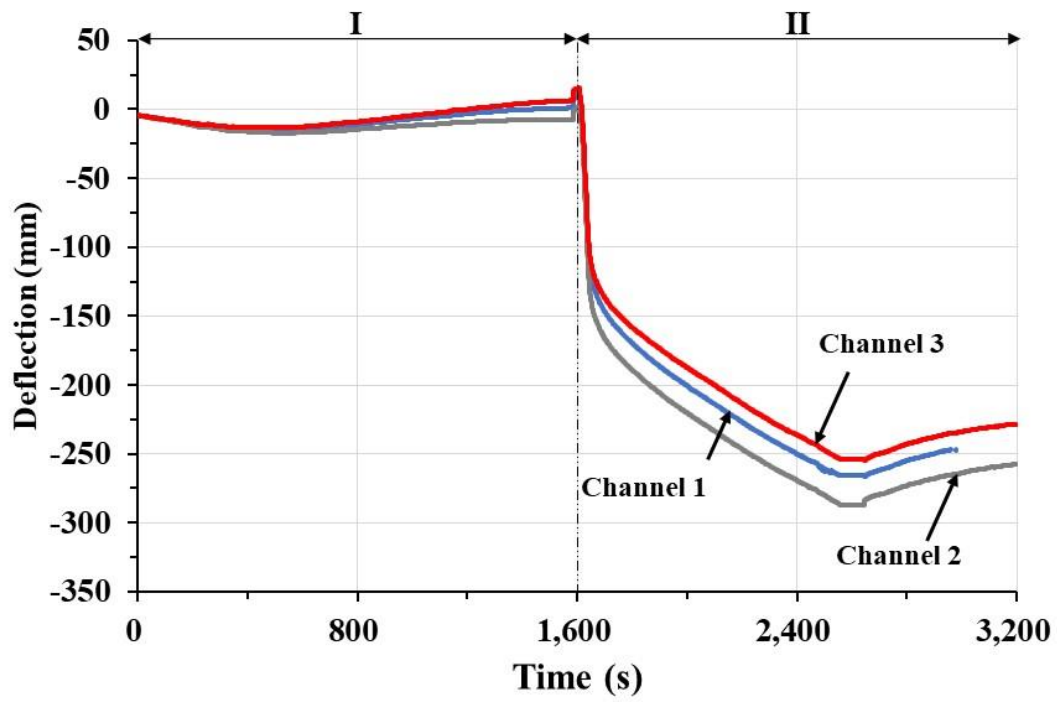
**Figure 34.** Load-lateral deformation curves of the test structure at the three monitoring points.

The fire collapse behaviour of the test structure was monitored in association with the gas cloud temperatures and lateral deformations. Figure 34 presents the time history of the lateral deformations at three monitoring points where channel 1 and channel 3 indicate displacement meters close to the locations of patch loading and channel 2 is the displacement meter at the centre of the test structure. Until 1,600 seconds, almost no lateral deformations occurred under a patch load of 15 tf.

The lateral deformations increased dramatically at 1,630 seconds when a load of 50 tf was applied at the start of the second load step. The lateral deformations were released at 2,550 seconds when the applied loads were removed. As far as the present schemes of loading and gas cloud temperatures are considered, the critical period of time until the test structure reaches the entire collapse is 1,600 seconds.

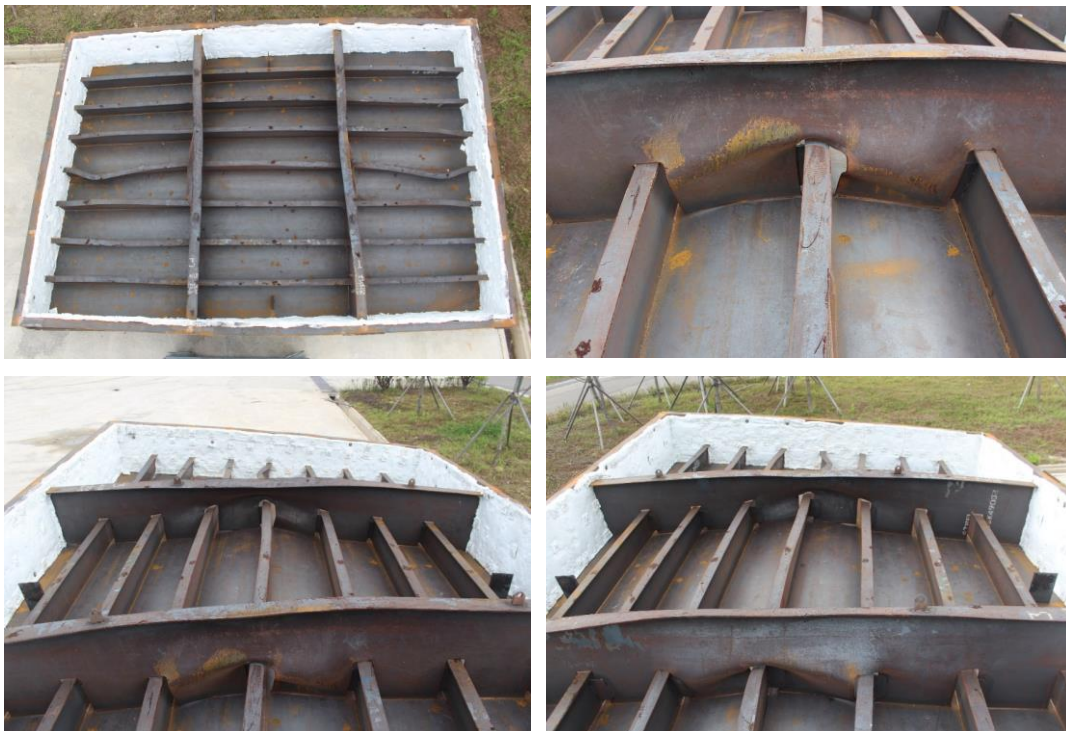
**Figure 35.** Deformed shapes of the test structure after the test.

The Appendix provides the time history of the lateral deformation obtained from the present test, which can be used to validate computational models for the fire collapse analysis of the test structure. Figure 35 shows the deformed shapes of the test structure after testing. It is observed that transverse frames as a main support member deformed significantly and this triggered the entire collapse of the test structure.
