Establishing a monitoring programme for the Allt a'Mharcaidh river restoration project: Monitoring sites and initial surveys

ECRC Research Report Number 181

February 2017

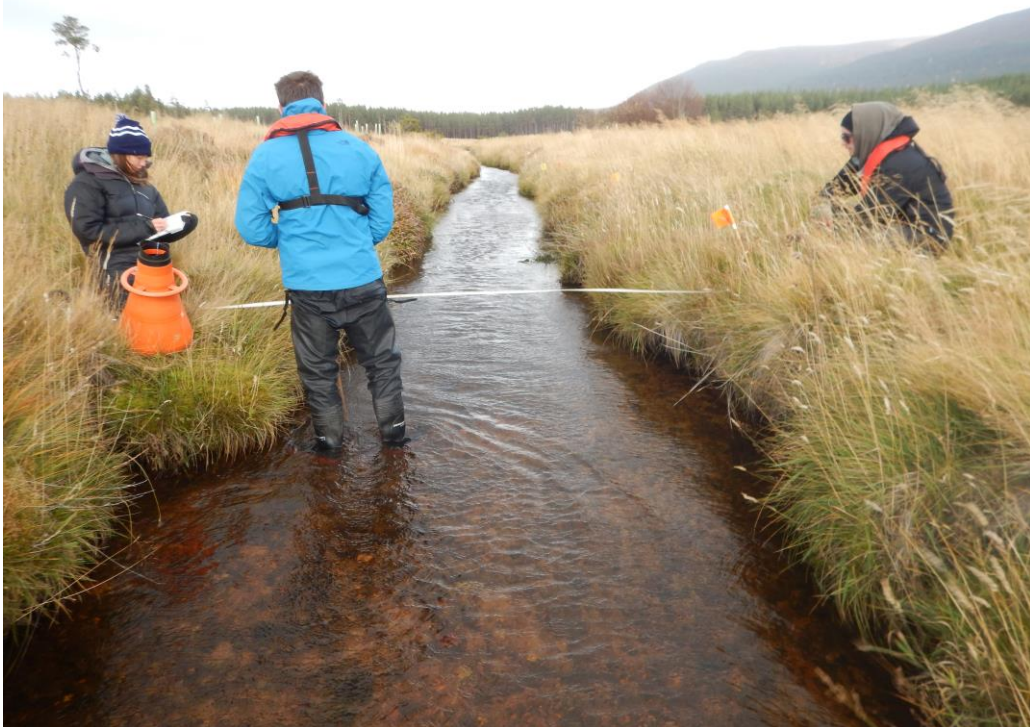
Monitoring of the experimental (top) and control (bottom) sections of the Allt a'Mharcaidh by UCL MSc Aquatic Science students (October 2015)

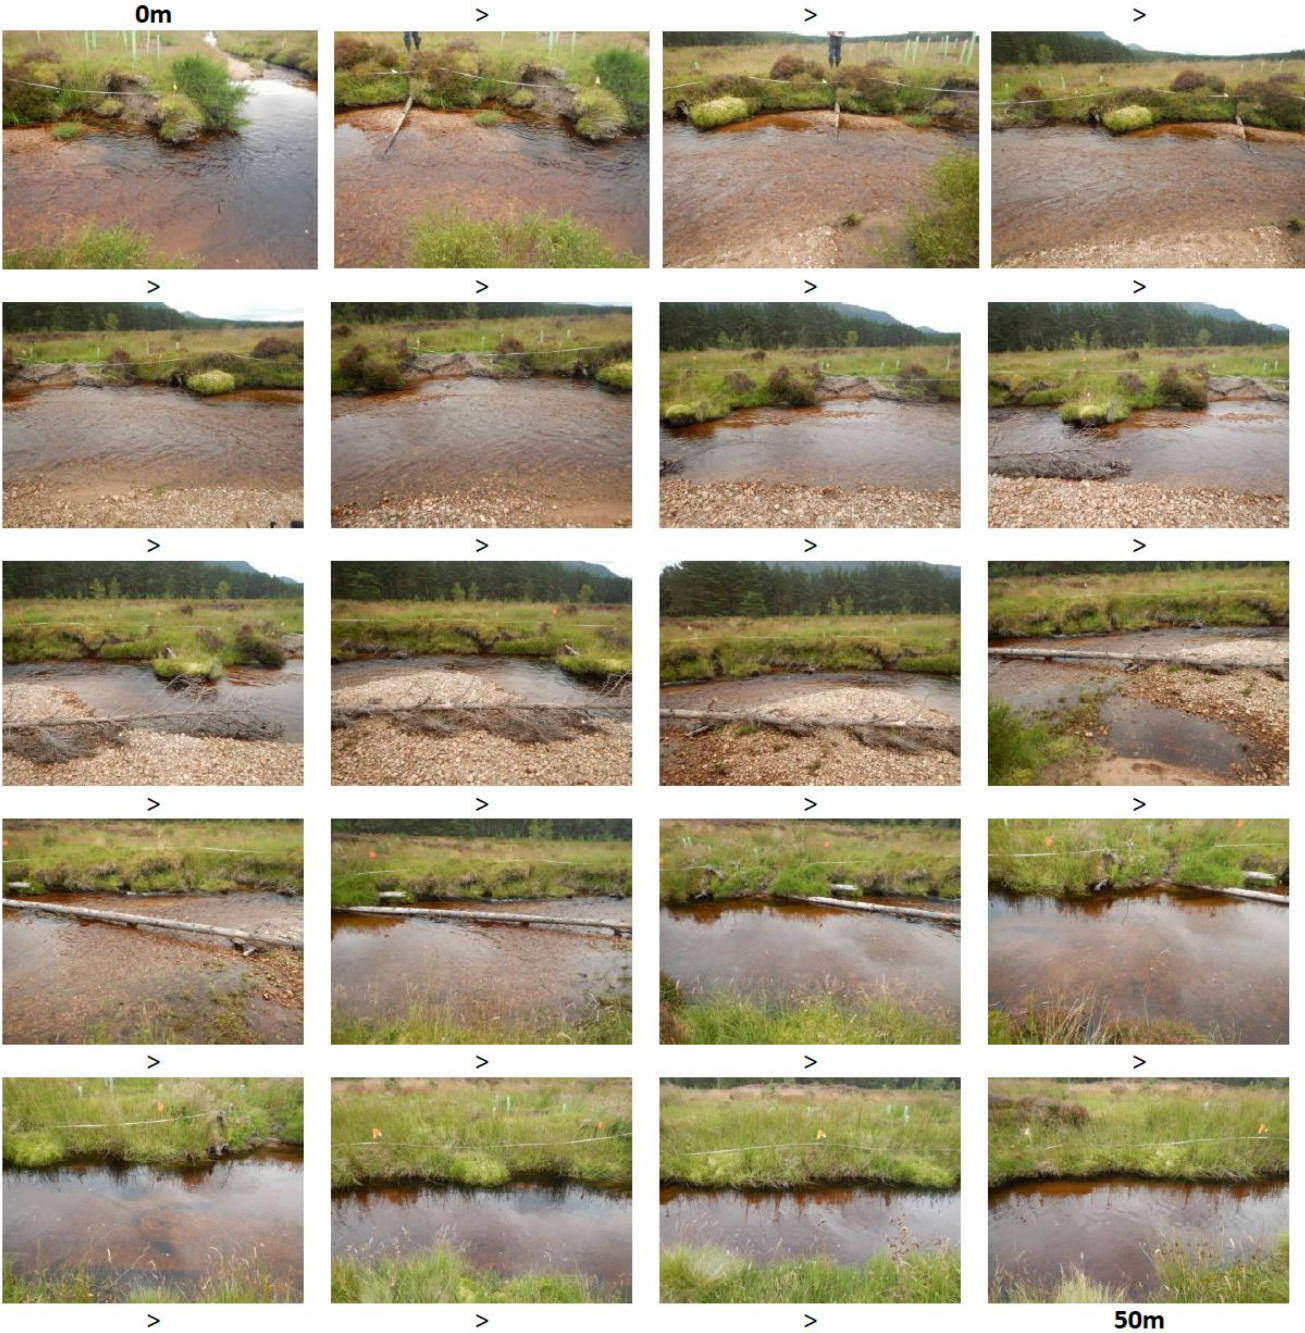
3.4. Experimental section bank photographs I: Looking south-east

A series of overlapping photographs was taken for each stream section along the whole stretch from the opposing bank. This provides a record of bank morphology and allows major changes (e.g. bank collapse) to be determined over the monitoring period. The stream width and morphology data in combination with these photographs were used to compose a sketch of the section. Major changes can then be recorded each year by amending these sketches in the field.

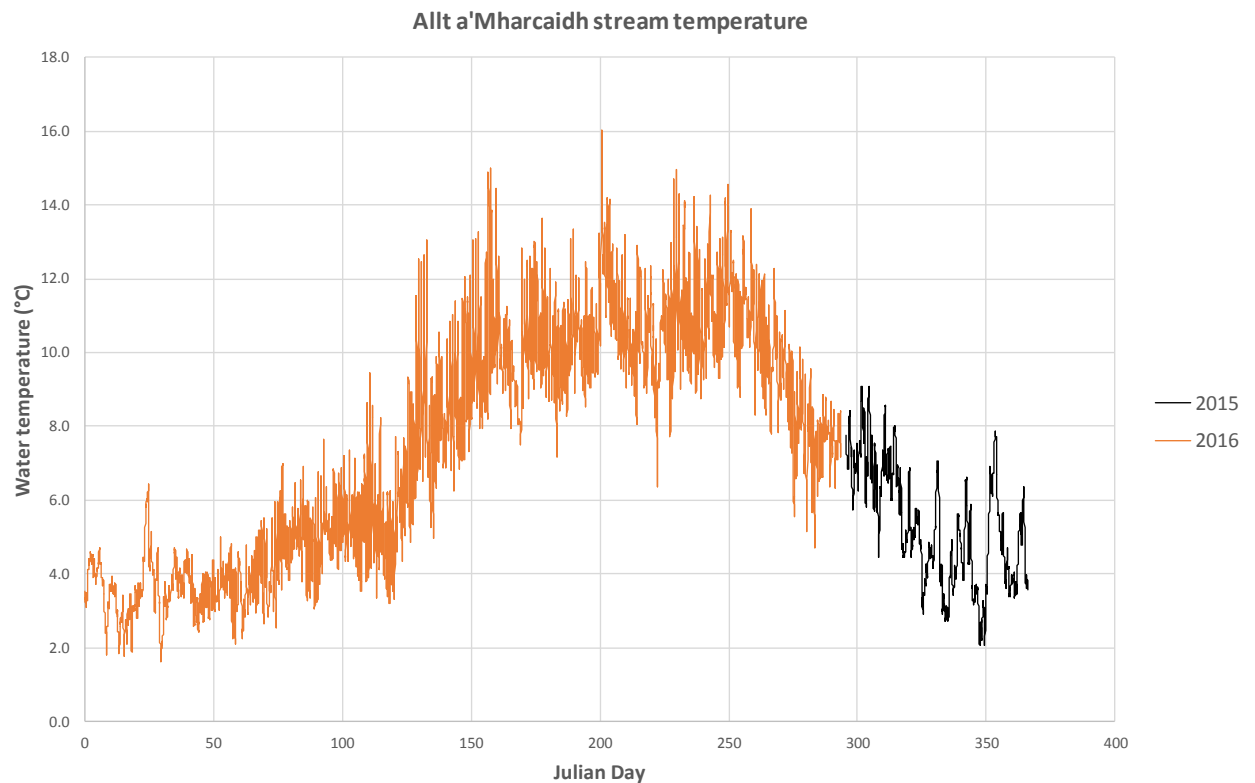
5. Stream thermistor data

The thermistor was deployed at approximately 0.5m depth at the upstream end of the experimental section. While this provides a reasonably high resolution record of contemporary water temperatures, with sufficient longevity, it could also provide a base-line against which to compare future water temperature monitoring of the stream with respect to (i) increasing air temperatures as a result of climate change and / or (ii) the mitigating effects of riparian tree planting at the site. The first year of data October 2015 – October 2016 are presented below.

A 'Tinytag Plus 2' temperature data logger was deployed just above the stream bed at the upstream end of the experimental section. This logger is fixed to the bank using dexion galvanised angle-sections and protected from direct sunlight by an open plastic tube which allows water to pass over the logger. Water temperature is recorded at 30 minute intervals.
