The Throne Hereford Road Weobley Herefordshire

Tree-ring Dating of Timbers

Research Report Series no. 263-2020

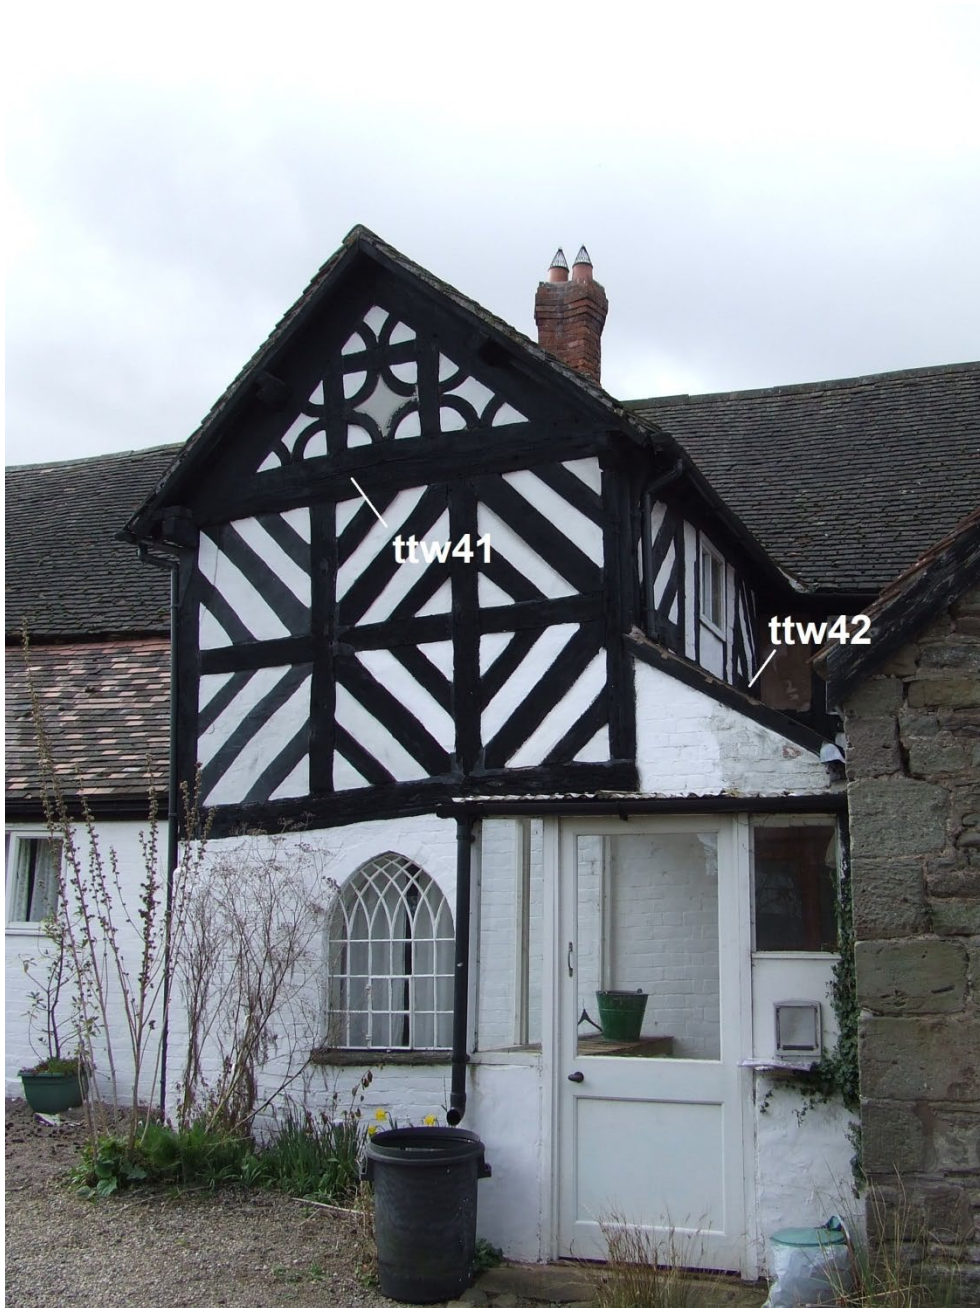
Figure 4: View of the porch, looking south-west, showing the tiebeam and mid-rail sampled for dendrochronology (photograph Martin Bridge)

The porch is a two-storey timber-framed structure built onto the back of the jettied range, against the east side of bay 6 (Fig. 4). At one stage in the history of The Throne it served to mark the principal entry to the building. On the ground floor the porch was jettied and open on both north and east elevations. The first floor is decorated with chevron bracing on these elevations. On three sides the porch has been underbuilt in brick. The dominant external decorative feature is the chevron bracing, which also shows in the interior. A more subtle, internal decorative device is the broach stop, used on the ends of chamfered beams where there are in excess of twenty examples. The west end truss T18 is a closed truss with raking struts rising from the cambered tiebeam to meet the principal rafters. The lower edge of the tiebeam has a wide chamfer and, as on T17, has broach stops at each end. Curiously, one of the raking struts in the truss is 'let in' to the principal rafter although it may also be mortised. This suggests that it is a later addition; however, the three semi-circular assembly marks where the raking struts meet the tiebeam indicate that the arrangement is primary.

Only four timbers were sampled from this construction phase (Figs 4 and 13), many of the timbers proving to have fewer than required minimum numbers of rings. All four series were found to be suitable candidates for dating and were measured. Two samples were dated from this phase, a tiebeam (ttw41) and a large ground-floor ceiling beam (ttw44). The two series did give a significant match against each other ($t = 3.6$ with 70 years overlap), but as this match was rather weak, the series were dated independently, the dating evidence being presented in Tables 3e and 3f.

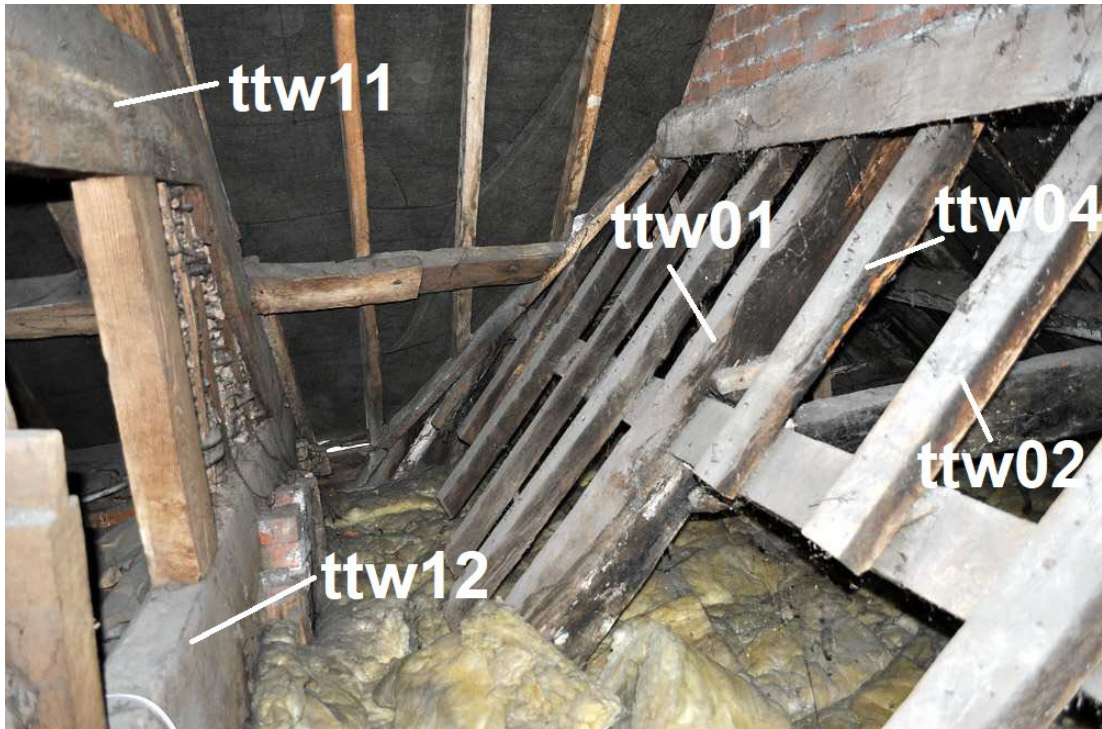
Figure 5: View of the south side of bay 1 on the right, with truss 8 on the left, showing timbers sampled for dendrochronology (photograph Duncan James)

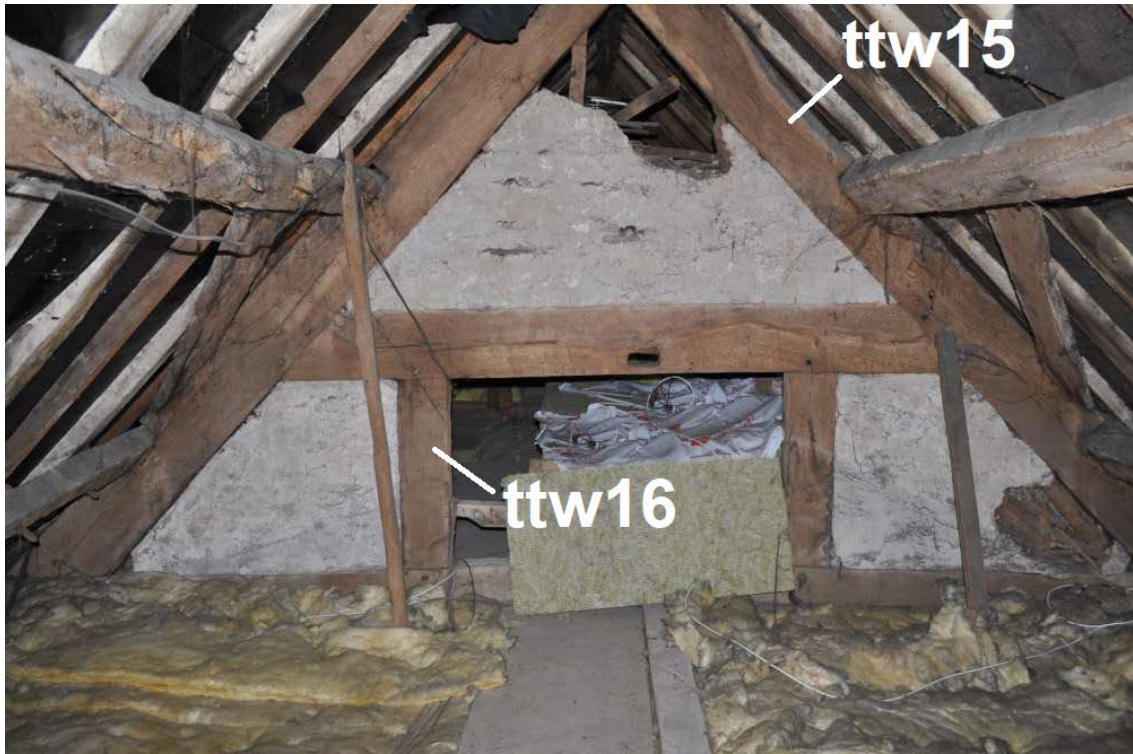
Figure 7: View of truss 10 looking south, showing timbers sampled for dendrochronology (photograph Duncan James)

Ten samples were taken from collars, principal rafters, queen struts, a purlin, a tiebeam, a wallplate, and a ground-floor fireplace lintel (Figs 2 and 6–9). In addition, a post (ttwx) at first-floor level beside truss 18, thought to be a remnant of a former structure was also sampled (Fig 2). One sample, from a tiebeam, was found to have too few rings for further analysis. Cross-matching among the remaining ten samples (Table 2) revealed that samples ttw16 and ttw18 were potentially derived from the same tree, and a combined series ttw1618m was used in subsequent analysis. In all, six individual samples (five series) matched each other, and were combined into a single 149-year mean ring-width series, THRONE1. This was subsequently dated to the period AD 1319–1467, the strongest matches being shown in Table 3a. The relative positions of the dated series from this phase are shown, along with their interpreted likely felling date ranges in Figure 14.

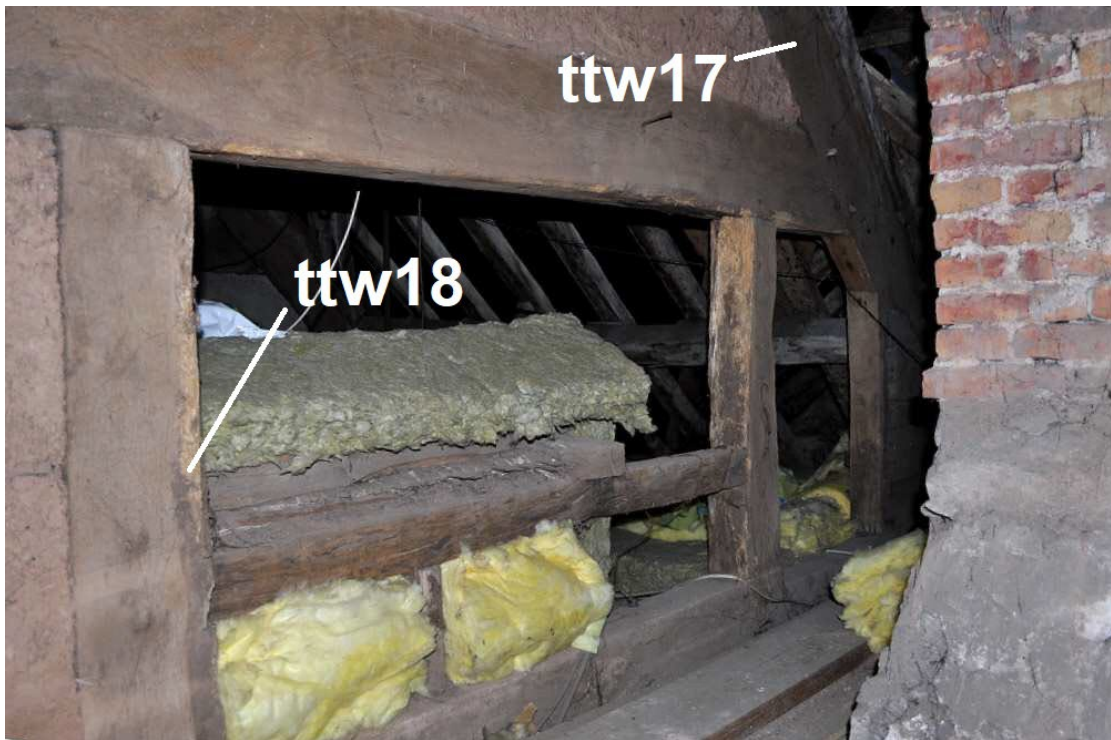
Figure 8: View of truss 11, looking north, showing timbers sampled for dendrochronology (photograph Duncan James)

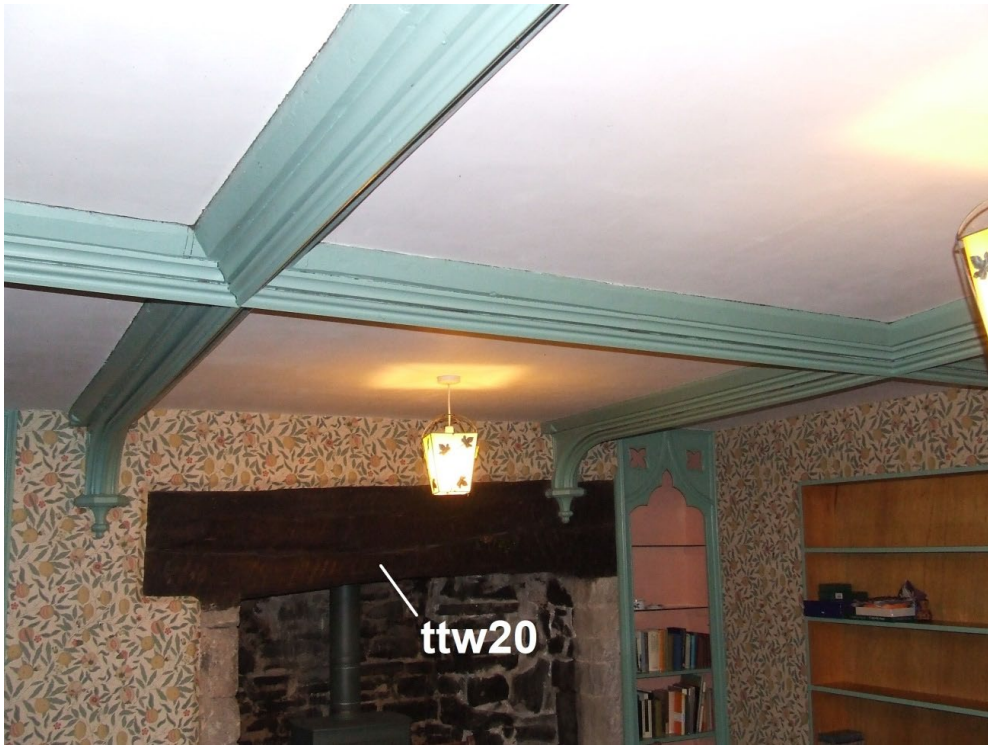
Figure 9: Ground floor of bay 5, showing the fireplace lintel sampled for dendrochronology (photograph Martin Bridge)

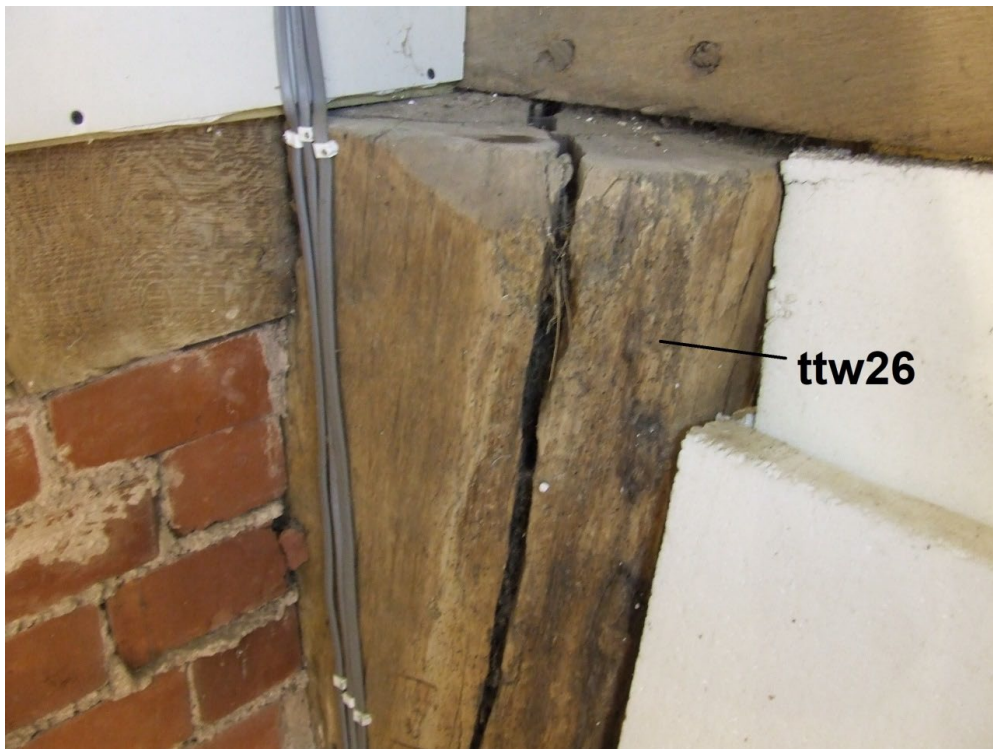
Figure 10: View of the west post of truss 15 sampled for dendrochronology (photograph Martin Bridge)

The samples from this range (Figs 2 and 10–12) represent a variety of structural elements and mostly contain good numbers of rings. Eight samples were taken, and all were measured. Three of the sequences do however show periodic bands of very narrow rings which were difficult to distinguish reliably and can result in the production of spuriously high *t*-values. Thus, whilst there were some potential matches between samples identified, these were, with one exception, not supported by individual dating of the series against the reference material, and are therefore considered unreliable. Sample ttw22 showed severe distortion to its innermost rings and in addition the outermost c. 20 heartwood rings were unmeasurable, thus the measured series comprised the central 123 years (ttw22o). This ring sequence was found to date to the period AD 1328–1510, the dating evidence being presented in Table 3b. Taking into account the additional approximately 20 heartwood rings out to the heartwood/sapwood boundary that could not be measured, its felling date is c. AD 1541–71. Samples ttw23 and ttw28 matched each other ($t = 5.4$ with 84

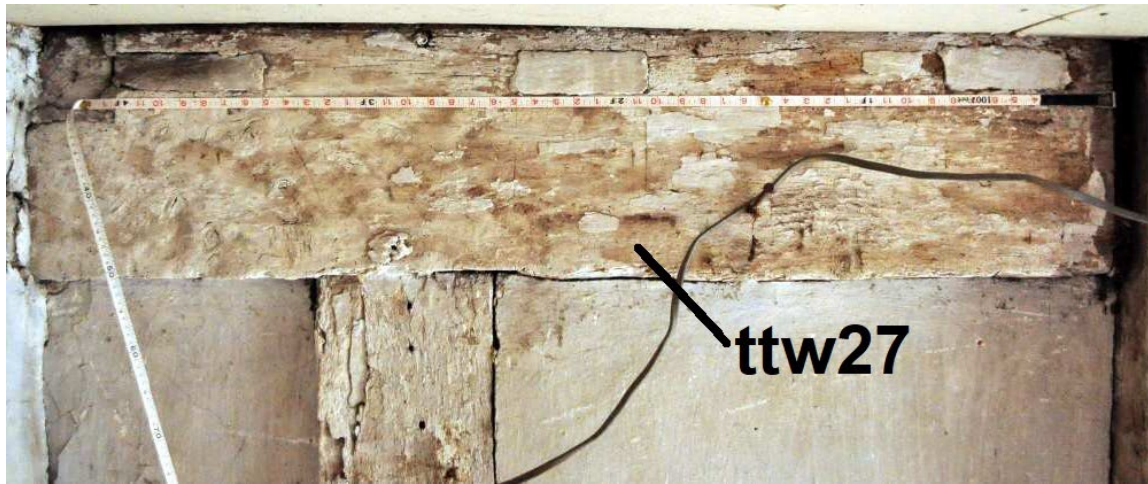
Figure 11: The girthing beam in truss 14 sampled for dendrochronology (photograph Duncan James)

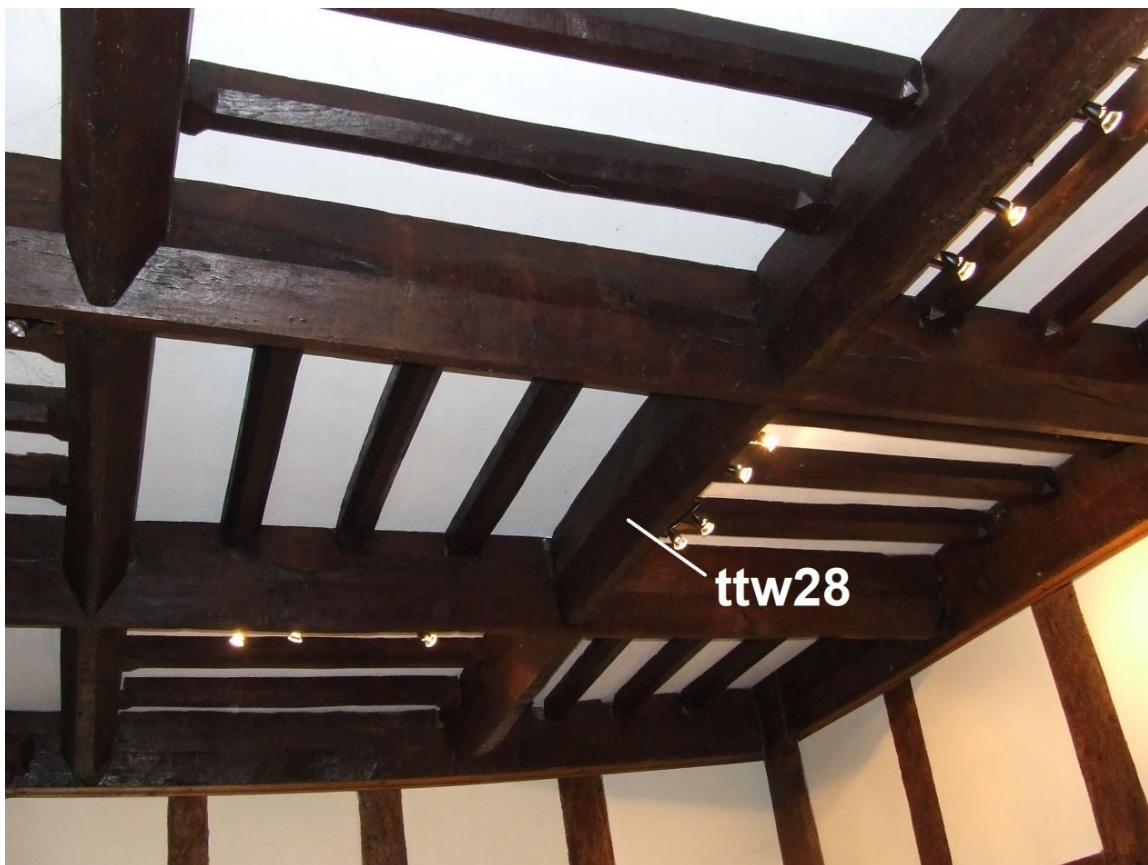
Figure 12: Ceiling of the ground-floor room in bay 7, looking east, showing the beam sampled for dendrochronology (photograph Martin Bridge)

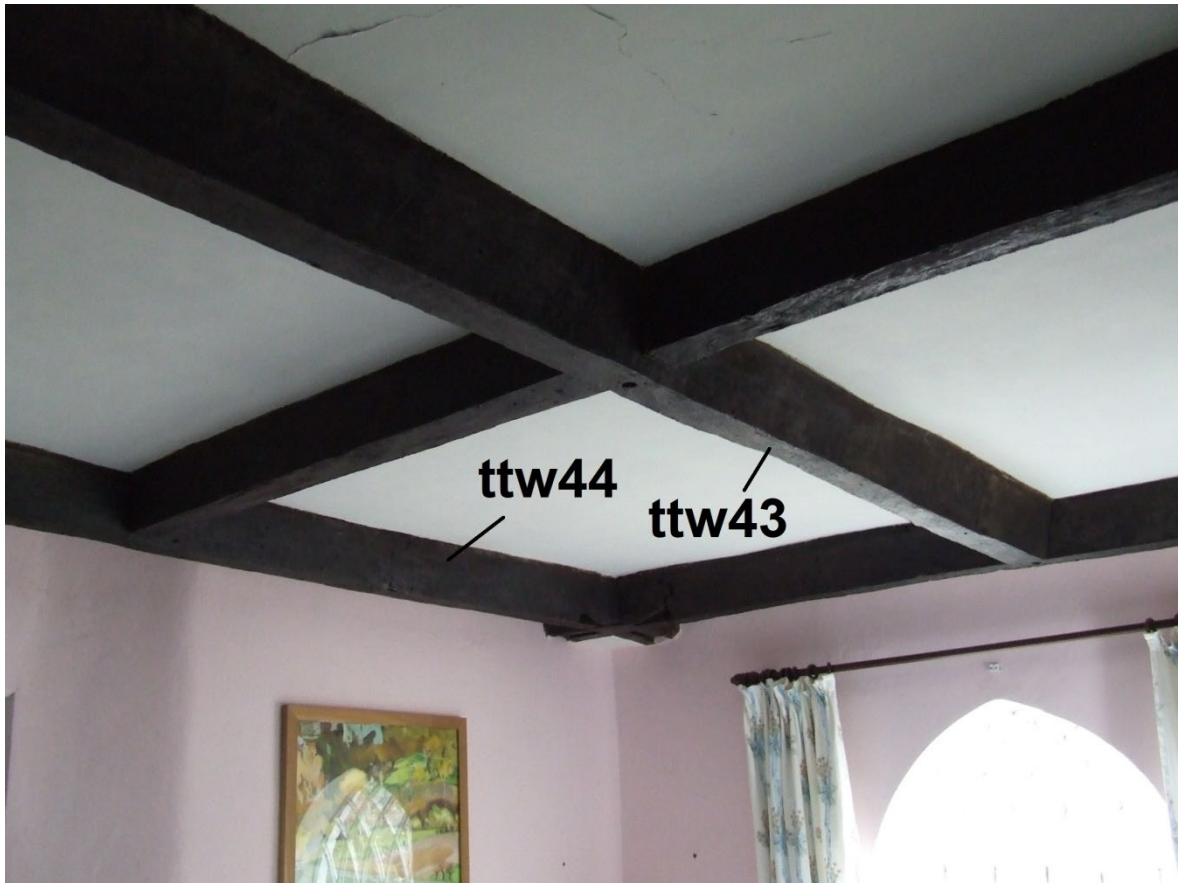
Figure 13: View of the porch ground-floor ceiling, looking north-east, showing the beams sampled for dendrochronology (photograph Martin Bridge)

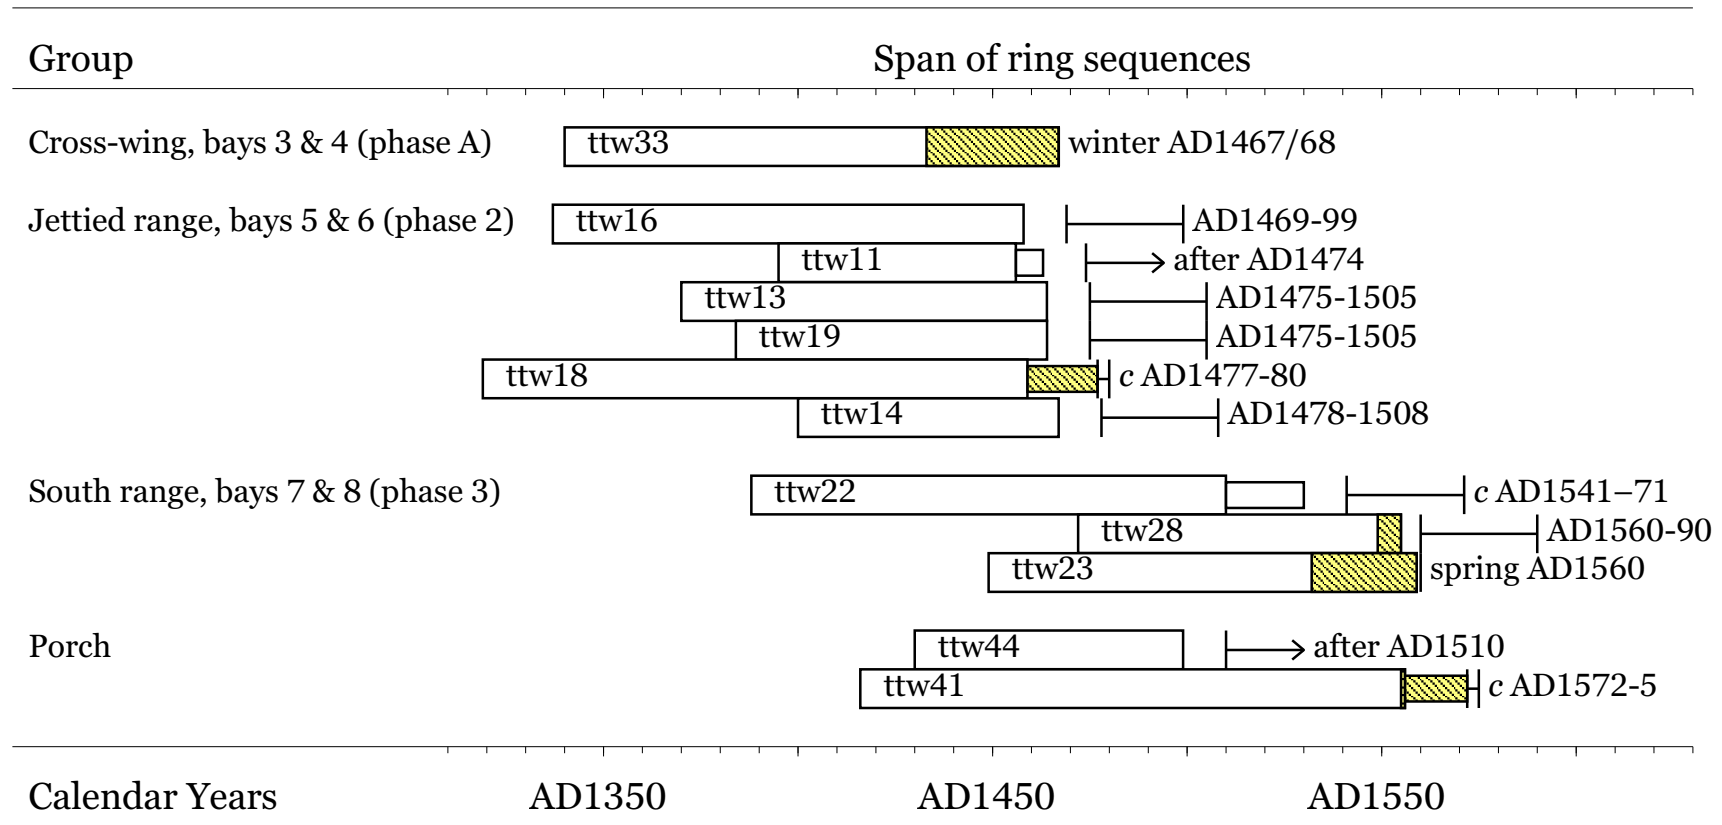
Figure 14: Bar diagram showing the relative positions of overlap and likely felling date ranges for the dated timber from the Throne, Weobley. The white bars represent heartwood rings, the yellow hatched bars represent sapwood rings, and narrow bars represent additional unmeasured rings

are given in the Appendix. The relative positions of overlap of all the dated timbers are shown in Figure 14, along with their actual or interpreted felling dates.

The number of dated timbers is fewer than anticipated, mostly as a result of the large number of timbers that contained bands of very narrow rings that will have adversely affected their dating potential. No dates have been obtained for the earliest construction phase. Nevertheless, important information has been gained through dating four phases of construction within the site (Figure 14).

The south range (phase 3) was dated by sample ttw23, which retained complete sapwood, and was felled in the spring of AD 1560. The other two dated samples from this phase have felling dates in broad agreement with this date suggesting that they are likely to have been felled at the same, or a similar, time (Table 1; Fig 14).
