A long-term monitoring study on the thermal comfort and durability of a straw bale Passivhaus cottage.

Valentina Marincioni^{1,2*}, Frances Bradshaw³

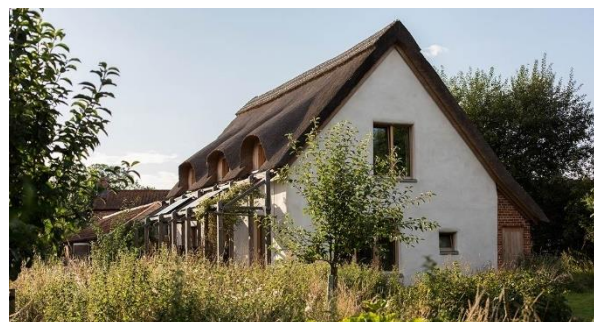
Fig. 1. Case study building, east elevation [2]

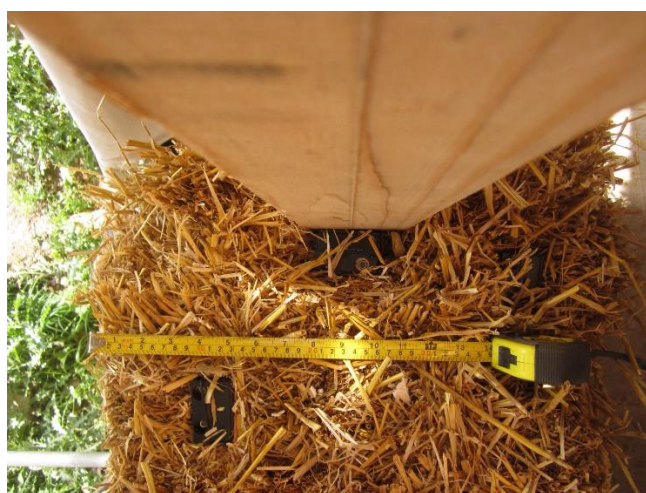
Fig. 2. Outer sensor (left) and central sensor (centre) installed in the strawbale wall.

- the inner bale position, 10 cm from the internal side of the straw bale (“inner sensor”);
- the outer bale position, located 10 cm from the external side of the straw bale (“outer sensor”);
- the central position, with the sensor located on the timber element at the centre of the strawbale wall (“central sensor”).

An example of the sensors installation is shown in Figure 2.

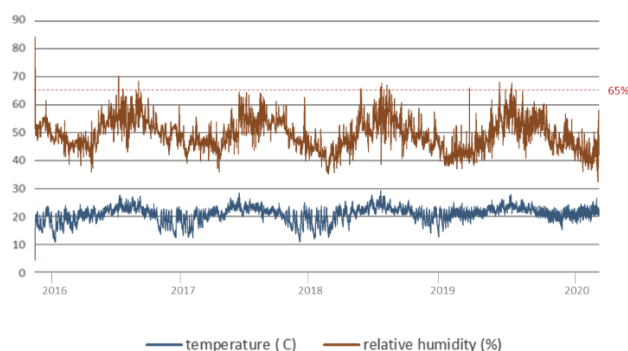
Fig. 3. Indoor conditions, measured in living room

The indoor monitoring shows an average temperature of 20.7 °C between 2015 and 2020, and an inter-quartile range of temperatures between 19.6 °C and 22.5 °C even when the cottage is often under-occupied, particularly until 2019 (see Figure 3). Analysing the heating and cooling seasons separately, the average temperature for the heating seasons (October to March) is 19.3 °C (interquartile range between 17.6 °C and 21.3 °C). Since 2019, when the building has been occupied full time, the interquartile temperature range in the heating season has been steadily between 20.1 °C and 21.7 °C, with limited use of active heating systems.

The average temperature for the cooling seasons is 22.3 °C, with a maximum temperature of 29.2 °C during the 2018 heatwave; on that day, the outdoor sensor indicated a maximum temperature of 35.7 °C and there is no active cooling in the building.

The indoor relative humidity is found to be within the recommended mould growth threshold for indoor environments throughout the monitoring period, apart from a very small number of instances. Also, the relative humidity is rarely below 40%, the lower threshold for thermal comfort.

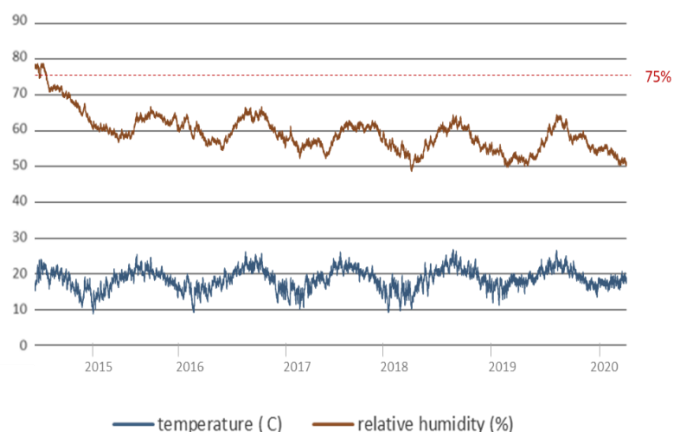
Fig. 4. South wall, inner sensor

The temperatures of the inner sensors follow closely the trend of the indoor temperature, measuring 3 °C less than the indoor temperature on average. The relative humidity at the four sensors locations is always lower than the mould growth criterion at surfaces and interfaces considered in this analysis (75%), apart from

a very short period immediately after construction for some of the sensors, as exemplified in Figure 4 (south wall). This period coincides with the drying period for the construction materials, in particular of the clay plaster and lime render that have been applied on the sides of the strawbale layer. The short duration of this initial wet period suggests little/no mould growth risk.

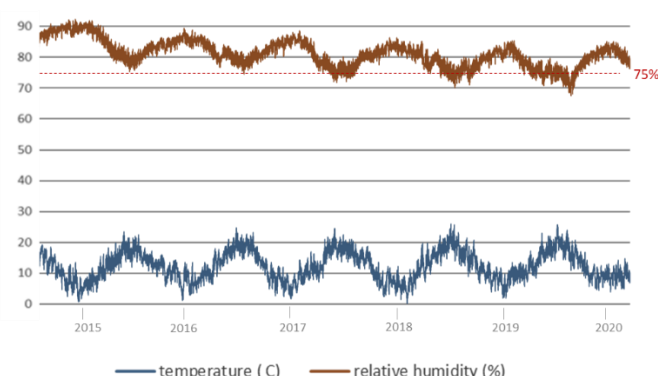
Fig. 5. North wall, outer sensor

As shown in Figure 5, the relative humidity at the outer sensors locations can be higher than the mould growth threshold of 75%; this was found to be the case for all orientations, and the north wall is shown as example. As those sensors are located towards the outside of the wall, the main concern is material decay, as opposed to indoor

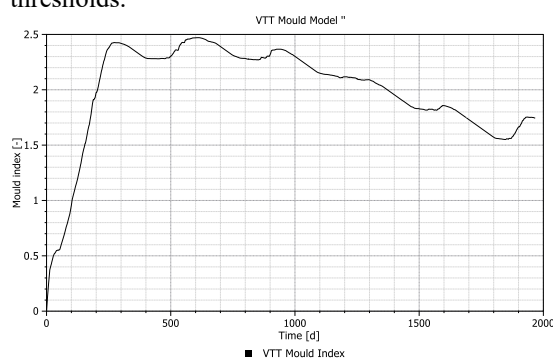
Fig. 6. Mould index for east wall, outer sensor, first floor

Figures 6 to 8 show the mould index results for the east, north and south wall respectively, for around 5 years. No locations show a mould index higher than 3, suggesting low-to-mid risk of mould growth. Only the east wall shows a mould index between 2 and 3, requiring further assessment. However, in this instance, Figure 6 shows that the peak of mould index was followed by a reduction in the index in the subsequent years. Thomson and Walker [5] found an arrested level of mould growth on straw after initial growth; in their experiment, after an initial growth associated with exposure to high levels of humidity, mould growth was not detected a second time. Therefore, the reduction of mould index in Figure 6 suggests limited mould growth risk in this wall. Figures 7 and 8 show a mould index below the set MI thresholds.

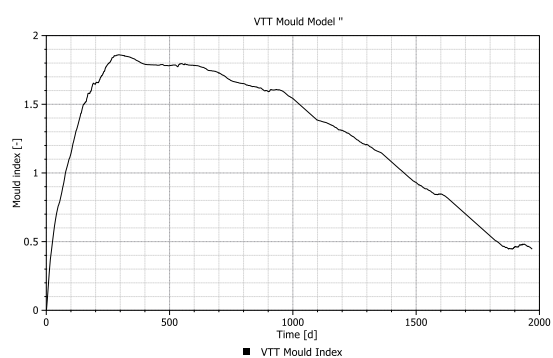
Fig. 7. Mould index for north wall, outer sensor

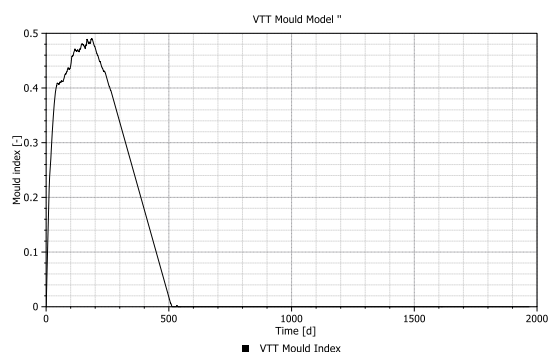
Fig. 8. Mould index for south wall, outer sensor
