What do dendrochronology and other timber-dating methods tell us about the history of english post mills?

Martin Bridge, Luke Bonwick, Martin Davies & David Pearce

KEYWORDS: *post mills; windmill history; dendrochronology; oxygen isotope dendrochronology; radiocarbon dating*

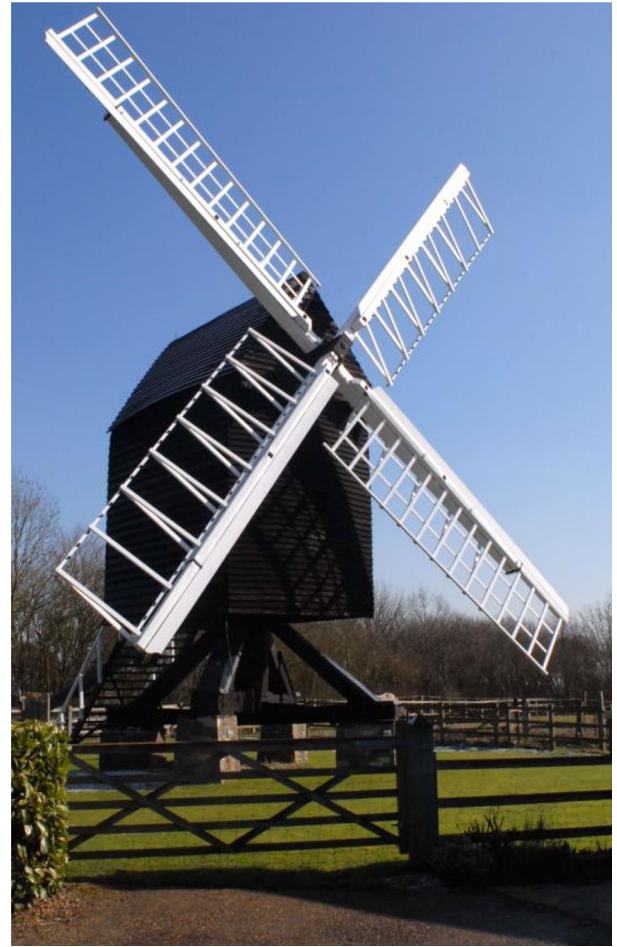
Figure 2. Bourn Windmill (Cambridgeshire). Note the open trestle supported on brick plinths, pitched roof shape and two plain sails (photo: Martin Davies)

At least by soon after 1515, and probably earlier, post mills like Bourn (Fig. 2) with main posts at least 14 ft 6 in (4.42 m) in length were being constructed. These larger, taller structures were significantly heavier, and their ‘trestle’ timbers could be placed above ground, often on brick piers, thereby increasing the span of their sails and thus the power they could generate, but also reducing the rate of decay of the trestle.

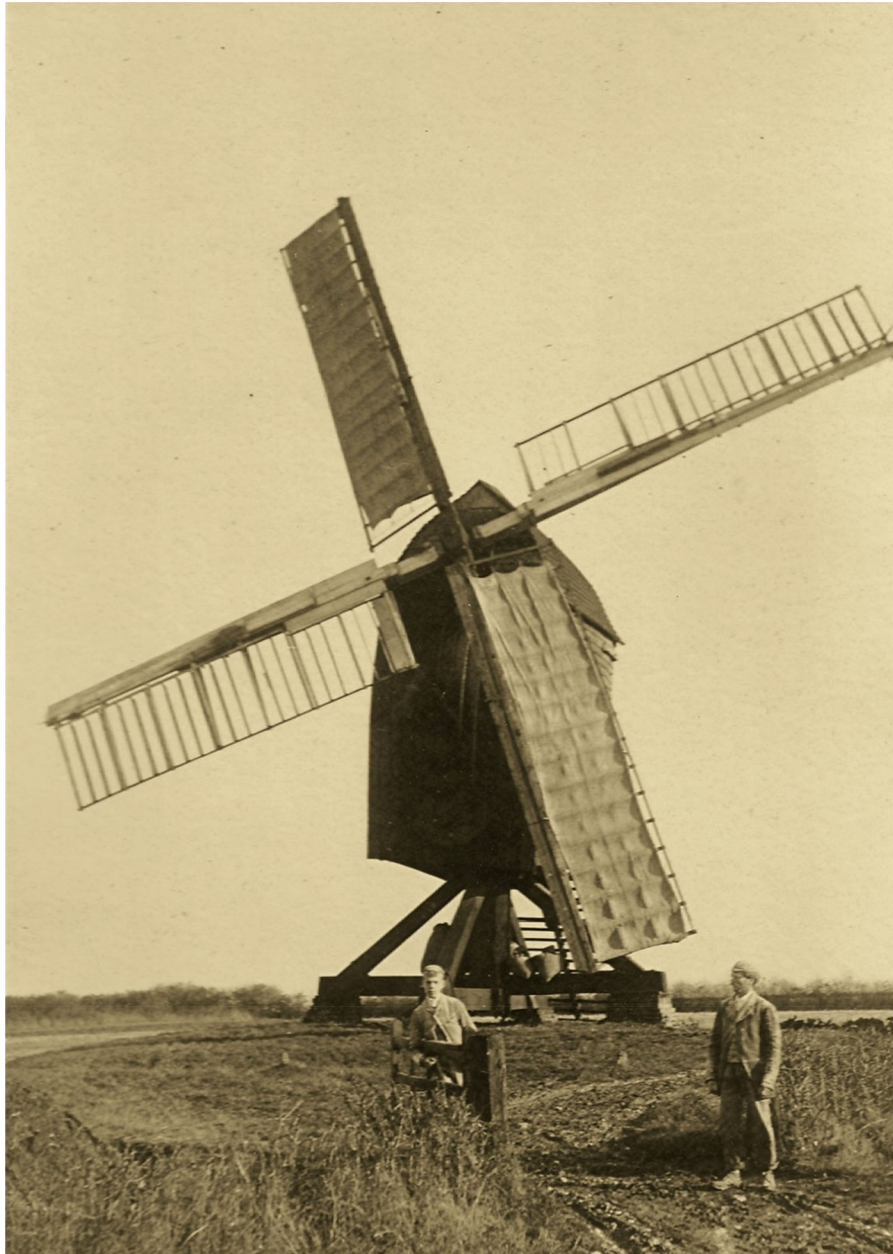
Figure 3. Gransden Windmill in its working days in the early 1870s—a rare early photograph of a typical early post mill. Note the open trestle supported on brick plinths, the two plain sails with cloths unfurled and the curved roof shape (photo: Revd Frederick Le Grice. From Gransden Society Archives)

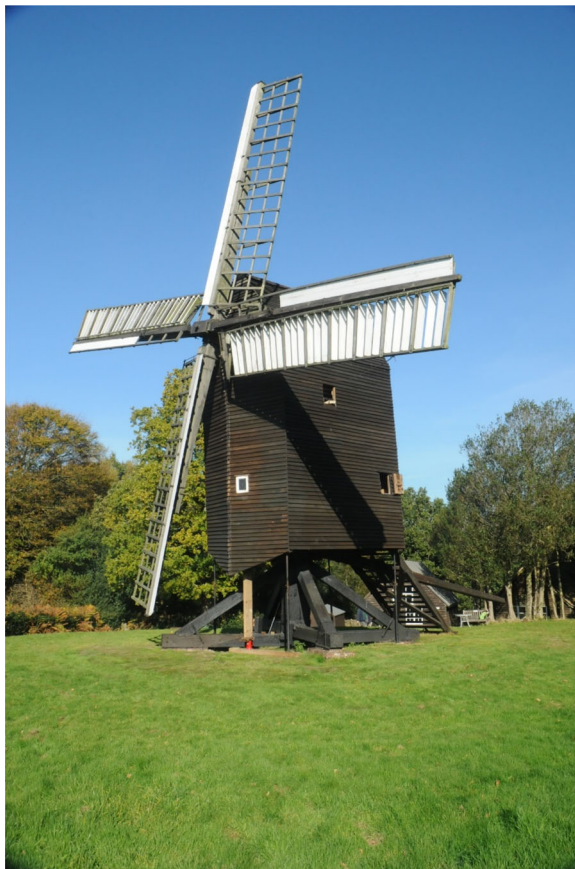
Figure 6. Nutley Windmill (East Sussex) in 2020 (photo: Martin Davies)

This mill (Figs 6 and 7), located in Ashdown Forest, has been revealed as containing another sixteenth-century main post.²⁷ The mill's history is complex, there being no firm evidence for a mill at this location before 1836. However, there is some intriguing evidence to suggest that the mill was moved to its present

The main post was found from the dendrochronological analysis to be from a tree with a last measured ring formed in 1529 (see Fig. 19). There is no evidence of sapwood, but it is likely that the heartwood-sapwood boundary was not long after this date, meaning the tree was likely to have been felled in the mid sixteenth century. The front cross-support to the floor was from a tree felled in the period 1738–70, which would match possible rebuilding if it had indeed been brought from Kent in the period highlighted.

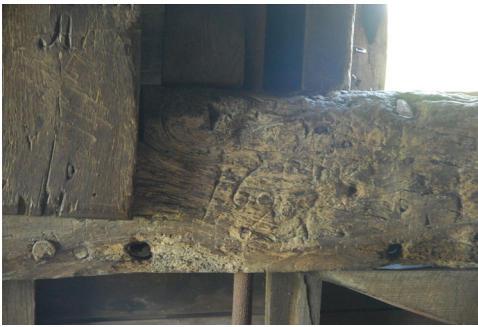
Figure 8. Inscribed date of 1627 on LH lower side girt at Pitstone Windmill (photo: Martin Davies)

The mill body carries a prominent inscribed date on its side wall framing (Fig. 8) which has been variously interpreted as 1627 and 1697. The earliest of these

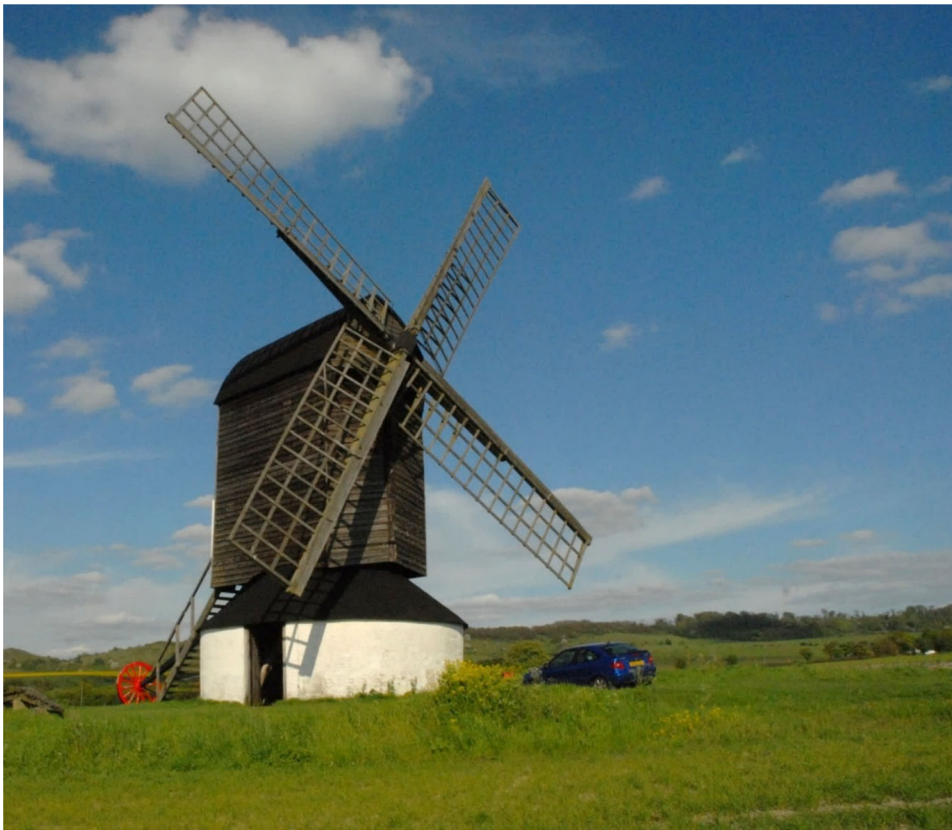
Figure 9. Pitstone Windmill (Buckinghamshire). Note the full set of four plain (cloth) sails (photo: Martin Davies)

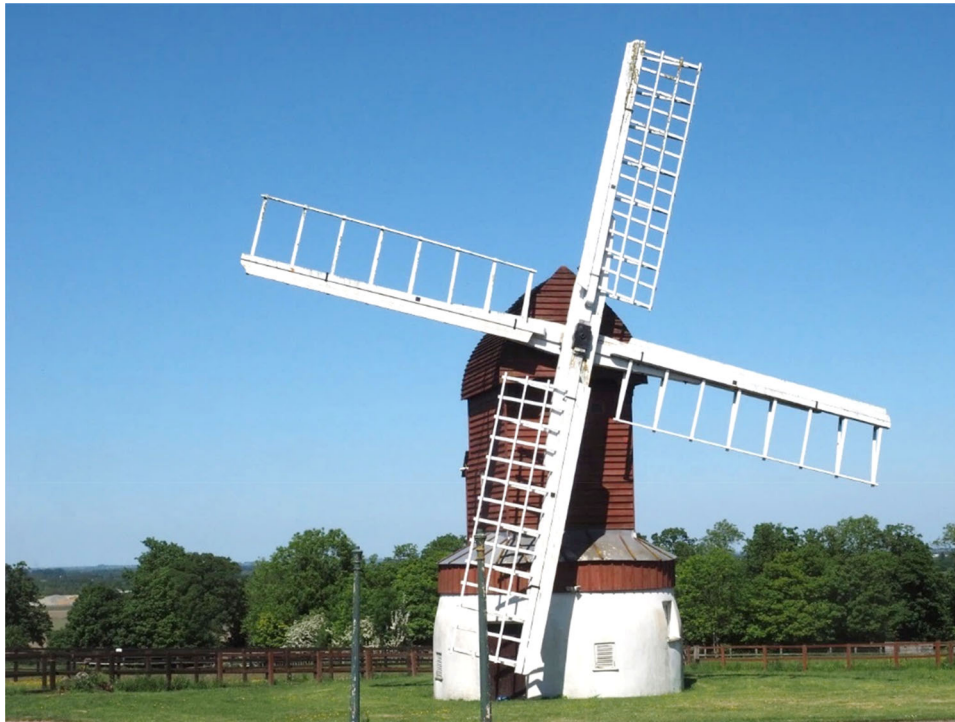
Figure 11. Madingley Mill in Cambridgeshire. Formerly located at Ellington and before that at Easton, both then in Huntingdonshire (photo: Martin Davies)

Located just north-west of Cambridge, Madingley Mill (Figs 11 and 12) has a fascinating history of alteration, removal and rebuilding. A timber in the right-hand wall of the buck carries the inscribed date of 1785. This mill originally stood in the village of Easton, Huntingdonshire. In 1835 it was moved again a few miles to Ellington and rebuilt in a modernised form with a roundhouse, an automatic fantail and shuttered sails of the type patented by William Cubitt in 1807. Its rebuilt external appearance matched that of Upper Dean post mill, Bedfordshire, which had been altered by the same millwright the previous year.³⁰ Exactly a century later the mill was dismantled again and reconstructed at Madingley (see Fig. 11), where it was intended as a landscape feature and was not

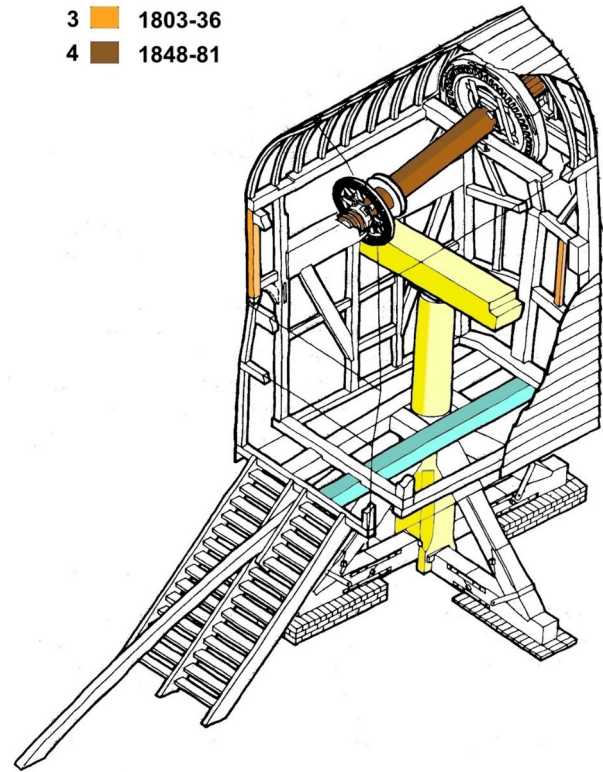
- 1 ■ 1628-60
- 2 ■ 1771-1801
- 3 ■ 1803-36
- 4 ■ 1848-81

Figure 14. Scientifically dated timbers at Gransden Mill, Cambridgeshire. Based on a drawing by Graham Black

Taking an ancient example, Gransden Windmill buck has two horizontal beams, the side girts, running from front to back of the mill (Fig. 14), and carried on the ends of the crown tree. The rest of the body is built up from the side girts by vertical and horizontal frame components. Most of the weight of the sails is taken directly by another heavy transverse timber, the weatherbeam or breast beam. Originally there was little if any diagonal bracing in the buck, as can be seen at Pitstone and Kibworth Harcourt mills: stiffness was provided by tightly fitted joints, and in old age the

This date ties up well with the dendrochronological evidence as to the age of the wooden windshaft which dated to 1845–77, suggesting that its replacement formed part of a major rebuild of the mill at that time which we know coincided with a change of the tenant millers. The rear extension to the stone floor to accommodate the addition of a second pair of millstones and a tailwheel to drive them were changes that probably also took place at this time.

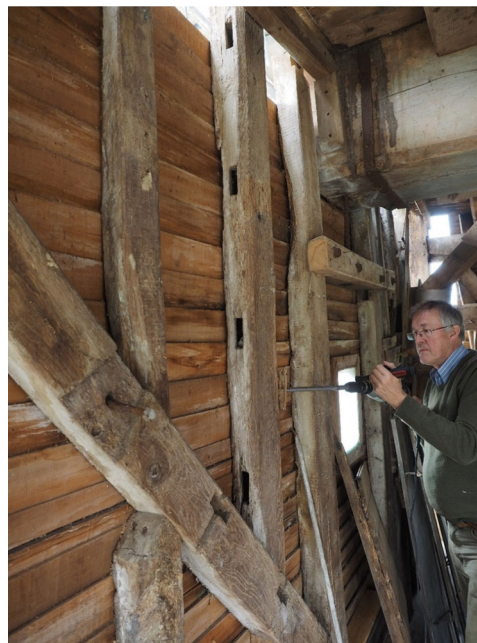
Figure 17. Two pre-used old timbers that were upcycled during a past rebuild into wall studs in the buck wall at Great Chishill Windmill. Martin Bridge is drilling a dendro sample from one of them, which when analysed showed it was from a tree felled in the period 1693–1726 (photo: Martin Davies)

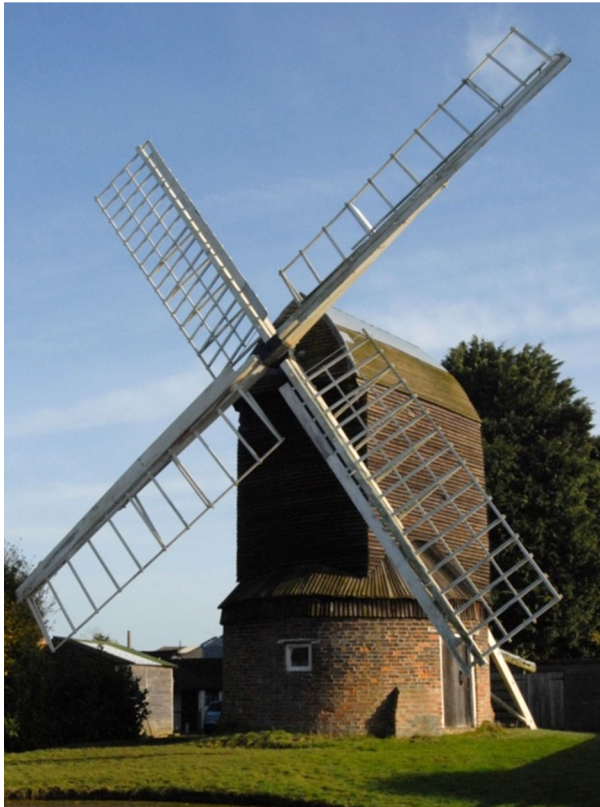
Figure 18. Kibworth Harcourt Mill, 2016 (photo: Martin Davies)

This is the only surviving post mill in the county (Fig. 18). There is a long, well-documented history covering this mill as it belonged to Merton College Oxford throughout its working life. In 1936, ownership was transferred to SPAB. The earliest record in the Merton College archives dates to 1286, with records of new construction in a different position in 1356, repair in 1448 and a rebuild in 1515.³⁶ Curiously, it is not shown on a 1609 map of the area, but is shown on a 1635 map, in its current location.

The mill body sits low to the ground and is simply framed with no diagonal bracing. Externally, the mill has a 'Midlands' appearance, similar to Madingley Mill and Danzey Green Mill at the Avoncroft Museum, where the roundhouse roof rotates with the buck. However, this 'Midlands' appearance at Kibworth Harcourt Mill is somewhat deceptive, as there is no evidence that the roof petticoat ever hid the usual kerb and rollers fitted between the roof and the top of the roundhouse wall to share the weight of the buck, as exist at the other surviving Midlands post mills. Layers of white paint on the trestle and lower part of the buck, underneath the roundhouse roof, confirm that the mill previously had an open substructure.
