# Finite element analysis of low-rise non-engineered timber residential buildings in Dominica under hurricane loads

Sarah Esper<sup>a</sup>, Dina D'Ayala<sup>a,b,\*</sup>

<sup>a</sup> EPICentre, Department of Civil, Environmental and Geomatic Engineering, University College London, London, United Kingdom

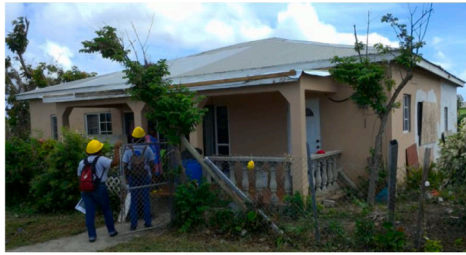
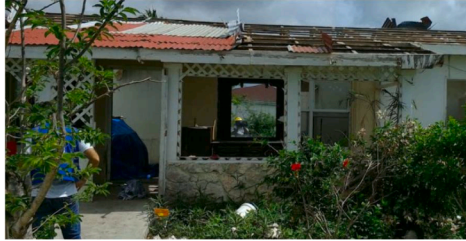
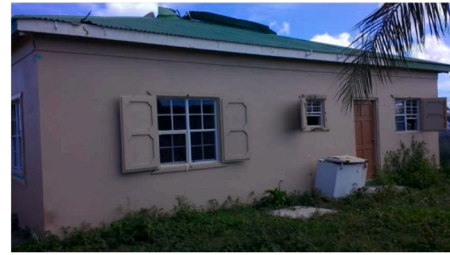
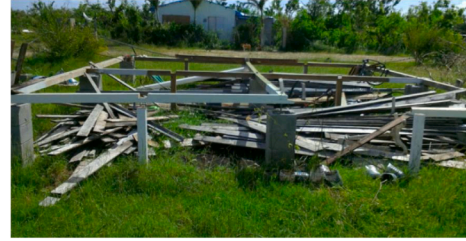
Fig. 2. UNDP criteria for colour tagging as used in Dominica building damage assessment [56].

**Green Tag**

"Minimal or no damage. Owners or renters do not require assistance to safely live in the building. This often includes damage in windows, doors and small damage in galvanized sheeting."

**Orange Tag**

"Major repairs are required and often include replacement of rafters and roofing but no wall or structural elements."

**Yellow Tag**

"Minor repairs required: buildings that require roofs repairs, mainly galvanize sheeting. In principle, rafters do not need to be replaced. However, rafter status must be carefully examined before galvanized sheeting is properly installed."

**Red Tag**

"Complete rebuilding required: in addition to roofing and rafters, at least 50% of the walls are severely damaged. If repairs are possible, these may be more complex and expensive than a complete rebuilding of the structure."
