Approaches to the Conservation and Management of Earthen Architecture in Archaeological Contexts

Volume 1

The Institute of Archaeology.
University College London

Thesis submitted for PhD (Archaeology)

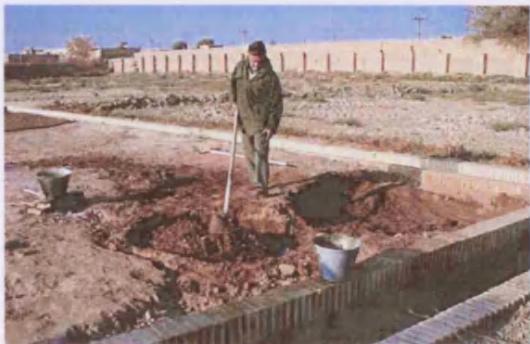
Fig. 7. General view of preparation of earth mix for mudbrick making, Yazd, Iran (IR07_0070).

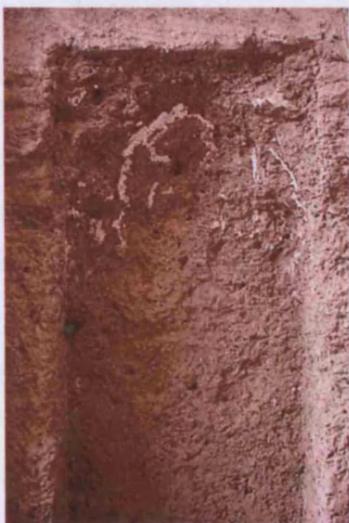
Fig. 39. Eroded earth and decorative *gaunch* plaster, Yazd, Iran (IR07_0048).

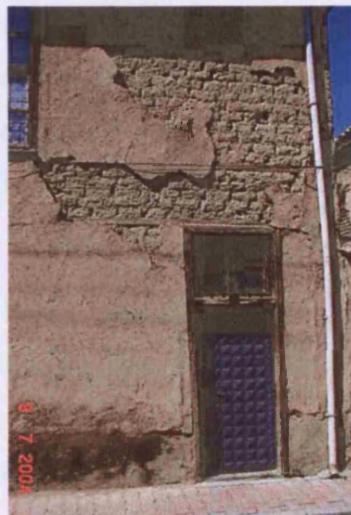
Fig. 42. Fallen cement and earth plaster revealing damage to mudbrick wall core, Konya, Turkey (TK06_0032)

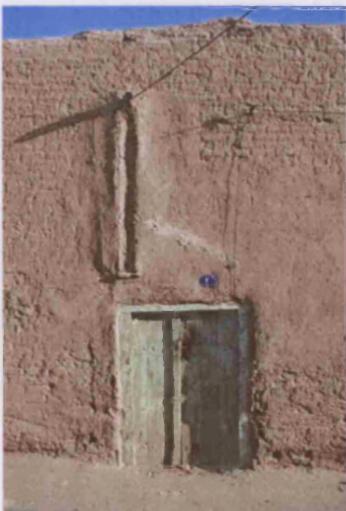
Fig. 45. Well maintained vertical drain, Yazd, Iran (IR07_0008).

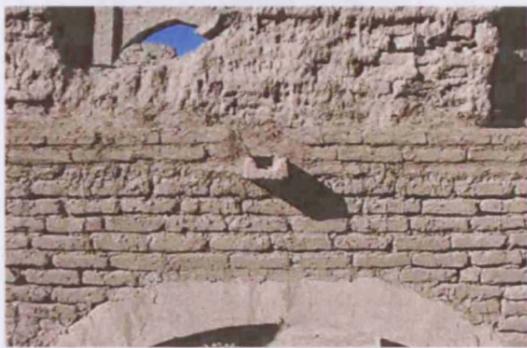
Fig. 48. Reconstructed drainage spout, Bam, Iran (IR10_0013).

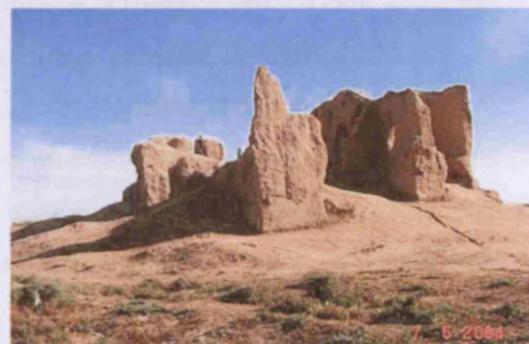
Fig. 73. The Little Kyz Kala in 2004 (HP_001_2004).

The 1924 photograph shows a 'honeycombing' effect. This suggests that when this sort of erosion occurs in a zone that is already damaged (such as the wall base) the overall rate of loss is accelerated (Appendix 5).

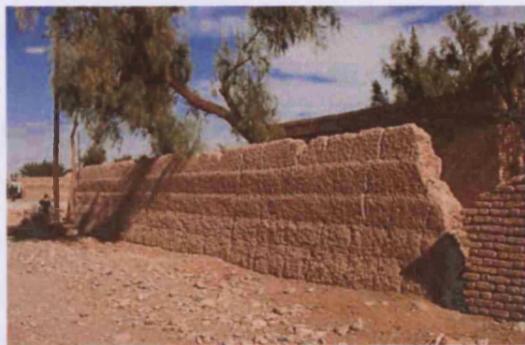
Fig. 84. Chineh wall with eroded wall top and drip gullies associated with increased humidity from adjacent vegetation, Shahdad, Iran (IR34_0013).

(*Tamarix*), these have a large surface area in order to retain a high quantity of moisture, which in response to diurnal temperature fluctuation will condense at night (Fig 83 & 84; *pers comm.* Archie Walls). Through the creation of a microclimate, these plants have the capacity to cause more rapid deterioration of upstanding earthen architecture and impact and damage earthen archaeological sites.

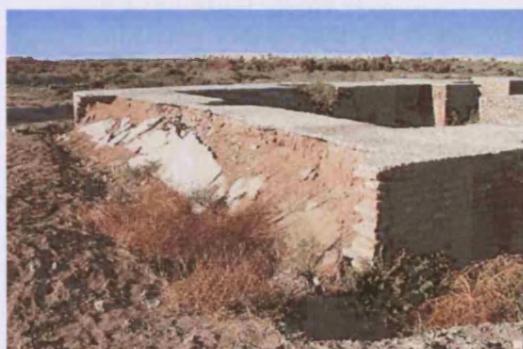
Fig. 128. Failure of harder, replacement encapsulation materials (and significant damage to surviving wall), Merv (TM01_0109).

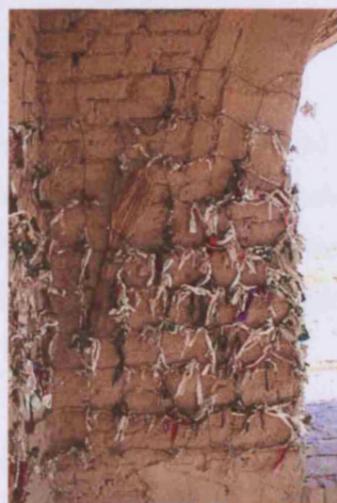
Fig. 148. Prayer rags tied onto wire exposed after collapse of cement render used in encapsulation/restoration work, Kyz Bibi Mausoleum, Merv (TM01_0105).

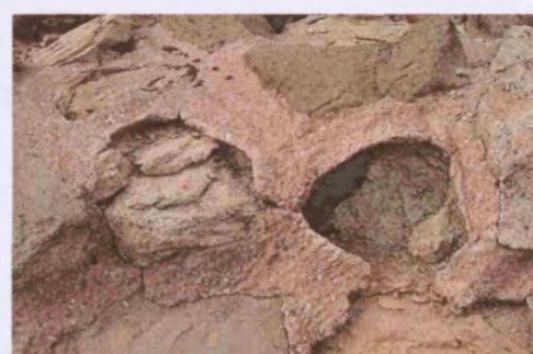
Fig. 155. Damage to stonework as a result of use of cement-amended mortar, Aztec (US01_0008).

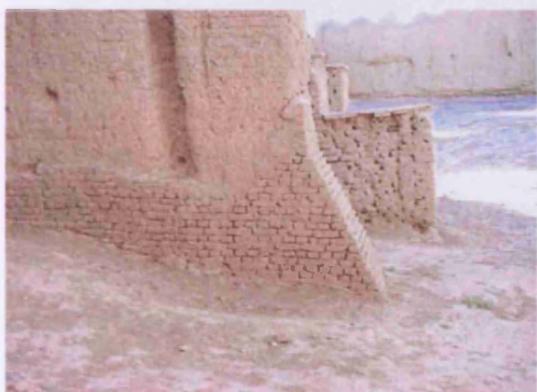
Fig. 170. Mudbrick undercut repair, Merv (TM01_0001).

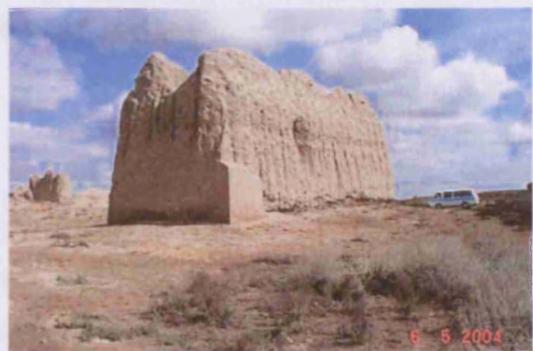
Fig. 173. Fired brick and mudbrick undercut repair, Merv (TM01_0075).

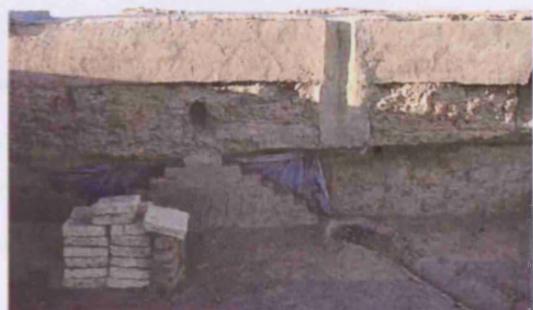
Fig. 175. Experimental undercut repair, Gonur (TM15_0051).
