2016-17 Central Italy Earthquake Sequence: Seismic Retrofit Policy and Effectiveness

ABSTRACT

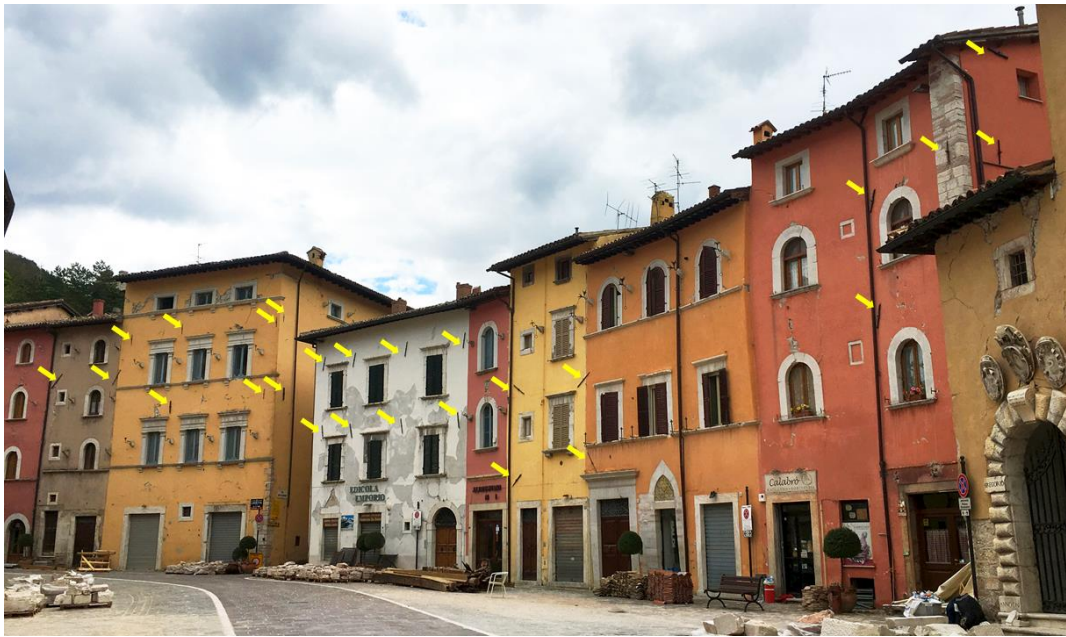
Figure 3. Wall Ties in the town of Visso in May 2017

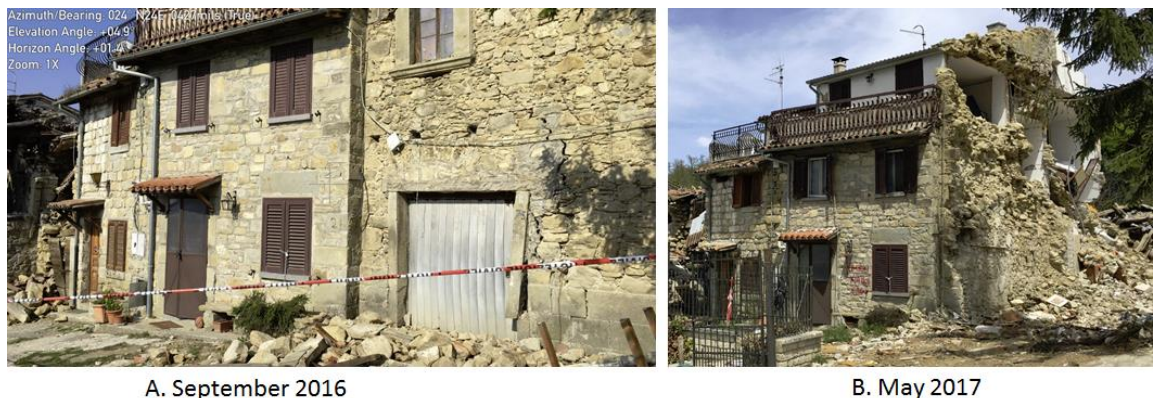
Figure 4. Comparison of buildings with and without re-pointed stone masonry in Illica

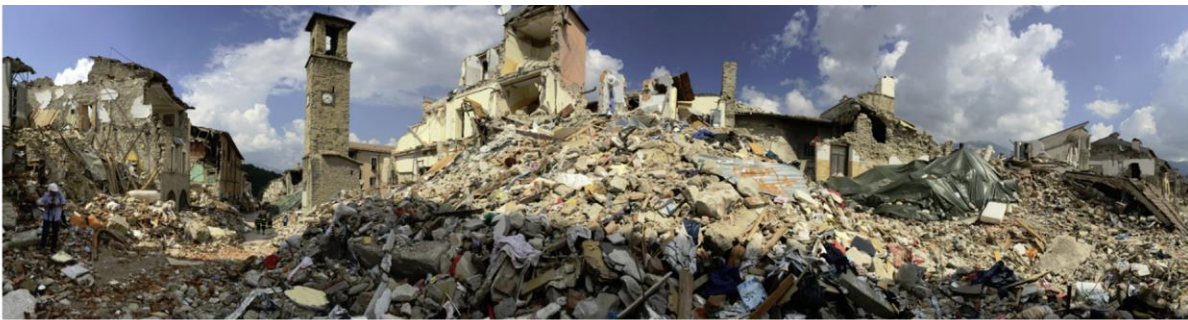
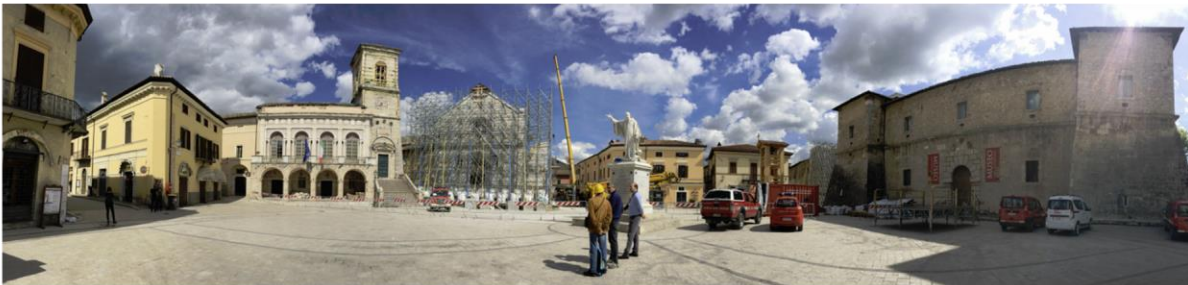
The damage to the historical center of the towns of Amatrice and Norcia is represented by Figure 5. As shown in Table 1, Amatrice is located 9km away from the epicenter of the **M6.1** August 24th Amatrice Earthquake and 27km from the epicenter of the **M6.5** October 30th earthquake. Norcia is located 15km from the **M6.1** earthquake, 5km from the **M6.5** earthquake. Norcia, being in the central region of the Earthquake Sequence, is also located 13km from the **M5.9** earthquake of October 26th. Sextos, et al., 2008, have provided detailed building-by-building damage maps for these two municipalities, using the Bray and Stewart damage classification (Bray and Stewart, 2000) (Sextos et al., 2018) and quantified the damage levels, and their progression during the earthquake sequence, for each building. The damage states are given in Table 2. In the town of Amatrice, Sextos et al. indicate that after the Amatrice Earthquake, 30% of the buildings were classified in damage state DS0 (no damage) and 23% in damage state DS5 (collapsed). After the end of the Earthquake sequence, 18% of the buildings were in damage state DS0 and 42% were in damage state DS5, indicating that the Amatrice earthquake caused severe damage to Amatrice, as did the October 30th earthquake. Following the Amatrice earthquake, 97% of the buildings in Norcia were found to have no damage (DS0), and no building collapsed (DS5). At the end of the sequence 67% of the buildings were found to have no damage (DS0), 4% were found to have minor damage (DS1) and 24% of the buildings were found to have moderate damage (DS2) and 3% of the buildings had collapsed (DS5).

a. Amatrice, September 2016

b. Norcia, May 2017

Figure 5. Representative Damage in the towns of Amatrice and Norcia

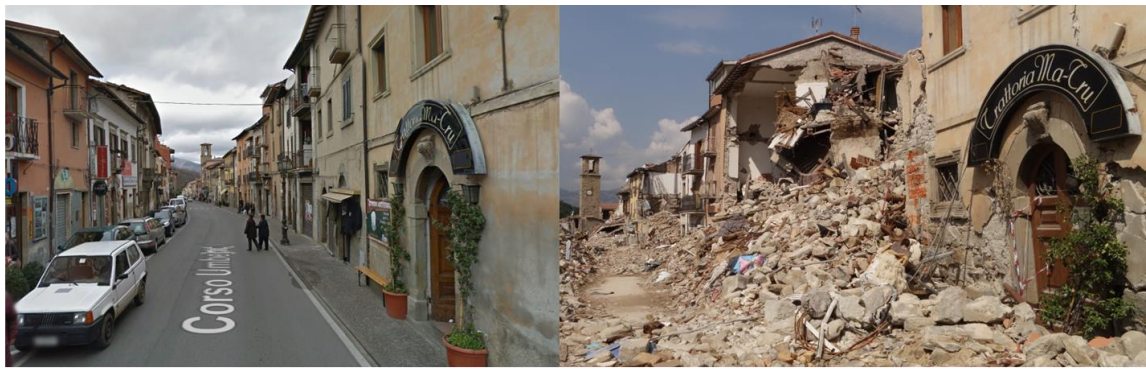
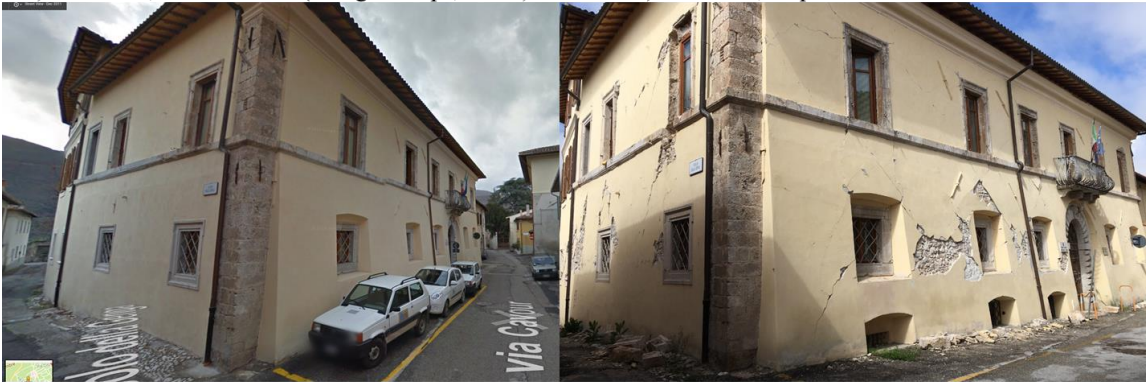
As a result, the building inventory in the town of Amatrice, and its neighboring towns, consisted of many buildings that were built long before any seismic considerations in building construction, nor social awareness of earthquake risk. In addition to having an older building stock built with no consideration of seismic resistance, visible strengthening methods in the town of Amatrice were not as numerous as they were observed in the town of Norcia. The images in Figure 7 compare the residential buildings between the towns of Amatrice and Norcia, respectively. The buildings shown in Figure 7A, in the town of Amatrice, collapsed during the August 24th Earthquake, as shown in Figure 7B. The buildings shown in Figure 7C, in the town of Norcia, showed minimal exterior damage in

May 2017, as shown in Figure 7D. The images show the difference in the construction of these buildings: the height limitations and buttressed walls in Norcia and the lack of these details in Amatrice.

Figure 7. Representative Residential Buildings in the Town of Amatrice and Norcia

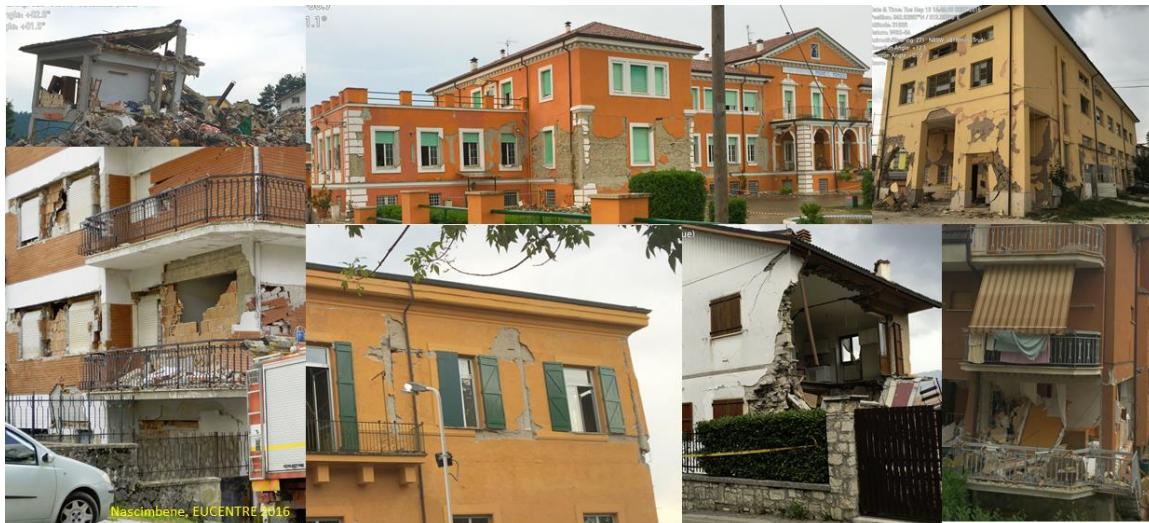
While the historical centers of the two towns are of comparable architecture, the architecture of the periphery areas are different between the towns and more diverse within them. The area on the periphery of Amatrice has three primary building types: low-rise and mid-rise reinforced-concrete moment frames with masonry infills (ductile and non-ductile), large early 20th-century mixed-masonry buildings, and single-family homes. As shown in Figure 8, most of these buildings appear to not have been strengthened and suffered severe damage during the August 24th Amatrice Earthquake.

Figure 8. Representative Buildings and Damage in Periphery of Amatrice, September 2016

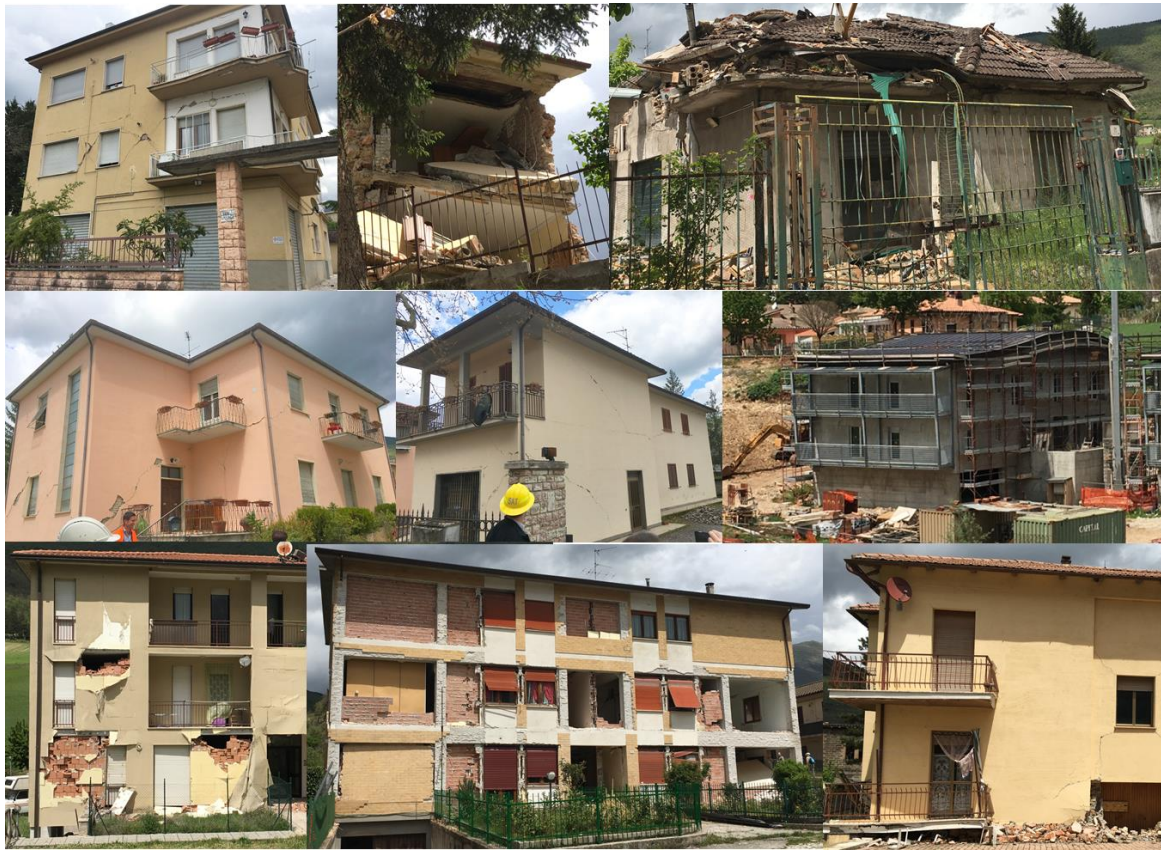
The periphery of Norcia has more modern construction, with most buildings being low and mid-rise reinforced-concrete frames. The ages of these buildings vary from non-ductile frames to modern buildings under construction, as shown in Figure 9. One area in the periphery of Norcia was damaged during the August 24th Earthquake causing evacuation of a few buildings. Because the site was visited in May 2017 only, it is difficult to attribute the observed damage to a specific event. The residents of this were the first to receive long-term temporary housing because they were the first evacuees of Norcia, as they were evacuated on August 24th. The residential buildings in the periphery of neither Amatrice nor Norcia appear to have been strengthened.

Figure 9. Representative Buildings and Damage in one area in the Periphery of Norcia, May 2017

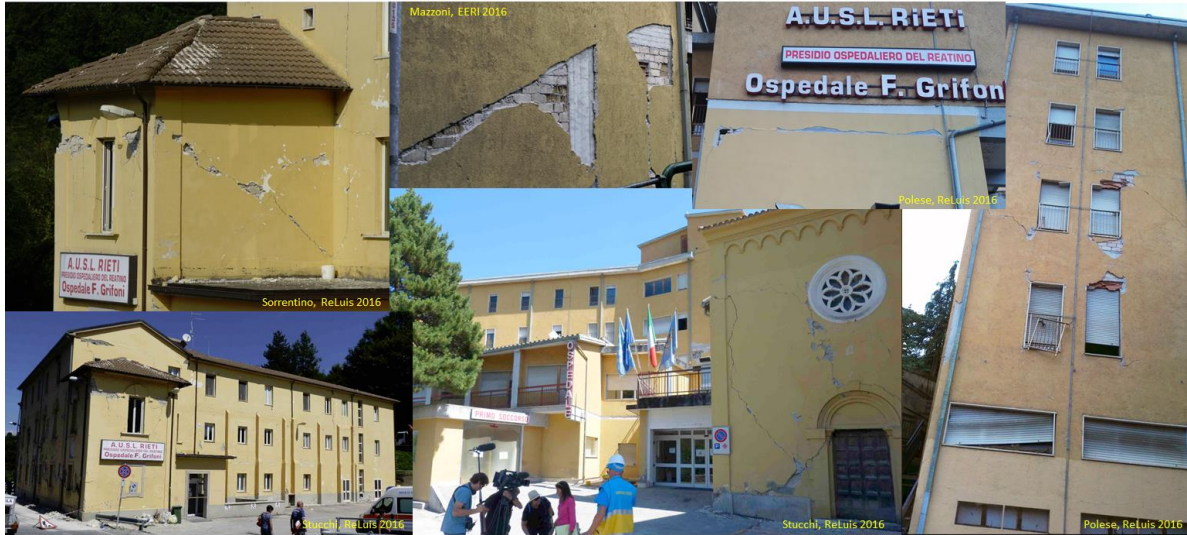
hospitals in this area to grow as the population grows. The different buildings are made of different structural systems and no evidence of strengthening was found. Structural damage was observed in the unreinforced masonry buildings while nonstructural damage was observed in the reinforced-concrete frames.

Figure 10. Amatrice Hospital, September 2016

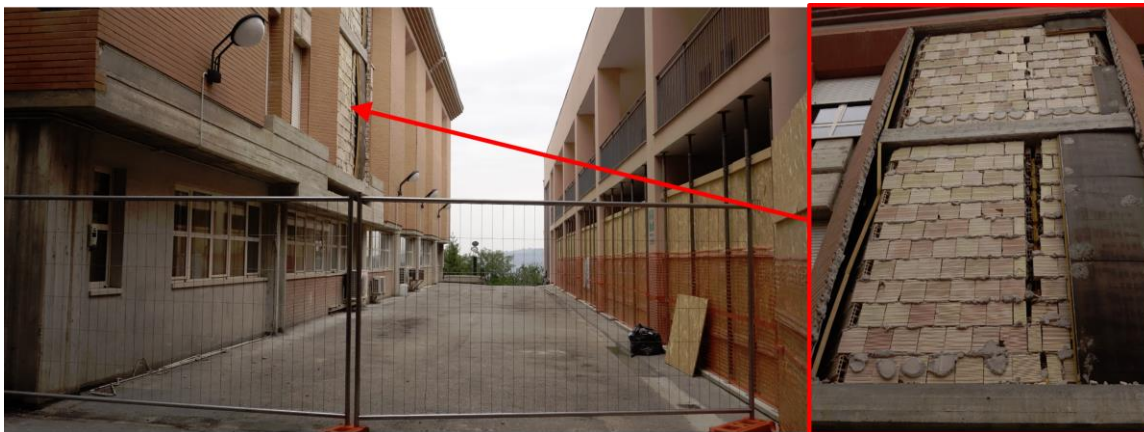
The September 2016 reconnaissance team had the opportunity to visit the hospital in Amandola, shown in Figure 11. Just like the Amatrice hospital, this hospital complex consisted of 4-5 different buildings, with the oldest one being an 18th century unreinforced-masonry building and the newest one was a reinforced-concrete frame with hollow-clay tile infills, completed in 2012. Even though it remained operation by relocating its services to parts of the complex that were considered safe, some buildings in this hospital were severely damaged by the August 24th event, in spite of its significant distance from the epicenter. Most of the damage was nonstructural and concentrated in the building built in the 1980s, hence, likely, designed before seismic regulations. The most significant damage is shown in in Figure 11, where the exterior cladding bricks fell atop an ambulance car. The Amandola Hospital was evacuated and taken out of service after the earthquakes of the end of October

Figure 11. Hospital in Amandola after August 24th Earthquake

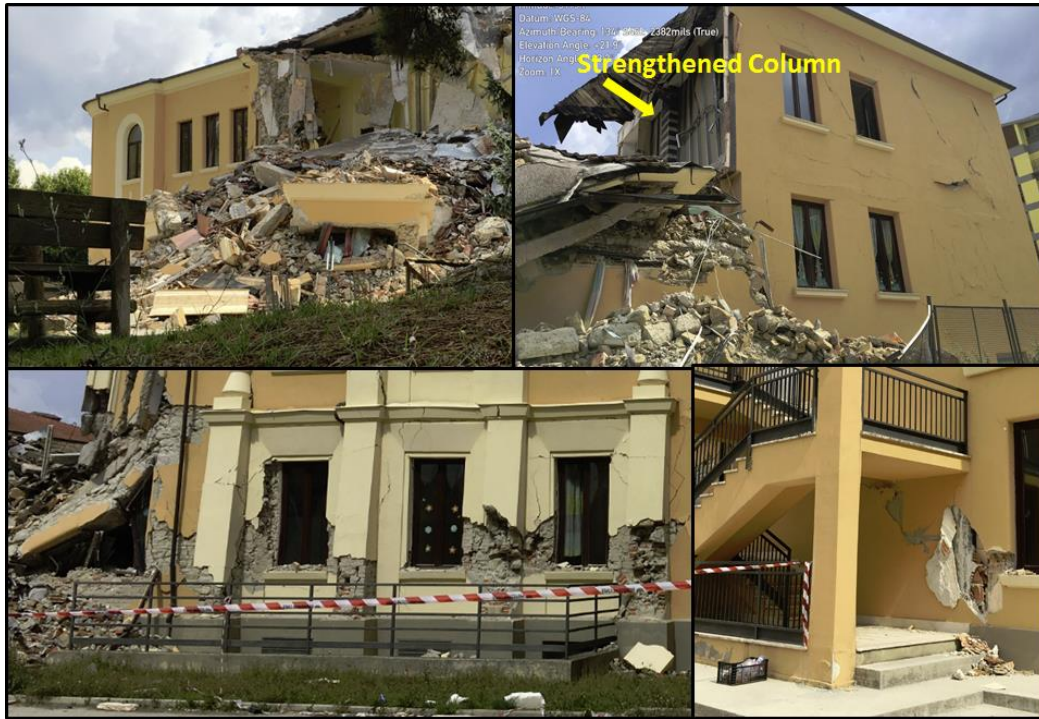
The Capranica school complex in Amatrice was badly damaged during the August 24th earthquake, with one of the wings collapsing, as shown in Figure 12. The school complex had been evaluated and strengthened -- the wing that collapsed had passed the seismic evaluation and did not require strengthening (Il Post, 2016). The school collapse symbolized the socio-economic collapse of the city. With less than one month until the beginning of the school year after the August earthquake, the town of Amatrice was able to repurpose existing prefabricated buildings and took advantage of a research project on prefabricated buildings to be used for school to start school on time (Il Corriere, 2016). The on-time opening of the school in Amatrice brought the community together with a common goal of starting a new

Figure 12. Primary-School Collapse in Amatrice, September 2016

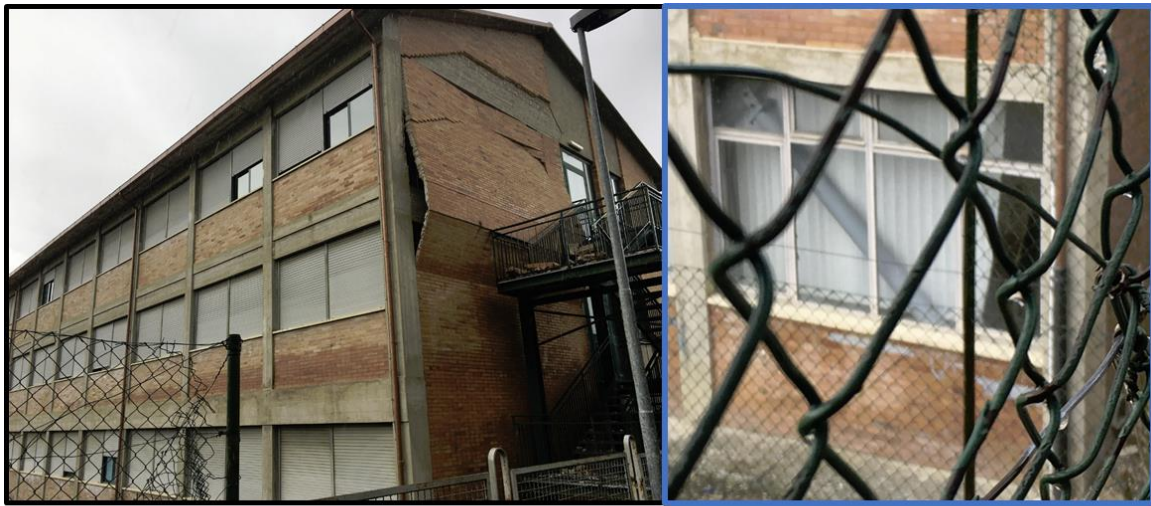
The primary school in Norcia was housed in a single building constructed in 1960 and strengthened in 2012 (Fiorentino, 2017). It only had repairable damage to the cladding after the October 30th event, shown in Figure 13A, but was deemed unusable until repairs are done. As shown in Figure 13B, the school building was strengthened using a modern engineered technique with passive dampers whose objective was to reduce lateral deformations. Even though the school buildings in the towns of Amatrice and Norcia behaved differently, the end result was the same for the two schools -- students were relocated to new long-term temporary school buildings.

Figure 13. Primary School in Norcia, May 2017

One technique that was used to strengthen a reinforced-concrete frame building was the use of passive dampers in a school in Norcia, shown in Figure 13. The passive dampers were effective in reducing lateral deformations of the frame thus preventing structural and minimizing non-structural damage (Fiorentino et al., 2017). This strengthening technique is significantly more expensive and invasive than those presented earlier in this paper. It is, however, the most effective, and least invasive, strengthening technique for reinforced-concrete structures. The nonstructural damage to this school shows that a strengthening scheme must be consider both structural and nonstructural components.

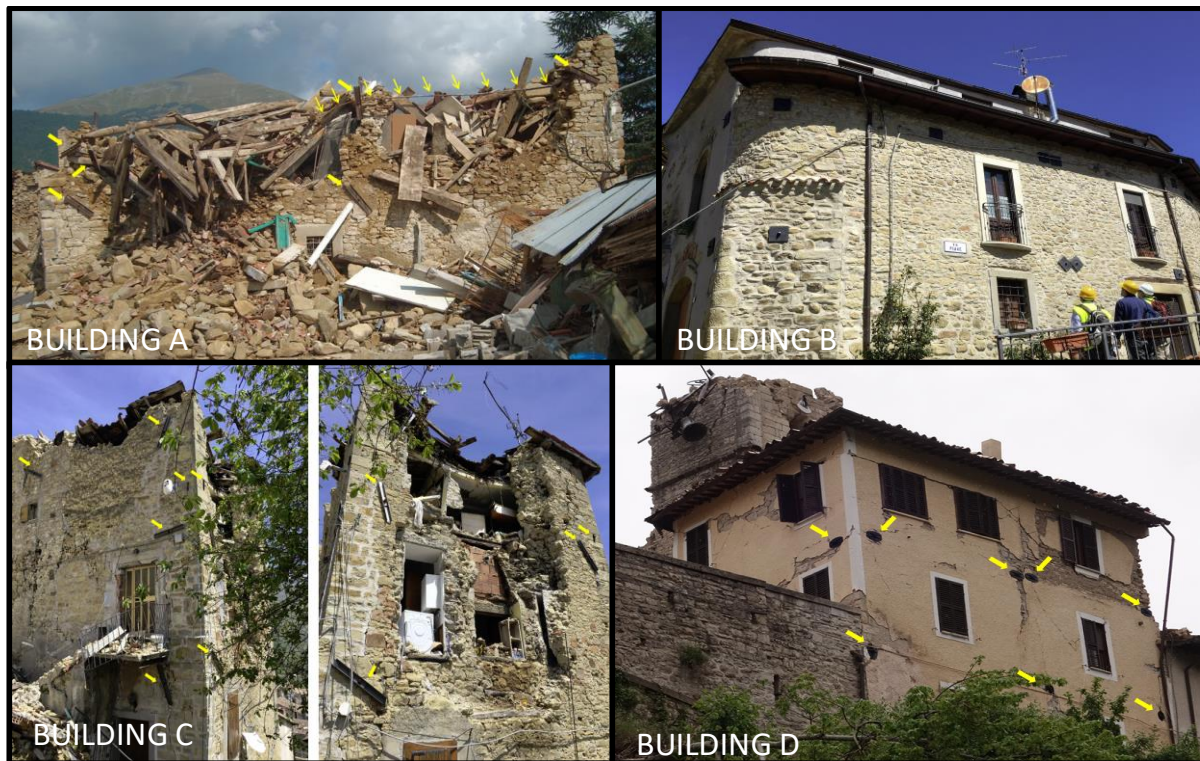
Figure 14 shows four different buildings with different levels of strengthening and different responses, not all consistent with what would be expected from the level of strengthening. Building A, located in Accumoli, collapsed during the August 24th earthquake even though it had been strengthened using several steel ties that spanned the length of the building. A careful observation of the rubble shows that the poor quality of the mortar did not maintain the integrity of the walls which must have collapsed under their own weight as soon as they began deforming out of plane, as has been observed in similar structures.

The strengthened building labelled Building B, also located in Accumoli, appears to have sustained the entire earthquake sequence without any visible damage. The number and distribution of steel ties, as well as the quality of the mortar on the side of the building and the fine stonework in the front of the building show that a well-engineered strengthening will

Figure 14. Strengthened Stone Masonry Buildings

The building labelled Building C shows a building in the center Accumoli in May 2017 where it is evident that the only strengthening measure that was applied to the building are steel ties, both old (small) and new (large), and repointing of the corners. The façade of this building was not damaged after the Amatrice Earthquake. Even though the facade of the building collapsed during the October 30th event, it was not a total building collapse. The steel ties and the repointing maintained the integrity of the corners of the buildings, but the wall facade did not maintain its integrity and was not anchored to the building corners. Building D is not located in Accumoli, as the other buildings are, but is shown as another building where it is evident that tie rods placed at critical locations reduce damage to the structure. The horizontal crack at the corner of the roof level and the lack of steel ties at that level, indicate that a concrete ring beam may have been placed there. The ring beam did maintain the integrity of the roof level, but this ring beam was not well anchored to the top floor, where damage is most evident.

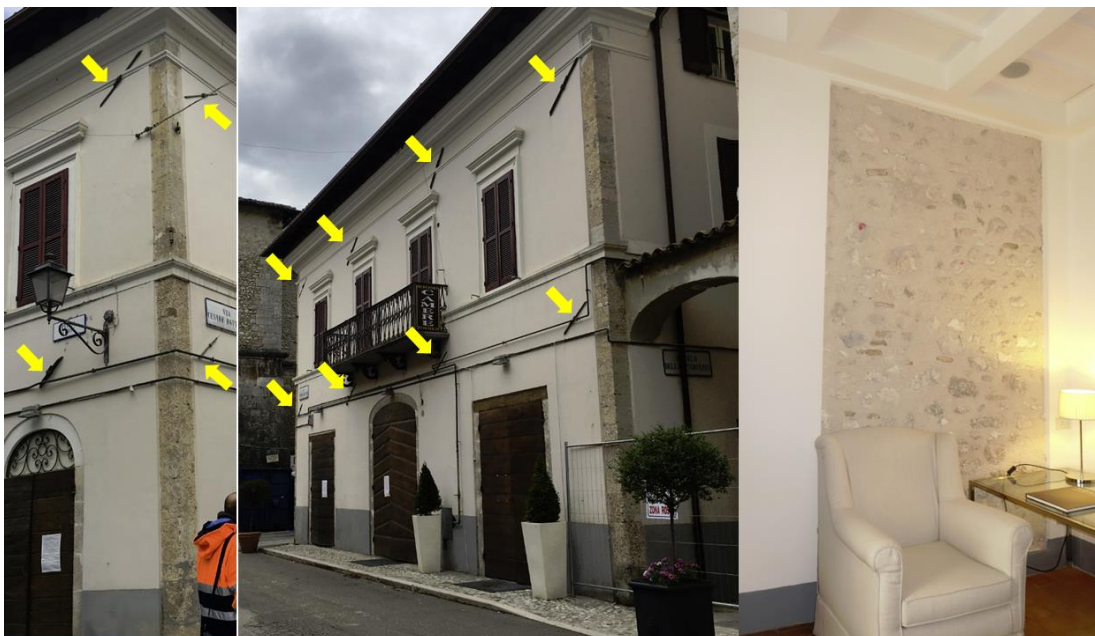
Because of its minimal cost and its effectiveness, the application of reinforced (steel mesh) plaster to interior and/or exterior walls is the most common type of strengthening methodology. It is typically combined with grout injection to improve combined action with the wall itself. This strengthening methodology, can be recognized by the contrast between the exposed stonework at the corners and the thicker plaster. Buildings with this characteristic are numerous in Norcia and they are easy to distinguish from those that look aged. Figure 16 shows Hotel Seneca, a historic-building hotel in the historical center of Norcia near the main square. The reinforced plaster was added to both exterior and interior walls, as shown in the figure, noticing its contrast, and additional thickness, with respect to the original stonework. It is worth noting the presence of steel ties that span both directions of the building (actually a pair of buildings). There are two types of ties present, some may have been there well before the latest strengthening, some appear to be more recent. Palazzo Seneca was strengthened before 2016 and did not sustain any damage during the earthquakes. Because the entire historical center of Norcia was evacuated, the Hotel had to shut down and did not reopen for business until circa April 2017. Because it is the least invasive procedure, reinforced plaster, with grout injection if necessary, appears to be the most common strengthening methodology in Norcia.

Figure 16. Example of Strengthening with Reinforced Plaster, Hotel Seneca in Norcia

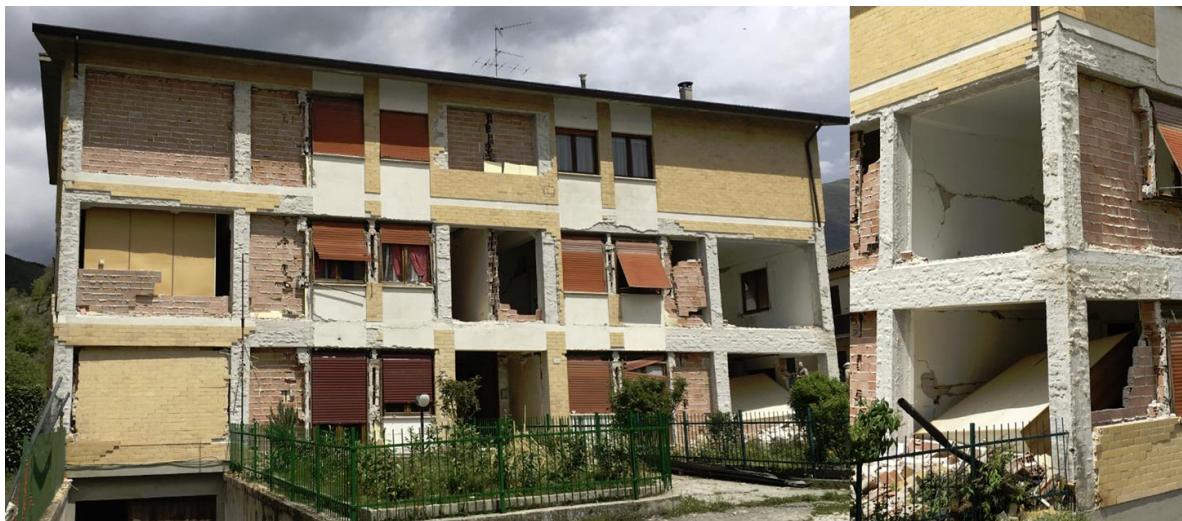
Figure 17 shows a representative RC buildings and typical damage due to earthquake. Because it is a mountainous region, RC frames are insulated using two layers of hollow clay tile or bricks, with the outer layer often being part of the cladding. During lateral shaking the deformation incompatibility between the flexible frame and the stiff infill cause the infill to fail either in plane or fall out of plane, as shown in the figure. Even though this type of response mechanism may not lead to structural failure, the damage to the nonstructural components makes the building unusable. There are cases, also, where the deformations are large enough and the infill masonry is stiff enough to cause damage to the nonductile concrete columns and/or joints, as shown in Figure 18.

Figure 17. Representative Reinforced-Concrete Building in Norcia

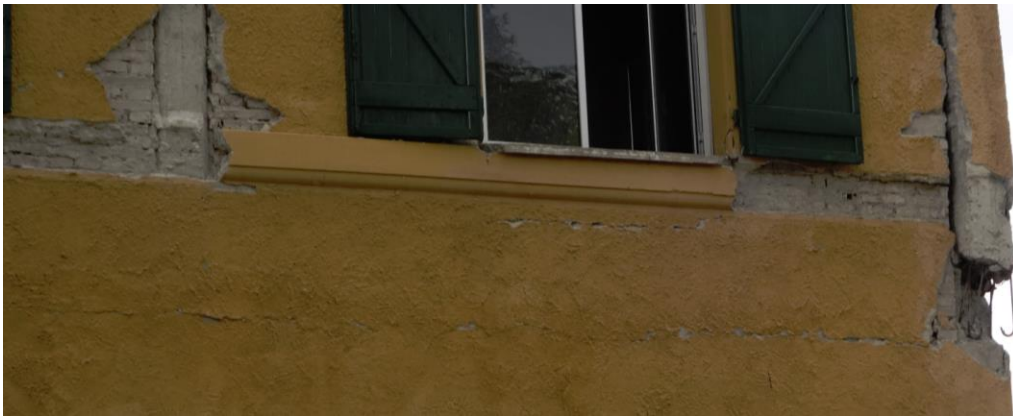
Figure 18. Damage to Non-Ductile Reinforced-Concrete Frame in Amatrice
