# MECHANISMS FOR PREVENTING RISING DAMP IN NEW BUILDING INFRASTRUCTURE

**Paper type:** Research paper

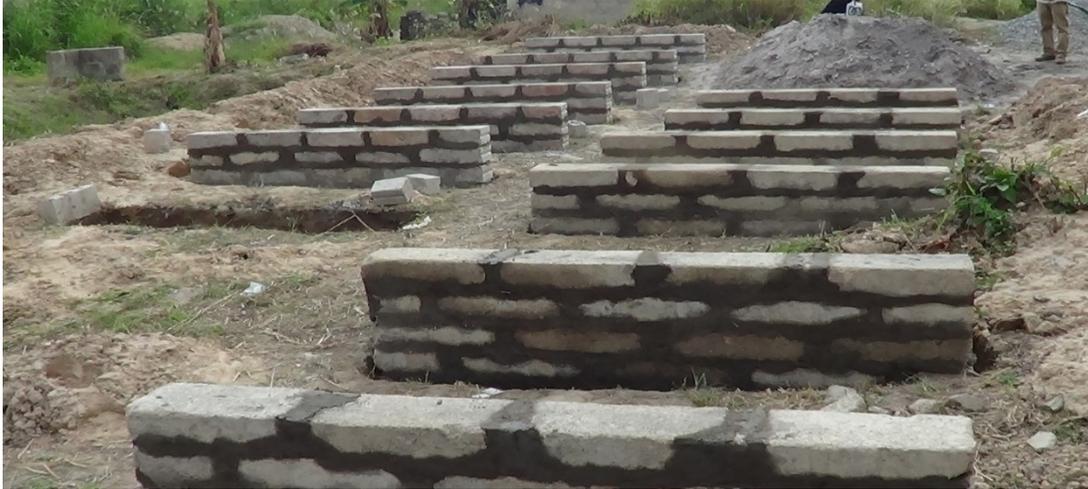
Fig 1 Photograph of test walls (extreme left are those constructed with SBs and extreme right are those constructed with CBs) (Source: Agyekum *et al.*, 2016)

Fourteen masonry test walls of dimensions 2.1 m high by 2.0 m long were constructed at the location. The walls were not erected under sheds in order to ensure their complete exposure to the inclement weather. The construction of the fourteen test walls began on 1<sup>st</sup> July 2014 and ended on 24<sup>th</sup> July 2014.

The first set of walls, which consisted of seven free standing walls were constructed of the SBs, whilst the second set of walls, also made up of seven free standing walls were constructed of the CBs. The CB construction was used to replicate to an extent the kind of blockwork construction commonly adopted during the construction of residential buildings in Ghana (Agyekum *et al.*, 2016).

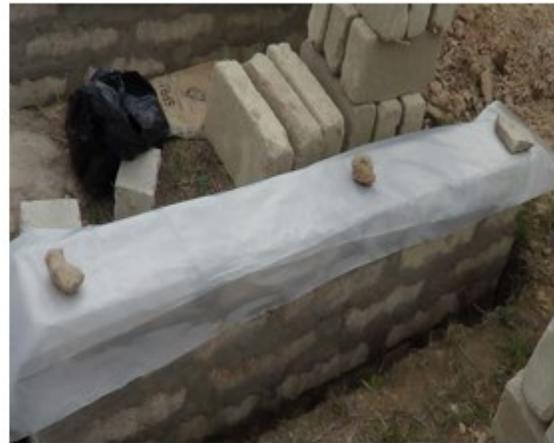
Fig 2 (a) Schematic diagram of the position of the dpc (b) Photograph showing how the dpc was laid (Source: Agyekum et al., 2016)

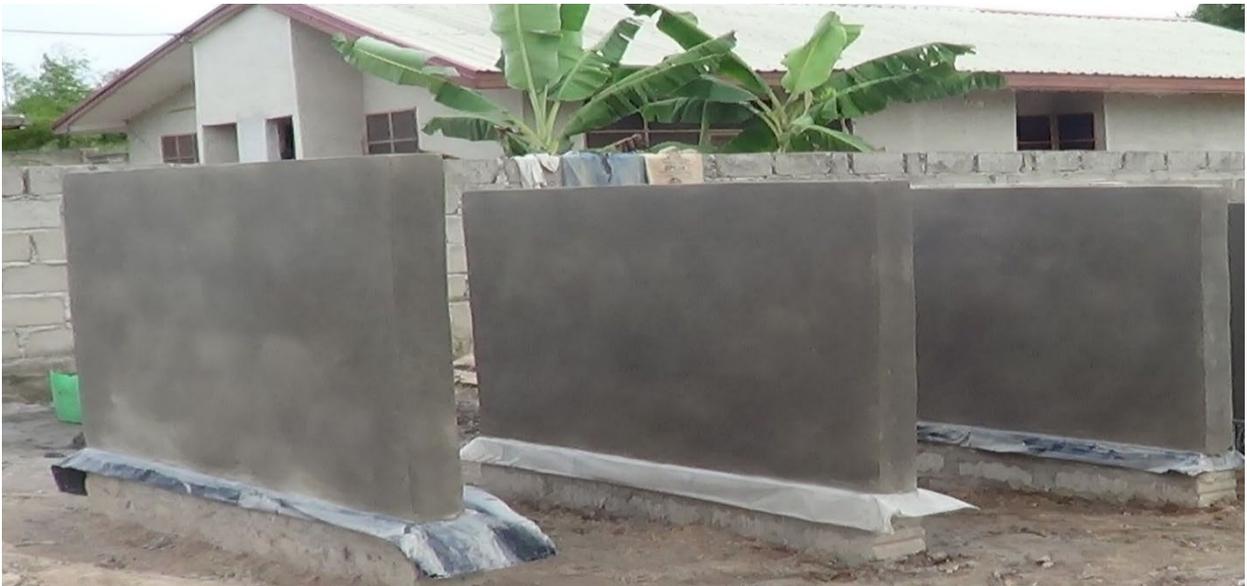
Fig 3 Photograph of test walls after the dpcs were laid

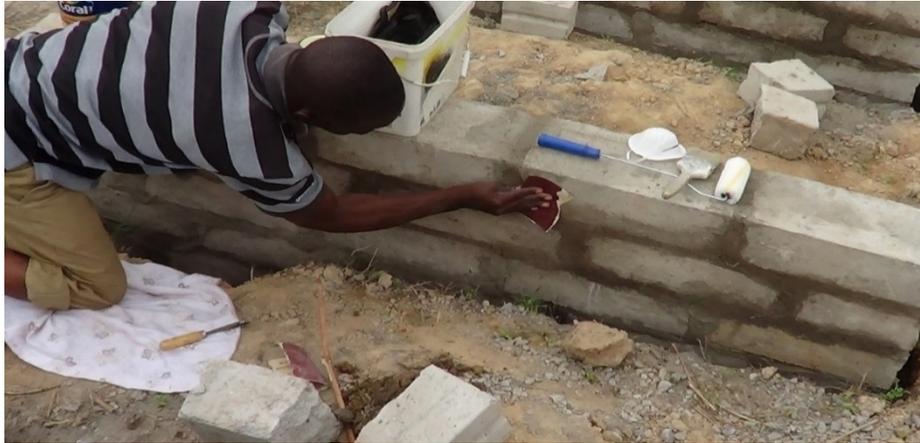
Fig 4 Photograph showing the preparation of the wall surfaces

The damp proof coatings were also applied to the fourth sets of test walls. During the application of damp proof coating 'A', the wall surfaces were thoroughly cleaned and dried (Figure 4). The soil of the adjoining walls was excavated about 3 feet (900 mm) deep. A catalyzer was mixed with the epoxy paint, stirred and left to stand for 30 minutes. The catalyzer was part of the

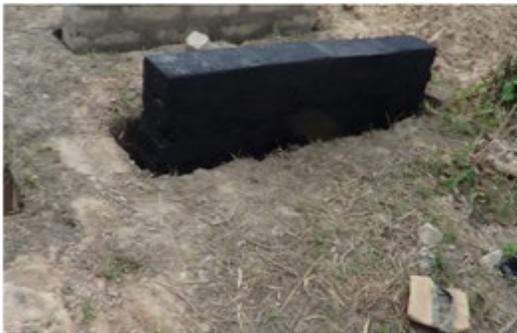
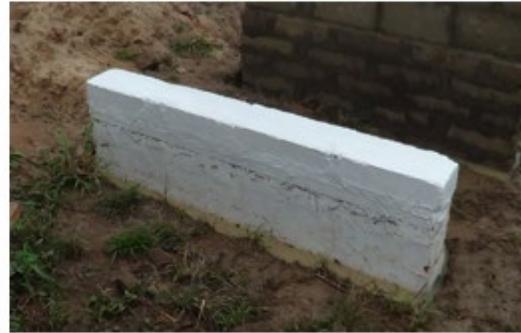
Fig 5 Photographs of the walls after the damp proof coatings 'A' (left) and 'B' (right) were applied

Similar preparations as done for the application of damp proof coating 'A' was done for the damp proof coating 'B'. Before its application the product was thinned with water in the rate of 40% and applied to the walls. After drying first coat, the second and third coats were applied without dilution and allowed to stand for 48 hours after which the walls became completely dried (Agyekum *et al.*, 2016). Figures 5 and 6 show the test walls after the applications of the damp proof coatings.

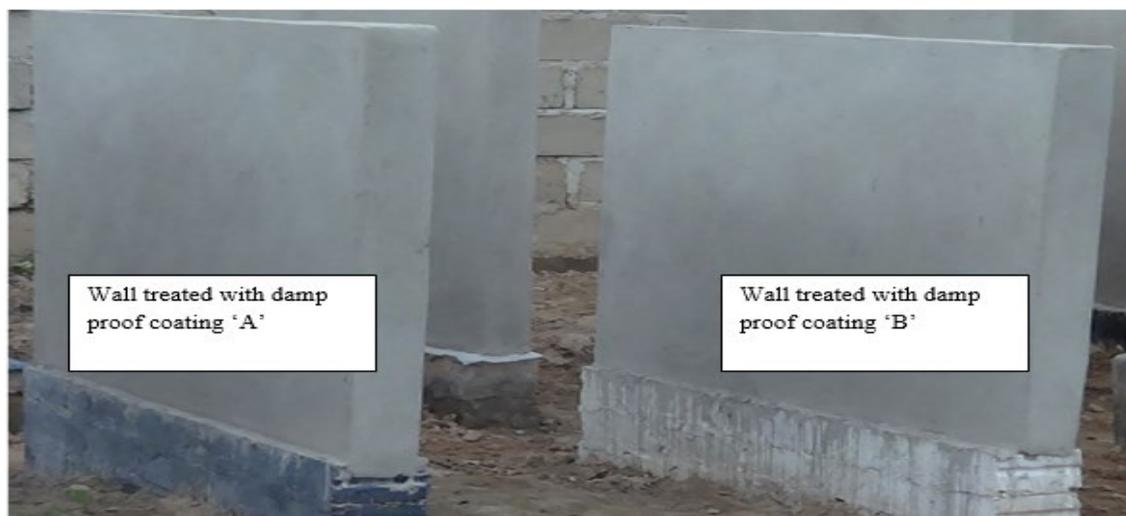
Fig 6 Photograph of test walls after they were treated with the damp proof coatings

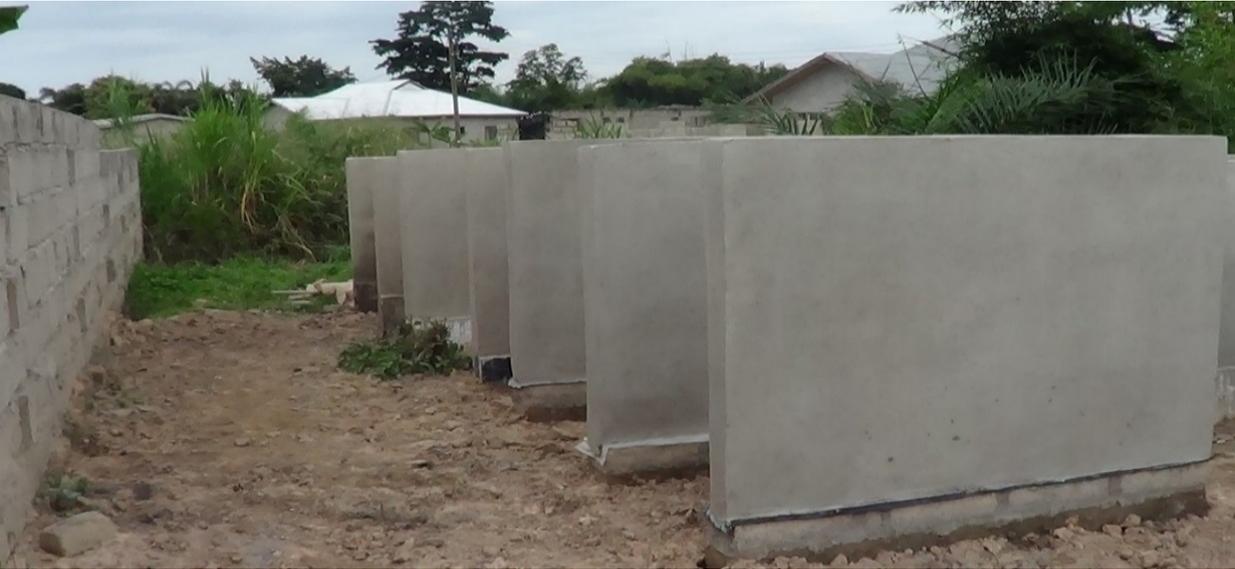
Fig 10a Photograph showing the damp front achieved by moisture in the walls constructed

One month after erecting the walls, a slowly progressing rising water front was visually observed. By the fifth month, the front had reached close to a third of the first course from ground level for the walls constructed with SB, and more than two thirds for that constructed with the CB. These initial observations were closely associated with the quality of the sandcrete blocks manufactured in the two cases. For instance, preliminary sorptivity test conducted on the two sets of sandcrete block samples (SB and CB) indicated that the those manufactured with the CB were more susceptible to water rise as compared to those made from SB. This indicate that the issue of quality control should really be taken into consideration during the manufacture of sandcrete blocks to be used in construction in Ghana.

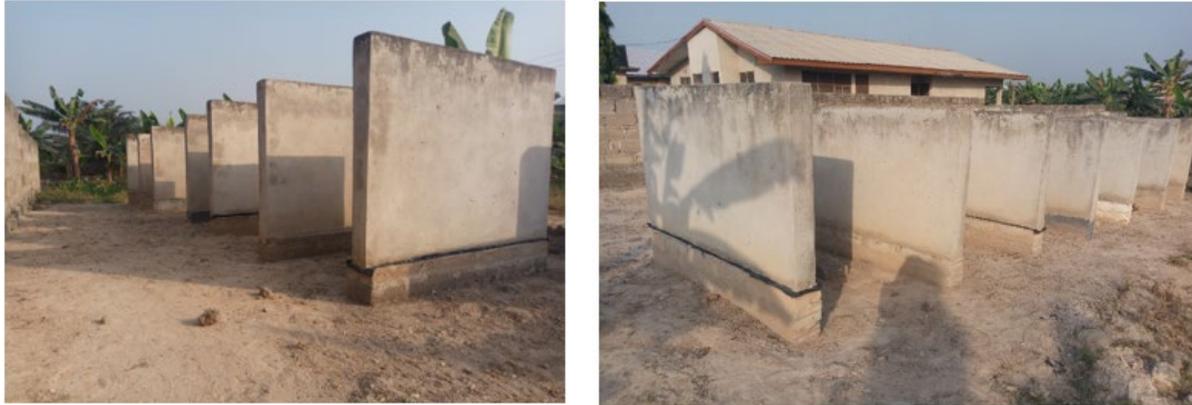
Fig 10b Photographs showing the conditions of the walls in the dry season

Riley and Cotgrave (2005) further stated that if the ground is not saturated, the soil exerts a suction that opposes the upward pull of the water in the wall. As a result, when the water table falls, the height of the moisture in the walls will drop to a new level provided there is sufficient time for equilibrium to be achieved. This further shows why in the dry season, the water levels

recorded in the walls were lower (Figure 10b). Each period of heavy rain on the ground at the base of the wall produces a temporary condition of saturation following which the water level in the wall rises again.

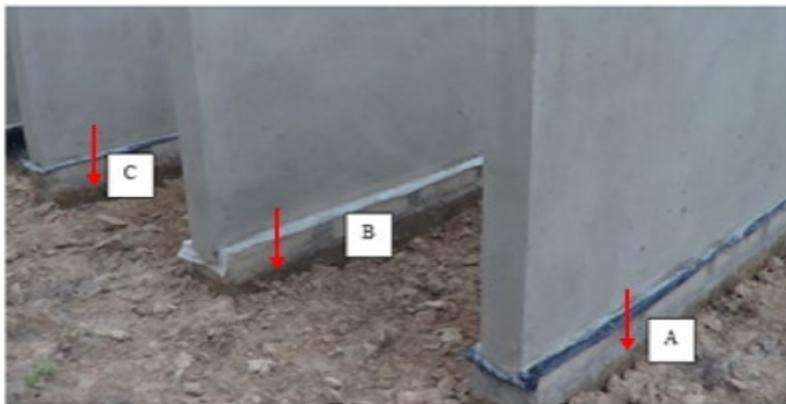
Fig 12 Water rise at the bases of the walls treated with three different DPCs - 0.15 mm thick (A), 0.12 mm thick (B) and 0.13 mm thick (C)

Though at the peak of the rainy seasons (Figure 12) the water levels rose higher, especially in the block walls manufactured with the CBs, the water could not go beyond the dpcs.

This indicates that the dpcs acted as barriers that prevented the water from rising higher. Comparing this scenario to that in SB 6 and CB 6 (Figure 14), there is the likelihood that water would have risen higher in the walls had the dpcs not been in place. From Figure 12 it is clearly evident that the bases that had not been treated had been soaked with water. The ability of the water to rise in the walls depended on factors such as ground and soil conditions, environmental factors, climatic factors, etc. of the area.

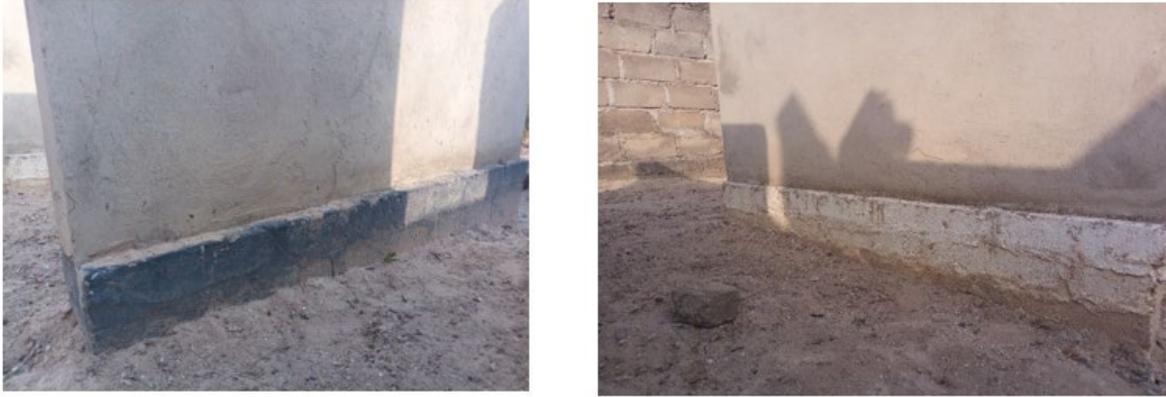
Fig 13b Photographs showing the conditions of the treated walls in the dry season

Figures 13a and 13b show the conditions of the two sets of walls (SB 4, CB 4; SB 5, CB 5) treated with the damp proof coatings during the rainy and dry seasons. The monitoring revealed that 4 years into the treatment of the walls, the damp proof coatings 'A' and 'B' are working perfectly. Moisture content measurements with the PCE MMK1 moisture meter with deep probes showed no traces of water at the bases of the walls, and the inner parts were considerably dry. This is because the entire perimeters of the wall bases were completely covered with the coatings, which filled the pore spaces within the sandcrete blocks, making it difficult for water to rise and penetrate.

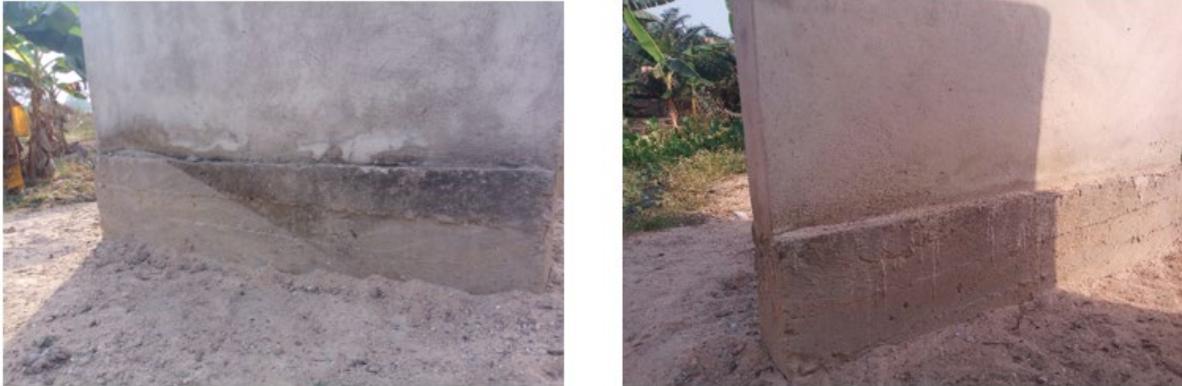
Fig 14 Photographs showing the conditions of the test walls with concrete bases

Test wall 7 for the two sets of sandcrete blocks were constructed with dense concrete bases. After four years of monitoring the walls against the capillary rise of moisture, the findings revealed that the bases of the walls showed no traces of moisture rise or penetration. The concrete bases were very dense and did not permit the ingress of water by capillary action. Figure 14 is a photograph that shows the conditions of the walls for the two different constructions.
