CULTURE, MEDIA & FILM | RESEARCH ARTICLE

Interdisciplinary approaches to understanding and preserving mudbrick architecture in regional and diachronic contexts

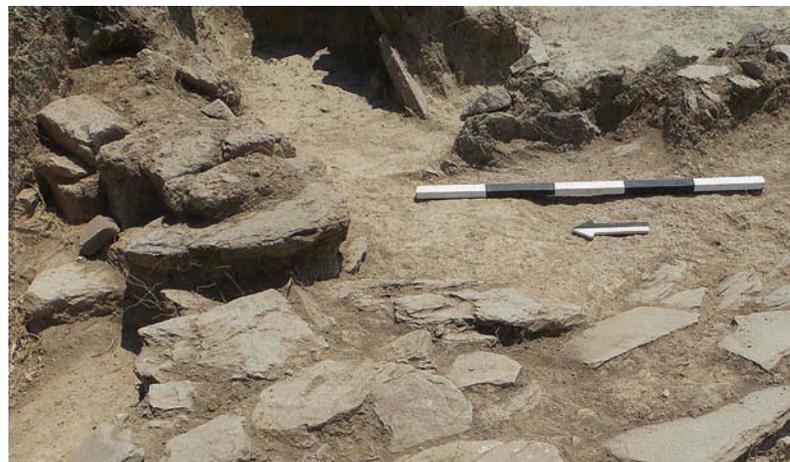
Figure 2. Two courses of mudbrick preserved *in situ* on top of stone socle recovered from Kaymakçı (KAP 97.545).

While research at Sardis dates to the 1970s, investigations at the Middle to Late Bronze Age site of Kaymakçı (see Figure 1) began in 2012. Three years of excavation on site under the KAP provides critical information about the extent and nature of local mudbrick construction. Excavation and analysis of recovered material reveal evidence of older earthen architecture traditions dating to the second millennium BCE. Despite poor preservation characterizing most architectural evidence of mudbrick, increasing diversification of methods of investigation in recent years (e.g. Love, 2017) enables collection of new, meaningful information regarding production technology and choice. Archaeological data indicate that stone foundations and mudbrick superstructures define normative architectural traditions. While there is an extensive mudbrick corpus, there is limited archaeological evidence for *in situ* construction. The best-preserved evidence consists of two courses of mudbrick superstructure sheltered from postdepositional degradation and weathering by a fortification wall (Figure 2).

Most, but not all, mudbrick finds show evidence of surface accretions developed during weathering from air and wind exposure (see Figure 2). Many exhibit uniform calcium (Ca)-rich surface coatings ranging between 0.001 and 0.005 m in thickness, similar to those found on ceramic, stone, and bone artifacts excavated from the site. The presence of Ca-rich surface accretions confirms that, while the site is situated on/or near bedrock, the clay matrix of Kaymakçı soils retains moisture for extended periods. Exposure to substantial wind and water following abandonment is most likely responsible for weathering on mudbrick structures at Kaymakçı. This is analogous to observed damages associated with derelict modern structures preserved in the area today.

coatings, suggesting a frequent maintenance cycle. This differs from ancient mudbricks recovered from Kaymakçı, which incorporate a finer range of aggregate, lower percentage of organic temper, greater variance in standard brick size, and high-fire sintering (see Table 1 and Figure 2).

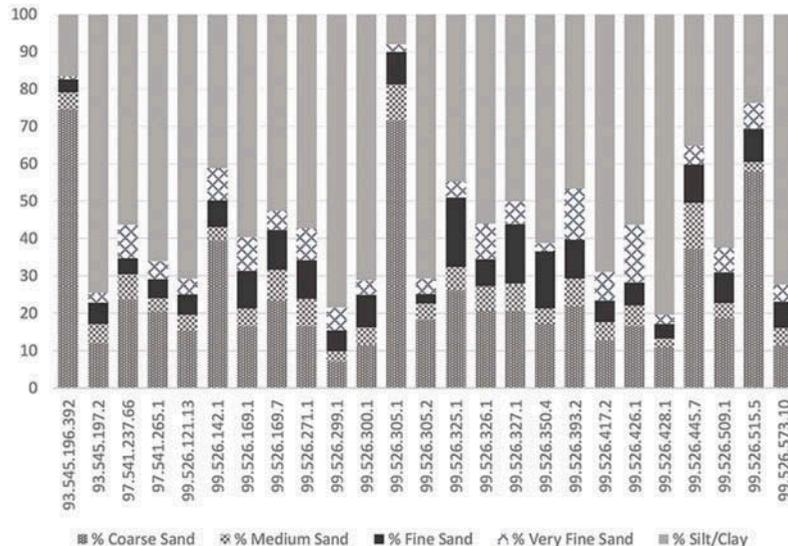
Figure 3. Percentage representation of sand and silt/clay particles in mudbricks from Kaymakçı.

Fluctuating ratios of material components contribute to observed variation in mudbrick recipes rather than resource diversification. Disparities might stem from small-scale production units, wherein each used particular recipes and operated locally or for short periods to produce needed bricks for a particular housing block. Differential mixing within single batches of mudbrick may also be the source of variability. Currently, the relationship between mudbrick composition (whether homogenous or heterogeneous) and their geospatial location in individual walls or structures is unclear, as excavation has only revealed individual bricks rather than complete mudbrick courses. Whatever their origin, such variation is discernible in macroscopic and microscopic observation, as well as in particle-size analysis, which reveals high variation in sand and silt/clay component ratios (Figure 3). Following Love's (2017) methodology, field-laboratory analyses on sun-dried mudbricks used a nested set of sieves to distinguish between coarse (500 µm), medium (250 µm), fine (125 µm), and very fine (64 µm) sand, and silt/clay fractions and determine particle distributions. While "ideal" brick recipes usually contain up to 25–45% clay (Love, 2017, p. 354; Rosen, 1986), Kaymakçı mudbrick recipes diverge significantly from this ratio, a trend observed when comparing between bricks within the same architectural feature (Figure 3).

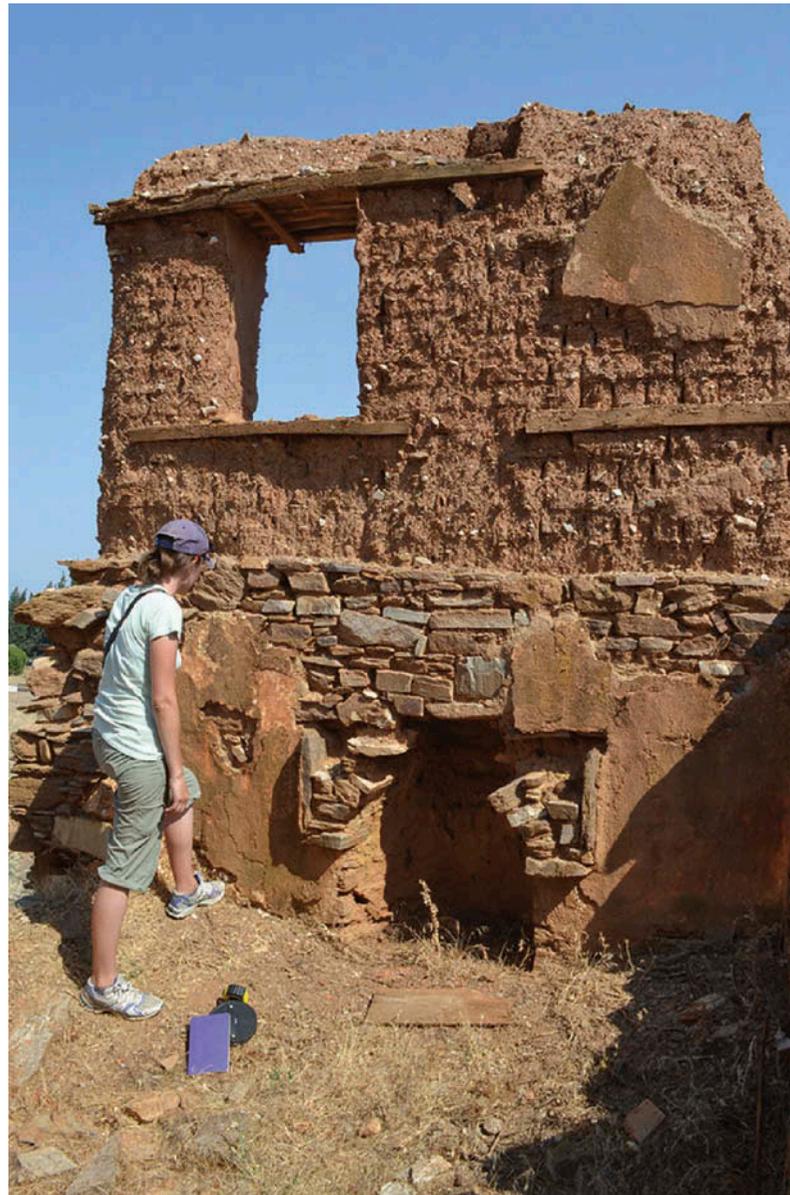
Figure 4. Typical vernacular mudbrick architecture where mudbrick is laid across stone foundations and wood beams provide support; please note areas where original plaster surfaces are preserved, Eski Haciveliler.

Most structures in Eski Haciveliler have stone foundations, some with extant mudbrick superstructures, wooden support beams, and, where preserved, layers of plaster covering the mudbrick (Figure 4). Both single- and two-story residences are found in the village, allowing in the latter case for the demarcation of storage, social, and family spaces. Found predominantly in the lower village, single-story dwellings are oriented toward courtyards and enclosed by walls that close the structures from the street (Luke & Cobb, 2013, p. 164). Through interviews with Haciveliler inhabitants, Luke and Cobb (2013, p. 164–6) highlight the importance of air movement, scent, and light in understanding how inhabitants organized and used their space. In addition, preserved sections of the buildings are extremely valuable documents recording the use of raw materials and manufacturing technologies used in construction through exposure of internal stratigraphic components. Therefore, mudbrick architecture from Eski Haciveliler and its orientation/interaction with the surrounding environment inform our understanding of building function, as well as degradation and post-abandonment processes at Kaymakçı, in spite of observed differences between ancient and contemporary bricks.

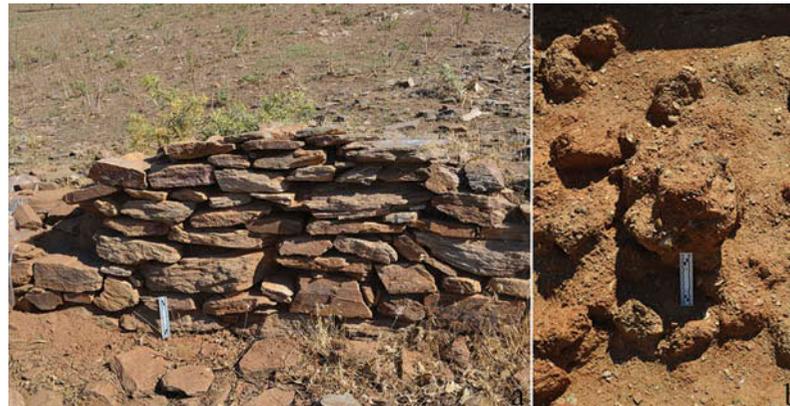
Figure 5. Eski Haciveliler conservation laboratory testing sites: (a) fieldstone masonry wall (south side) surrounding the schoolhouse perimeter and (b) mudbrick wall (west side) from the schoolhouse.

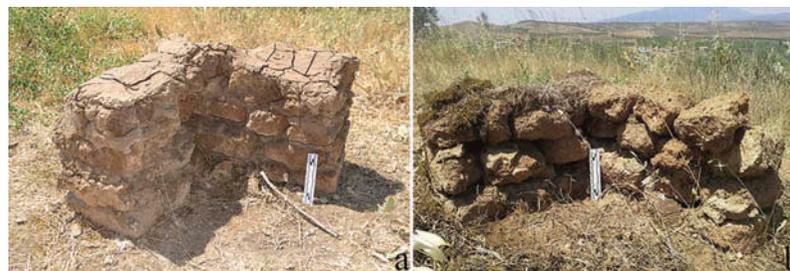
Figure 6. Tekelioğlu experimental L-shaped mudbrick wall: (a) just after construction in July 2013 (southeast side) and (b) 11 months later in June 2014 (southeast side).

Following the end of the 2013 field season, local colleagues continued to monitor the wall—wetting and photographing daily for an additional 2 weeks during the dry season. Thereafter, the wall was inspected on variable intervals (2–3 times per week, once per week, once every other week). Throughout this period, we were in regular discussion with our collaborators and made protocol adjustments based on their observations and knowledge of the environment. This dialogue was critical and resulted in the removal of the plastic covering 4 weeks after the date originally

scheduled due to unexpectedly high temperatures. The wall stabilized in November 2013 and remained in place with very little damage until March 2014, when grazing cattle caused significant damage. Following this incident, our local partners partially reconstructed the wall. Assessment in June 2014 (Figure 6(b)) indicated substantial color alteration and complete failure of all mud coatings applied between mudbrick courses, despite the high Ca-content of soils used. This is unsurprising as the mud coatings did not contain added binders (lime or cement) and reflects the need for semiannual (or more frequent) maintenance—critical information for preservation planning of the archaeological site. While we observed significant structural instability, most damage could be attributed to the April event when referencing our archive of digital documentation condition images.

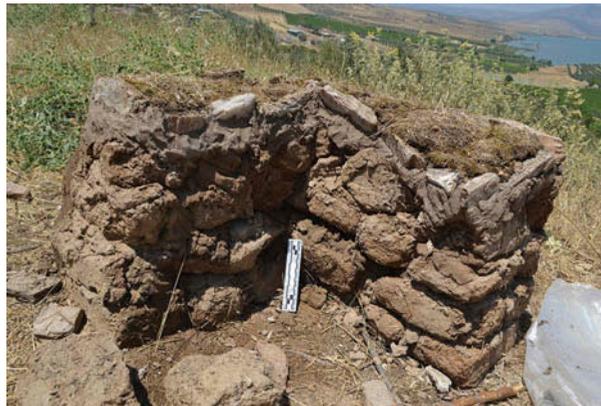
Figure 8. Soft vegetative cap applied Tekelioğlu experimental L-shaped mudbrick wall (top surface) directly after application.

In contrast to the Eski Haciveliler field trial, the soft cap system only protected the top horizontal surface of the experimental mudbrick wall in Tekelioğlu. Prior to installing the cap, thin sedimentary stones were set perpendicularly along the wall perimeter for protection using a lime–cement–soil–sand mortar mixture (5:1:2:6) using T4 soil. Following setting of the stone perimeter, we placed soft vegetative cap layers on top of the mud-coated, premoistened mudbricks using sand, geotextile, gravel, mud coating, gravel, dry soil, and vegetation (Figure 8). The completed cap was wetted, documented, and covered with a wet towel and plastic sheet to control drying. Local collaborators remoistened the towels daily for 15 days and at varying intervals thereafter, until the end of the dry season.
