# Description of Small and Large-Scale Cross Laminated Timber Fire Tests

A large-scale fire test was conducted on a compartment constructed from cross laminated timber (CLT). The internal faces of the compartment were lined with non-combustible board, with the exception of one wall and the ceiling where the CLT was exposed directly to the fire inside the compartment. Extinction of the fire occurred without intervention. During the fire test, measurements were made of incident radiant heat flux, gas phase temperature, and in-depth temperature in the CLT. In addition, gas flow velocities and gas phase temperatures at the opening were measured, as well as incident heat fluxes at the facade due to flames and the plume leaving the opening. The fuel load was chosen to be sufficient to attain flashover, to achieve steady-state burning conditions of the exposed CLT, but to minimize the probability of uncertain behaviors induced by the specific characteristics of the CLT. Ventilation conditions were chosen to approximate maximum temperatures within a compartment. Wood cribs were used as fuel and, following decay of the cribs, self-extinction of the exposed CLT rapidly occurred. In parallel

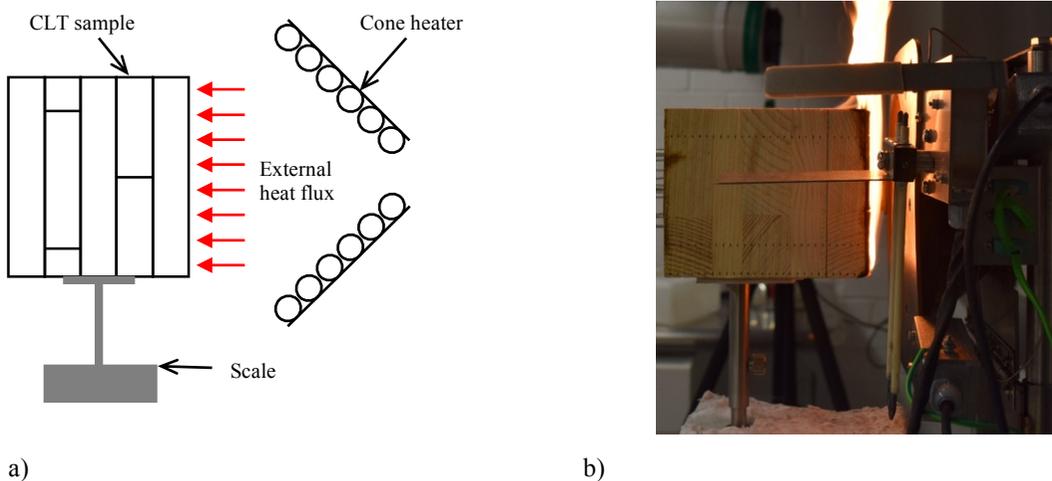
The samples were placed on a scale to measure the rate of mass loss over time – as illustrated in Fig. 1. The external heat flux was instantaneously applied to the samples and caused the surface of each sample to increase in temperature and then auto-ignite. The samples were allowed to burn until flaming combustion ceased or until the sample was completely burned. As the surface regressed away from the cone heater, the external heat flux on the exposed surface decreased due to the increased distance from the heat source. The time to self-extinction and the corresponding distance away from the heater were measured. A Schmidt-Boelter heat flux gauge was used to measure the external heat flux at the location of the exposed surface when self-extinction occurred. This value corresponded to the critical heat flux for self-extinction. A total of 27 samples were tested across various heat fluxes. The minimum number of repetitions was two, and the maximum number of repetitions was eight. The methodology was rigorously tested and the data was consistent both between samples and with values from literature [7].

Fig. 1. a) Schematic of the experimental setup; b) Image of test.

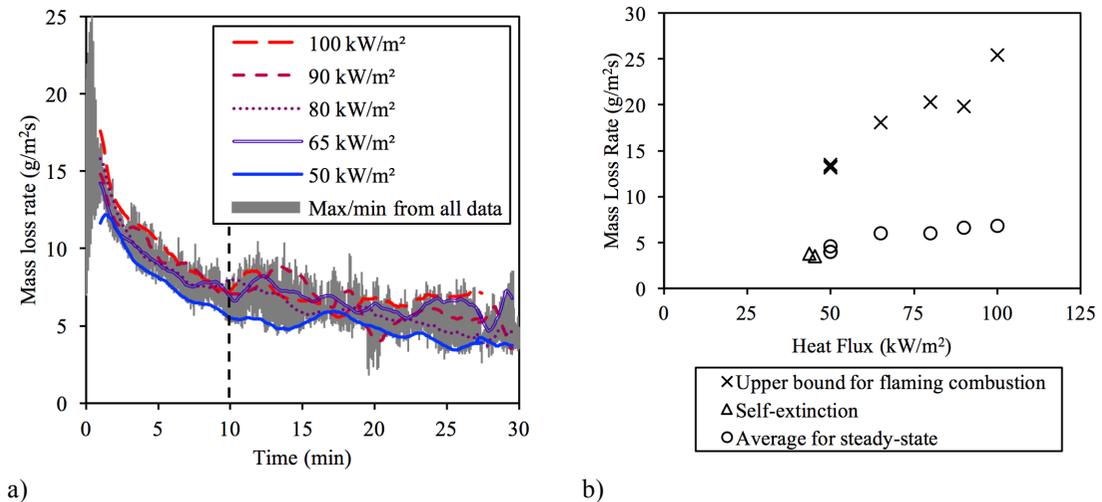
Figure 2a shows the 2 minute averaged mass loss data for each of the heat fluxes applied (with the maximum and minimum for all data shown in grey); the two phases of burning are clearly evident. These results show that ignition is faster with higher external heat fluxes and that after ignition, a peak mass loss rate occurred in the early stages of heating. The peak value increases with the external heat flux. As the burning continued, the mass loss rate began to decrease. This behavior is consistent with the process described above. The transition to steady state burning was not instantaneous; however, it can be observed that it occurred faster for high heat fluxes than for low heat fluxes; this was due to the time taken to form the char layer. For the lower heat fluxes it was estimated that steady state occurred after approximately 13 minutes, and for higher heat fluxes steady state occurred after approximately 8 minutes. Given the range of heat fluxes common in a compartment fire, it was assumed that 10 minutes is a representative time for transition to steady state. Figure 2(a) shows that beyond this representative steady-state time the mass loss rate continues to decay. Nevertheless, for the purposes of this study this further decay will be neglected and the terminal mass loss rate is assumed to be reached at 10 minutes from the onset of exposure. The average and terminal mass loss rates depend on the external heat flux with higher heat fluxes resulting in higher mass loss rates.

Fig. 2. Mass loss rate of timber exposed to external heat fluxes.

Figure 2b shows the mass loss rate and the associated heat flux values for each test. For each heat flux value, the peak (upper bound) and average steady-state (terminal) mass loss rate is included to show the upper and lower bounds for the test. Values above or below the range are not physically possible for the test configuration and parameters. The peak values occurred just after ignition while the average steady-state values were recorded just after 10 min of burning. The critical mass loss rate for flame extinction was measured as  $3.7 \pm 0.2 \text{ g/m}^2\text{s}$  while the critical heat flux was  $45 \pm 1 \text{ kW/m}^2$ .

Steady-state burning occurred after approximately 10 min (as evidenced by the small scale tests shown in Fig. 2a); debonding of CLT started to occur 30 min after ignition (as evidence by Fig. 3). It was therefore concluded the target burning time for the large-scale compartment after the ignition of the CLT (or flashover) should be between 10 and 30 min.

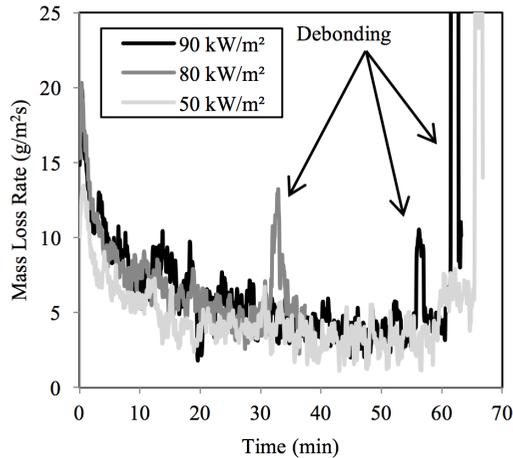
Debonding can occur in CLT [8] and is characterized by large peaks in the mass loss rate data. The large peaks occur when a significant portion of either the char layer or the timber plies fall off – reducing the insulation and exposing the virgin timber to higher heat fluxes. The mass loss rate remains higher than steady-state values until the char layer increases to sufficient depth to reduce the heat flux delivered to the pyrolysis front. Debonding occurred in several of the tests described above. The resulting peaks in mass loss rate can be seen in Fig. 3.

Fig. 3. Mass loss rate over time – debonding events are annotated.

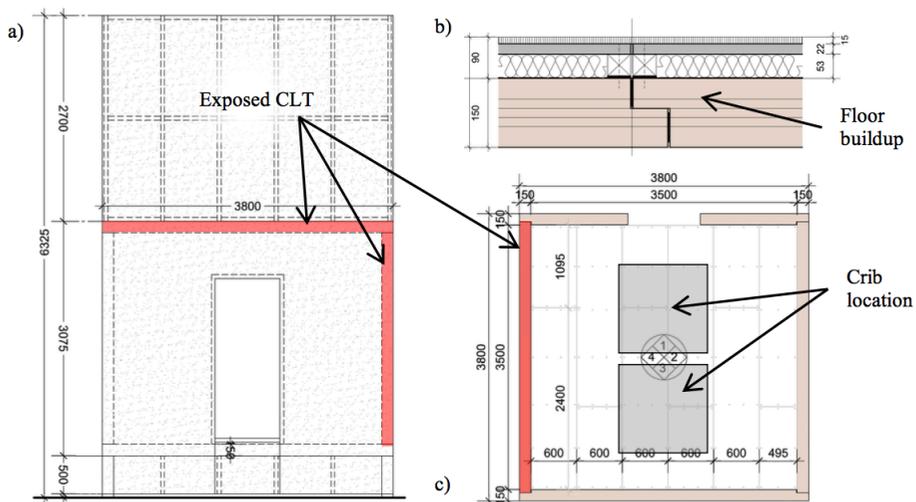
The geometry of the compartment (Fig. 4) was based on the dimensions of a living room in the project described above. To introduce a level of standardization with other compartment fire testing, the aspect ratio of the plan was adjusted to a 1:1 ratio. The ceiling height was not adjusted. This resulted in a base build compartment geometry of internal dimensions 3.5×3.5×2.7 m. An opening was provided based on typical door dimension (0.85×2.1 m). To meet the structural requirements for the project, each element of CLT was 150 mm thick, comprised of five lamellae with a buildup of 45×20×20×20×45 mm (this was the same stock of CLT that was used for the small scale testing described above). The compartment was raised 500 mm above ground level to facilitate access beneath the compartment.

An internal floor buildup was developed that met the project's acoustic requirements. This consisted of a layer of acoustic rubber; 50 mm mineral wool insulation; 22 mm fiber cement floor panels. In any finished apartment there would also be a surface finish (e.g. tiles, or carpet). 50×50 mm wooden battens at 500 mm centers were provided in the insulation layer. Where the CLT walls were provided with non-combustible linings, this was comprised of 2×13 mm Knauf FireShield plasterboard liners independently secured at 200 mm spacing. The Knauf FireShield is a commercially available product that is frequently used in Australia for fire protection; product datasheets indicate that the core is comprised of calcium sulphate dehydrate with small quantities of glass fibre and vermiculite. This boarding solution was a standard fixing applied to a non-standard (i.e. CLT) substrate. The internal wall linings reduced the overall compartment dimensions commensurate to their thickness.

Fig. 4. Drawings of a) the front of the compartment; b) the compartment floor buildup; c) compartment plan view and crib location.

- The fuel load and configuration were chosen such that they would be sufficient to induce flashover – two wood cribs were provided with a total of 80 kg of fuel and centrally located in the room (indicated on Fig. 4);

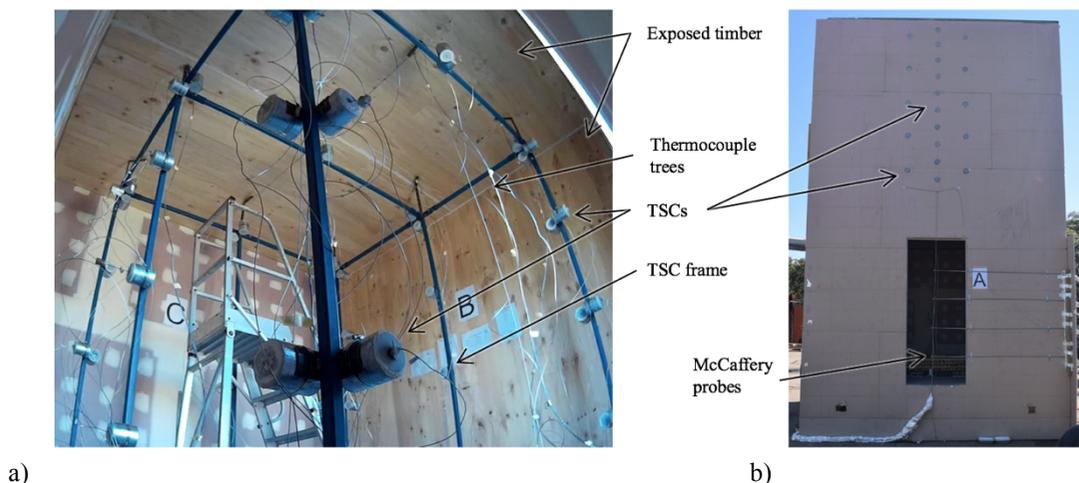
- The opening of the compartment was provided with a single thermocouple tree (comprised of eight evenly spaced thermocouples) and four evenly spaced bidirectional McCaffrey probes [11] (shown in Fig. 5b).

In addition, 3D laser scanning and compartment pressure testing was carried out before and after the test. Three cameras were located to record the behavior of the external plume. The upper facade was instrumented with 20 TSCs and 20 associated thermocouples positioned at different heights above the opening (shown in Fig 5b).

Fig. 5. Instrumentation locations (internal and external).

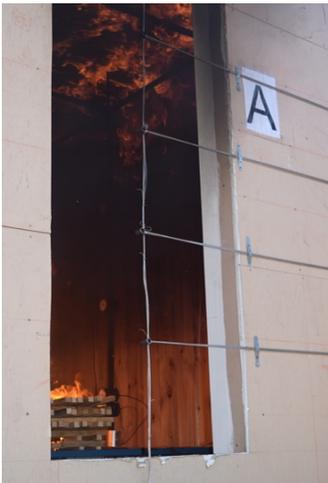
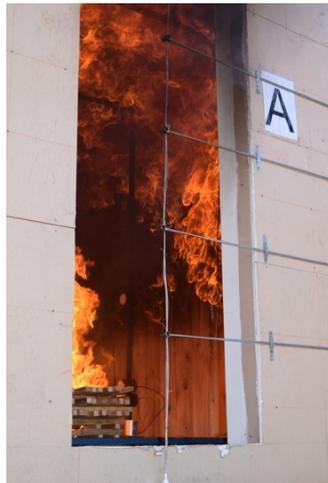
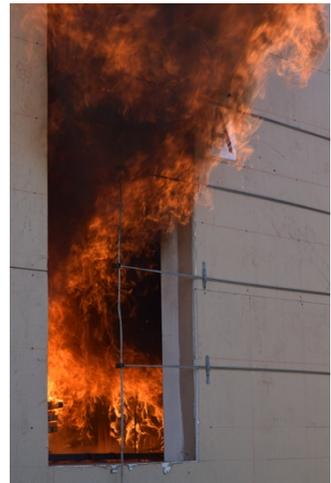
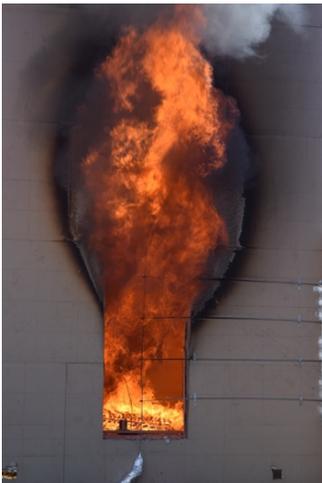
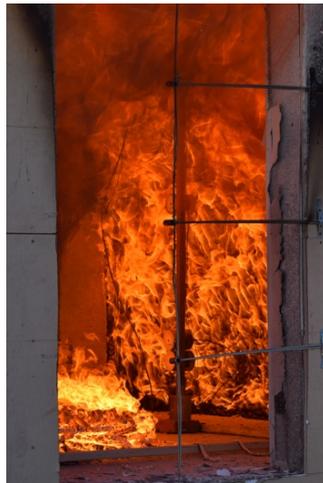
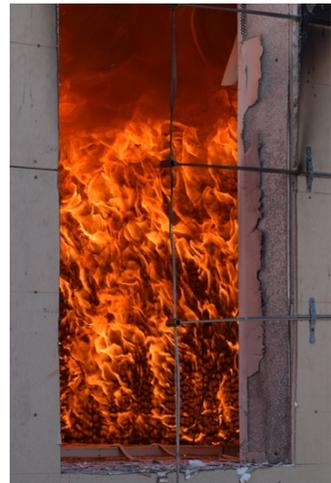
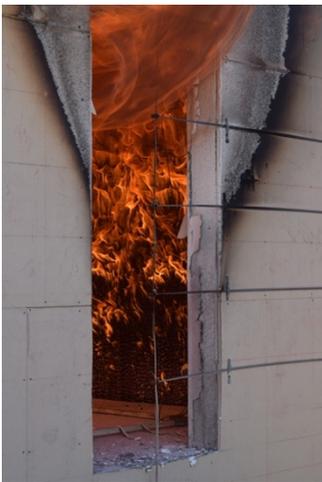
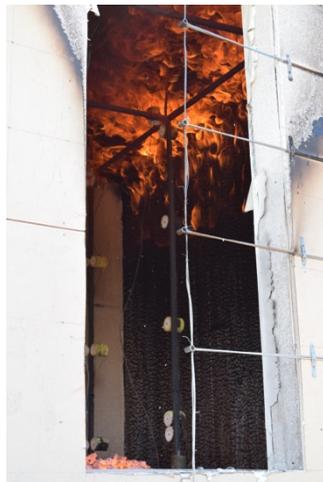
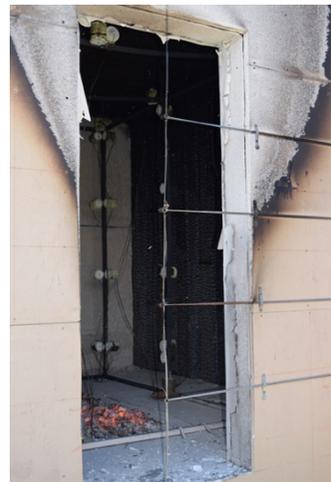
Figure 6 shows images from several notable features of the test (and the time after ignition at which the images were captured) specifically:

- Ignition of the ceiling at approximately 12 min and 14 s;
- Rapid spread of flame down the exposed CLT wall at 12 min 24 s;
- Flaming reaching the base of the CLT wall at 12 min 33 s;
- Fully involved compartment and associated plume at 19 min 58 s (note that this image is illustrative of the conditions throughout the duration of the fully involved fire);
- Visibly flaming CLT wall at 20 min 13 s;
- Notable reduction in flame length at the base of the CLT wall at 21 min and 42 s;
- Very significant reduction in flaming at the base of the CLT wall at 23 min and 22 s;
- Localization of flames to the top of the CLT wall and ceiling at 27 min 15 s; and
- Extinct CLT elements at 30 min 36 s.

The visual observations indicate that all fire protection remained in place, and that self-extinction of the compartment occurred, and that this occurred during the decay phase of the wood cribs. The extinction of the CLT panels was notable because, initially, the burning at the base of the CLT wall became less vigorous – with the flames reducing in length until flameout occurred. Over the course of 4.5 min, this process occurred across the full height of the wall. Once the wall ceased flaming, the CLT ceiling ceased flaming immediately. It was also notable from visual observations that during the progression of the self-extinction, extinction at the left side of the ceiling occurred, while flaming continued on the CLT wall i.e. there was uneven distribution of flaming at the ceiling – with more flaming above the CLT wall. It was observed that the maximum char depth (excluding local imperfections) was approximately 20 mm.

Fig. 6 Selection of images from test.

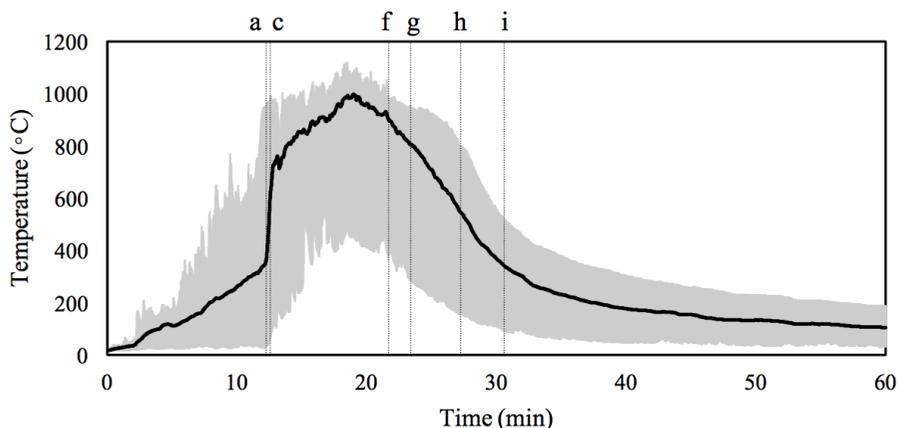
The gas phase thermocouple data were recorded with relatively high density, and thus it is possible to analyze the temperature data as a function of space and time. For simplicity, Fig. 7 illustrates the overall temperatures in the compartment. The time associated with some of the observations illustrated in Fig. 6 are overlaid onto the plot.

Figure 7 shows the mean temperature in the compartment, the maximum temperature, and the minimum temperature recorded by any thermocouple at each sampling time. It was found that the highest temperature at any time in the compartment was 1125°C, the maximum average temperature was 1000°C, and the maximum lowest temperature was 706°C. It should be noted that the lowest temperature was consistently recorded at the base of the thermocouple tree adjacent to the opening. Correction of radiation errors [13] has not been completed at this stage.

The data indicated that at the average temperature in the compartment dropped below 100°C after 63 min, and that the maximum temperature dropped below 50°C after 126 min. When the test was terminated at 5 h and 32 min, the average temperature in the compartment was 26°C.

Fig. 7. Gas phase thermocouple data for the first 60 min after ignition. Plot shows mean temperature for all sensors, minimum temperature recorded anywhere in the compartment, and maximum temperature recorded anywhere in the compartment. Letters indicate observations as per Fig. 6.

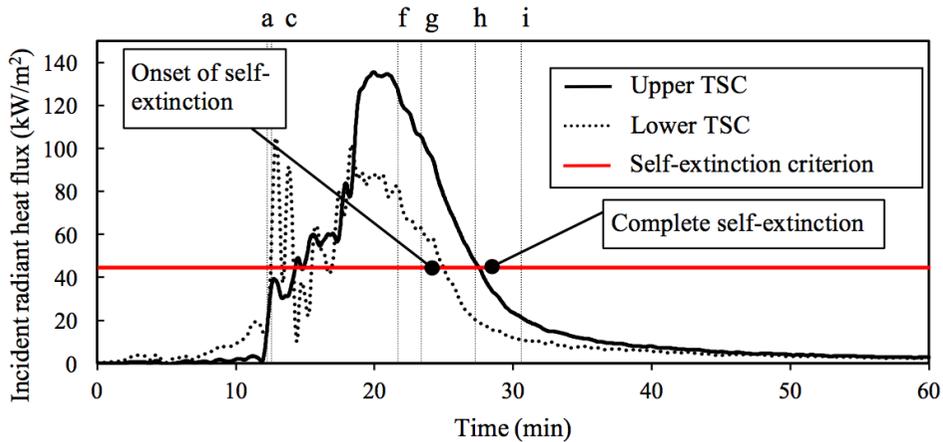
Figure 8 shows the heat flux data from TSCs towards the top and base of the exposed CLT wall throughout the test. In addition, the plot shows the critical heat flux for self-extinction derived from the small scale test. The events illustrated in Fig. 6 are also plotted on the diagram, and the visually observed self-extinction events are annotated on the plot.

Fig. 8. Heat flux readings during the first 60 min after ignition. Plot shows an upper and lower TSC associated with the CLT wall. Letters indicate observations as per Fig. 6.

Although a number of the TSCs were damaged during the fire, it was possible to extract data for the exposed timber wall. A comparison between data from the large-scale test, and the critical heat flux for self-extinction of Radiata Pine shows that when the maximum heat flux on the wall dropped below  $45 \text{ kW/m}^2$ , self-extinction occurred within 30 s. This result aligns well with the data from the small scale testing which suggested that self-extinction would occur when the incident heat flux was less than  $45 \text{ kW/m}^2$ .

However, although the value from the top of the wall aligned well with the critical heat flux for self-extinction, it was found that at the onset of self-extinction (from visual observations), the heat flux readings at the base of the wall were substantially in excess of  $45 \text{ kW/m}^2$  (approximately  $55 \text{ kW/m}^2$ ).

It should be noted that there are several possible sources or error associated with the measurements obtained from the TSCs. For example, previous work [9] has found that a slight overestimation of the heat flux can be expected during the cooling phase (overestimation was found to be  $9 \text{ kW/m}^2$  for the devices in [9]).
