NORCIA AND AMATRICE: A COMPARISON OF THE TWO HISTORIC CENTRES' PERFORMANCE UNDER THE CENTRAL ITALY EARTHQUAKE SEQUENCE

V. Putrino¹, D. D'Ayala²

Abstract

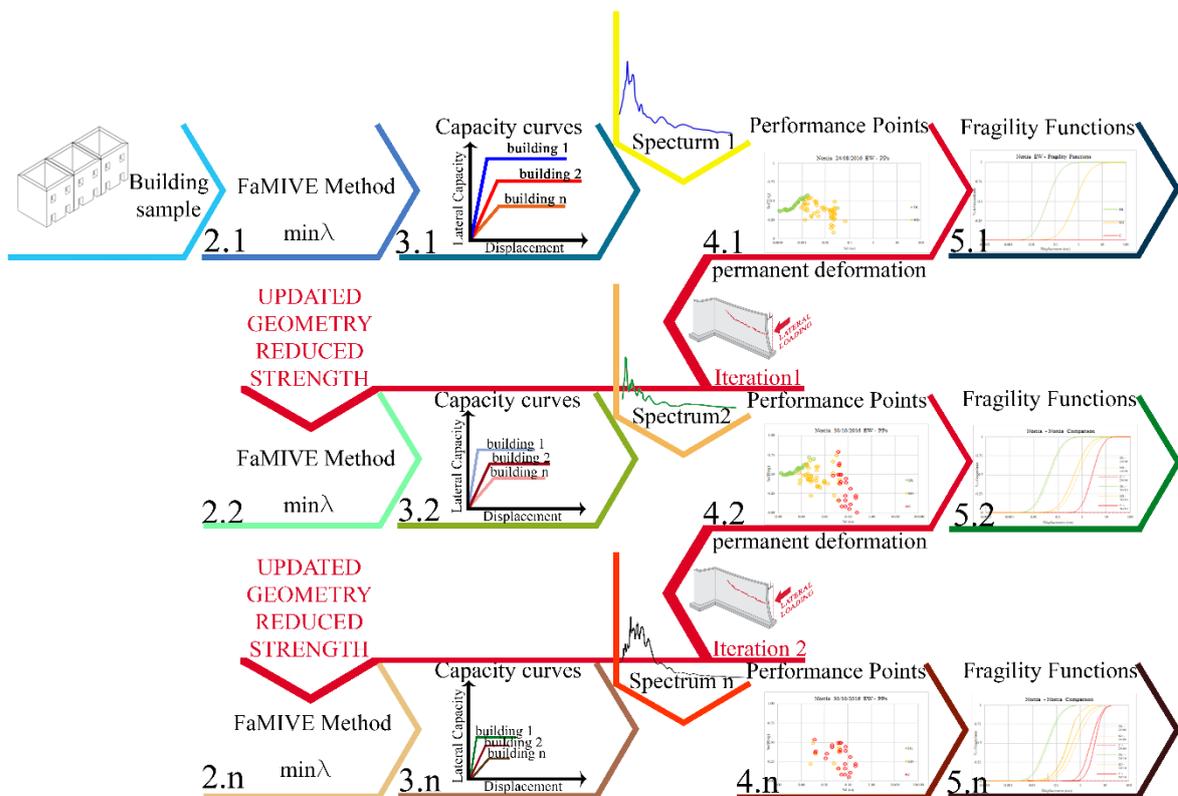
The proposed procedure to assess the cumulative damage of existing masonry structures exposed to repeated shakings can be summarized as shown in Figure 1.

Figure 1: Proposed methodology to assess the cumulative damage to masonry structures

Step (1) consists in the definition of a representative building sample, able to exhaustively represent the variety of building typologies of the case study under consideration. Section 3 explain how the buildings are chosen in the two cases presently analysed.

Step (2) is to choose an appropriate analytical assessment procedure able to evaluate the seismic vulnerability of the two samples. The procedure used in this work is the macro-element modelling approach FaMIVE [17], which allows to analyse a large number of buildings in a short time, producing simplified capacity curves based on ultimate lateral strength capacity and elastic and ultimate displacement. Having chosen suitable strong motion records, a capacity spectrum approach, such as N2 [18], can then be applied to determine the performance point for each capacity curve, representative of the response of each façade [19].

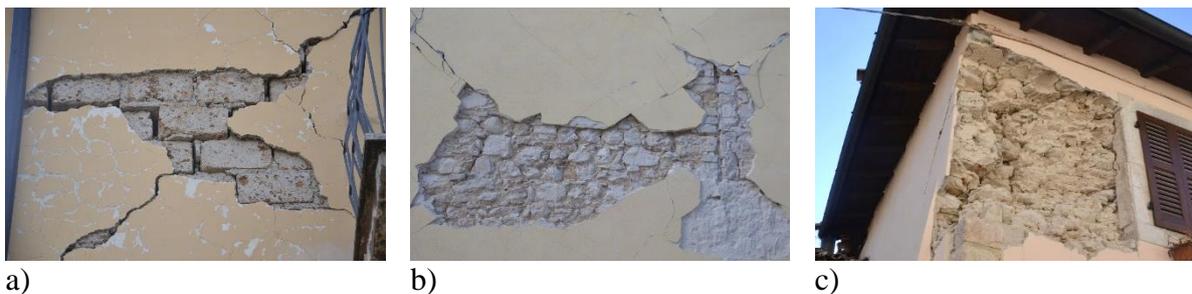
Given the general difference in fabric and mortar quality between the two towns’ buildings, the upper bound values of E (Young Modulus) were used to identify the characteristics of Norcia’s masonry typologies, while the lower bound were used to identify the ones of Amatrice. In a similar manner the values of cohesion τ_0 have been assigned. Figure 2 a) b) and c) show examples of masonry observed in Norcia, representative of the three typologies.

Figure 2: Details of the M1, M2 and M3 masonry types in Norcia

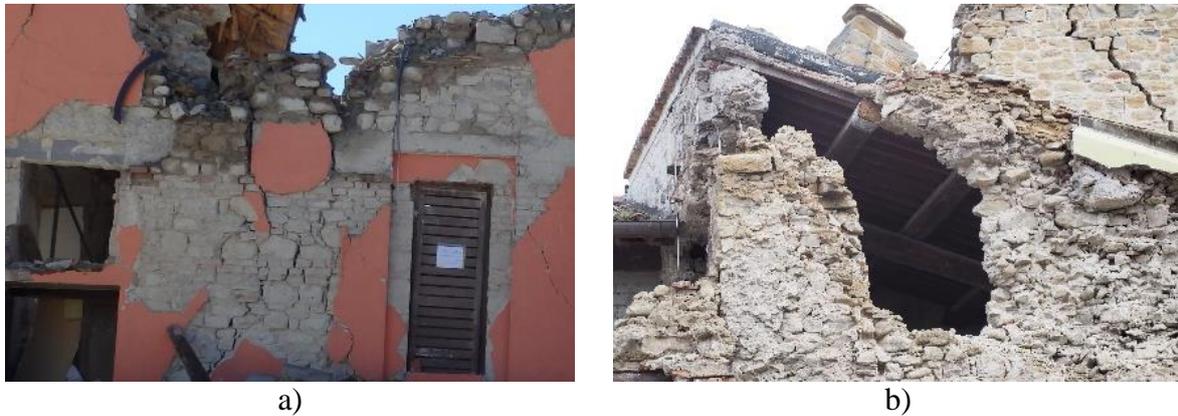
Owing to the widespread level of damage in Amatrice, it was possible to observe the inner layers and the lack of connection in the thickness of the walls (Figure 3a)). The majority of buildings were made of poorly dressed stones, mostly irregular and characterized by bad quality of mortar as shown in Figure 3 b). Very often, the walls were covered with thick layers of wired mesh and concrete jacketing [7], that would help bond the units together. Table 2 summarizes the key parameters characterizing the two building stocks.

Figure 3: Details of the M2 and M3 masonry types in Amatrice

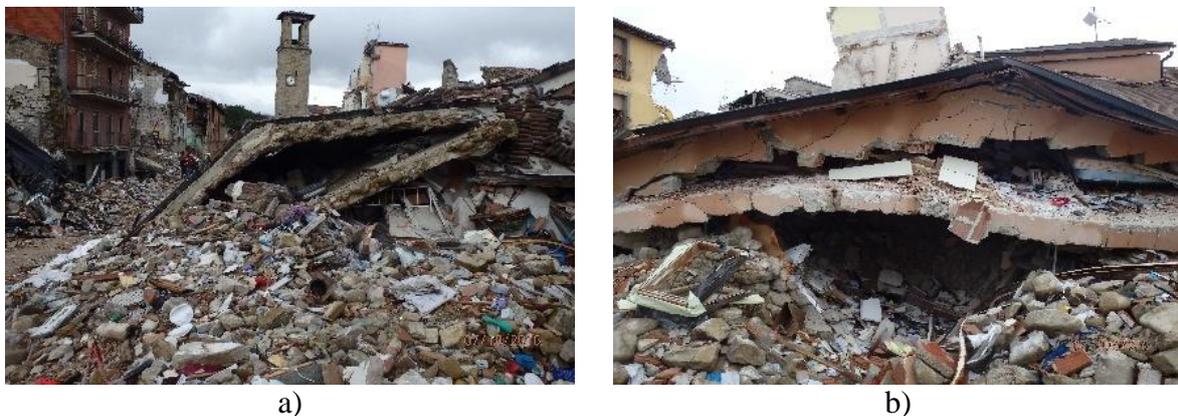
Given the limited number of collapsed buildings in Norcia, the inspection of the horizontal structures was only partially possible, therefore the information regarding this specific aspect of the building stocks' characterization refers to [23]. The three main flooring typologies encountered were wooden floors (WF) made of traditional joists, barrel vaults (VF) and reinforced wooden floors (RWF). In the case of Amatrice, additional presence of concrete floor slabs (CF) is added to the list, as these have been observed on site and reported in Figure 4 a) and b).

Figure 4: Details of the concrete slabs observed in Corso Umberto I – Amatrice

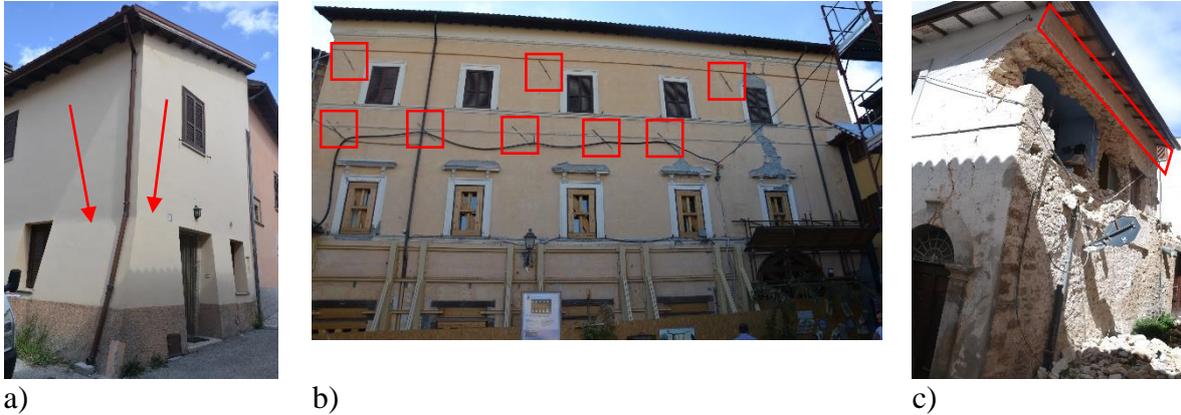
For the roof structures, the more traditional case of timber joists with screed and tiles (R1) was found only in 20% of the sample, while the remaining 80% showed to have roofs made with concrete slabs (R2) [23]. These typologies were implemented following the post-1979 building prescriptions listed within the Regional Law no.34 1981, enacted after the Irpinia earthquake [6]. While on site, it was possible to observe the lack of connection between these elements and the underneath masonry walls as shown in Figure 5 a), taken in Amatrice and

Figure b) taken in Norcia. With reference to the restraining elements, more traditional provisions such as buttresses (B) shown in Figure 5 a), ties (T) in Figure 5 b) were observed in Norcia, together with a number of buildings showing concrete ring beams (RB) (Figure 5 c)).

Figure 5: Restraining elements observed in Norcia: a) buttresses, b) ties o c) concrete ring beams

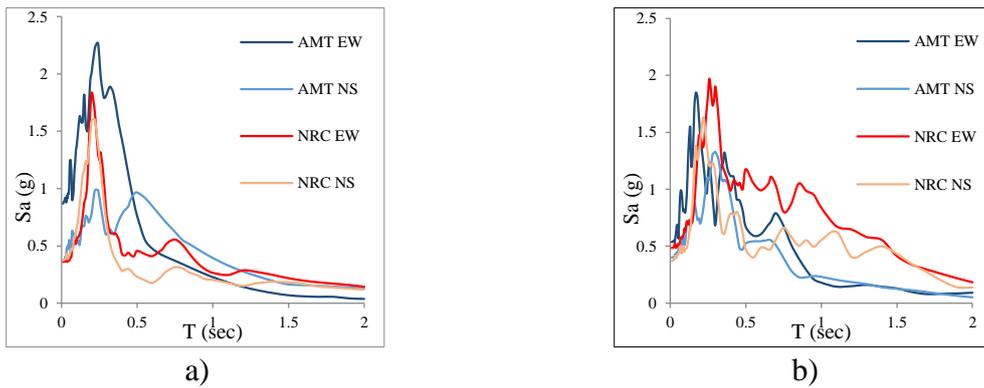
Acceleration response spectra are extracted from the ESM database [25] and shown in Figure 6 a) and 6 b) respectively showing the 24th of August and the 30th of October events recorded at both AMT and NRC stations.

Figure 6: Spectra of the 24/10/2016 event (a) and 30/10/2016 event (b) recorded at AMT and NRC stations

The August event (a) has the largest ever peak ground acceleration recorded on Italian soil at the Amatrice instrument. It is also characterized by large amplifications in the 0.1-0.5 s period range, with a large drop for larger values. On the contrary, the event of the 30th of October (b) shows amplification in the medium period range, with accelerations exceeding 1.0 g for periods around 1.0, which can help explaining the collapse of all the churches in Norcia [1][4][7].

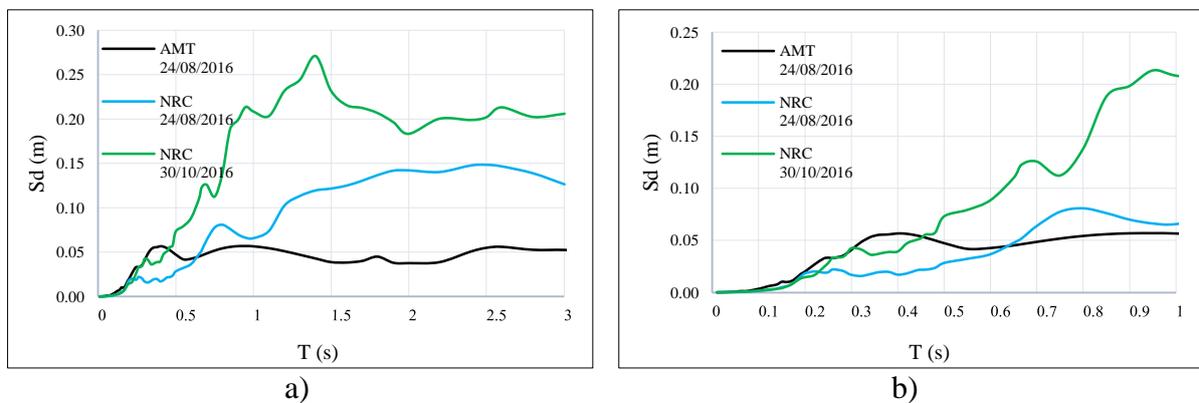
Very relevant to the understanding of the building stock performance in the two towns is the demand in terms of spectral displacement imposed by the two seismic shocks considered as shown in Figure 7 a). For natural period lower than 0.5 s, the Amatrice record of the first event shows values of displacement demand up to 60 mm, while the demand recorded by the NRC instrument is in the range of 20 mm.

Figure 7: Seismic demand in terms of spectral displacement for: a) the 24/08/2016 event with records from AMT and NRC station and the 30/10/2016 event with record from NRC station and b) close up of the same records in the range of $0 < T_1 < 1$ s

A close up in the range of $0 < T1 < 1$ s [reported in Figure 7b)], which contains 97% of the two building samples natural periods, shows that for values of up to 0.5 s (85% of the building samples), the displacement demand of the 24th August event in Amatrice was substantially greater than the one in Norcia, while the 30/10/2016 event imposed on the Norcia building stock a demand twice as large as the one in August.

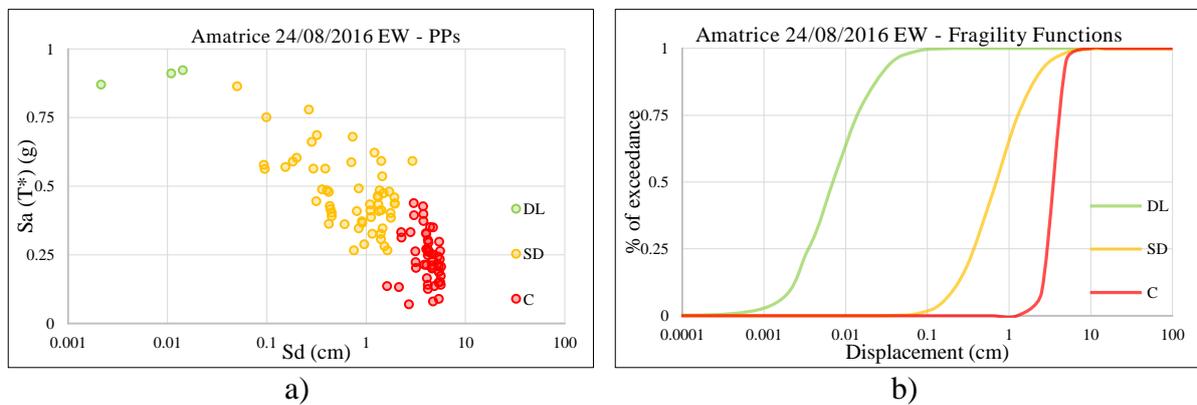
Figure 8 a) shows the cloud of performance points representative of all the facades of the A_sample subjected to the 24th August 2016 event, and Figure 8 b) the corresponding fragility functions.

Figure 8: Performance points (a) and Fragility Functions (b) for Amatrice after the 24/08/2016 event

the much narrower range of strength demand for the N_sample (0.08 g to 0.57 g) when compared to the A_sample (0.07 g to 0.92g) for a similar range of displacement demand. It should be also noted that the performance points for collapse for A_sample are confined within a narrow range corresponding to the limit ultimate displacement of their capacity curves, which in turn is a function of the masonry units' size and masonry quality. No collapse was computed for the N_sample.

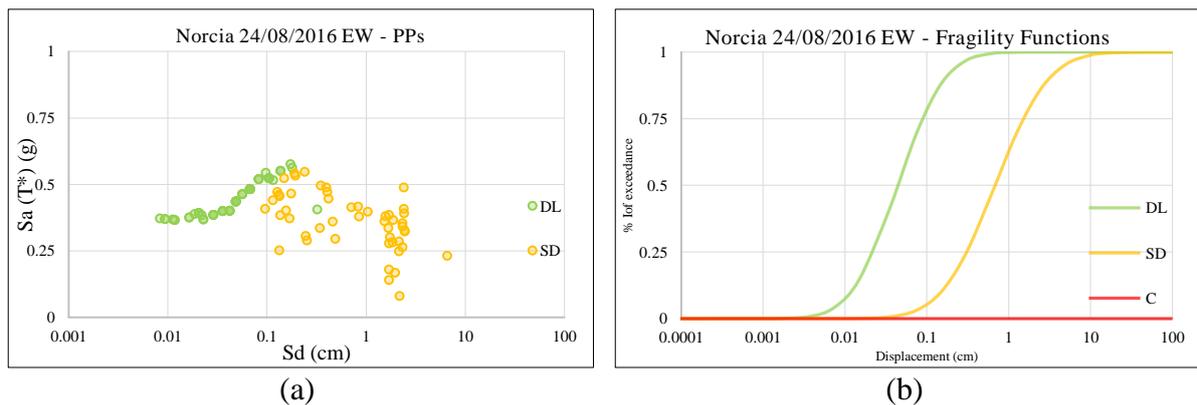
Figure 9: Performance points (a) and Fragility Functions (b) for Norcia after the 24/08/2016 event

Figure 9 a) and b) show the performance of N_sample and related fragility functions for the same event. shows that the distribution of damage limitation performance points for A-sample is confined to very modest lateral displacement, when compared with the N_sample. This is due to the substantially greater strong ground motion experienced, but also to the stiffer and lower strength capacity of the A_sample with respect to the N_sample. This is confirmed by

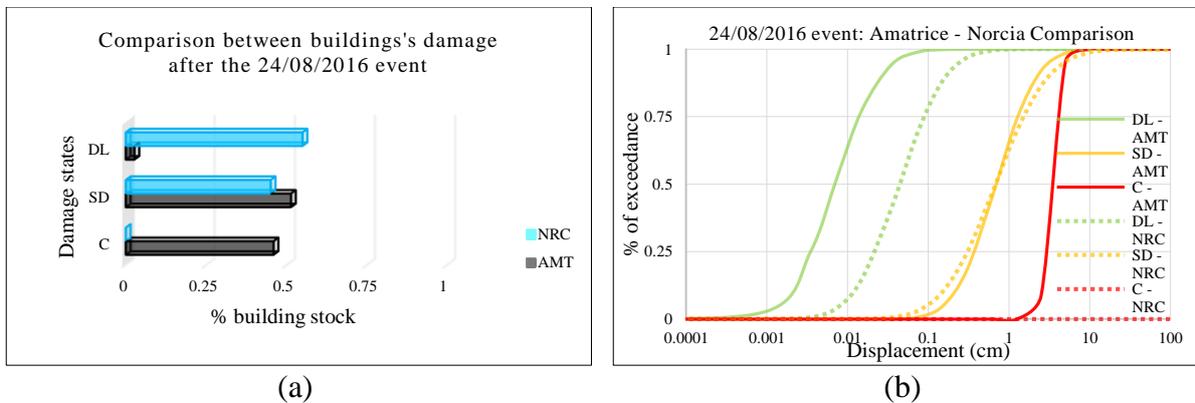
Figure 10 a) shows the proportions of buildings in each damage state after the August event in each of the two town, providing a good correspondence to the empirical onsite observations. Figure 10 b) compares the corresponding fragility functions. While the structural damage condition is not substantially different for the two samples, the larger proportion of buildings with buttresses and ties, coupled with the lower level of acceleration and displacement demand for the lower period range, ensure a much better performance of the N_sample with respect to the damage limitation threshold.

Figure 10: Comparison between the % of building stocks' damage (a) and the two sets of fragility functions (b) for the 24/08/2016 event.

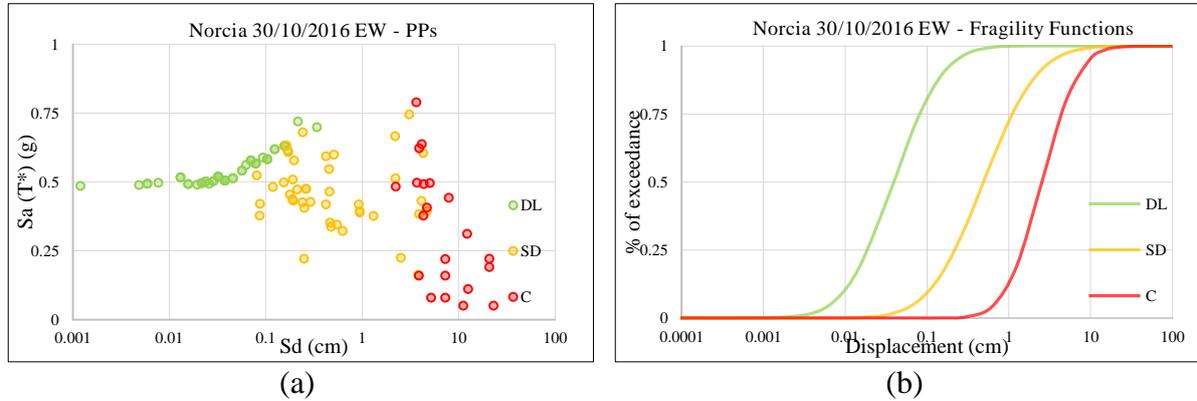
Table 4 shows the values of mean (θ) and standard deviation (β) of both samples after the August 2016 event, and for the N_sample after the 30th October event, for each damage state. Figure 11 a) and 11 b) show the condition of the N_sample after the 30th October event. The performance points and fragility curves presented are obtained by running a second iteration to the N_sample of Figure 9 a) as described in section 2.

Notwithstanding the clear increase in terms of lateral spectral acceleration demand $S_a(T^*)$, which now reaches 0.75 g, there is still a significant proportion of buildings remaining within

the DL state. However, the distribution of performance points in SD is much sparser, and almost 20% of the buildings enter the collapse state. The cloud of performance points has a general shift towards the right, indicating that the displacement demand has increased: some of the points reach collapse for 20 cm displacement against the 6.5 cm recorded after the August event.

Figure 11: Performance points (a) and Fragility Functions (b) for Norcia after the 30/10/2016 event

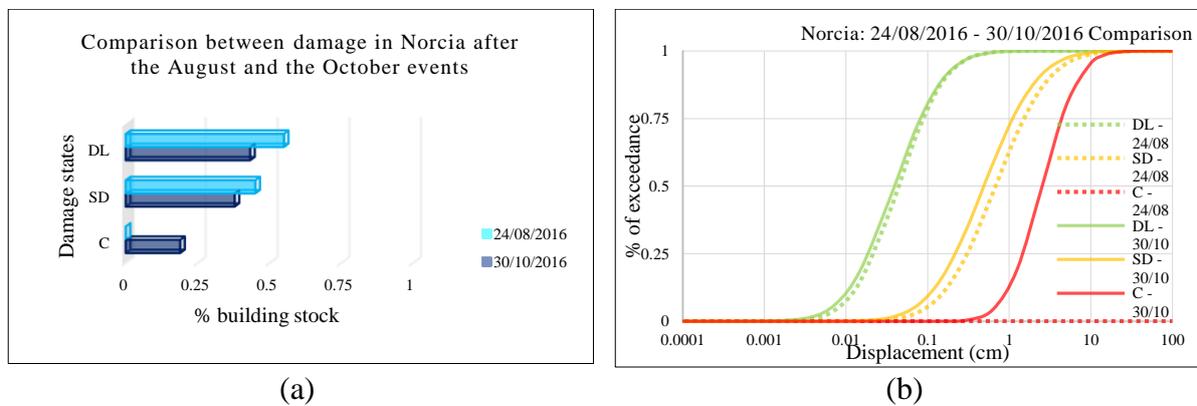
Figure 12 a) and b) show the comparison of the status of N_{sample} after the first and second event, respectively. Beside the evident presence of collapses, the fragility functions for lesser damage states are shifted towards the left, as the residual values of the damage thresholds for each damage state is smaller than in the buildings exposed to the first event, and they have greater variability. Such shift is evident in the reduction of the median (θ) values and increase of the standard deviation (β) of the N_{sample} for the two events, summarised in Table 4.

Figure 12: Comparison between percentages of Norcia building stock's damage between the two seismic events (a) and the two sets of fragility functions (b) for the 24/08/2016 and the 30/10/2016 events.
