Towards generation of as-damaged BIM models using laser-scanning and as-built BIM: First estimate of as-damaged locations of reinforced concrete frame members in masonry infill structures

Reem Zeibak-Shini [†], Rafael Sacks, Ling Ma, Sagi Filin

Faculty of Civil and Environmental Engineering, Technion – IIT, Israel

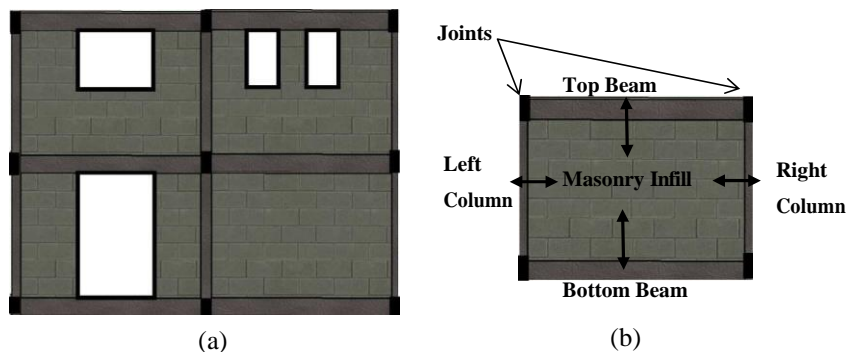
Fig. 2. (a) RC framed buildings with URM infills. (b) A structural cell within the building frame and its members' topological configuration.

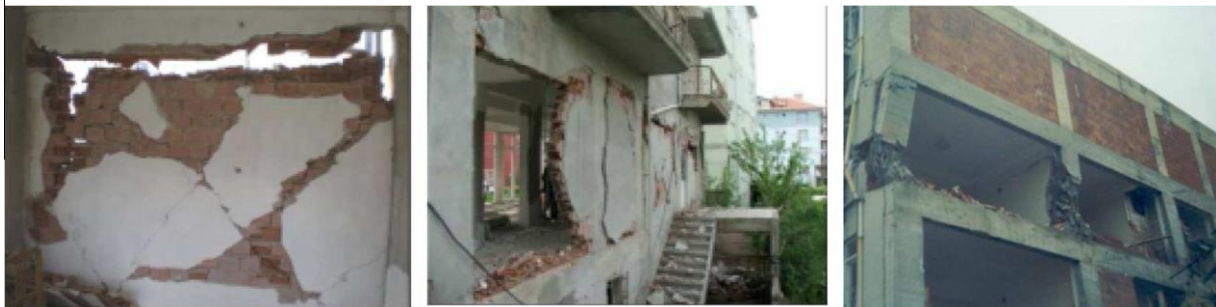
Fig. 3. Typical out-of-plane failure of URM infills in RC framed building, showing top-down collapse creating new voids that reveal the underside of the RC beams.

After an earthquake, the masonry may collapse out-of-plane partially or completely, creating new voids or enlarging existing voids. In the majority of cases, the top edges of new and/or pre-existing voids align with the bottom face of the top beam, because masonry walls require beams or lintels above openings and because masonry infills always collapse downwards. The beams and columns may be bent or sheared, but in most cases the topological relationships between the columns and the URM/void space remains unchanged. Fig. 3 shows some typical examples of the kinds of damage that are considered.

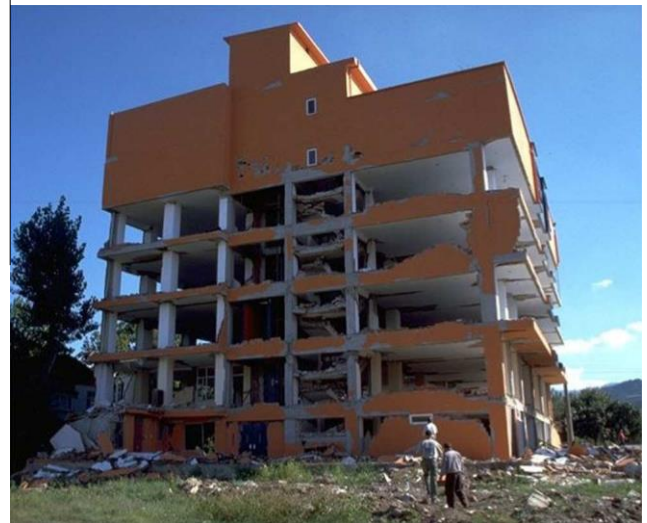
Fig. 5. A photograph of a façade of the Kocaeli residential building [45].

The first case study is a residential building damaged in a magnitude 7.6 earthquake in Kocaeli, Turkey, on August 17th 1999. The information regarding this building before and after the earthquake was obtained from the EERI database [45]. To begin with, a complete ‘as-built’ BIM model was prepared in Tekla Structures 20.0 using the 2D drawings and other information regarding the building components available in the EERI website, and exported as an IFC file.

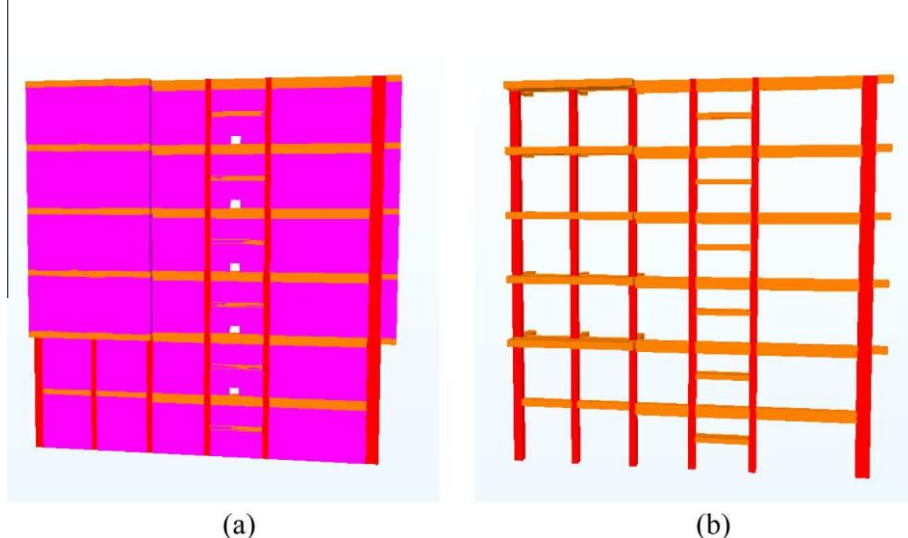
Fig. 7. The as-built façade: (a) RC structural frame model with URM infills; (b) RC structural frame without infills.

the same scanner viewport, all components visible to the scanner were then extracted from the as-built BIM IFC file (Fig. 7a). Next, the beams and columns that form the structural frame were filtered from that file (Fig. 7b) and the floors, bays and structural grid cells were identified and labeled. The dimensions of the beams and columns and of the grid itself were also extracted from the as-built BIM.

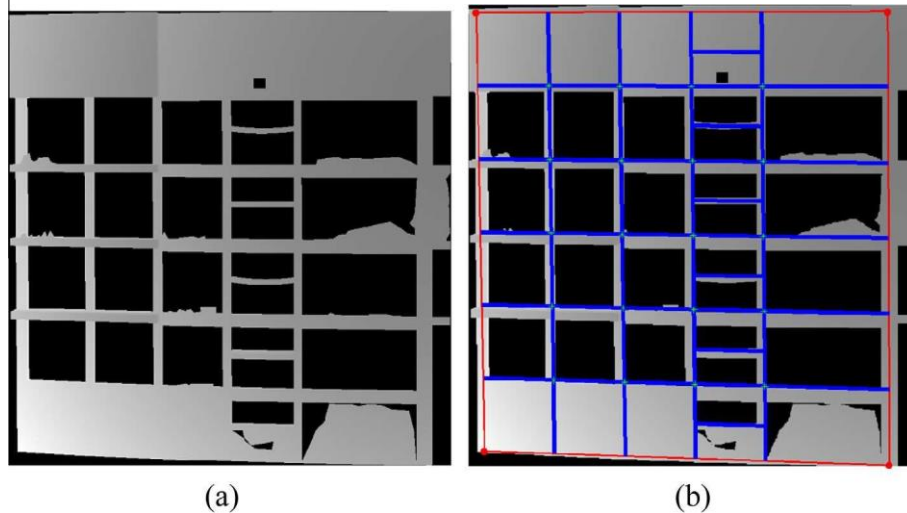
Fig. 8. (a) Range image of the 'as-damaged' scan; (b) first pass mapping of the as-built structural grid (blue) onto the as-damaged range image. (For interpretation of the references to colour in this figure legend, the reader is referred to the web version of this article.)

First, for the sake of efficient data processing, the point cloud is converted into a range image (a significantly more compact data representation) (Fig. 8a). The range image represents the point cloud in a spherical coordinate system rather than the Euclidean system. The first pass attempt to determine the new locations of the beams and columns in the as-damaged state is achieved by proportional scaling and mapping of the as-built grid into the

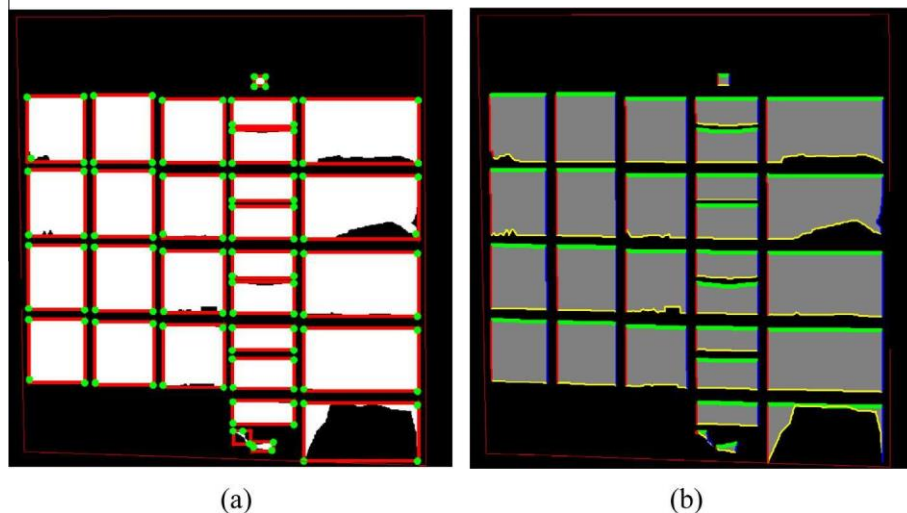
Fig. 9. (a) Bounding box and four corners of the 'as-damaged' voids in the range image. (b) Bottom, top, right and left sides of the voids in yellow, green, blue and red respectively. (For interpretation of the references to colour in this figure legend, the reader is referred to the web version of this article.)

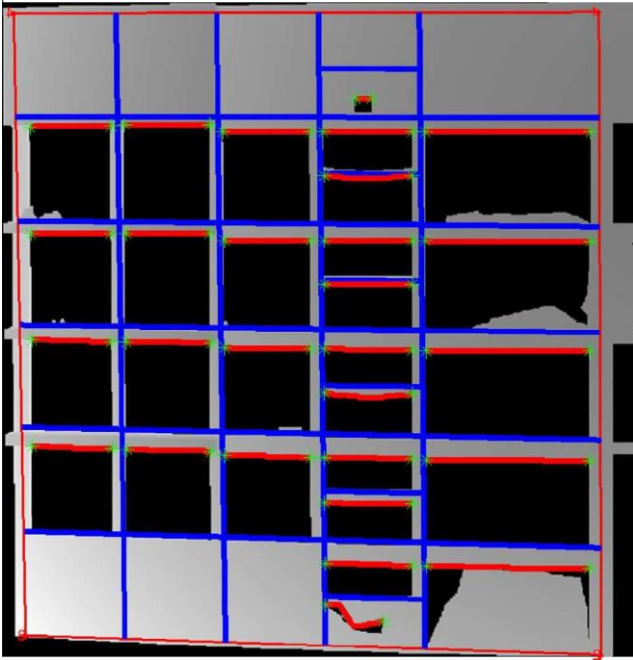
Fig. 11. Identification of voids' top edges in each structural cell.

The new base levels of damaged beams are derived by extending and connecting the top edges of the identified voids belonging to the same cell, as is shown in Fig. 11. Each of the resulting polylines is then shifted upwards by the beam's height (which is known explicitly from the 'as-built' BIM) to determine the top levels of the beams. Where no voids exist in a cell, the polylines of neighboring cells are extended to locate the joints and the beams are assumed to connect those joints. This makes the default assumption (for lack of any information at this stage other than the observation that the masonry infill in the cell is apparently intact) that the earthquake

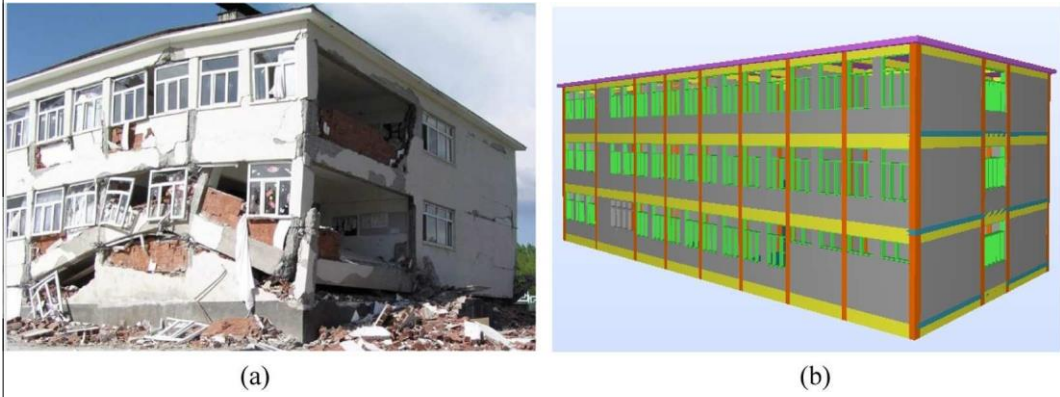
Fig. 13. (a) A photograph of a corner of the damaged Bingol school building [46]; (b) as-built BIM model of the building.

The second case study is a school building damaged in a magnitude 6.4 earthquake in 2003 in Bingol, Turkey, which sustained heavy damage, as can be seen in the photograph shown in Fig. 13a. In addition to the collapse of most of the URM infill walls, a soft story collapse occurred and the first floor of the building pancaked. Many beams and columns were heavily damaged, undergoing translation and rotation and some columns had sheared. The information regarding this building before and after the earthquake was obtained from the EERI database [46]. Fig. 13b shows the BIM model prepared from the drawings.

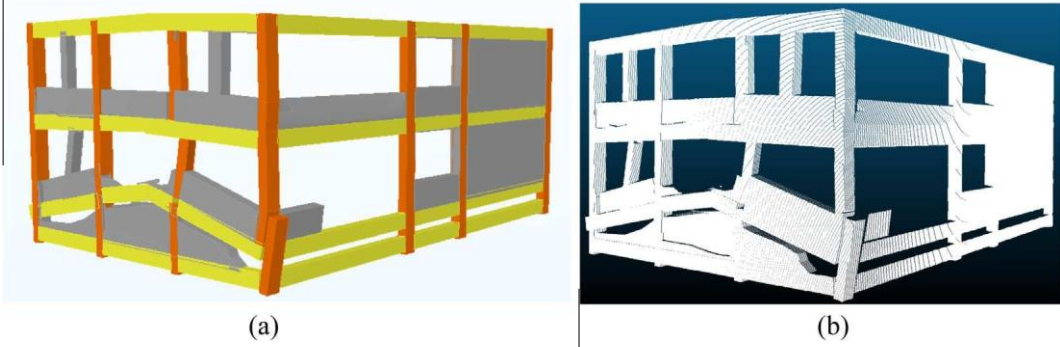
Fig. 14. As-damaged state: (a) user pre-prepared BIM model; (b) scanned point cloud.

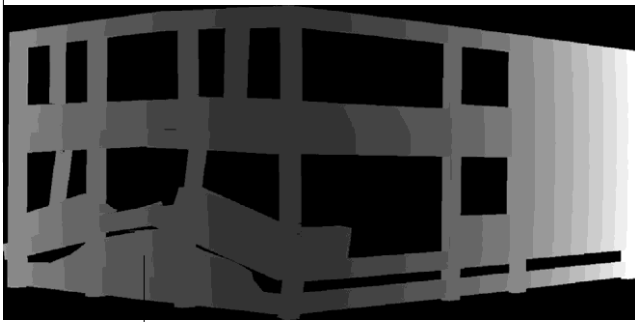
Fig. 15. Range image of the as-damaged scan. Gray scale represents range values – distant points are lighter, darker points are closer to the viewer. Black pixels represent no-data.

The simulated scan was performed with approximately the same point of view as the as-damaged photograph (Fig. 13a), viewing two of the building’s façades in angular resolution of 0.02°. The point cloud contained some 740,000 points. Fig. 15 presents the point cloud in spherical coordinate system as a range image.

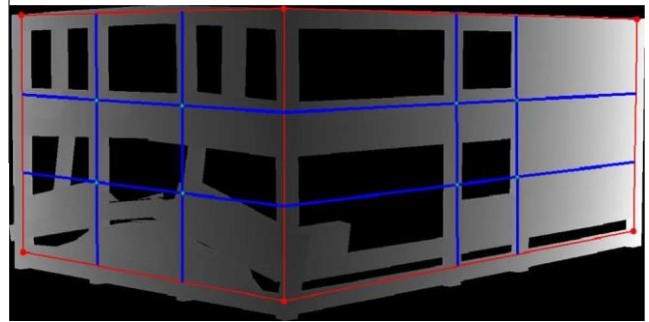
Fig. 17. Initial cells in the 'as-damaged' scan derived by scaling and mapping the 'as-built' grid onto the range image (in blue). (For interpretation of the references to colour in this figure legend, the reader is referred to the web version of this article.)

On the other hand, the overall boundary of the damaged building’s façades can be derived based on the extent of the ‘as-damaged’ scan. Due to the partial collapse of the ground floor in the case study building, the overall height is smaller than it was before the damage. Thus, the ‘as-built’ structural grid is used proportionally to divide the ‘as-damaged’ scan into initial cells, as shown in Fig. 17.

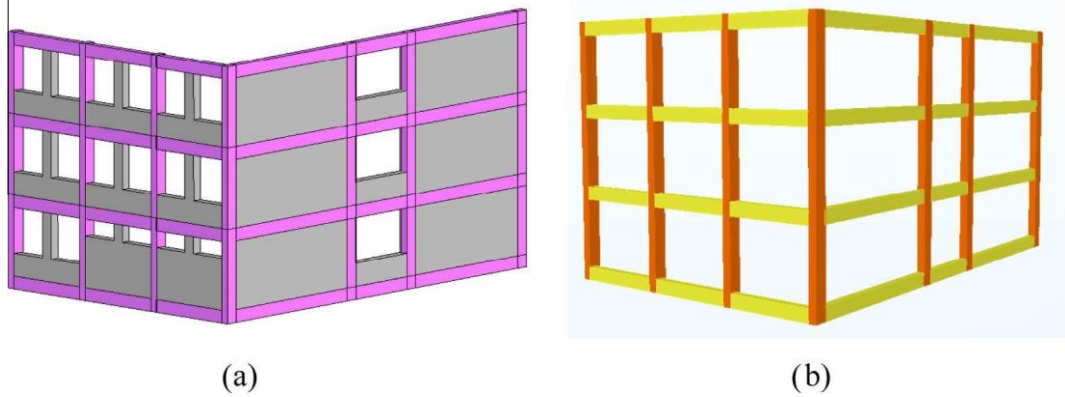
Fig. 16. The 'as-built' model: (a) RC frame with URM infills. (b) RC structural frame with beams and columns only.

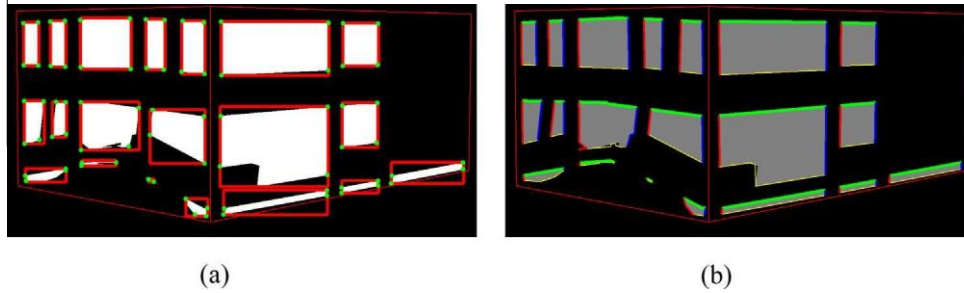
Fig. 18. (a) Bounding boxes and corners of the voids in the range image. (b) Bottom, top, right and left sides of the voids in yellow, green, blue and red respectively. (For interpretation of the references to colour in this figure legend, the reader is referred to the web version of this article.)

voids and their top edges were identified in the range image, as can be seen in Fig. 18.

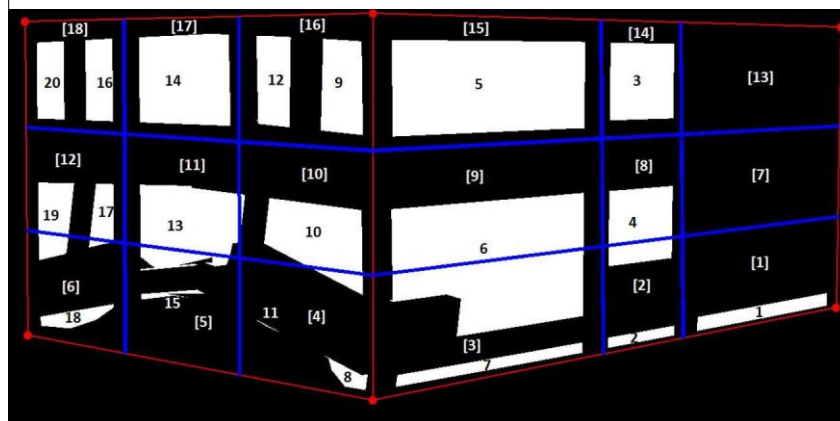
Fig. 19. Void numbering (no brackets) and cell numbering (in brackets).

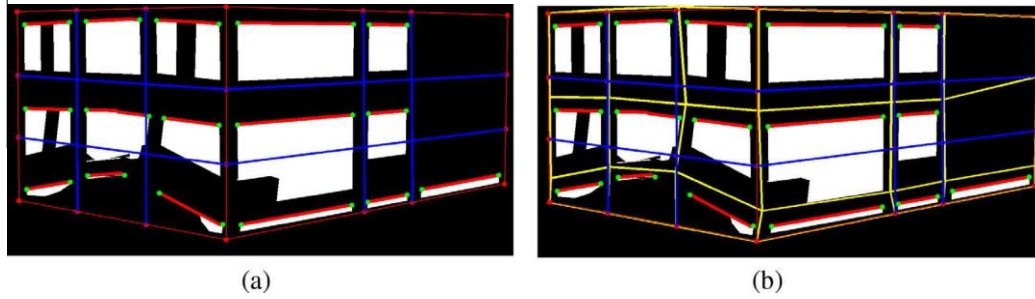
Fig. 20. (a) Identification and linkage of voids' top edges in each structural cell; (b) resulting structural grid (initial skeleton in blue, refined skeleton in yellow). (For interpretation of the references to colour in this figure legend, the reader is referred to the web version of this article.)

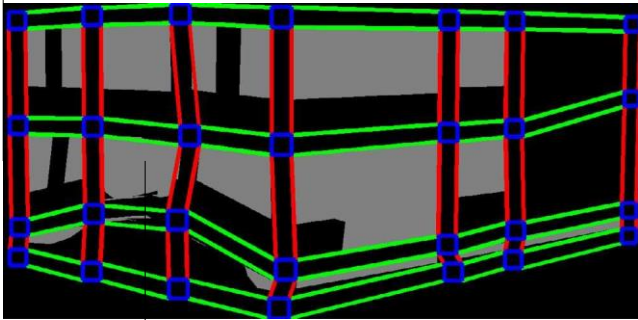
Fig. 21. Reconstructed as-damaged RC frame (beams in green, columns in red). (For interpretation of the references to colour in this figure legend, the reader is referred to the web version of this article.)

As for case 1, the refined beam gridlines represent the estimated top edges of the as-damaged beams, and the column gridlines locate the centerlines of the as-damaged columns. The result is shown in Fig. 21. Finally, as before, the LRF is defined for each gridline, the corresponding members are placed accordingly, and the alphanumeric data is copied.
