# Moving beyond energy, integrating it with Indoor Environment Quality: UK school building case study

NISHESH JAIN<sup>1</sup>, ESFAND BURMAN<sup>1</sup>, CRAIG ROBERTSON<sup>2</sup> DEJAN MUMOVIC<sup>1</sup>, MIKE DAVIES<sup>1</sup>

<sup>1</sup> Institute for Environmental Design and Engineering, University College London

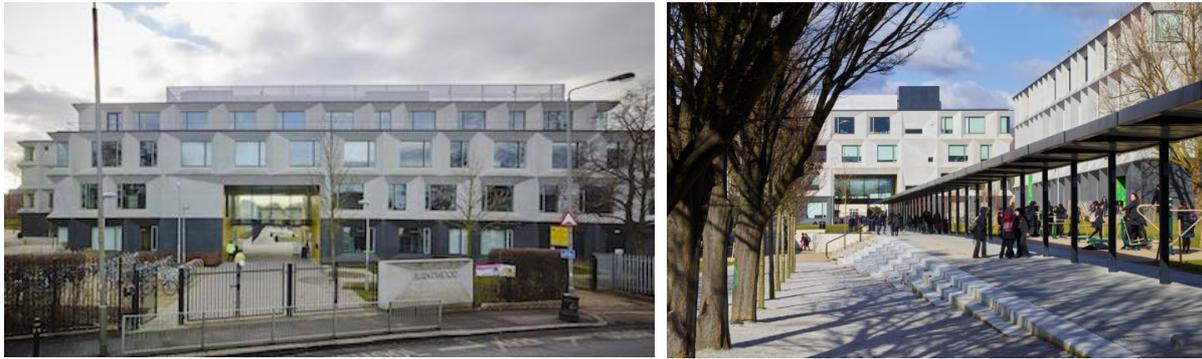
Figure 1: Case study school; (Right) Entrance – West façade, (Left) Central courtyard.

by implementing on-site renewable technologies. To satisfy this, a Biomass boiler utilising solely wood pellets and solar thermal collectors was implemented. Figure 1 shows the school building and Figure 2 shows the campus layout.

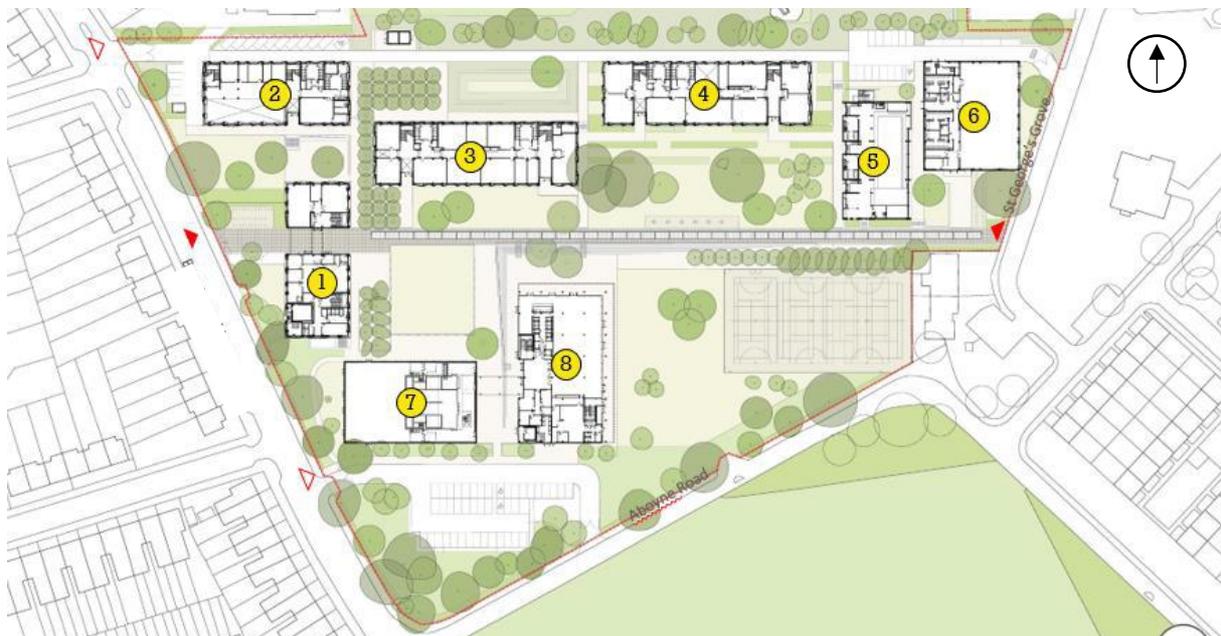
Figure 2: Campus layout

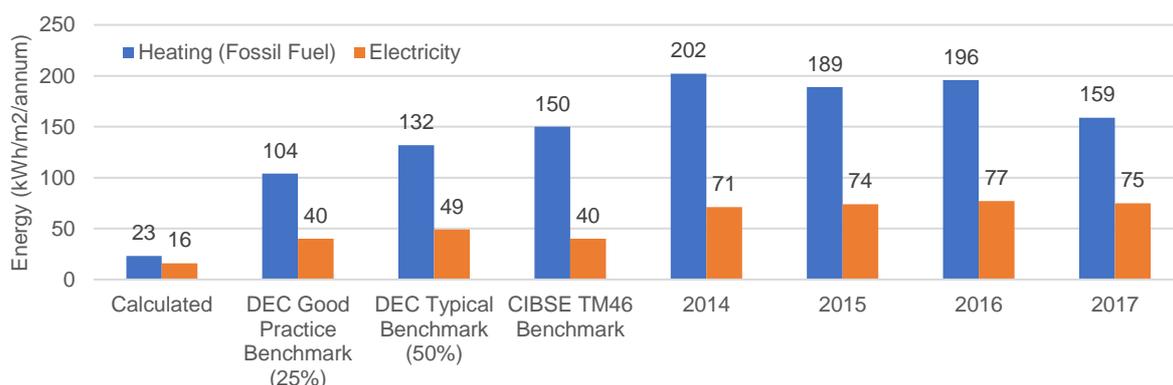
Figure 3 Comparison of actual gas and electricity use of school compared against design estimates and industry benchmarks (kWh/m<sup>2</sup>/annum)

Operational stage electricity and gas use data was available from utility bills for four years (2014-2017). Figure 3 shows the comparison against design estimates (for RIBA Stage D Report); good practice (25<sup>th</sup> percentile) and typical (median) benchmarks as per DEC database [20], and CIBSE TM46 benchmark [21].

It is seen that heating energy use is significantly higher than benchmark buildings – especially for a new build school. Electricity use is also slightly more than benchmark buildings. However, both heating and electricity strikingly much higher than the design estimates. As per the latest display energy certificate, the operational rating of the

school is currently DEC-F, i.e. that the energy used is more than 1.5 times of the typical benchmark school building.

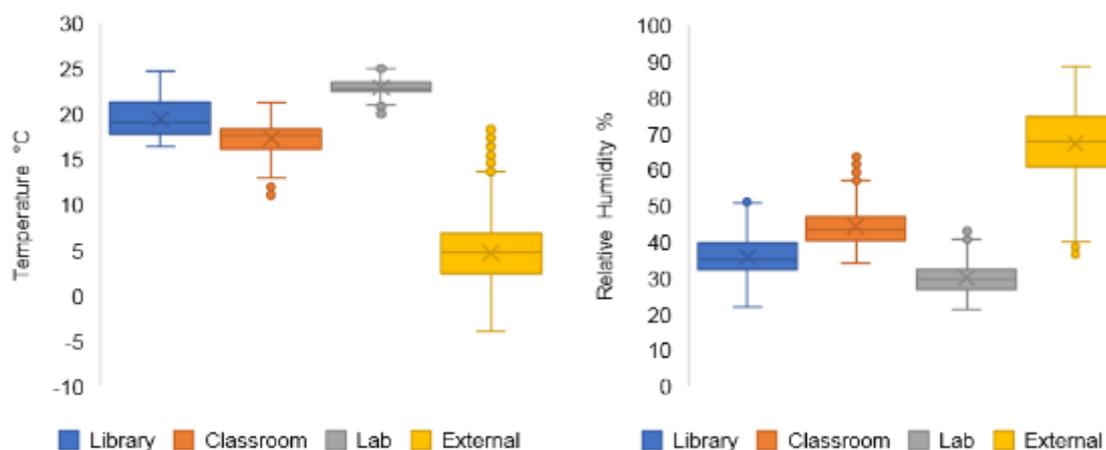
Figure 4 Box and whisker plots showing the spread of Temperature and Relative Humidity during heating season (Feb 2018)

The building maintained comfortable indoor temperature and relative humidity in most spaces during, both, heating and non-heating seasons. Indoor temperature in the monitored space was kept around 20°C and 23°C during heating and non-heating season respectively. RH was between 40%-55%. Figure 4 and Figure 5 show internal and external temperature and RH ranges of three representative building spaces<sup>1</sup>.

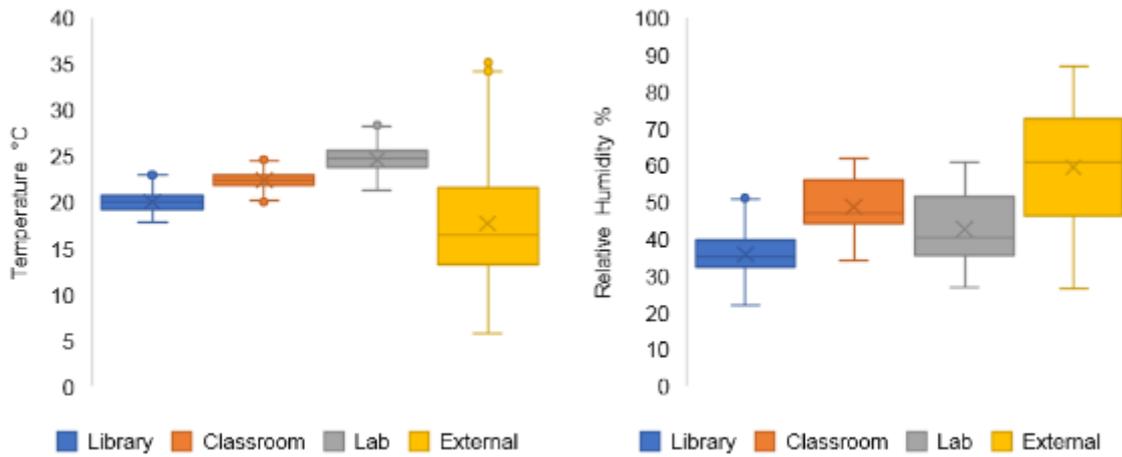
Figure 5 Box and whisker plots showing the spread of Temperature and Relative Humidity during non-heating season (May 2018)

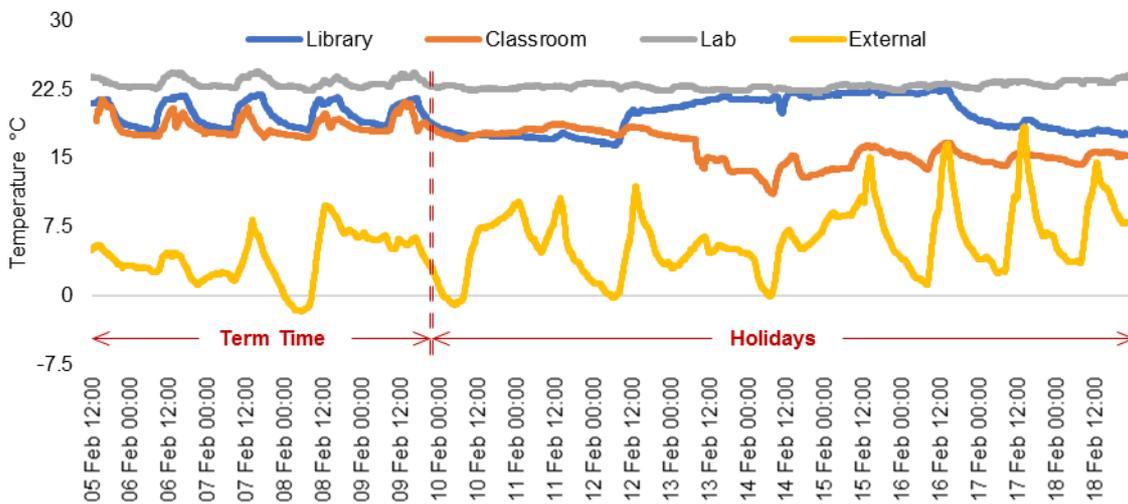
Figure 6 Temperature and during term time and holidays in the heating season

Figure 6 shows detailed indoor temperatures during the heating season. It is observed that during occupied times the indoor temperatures in all the sampled rooms were maintained above 23°C. Also, during the holidays, the temperatures were recorded much above the outdoor levels for the lab and the library, whereas the classroom temperature profile was similar to the external measurements.

mechanical ventilation and heating are provided to multiple zones. Moreover, the supply fan during unoccupied times was operating at 30% to 40% of its nominal speed. Additionally, the heating system maintains an elevated temperature in the range of 22-23°C or higher in the winter season, which is more than the intended setpoint temperatures of 20°C (Figure 6).

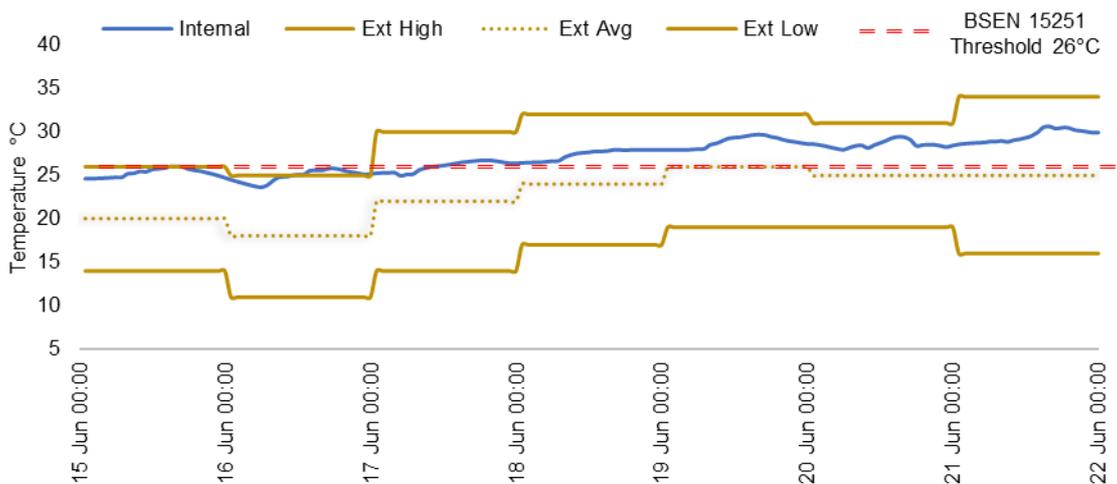
Figure 7 Indoor monitored temperatures in a classroom during a hot summer week

During the non-heating season, while most of the spaces did not suffer from overheating, rooms on the south façade, lacking solar controls (blinds/shades) had high heat gains. They were susceptible to overheating risks in peak summers. Figure 7 shows indoor temperatures in a south facing classroom on the second floor during a hot spell in the month of June. To evaluate the overheating risk of mechanically ventilated buildings, a threshold 26°C is specified by BS EN 15251 [23]. Overheating during summer has also been regularly flagged in occupant survey results with two-thirds of respondents reporting the spaces to be Warm or Hot.

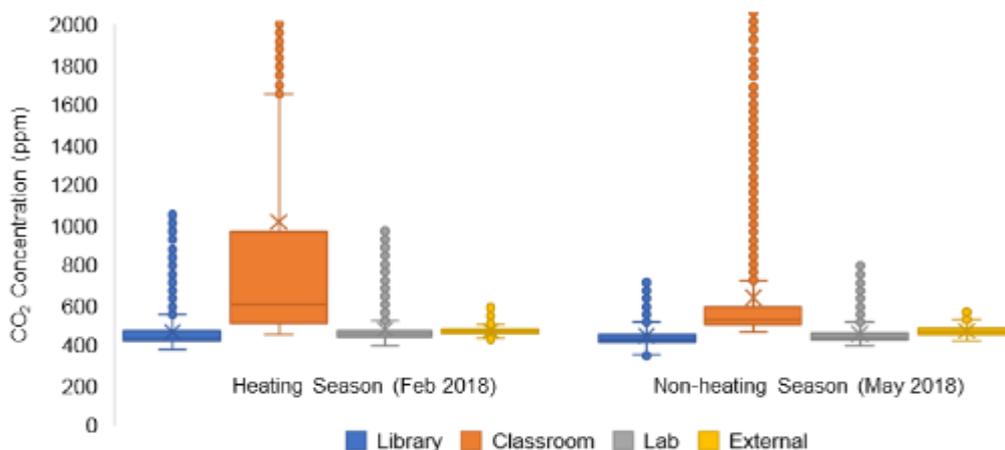
Figure 8 Indoor monitored CO<sub>2</sub> concentrations

Because of mechanical ventilation with CO<sub>2</sub> based controls in the building, most spaces had adequate fresh air supply during occupancy hours. Figure 8 shows that CO<sub>2</sub> levels during the heating and non-heating season in the monitored space were generally under 1500 ppm, as recommended by BB101:2006 [24].

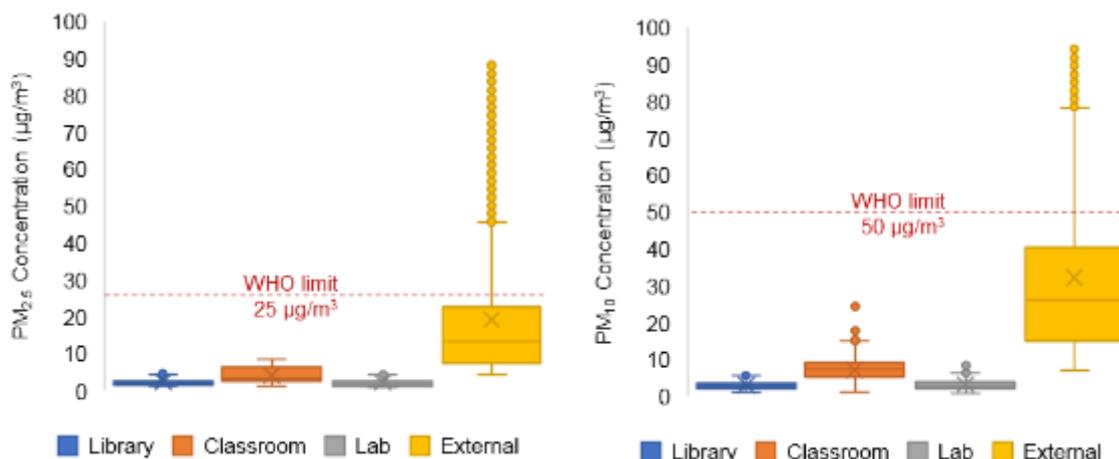
Figure 9 Daily mean PM<sub>2.5</sub> and PM<sub>10</sub> concentrations during heating season

Being mechanically ventilated, the building has good airtightness and fresh air intake is controlled and filtered. PM<sub>2.5</sub> and PM<sub>10</sub> concentrations in the monitored spaces were always below external values and significantly below the WHO 24-hour mean threshold of 25 µg/m<sup>3</sup> and 50 µg/m<sup>3</sup> for PM<sub>2.5</sub> and PM<sub>10</sub> respectively (Figure 9).

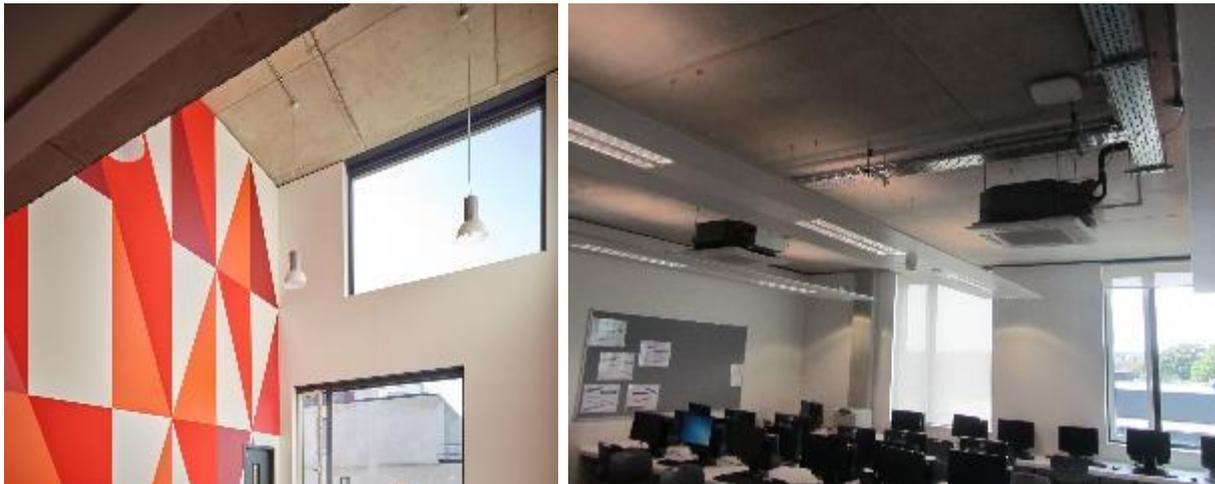
Figure 10 Exposed concrete ceiling in common areas and classrooms

**Acoustics:** The acoustic underperformance of the building was conflicting with the exposed thermal mass requirements. As seen in Figure 10, classrooms, stairwells and common spaces, all have exposed concrete ceiling for exploiting the use of thermal mass for better thermal comfort and energy efficiency. However, this leads to a conflict with acoustics because of longer reverberation times and noise transmittance through the structure. Baffling in the stairwells and exposed ceilings and acoustic breaks in

construction assemblies can be used to avoid noise issues and its transmission through the structure.
