Building Performance Evaluation: Balancing Energy and Indoor Environmental Quality in a UK School Building

with energy, affects occupant wellbeing and indoor environmental quality (IEQ) [2]. This paper reports on the findings of the building performance evaluation of a newly built and partly refurbished school campus in London.

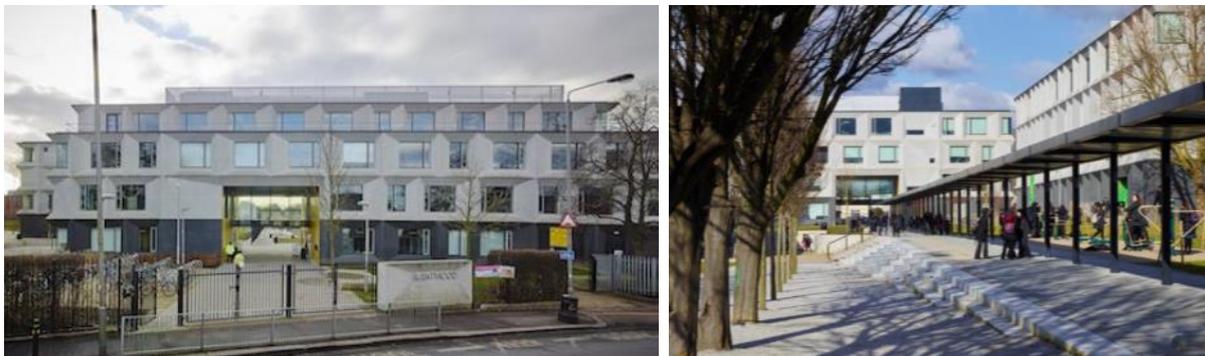
Figure 1: Case study school; (Left) Entrance – West façade, (Right) Central courtyard.

The paper addresses design and operational performance issues, inter-relationships between energy and IEQ and root causes of performance gaps in the context of school buildings, underpinned by findings and observations from a case study building. The case study building is a secondary school and sixth form with academy status, located in inner London, England. The school went under redevelopment in 2014 with the construction of six new buildings (including teaching spaces, sports hall and performance arts and dining hall) and the refurbishment of several existing ones (swimming pool and gymnasium building and assembly hall). The buildings were generally four stories high with a total useful floor area of 21,405 m². The project was required to implement on-site renewable energy technologies to meet the local council's planning conditions. To satisfy this, a biomass boiler utilising solely wood pellets and solar thermal collectors were implemented. Figure 1 shows the school building and Figure 2 shows the campus layout.

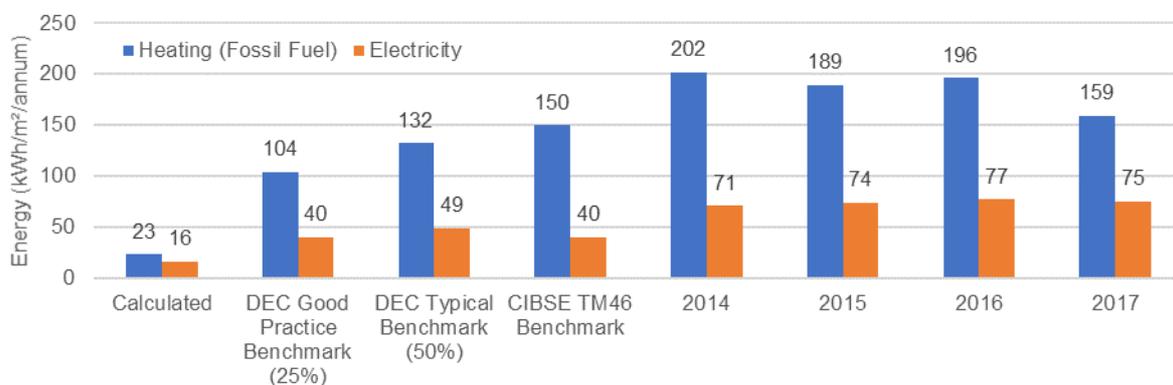
Figure 3 Comparison of actual gas and electricity use of school compared against design estimates and industry benchmarks (kWh/m²/annum)

It is seen that heating energy use is significantly higher than benchmark buildings – especially for a new build school. Electricity use is also slightly more than benchmark buildings. However, both heating and electricity use are strikingly much higher than the design estimates. As per the latest display energy certificate, the operational rating of the school is currently DEC-F.

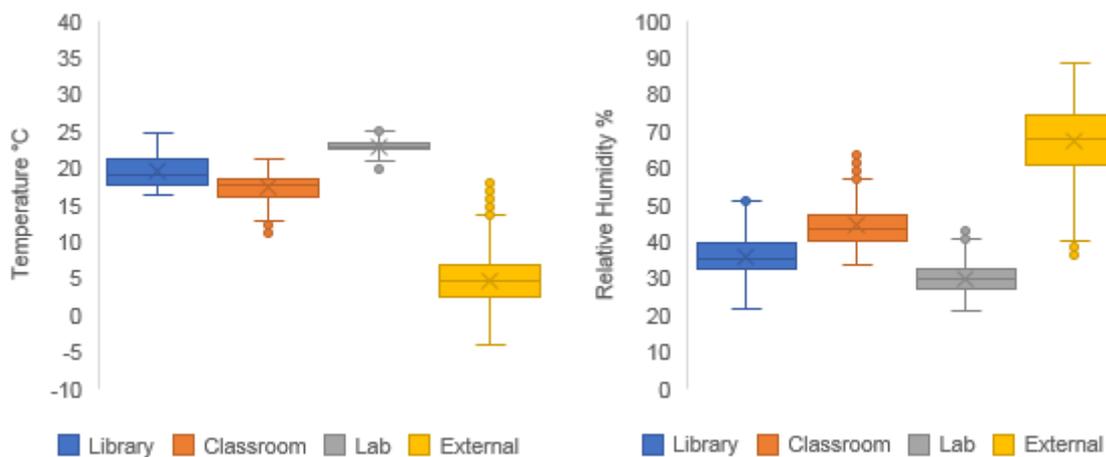
The building maintained comfortable indoor temperature and RH in most spaces during both heating and non-heating seasons. Indoor temperatures in the monitored spaces were kept around 20°C and 23°C during heating and non-heating seasons respectively. RH was between 40%-55%. Figure 4 and Figure 5 show internal and external temperature and RH ranges of three representative building spaces⁴.

Figure 4 Box and whisker plots showing the spread of Temperature and RH during heating season (All hours in Feb 2018)

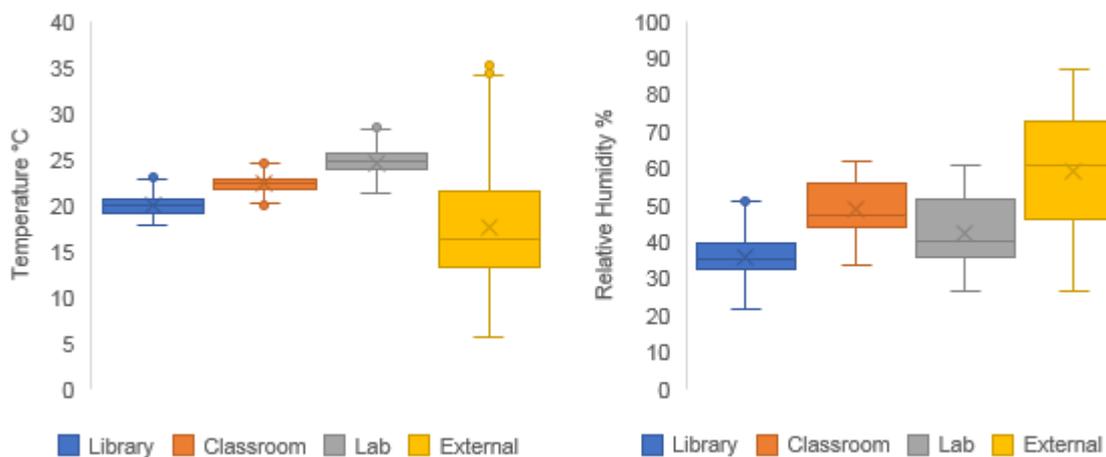
Figure 5 Box and whisker plots showing the spread of Temperature and RH during non-heating season (All hours in May 2018)

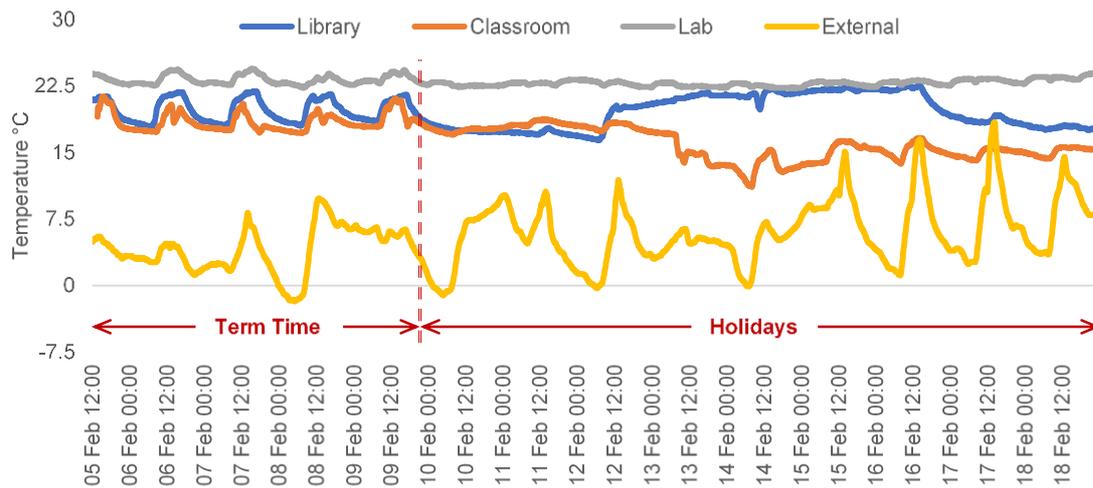
Figure 6 shows time series of indoor temperatures during the heating season. It is observed that during occupied times the indoor temperatures in all sampled rooms were maintained above 23°C. Also, during holidays, the temperatures were recorded much above the outdoor levels for the lab and the library, whereas the classroom temperature profile was similar to the external measurements.

Figure 6 Temperature variations during term time and holidays in the heating season

Operational inefficiencies Lights in the circulation areas, computers in ICT rooms, heating system and MV systems were operational even after the end of the classes. During out-of-hours and half-term breaks, when there is very low occupancy, mechanical ventilation and heating are provided to multiple zones. The supply fan during unoccupied times was operating at 30% to 40% of its nominal speed, a necessity for operational fans due to reduction of cooling capacity in the motor at lower speeds. However, turning the system off outside core hours and relying on operable windows for fresh air could save a significant amount of energy especially during non-heating season. Additionally, the heating system maintains an elevated temperature in the range of 22-23°C or higher in the winter season, which is more than the intended setpoint temperatures of 20°C (Figure 6).

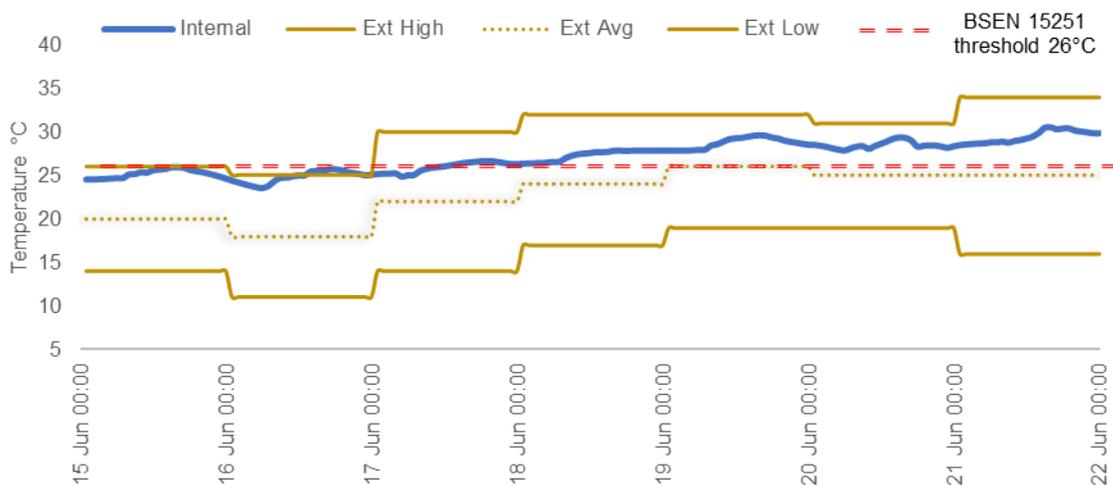
Figure 7 Indoor monitored temperatures in a classroom during a hot summer week

During the non-heating season, while most of the spaces did not suffer from overheating, rooms on the south façade, lacking solar controls (blinds/shades) had high heat gains. They were susceptible to overheating risks in ‘hot’ summers. Figure 7 shows indoor temperatures in a south facing classroom on the second floor during a hot spell in the month of June. To evaluate the overheating risk of mechanically ventilated buildings, a threshold 26°C is specified by BS EN 15251⁵ [33], which was seen to be exceeded as external temperatures remained high. However, for all sampled spaces the BB101:2006 [34] overheating criteria, which was the basis of the design was met. The temperatures of the samples spaces were within the hours of exceedance limits, daily weighted exceedance limits and upper limit temperature. This, suggests that while the current overheating risk is not high for longer periods of time, in the context of changing climate and increasing temperatures, the building will need to adapt by using strategies such as night purge ventilation.

Thermal Comfort: Temperature and RH monitoring graphs show that heating system operation and pre-conditioning of fresh air from MV system were appropriate. Also, there is a high level of airtightness in the buildings (design airtightness: 5 m³/hr/m² @ 50 Pa) as the sampled zones are able to retain heat and temperatures overnight during the heating season (see term time temperatures in Figure 6). However, temperatures measured in some of the south facing zones pointed to the risk of overheating in summer. These issues were exacerbated by the airtight envelope and inadequate number of operable windows in the classrooms. Figure 7 shows the increased indoor temperatures on hot summer days in the classroom as the MV system was not operational in one building due to maintenance issues and windows were not able to provide enough fresh air. In these situations, night purge ventilation could be used a strategy to mitigate overheating risks during hot spells.

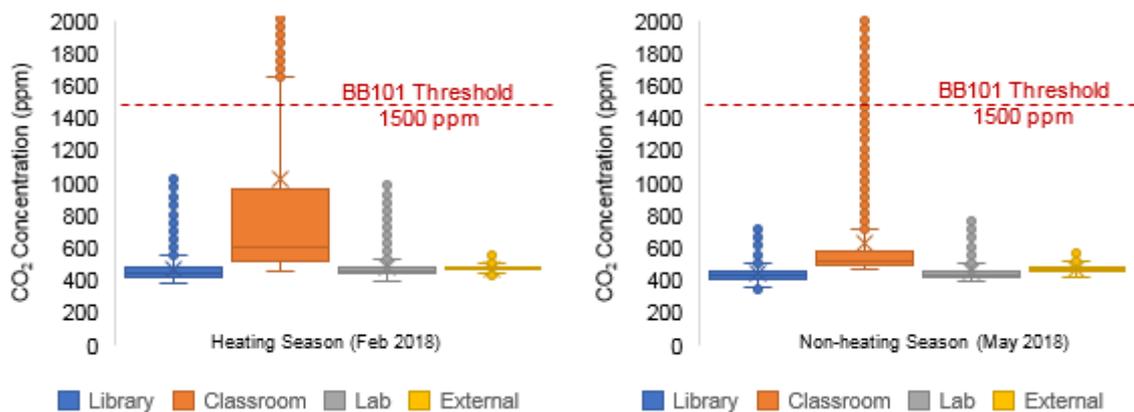
As buildings are mechanically ventilated in this school most spaces had an adequate fresh air supply during occupancy hours. The daily averaged value of 1500 ppm, recommended by BB101:2006, was the basis of the design [34]. Figure 8 shows that CO₂ levels during the heating and non-heating season in the monitored space were always under 1500 ppm except for the classroom where the CO₂ sensor for ventilation control was faulty.

Figure 8 Indoor monitored CO₂ concentrations for all hours in Feb and May 2018

Air Quality: Fresh air availability in indoor spaces was generally good with low levels of CO₂ concentrations except in the building with the malfunctioning MV system (Figure 8). The MV system effectively controlled the ingress of micro particles (Figure 9). However, Benzene and NO₂ concentrations (Table 1 and Table 2) suggest that there might be a need for additional measures such as activated carbon filters to protect building users against other outdoor sources of pollution in urban environments. Low levels of VOCs indicate appropriate indoor finishes and material selection.

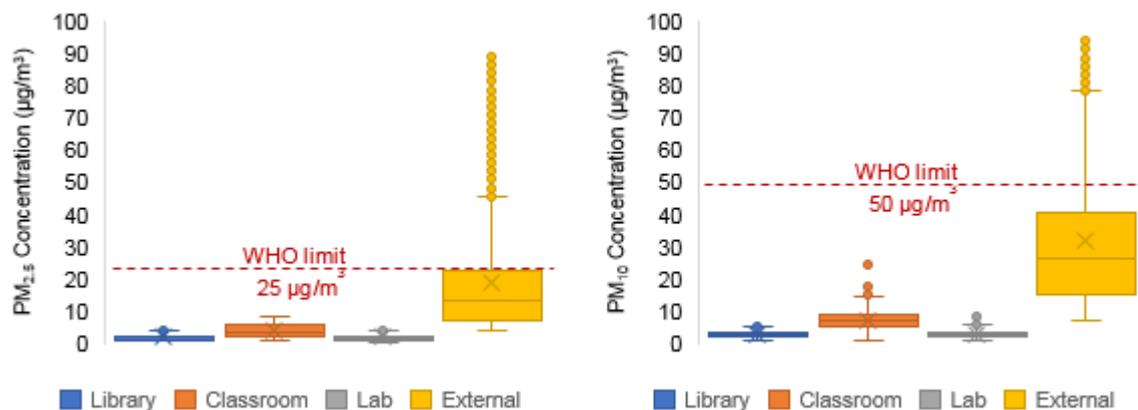
Being mechanically ventilated, the buildings have good airtightness and the fresh air intake was controlled and filtered. PM_{2.5} and PM₁₀ concentrations in the monitored spaces were always below external values and significantly below the WHO 24-hour mean threshold of 25 µg/m³ and 50 µg/m³ for PM_{2.5} and PM₁₀ respectively (Figure 9).

Figure 9 Daily mean PM_{2.5} and PM₁₀ concentrations during heating season (All hours in Feb 2018)

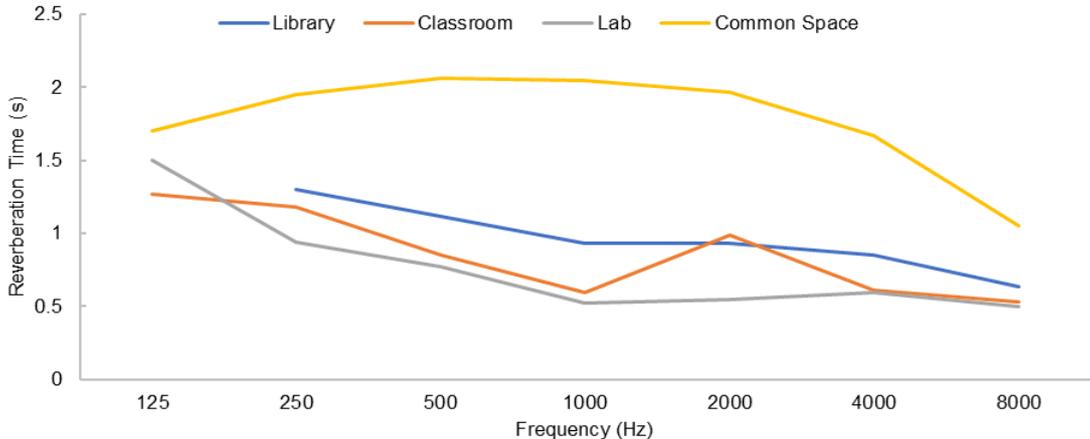
The RT values, in Figure 10, show that in the middle frequencies (500-1000 Hz), values typically ranged between 0.6-0.9s for the classroom, 0.9-1.2s for the library, and 0.5-0.8s for the science lab. These are within BB93 requirement of average value being ≤ 0.8s for classroom and lab, and ≤ 1.0 in library. The common space, however, with exposed thermal mass and no acoustic tiles, stands out due to high RT values (BB93 requirement of 0.8-1.2s) with a peak value of more than 2.0s in the 500-1000Hz frequencies. This points to the significance of measures such as acoustic rafters or

tiles to ensure acoustic criteria will be met where exposed thermal mass is part of the environmental strategy of a building.

Figure 10 Reverberation time as a function of frequency for the four investigated spaces

Acoustics: The acoustic underperformance of the building was conflicting with the exposed thermal mass requirements. As seen in Figure 12, classrooms, stairwells and common spaces, all have exposed concrete ceiling for exploiting the use of thermal mass for better thermal comfort and energy efficiency. However, this leads to a conflict with acoustics because of longer reverberation times (as seen in Figure 10) and noise transmittance through the structure. While acoustic measures were taken in study spaces, baffling in the stairwells and exposed ceilings and acoustic breaks in construction assemblies can be used to avoid noise issues and its transmission between the spaces as reported by building occupants.

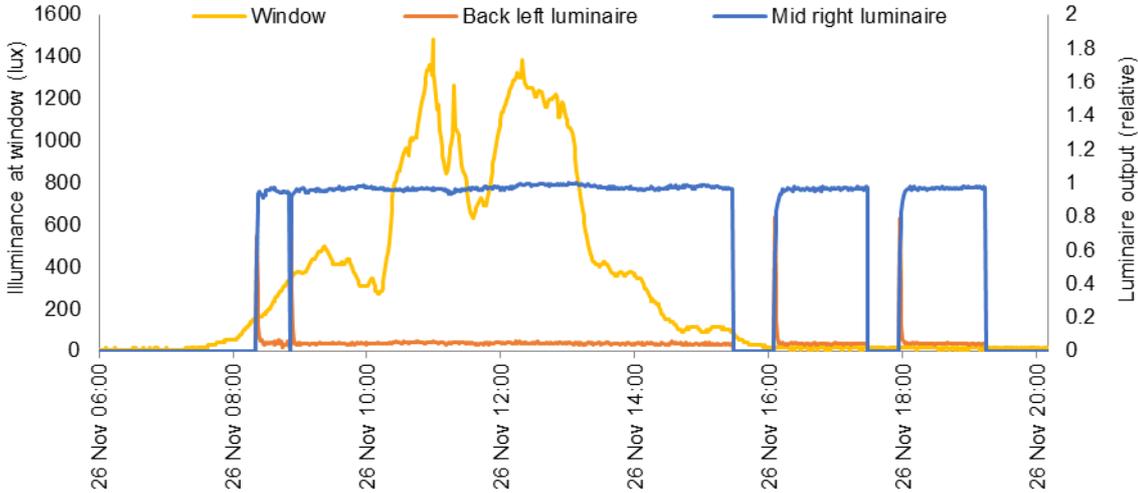
The provision of large windows provided good daylight but during the early stages of post-occupancy a few spaces lacked blinds. This led to glare issues, which were reported in discussions with the occupants and building managers. While this was recognised and rectified, in Classroom 1 blinds were still missing from eastern windows. Furthermore, day-linking of the luminaires was not appropriate in either classroom. While in Classroom 1 the automatic controls were never configured, in Classroom 2 luminaires near to the window were very dim. Figure 11 shows that luminaires near the window (back left luminaire) were set up incorrectly and five minutes after being switched on, dim to around 7% regardless of the amount of daylight. Figure 11 also shows that the PIR sensor was not effective as the other room luminaires (mid right luminaire) were constantly on most of the day. These findings point to the commissioning issues related to automated lighting control.

Figure 11 Failure of automated lighting control, Classroom 2

Lighting: Glare prevention is particularly important in schools. Excessive glare hinders teaching as interactive screens, projectors and whiteboards become difficult to read. Glare also has adverse health effect for students suffering from migraines [36]. Blinds, while reducing some natural light, are an easy solution to avoid glare. Regarding the artificial lighting, the problems with automated lighting controls (as seen in Figure 11) were likely due to poor commissioning; the daylight sensor in Classroom 2 had incorrect configuration of the photocell, the PIR sensor also had a long time-off setting.

The issue with automated lighting sensors in the classroom affected both energy and IEQ. While the unnecessary dimming of some of the lights led to dark areas and uniformity issues, the longer time-off settings of PIR meant that lights remained on for longer than necessary. Generally, provision of operable windows for natural ventilation and comfort cooling in summer needs to address outdoor noise ingress issues. However, it also needs to be integrated within lighting comfort requirements. While the outdoor noise was not a major issue in the school, use of roll-up blinds for glare prevention was. As internal blinds conflict with airflow from open windows because of rattling an integrated design solution for the façade balancing all requirements is required.
