2015 Nepal earthquake: seismic performance and post-earthquake reconstruction of stone in mud mortar masonry buildings

Abstract

2 Damage to SMM buildings in the 2015 Gorkha earthquake

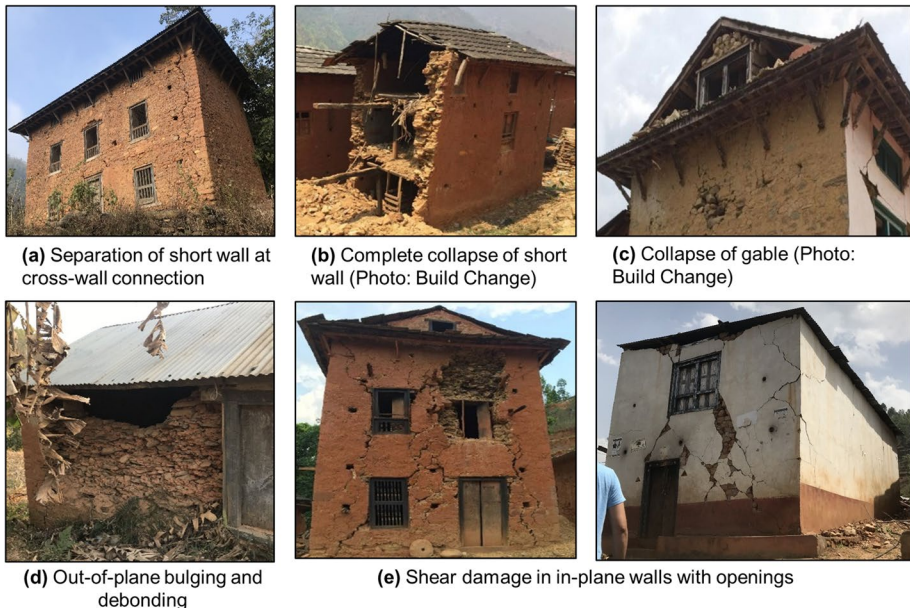
Fig. 1 Main failure mechanisms of PRE-SMM typology observed in the 2015 Nepal earthquake (Images b and c reproduced with kind permission of Build Change Nepal)

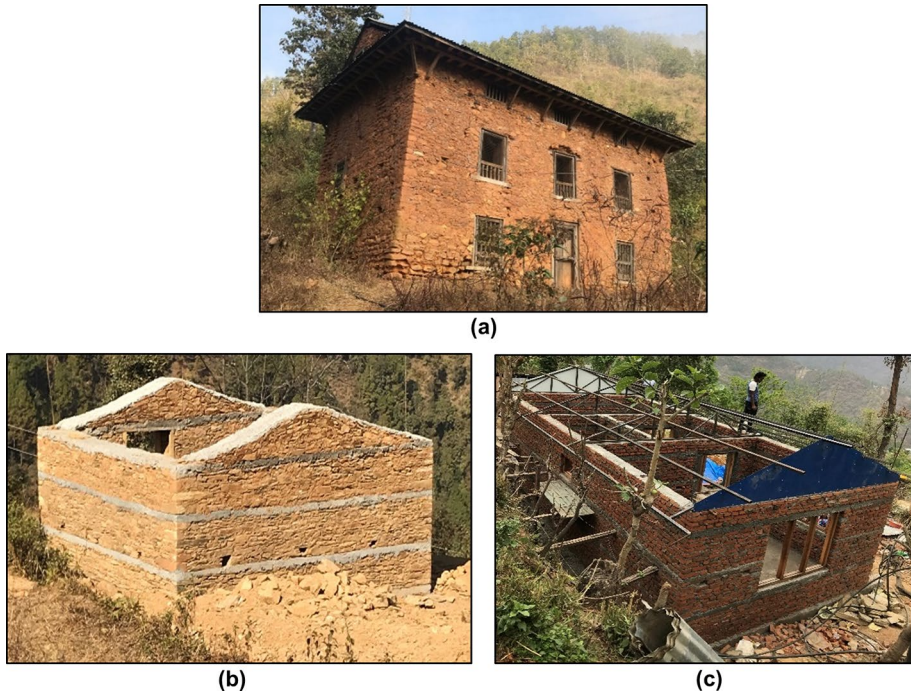
Fig. 2 Photographs of typical load bearing masonry constructions: **a** PRE-SMM; **b** POST-SMM and **c** POST-BCM construction (photos from Sindhupalchowk district, Nepal)

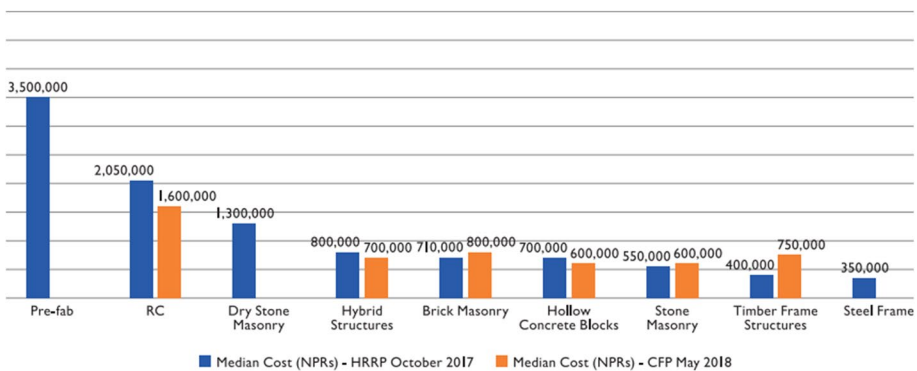
Fig. 3 Median construction cost for different typologies of newly built houses in Nepal after the 2015 seismic sequence (HRRP 2018). HRRP Housing Recovery and Reconstruction Platform, CFP Common Feed-back Project (Figure reproduced with kind permission of HRRP Nepal)

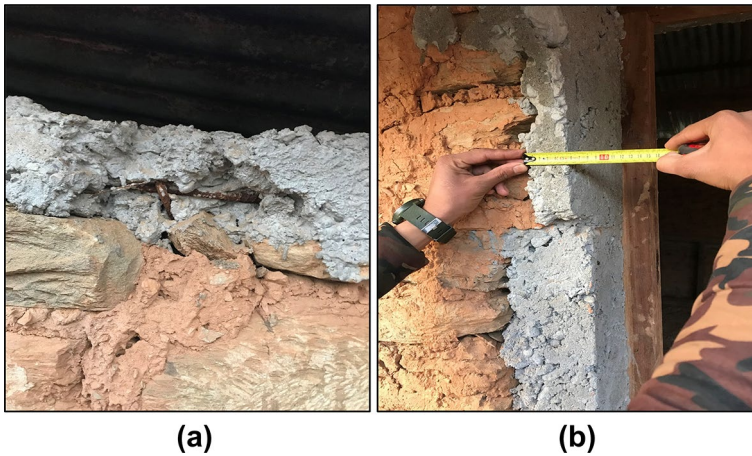
Fig. 4 Examples of poor quality workmanship of the RC seismic bands in the POST-SMM constructions

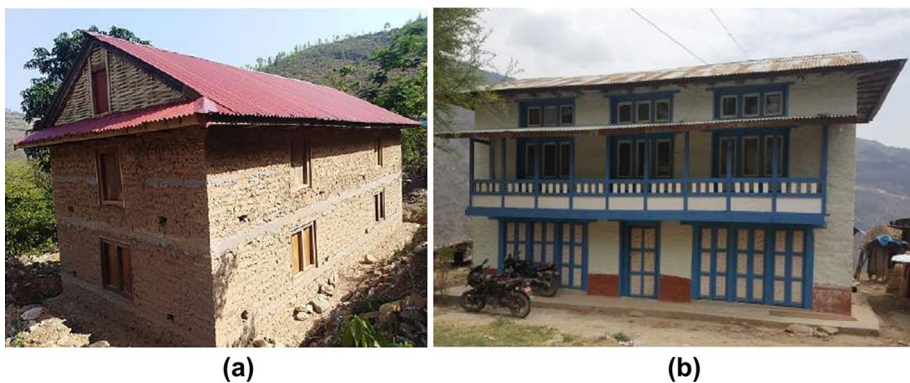
Fig. 5 Photographs of multi-storeyed non-compliant SMM houses built with limited (or without) NRA technical assistance: **a** photo from Sindhuli and **b** photo from Solukhumbu (HRRP 2018). In these houses, the seismic bands are not placed at the recommended spacings (Images reproduced with kind permission of HRRP Nepal)

due to the lack of quality control measures on site for mortar preparation, concrete mixing etc., the uncertainty in the material properties and hence in the lateral capacity of the walls is substantial. However, these issues are hard to overcome in rural areas. The non-compliance issues are more frequent in multi-storeyed constructions with large plans, built by economically able households with limited financial/technical assistance from the NRA engineers as they themselves lacked relevant trainings (see Fig. 5).

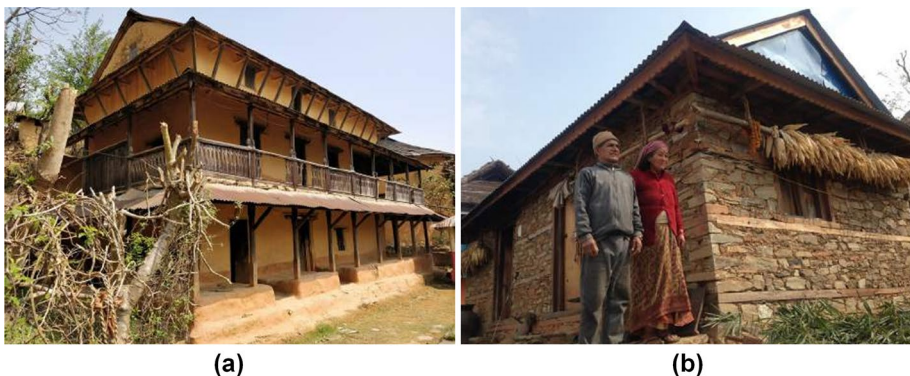
Fig. 6 SMM houses with seismic resistant features of timber elements: **a** an 80 years old PRE-SMM house in Syangja district that has survived three major earthquakes including the recent 2015 Gorkha earthquake and **b** a newly built POST-SMM house (HRRP 2018) (Images reproduced with kind permission of HRRP Nepal)

It is interesting to note that, after the heavy damage sustained by the traditional SMM typology in the 2015 seismic sequence, a misbelief has spread among the affected communities that the use of modern construction materials such as concrete and steel makes houses seismic resistant. However, with engineering-based minimal improvements of the local crafts practiced and developed over centuries, seismic resistant structures can be built with traditional materials such as stone and timber (see D'Ayala 2013 and Fig. 6a for example). The well-built PRE-SMM house shown in Fig. 6a has traditional seismic

resistant features of timber elements: seismic bands (two per storey), lacings, vertical posts and timber roofing system that includes keys and compression struts. Hence, improving the construction practice of traditional vernacular constructions, with which the masons are familiar, should have been promoted in the reconstruction. Indeed, there is evidence of timber elements in the POST-SMM construction (Fig. 6b) being used in some rural houses where transportation of cement and reinforcement bars is difficult. Further discussions on the issue of loss of rural vernacular architecture after the 2015 seismic sequence is available in Adhikari and D'Ayala (2019a).

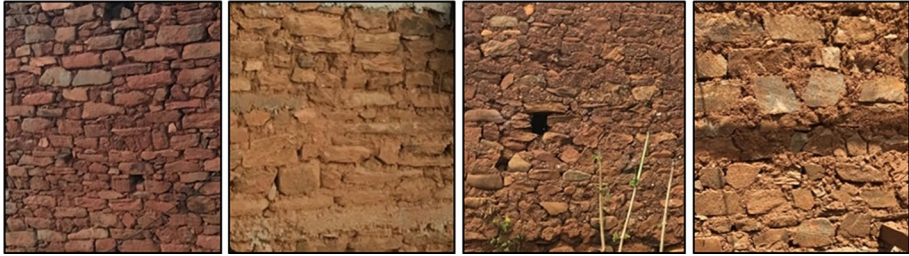
Fig. 7 Masonry bond pattern from 4 different Nepalese SMM buildings

wythes. Figure 7 presents photographs of the SMM bond pattern from 4 different buildings in Sindhupalchowk district. In some buildings the stones are flat and tend to form horizontal courses along the height while in others the shape is random, and no distinct horizontal courses can be identified. Similarly, the stone size also varies from building to building and within the same wall to fill in gaps among larger stones. These irregularities affect the amount of mortar used in the walls to fill up void and even out irregular stone units. Consequently, the corresponding mechanical properties and hence the lateral seismic resistance of these constructions are highly variable (e.g. see Milosevic et al. 2013; Malomo et al. 2019a, b; Vasconcelos and Lourenço 2009). More detailed discussions on types of SMM wall constructions found in South Asia including Nepal can be found in Bothara and Brzev (2011) and Pun (2015).

In this study, to account for the random irregular shape of rubble stone, a triangular 3-D mesh is first created, and then random shaped units are generated by clustering these triangular applied elements (each with 6 degrees of freedom) by means of the ‘unit’ springs. Figure 10 is self-explanatory: different coloured clusters represent stone units which are connected at their faces by the ‘interface’ springs. It should be noted that such modelling technique inherently presents some uncertainty as the wall construction itself presents great variability in terms of shape and size of units and the resulting bond pattern (also refer to Fig. 7).

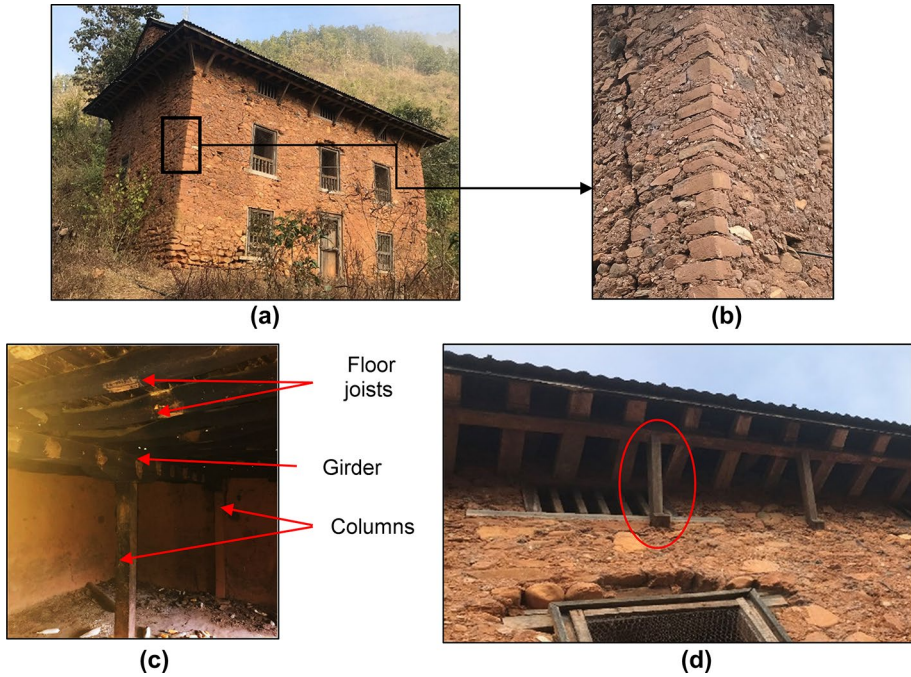
Fig. 8 Construction characteristics of a typical PRE-SMM building: **a** 3-D view; **b** view of a corner connection; **c** timber frame and floor structure and **d** timber roof system with timber keys and compression struts

Figure 8 presents photographs of a typical PRE-SMM house in rural mountainous districts, which is used as an IB representative of this typology for carrying out its seismic vulnerability assessment in the present study (Sects. 5, 6). It is a two-storeyed building with an attic floor covered in a multi-pitched timber roof structure. The cross-wall connections in these constructions are built with fairly rectangular shaped corner stones (Fig. 8b). Besides the SMM wall load bearing system, a timber frame centrally placed along the longitudinal direction also supports the floor structure, see Fig. 8c. The longitudinal girder at each floor level, resting through the whole thickness of the short walls, supports several transverse joists resting over the whole thickness of the long walls, forming the mud-topped timber floor structure. The unique timber roof structure, supported by a system of compression struts locked to the masonry by timber keys as seen in Fig. 8d, confines all the walls thus promoting the global *box-like* behaviour. It is worth noting that the IB is non-symmetric in the longitudinal direction due to the typical distribution of opening only on the front wall.

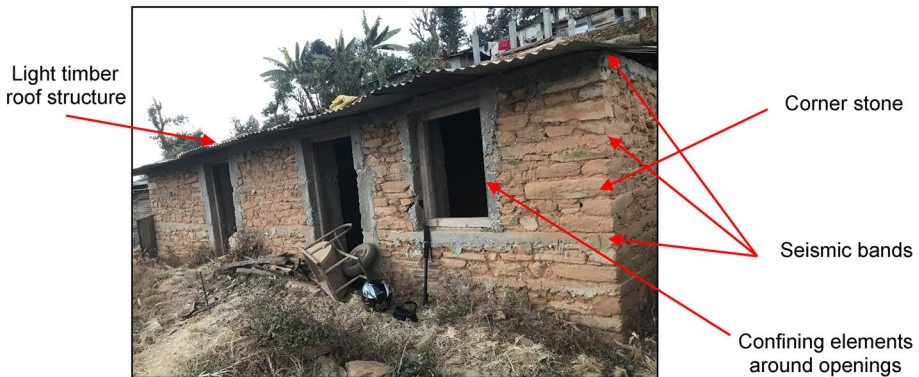
Fig. 9 Construction characteristics of typical POST-SMM buildings (photo from Sindhupalchowk district)

The POST-SMM buildings also have 400–600 mm thick uncoursed random rubble stone masonry walls as in the PRE-SMM construction. Most of the POST-SMM constructions are single storeyed with one to two rooms only, as already discussed in Sect. 3.1, although the NBC 203: 2015 code allows multi-storeyed construction of up to two storeys plus an attic floor. The storey height is typically low at about 2 m. The seismic-resistant measures applied in these buildings follow the prescriptions in the NBC 203: 2015 and are highlighted in the photograph of a newly built house shown in Fig. 9, which is used as an IB representative of the single-storeyed POST-SMM typology in the numerical analysis and seismic performance assessment (Sects. 5, 6). The RC seismic bands are typically 75 to 100 mm deep and extend through the whole thickness of the SMM walls. The roof is mostly gable type and is made of a timber structure with light roofing material (corrugated iron sheet).

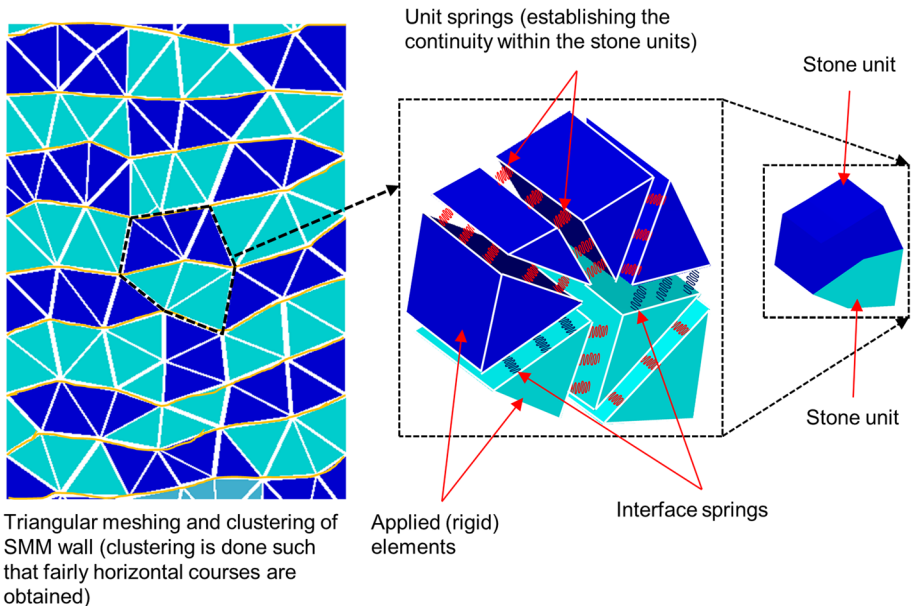
Fig. 10 Schematic of simplified micro-modelling of random rubble stone masonry using AEM

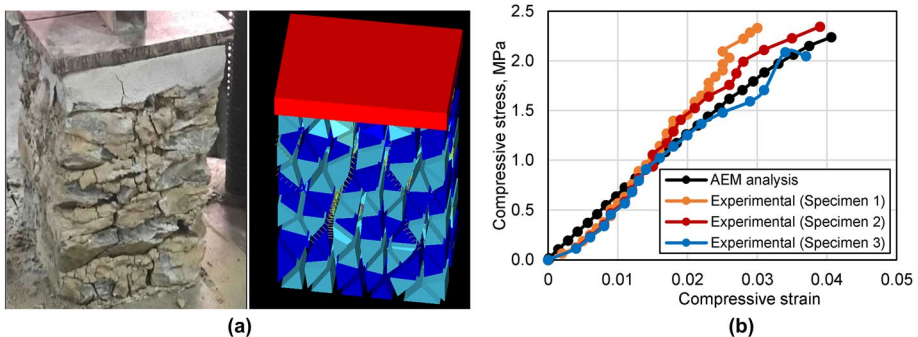
Fig. 11 Comparisons of experimental and numerical behaviour: **a** crack pattern and **b** stress–strain curve (Leftmost image reproduced with kind permission of Build Change Nepal)

Figure 11 compares the numerical crack patterns and the stress–strain diagram to the experimental results for the SMM wallete subjected to uniaxial compression. Vertical and inclined cracks are observed which mainly pass through the mud mortar joints, both in the experiment and numerical analysis result. In terms of stress–strain curve, apart from a slight discrepancy in the initial stiffness, the average Young’s modulus as well as peak strength and strain are well predicted by the numerical analysis. The slight difference in the initial stiffness is most probably due to the fact that the test specimen presented some voids and hence showed non-linearity at the beginning of the test.

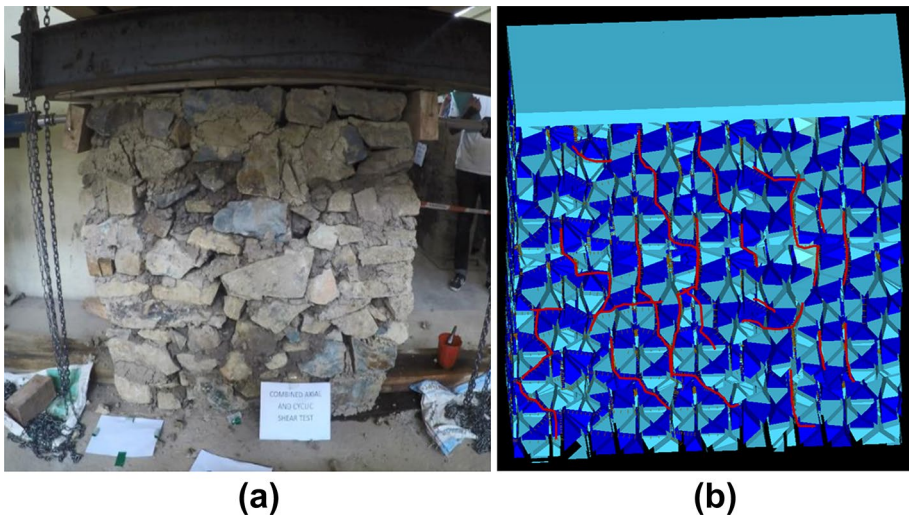
Fig. 12 Crack patterns comparison under cyclic shear–compression loading: **a** experimental and **b** AEM analysis (maximum crack opening is 20 mm) (Image a reproduced with kind permission of Build Change Nepal)

Figure 12 shows the comparison of ultimate crack pattern under cyclic shear–compression loading. As the cyclic displacement level increases, the cracks become widely distributed all over the wall surface, passing mostly through the mud mortar joint/interfaces. Figure 13 presents the comparison of hysteretic load–deformation behaviour from the AEM

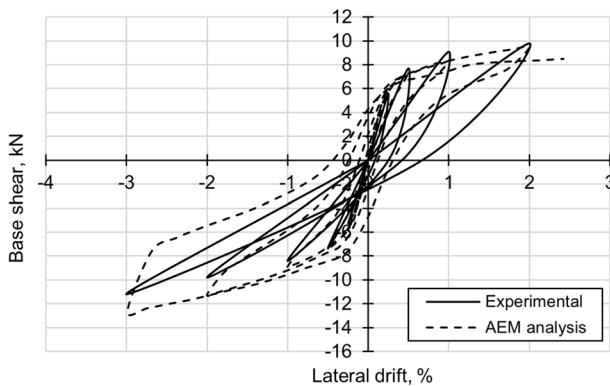
Fig. 13 Comparison of cyclic hysteretic response from experimental and AEM analysis under shear–compression loading

analysis and the experiment. Overall, the lateral loading and unloading stiffnesses, peak capacity as well as the ductility are well reproduced by the AEM analysis, although the numerical cycles have a larger hysteresis.

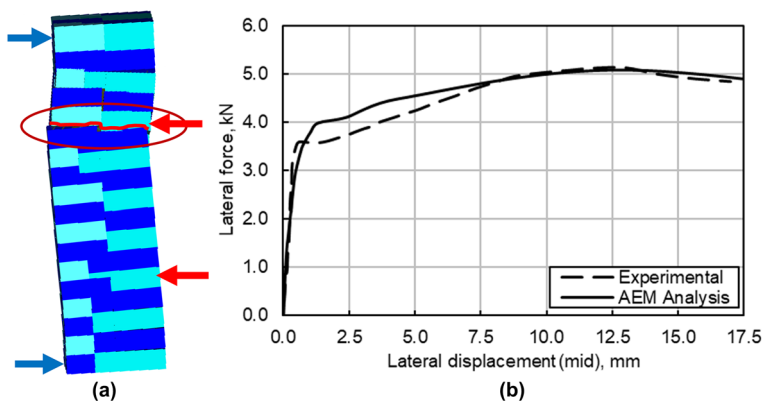
Fig. 14 Comparison of location of crack at ultimate stage: **a** experimental and **b** AEM analysis results

In order to validate the bending behaviour of mud mortar masonry walls, the experimental test on a semi-dressed stone masonry pier of dimensions 1400 mm × 500 mm × 350 mm (height × length × thickness) conducted by Pun (2015) is considered. The location of crack at ultimate stage (which was at a height of 925 mm from the bottom in the experimental test, see Fig. 14a) as well as the load–deformation behaviour (Fig. 14b) are well reproduced by AEM analysis.

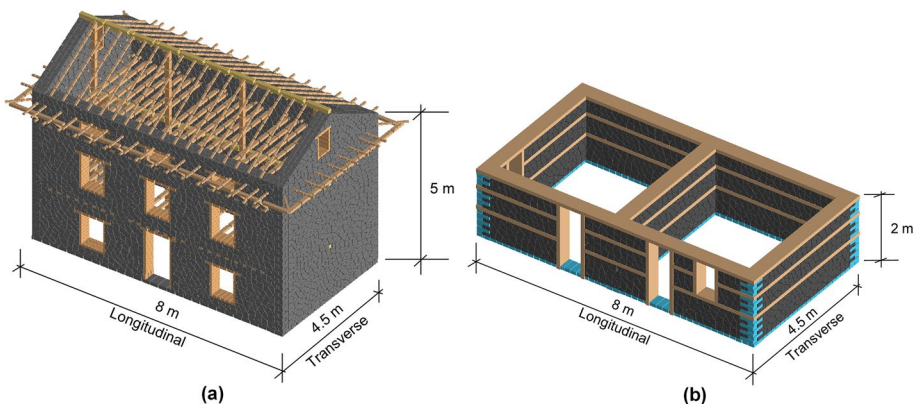
Fig. 15 Numerical models of the IBs: **a** PRE-SMM typology and **b** POST-SMM typology

In both the PRE-SMM and POST-SMM IB models, the SMM walls including the cross-wall connections are characterized by the material properties listed in Table 1.

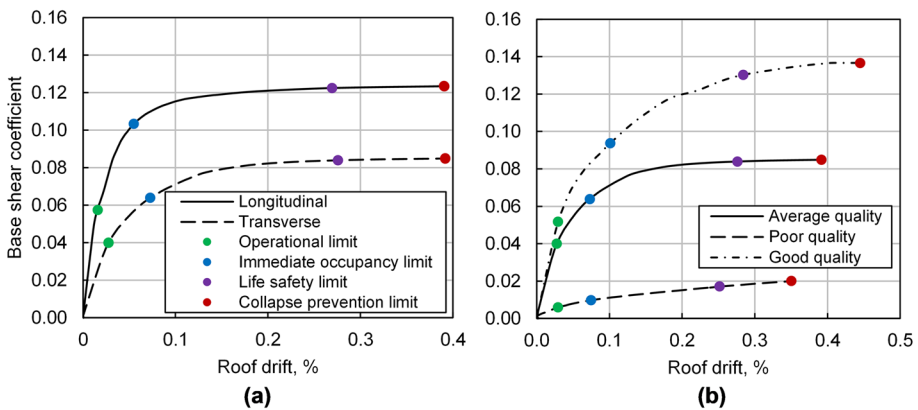
Fig. 16 Capacity curves for the PRE-SMM typology: **a** in two principal directions and **b** effect of material quality on the capacity curve (note that the capacity curves in the transverse i.e. weakest direction are compared)

0.12 g and 0.08 g in the longitudinal and transverse direction, respectively. Due to the poor strength of mortar as well as the random shape of the stone units, the non-linear response starts at a drift as low as 0.05% and the ultimate drift capacity is only about 0.4% in both principal directions. The ultimate drift is selected as the *collapse prevention* limit when a collapse mechanism is formed, and the cracks' width is greater than 15 mm; triggering a substantial rate of increase of the roof displacement (more than 5 mm), as observed in the capacity curve. Figure 16 also shows the roof drift thresholds representative of the four different performance levels which are used in the seismic performance assessment and fragility analyses in Sect. 6.2.

Figure 16b compares the capacity curves for the PRE-SMM typology for the three different material quality cases, showing substantial change in the ultimate capacity. An analytical study by D'Ayala and Kishali (2012) also found typically low lateral capacity with significant dispersion i.e. 0.07–0.19 g for two-storey Turkish SMM buildings which is comparable to the range for the PRE-SMM typology i.e. 0.02–0.13 g (Fig. 16b) in terms of the dispersion. It is thus important to improve the practice of material preparation as well as workmanship in the wall construction since both of these affect the resulting masonry fabric and hence the material properties. The *poor* quality case has more severe reduction (about 75%) in the ultimate capacity than the increment (about 60%) in the *good* quality case. However, in terms of ductility and the drift limits at different performance levels, only slight changes ($\pm 10\%$) are observed. This is due to the fact that the roof drift is controlled by the crack patterns and crack width which are not affected substantially by the material quality in case of rubble stone masonry with inherently poor interlocking between the units, unless there is an introduction of ductile structural elements.

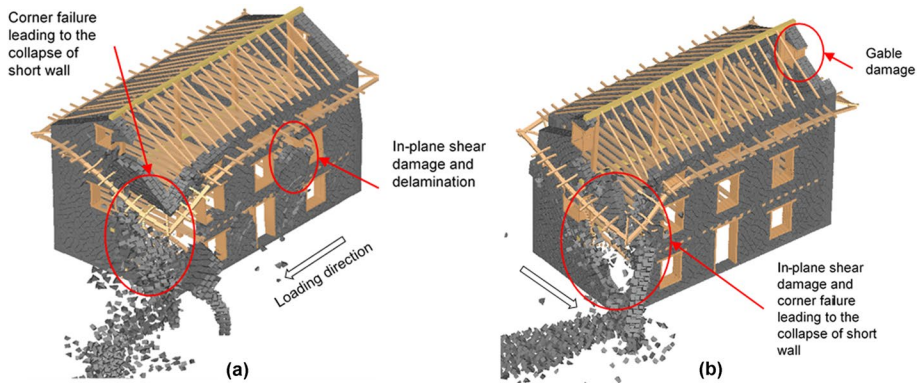
Fig. 17 Ultimate collapse mechanisms of the PRE-SMM IB when loaded along: **a** longitudinal and **b** transverse direction

Figure 17 presents the ultimate collapse mechanisms of the PRE-SMM typology when loaded in the longitudinal and transverse directions. In the case of longitudinal direction loading, the building suffers torsional action due to the irregular distribution of openings and hence the damage starts at the weakest corner triggering the overturning

collapse of the corner (Fig. 17a). The long wall with openings also suffers in-plane shear damage which ultimately activates the delamination in the transverse direction. In the case of transverse direction loading, diagonal shear crack originates at the corners of the openings in the short wall and in-plane shear failure including the corner collapse occurs (Fig. 17b). In both cases, the ultimate collapse mechanism involves the collapse of the short walls. These damage patterns are comparable to those observed on these buildings in the 2015 earthquake (see Fig. 1). It is important to notice the crucial function of the longitudinal internal timber structure, which prevents the floor and roof from collapsing, hence reducing the risk of injuries and fatalities, and allowing safe evacuation. The damage levels at the limit of different performance levels are shown and explained in Fig. 18.

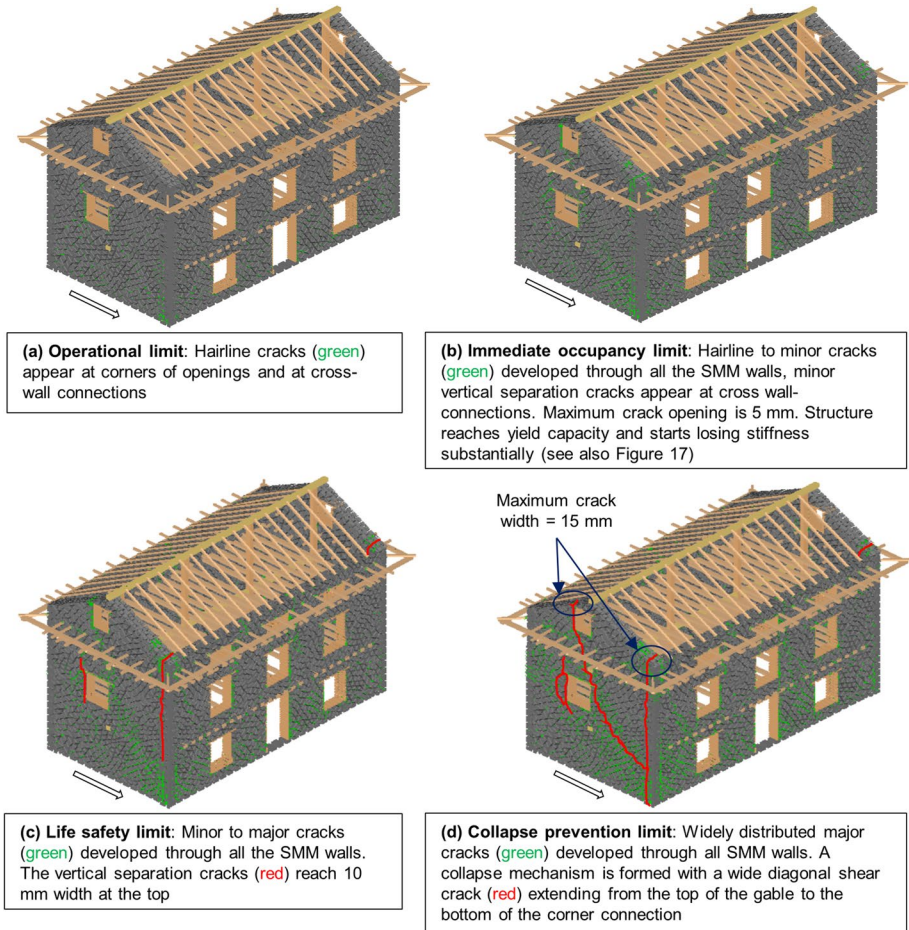
Fig. 18 Damage levels in the PRE-SMM IB at the limits of different performance levels

Both in the numerical analysis as well as in the observed damage (Figs. 18d, 19), excessive out-of-plane overturning of the walls is prevented, and the ultimate collapse mechanism involves the corner failure and damage of short walls. This also indicates that the timber floor and the roof system promote the global *box-type* action.

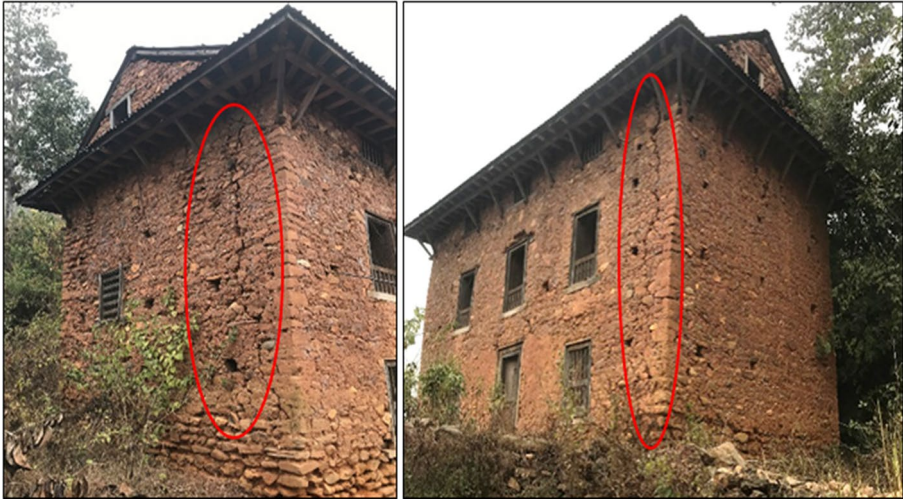
Fig. 19 Actual damage due to the 2015 earthquake in the case study PRE-SMM building from Sindhupalchowk district (vertical separation cracks have a maximum width of about 20 mm)

Figure 19 shows the actual damage state of the case study IB after the 2015 Gorkha earthquake which was surveyed by the first author during his field trip. Major vertical separation cracks (maximum crack width of about 20 mm) in both direction walls can be seen suggesting that the building was subjected to bi-directional effect of ground motion. Minor diagonal cracks (less than 5 mm) are also present in both long and short walls. Although the building suffered severe vertical separation cracks, it survived collapse.

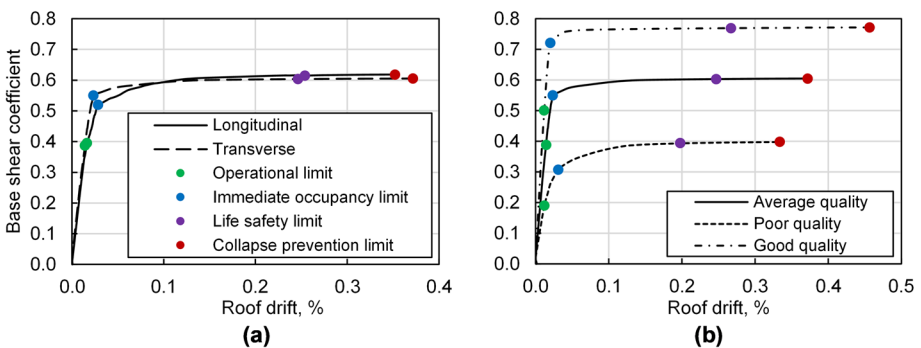
Fig. 20 Capacity curves for the POST-SMM typology: **a** in two principal directions and **b** effect of material quality on the capacity curve (note that the capacity curves in the transverse direction are compared)

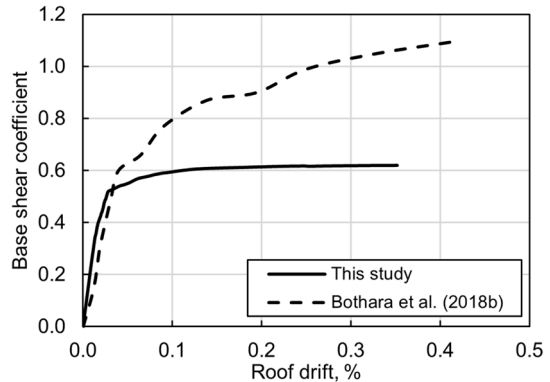
Fig. 21 Comparison of capacity curve for the POST-SMM IB in the long direction: this study and literature

A recent study by Bothara et al. (2018b) also found typically high lateral capacity (about 1.0 g) for single-storeyed SMM school buildings from Nepal (Fig. 21).

Slightly higher initial stiffness in the present study is observed, although a one order of magnitude higher elastic modulus is used in the school building analysis. This is justified by the difference in the layout of openings in the two construction typologies, i.e. the school building has several openings on the back wall as well (see Bothara et al. 2018b). In contrast, due to the higher values of tensile strength and shear modulus (and possibly higher value of friction coefficient, although not reported) in the analysis by Bothara et al. (2018b), the yield as well as ultimate strength capacities are considerably higher than the same from the present study.

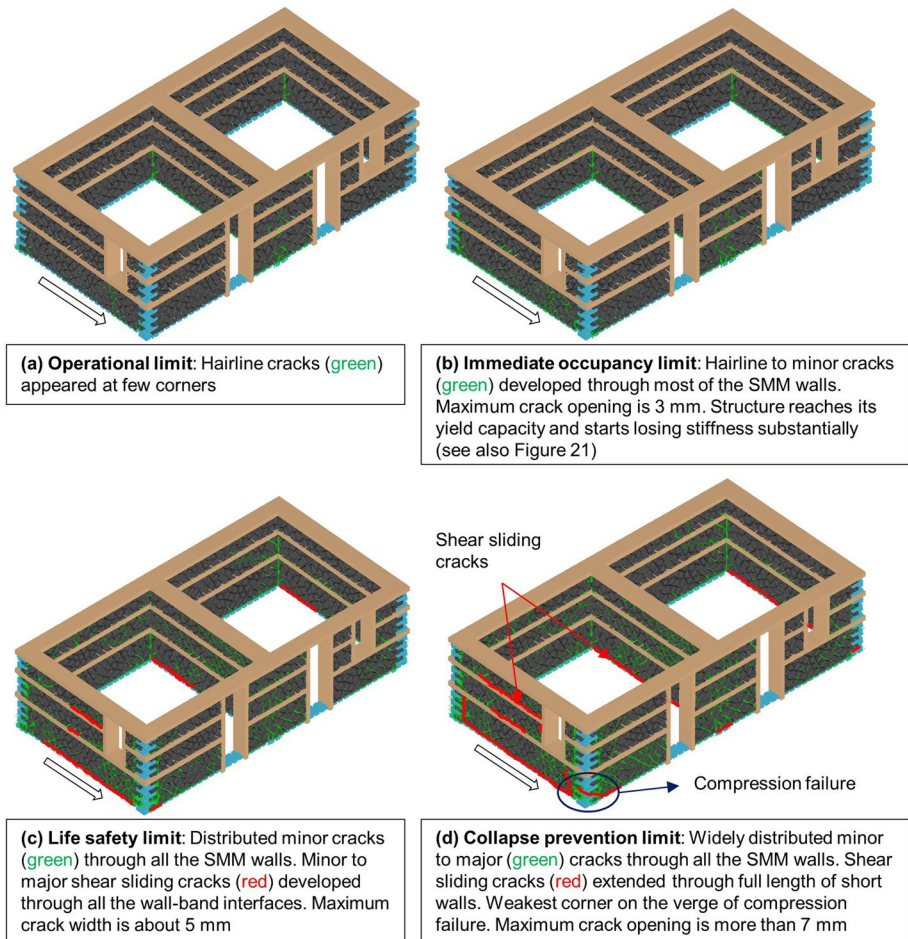
Fig. 22 Damage levels in the POST-SMM IB at the limits of different performance levels

Figure 22 presents the damage levels at the limits of different performance levels under the pushover analysis in the transverse direction. The seismic bands and the confining elements around the openings successfully contain and prevent the propagation of diagonal shear failure of the wall panels. The final collapse mechanism in POST-SMM buildings is shear sliding failure of masonry portions at the wall-band horizontal interfaces resulting in the compression failure at the corner (see Fig. 22d). Such shear-sliding failure modes are typical when there is low vertical pre-compression and low-strength mortar (Tomazevic 1999).

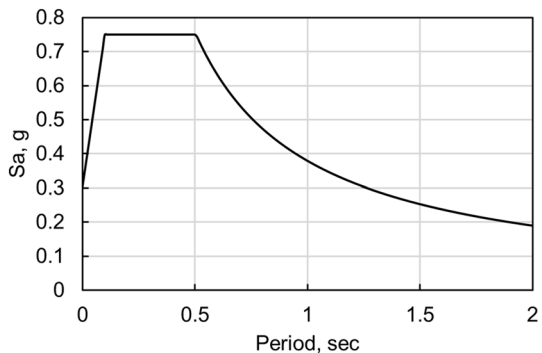
Fig. 23 Elastic site spectrum as per NBC 105: 2019 for a site in Sindhupalchowk district, Nepal

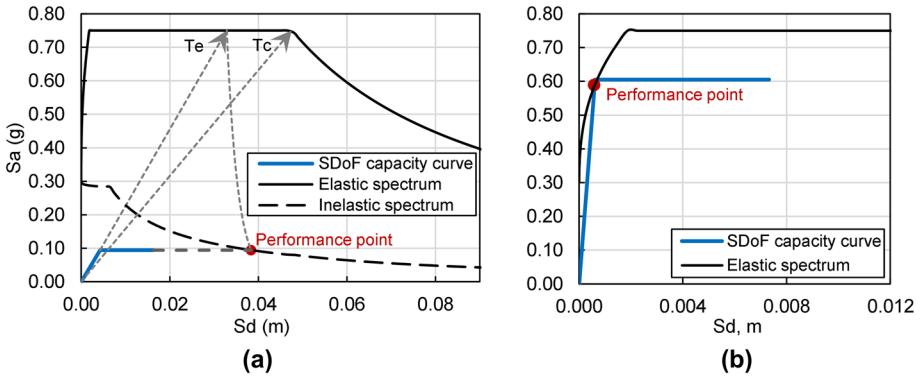
Fig. 24 Graphical application of N2 method for seismic performance assessment of **a** PRE-SMM IB and **b** POST-SMM IB, both with average quality mortar, under the action of NBC 105: 2019 site spectrum

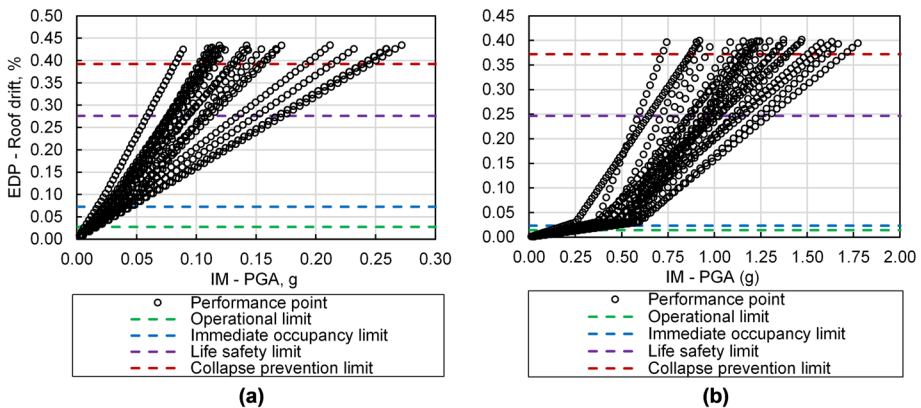
Fig. 25 Cloud of performance points for: **a** PRE-SMM typology and **b** POST-SMM typology (with *average* quality mortar) under a suite of FEMA P695 set of 22 ground motions

Based on the performance point distribution and the thresholds of performance levels presented in Fig. 25, the derivation of fragility functions is performed statistically using the least square regression method, as detailed in D’Ayala et al. (2015). Tables 5 and 6

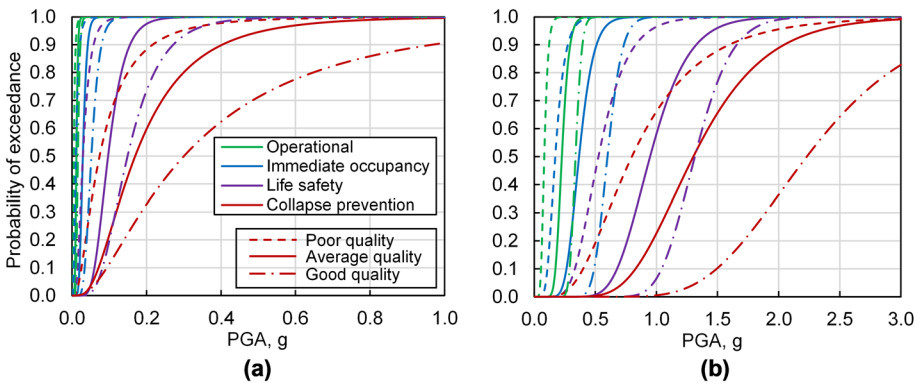
Fig. 26 Seismic fragility functions for: **a** PRE-SMM IB and **b** POST-SMM IB. Dispersion due to the material quality is also shown

present the median and dispersion of the PGA capacity for different performance levels for the PRE-SMM and POST-SMM IBs with different material quality cases. The same information is presented in terms of fragility curves in Fig. 26. The *immediate occupancy* limit is exceeded for the PRE-SMM IB at a median PGA of as low as 0.05 g, even with *good* material quality while the same limit is exceeded for the POST-SMM IB only at a median PGA of about 0.17 g, even with *poor* material quality. Similarly, for the PRE-SMM IB, the median PGA for exceeding the *collapse prevention* limit is about 0.30 g, even with *good* material quality while the same for POST-SMM IB is exceeded at a median PGA of about 0.80 g, even with *poor* material quality. For both IBs, the fragility functions,

From the fragility functions (Fig. 26), vulnerability functions for the PRE-SMM and POST-SMM IBs are generated by computing the damage probabilities for each damage states at a given IM (i.e. PGA) level and then convoluting with a consequence model (see Yamin et al. 2014; D'Ayala et al. 2015). HAZUS (FEMA 2012) consequence model for residential building class are used in this study, as a country-specific damage to loss functions for Nepalese SMM buildings has not been developed yet and the loss functions would be dependent on factors whose quantification is beyond the scopes of this study, such as the cost of materials, labour cost, policies etc. (see Hill and Rossetto 2008; Bal et al. 2008; D'Ayala et al. 2015 etc.). While the authors are aware of the limitations of such choice, the HAZUS consequence model has been used by other researchers for seismic loss assessment in developing countries, e.g. Pakistan (Ahmad et al. 2014), and can be used for comparison of relative vulnerability within the same scenario. The resulting seismic vulnerability functions for the PRE-SMM and POST-SMM IBs are presented in Fig. 28. The Mean Damage Ratio (MDR) represents the ratio of the building repair cost to the replacement cost. It is noteworthy that due to the different material quality, the PGA for 50% MDR has a dispersion of more than $\pm 50\%$ in both cases which is very high and shows that the global vulnerability can be substantially reduced using good quality materials as well as with proper workmanship in the SMM construction. The vulnerability curves for both PRE- and POST-SMM IBs are compared in Fig. 29. For the PRE-SMM IB, a ground motion with PGA of as low as 0.11 g can cause 50% MDR while for the POST-SMM IB, a similar level of loss is reached at a PGA level of about 1.00 g. Thus, on average, it can be said that the PRE-SMM typologies are one order of magnitude more vulnerable than the POST-SMM typology.

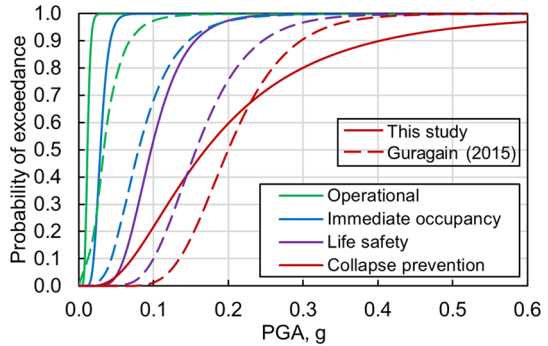
Fig. 27 Comparison of fragility curves for PRE-SMM typology from this study and from Guragain (2015)

In Fig. 27, the fragility functions for the PRE-SMM IB are compared against the fragility functions from the studies conducted by Guragain (2015). It should be noted that the fragility curves reported in Guragain (2015) represents a broader class of PRE-SMM typology (i.e. single and two-storeyed) hence the median PGA exceeding each damage state is generally higher in their study. Moreover, the dispersion in the fragility functions for each performance level is also higher in Guragain (2015) study except for the *collapse prevention* performance level.

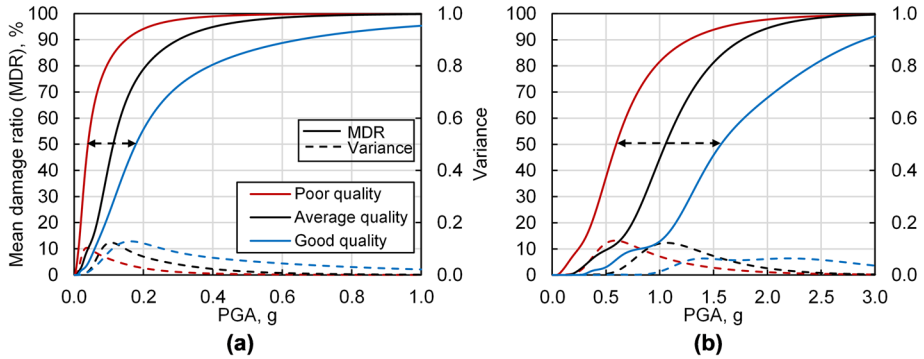
Fig. 28 Seismic vulnerability functions for: **a** PRE-SMM IB and **b** POST-SMM IB. Dispersion due to the material quality is also shown

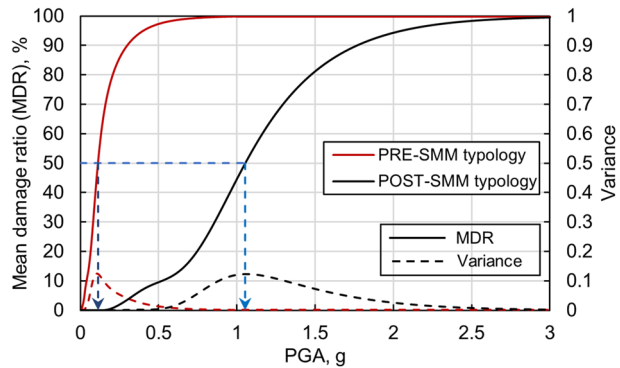
Fig. 29 Comparison of seismic vulnerability functions for the PRE- and POST-SMM typologies with *average* material quality

typology was inevitable. For a similar intensity level, the MDR for the POST-SMM buildings would be less than 30%, meaning that only repairable damage can be expected.
