Improved daylight management of historic showrooms: a methodology based on detailed recording and analysis

Nigel Blades, John Mardaljevic, Katy Lithgow, Stephen Cannon-Brookes, Lisa O'Hagan and Sarah McGrady

Case study of the Volury at Ham House

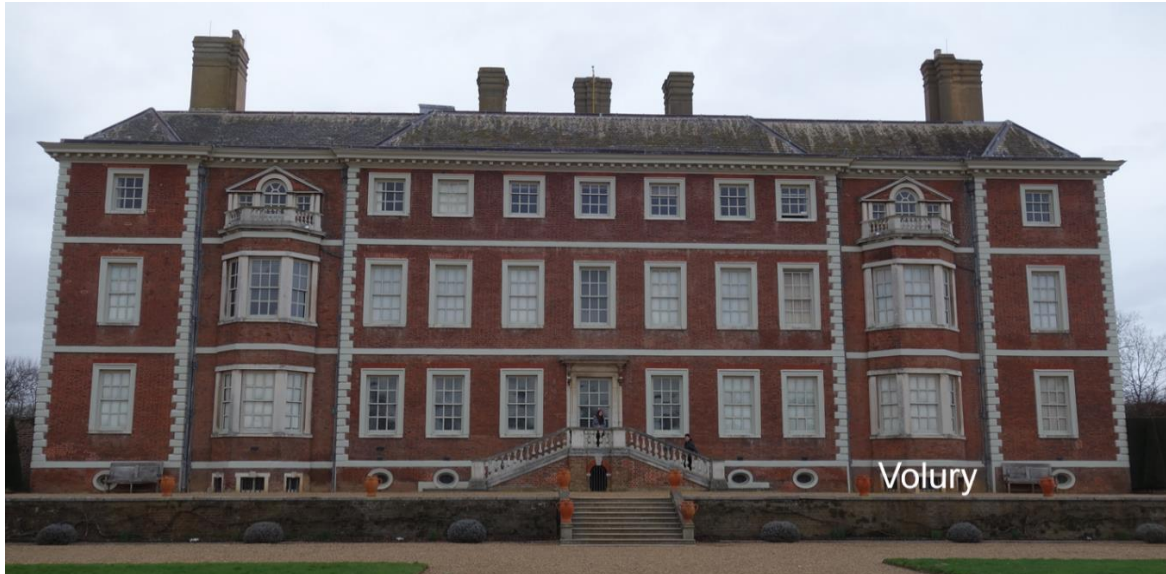
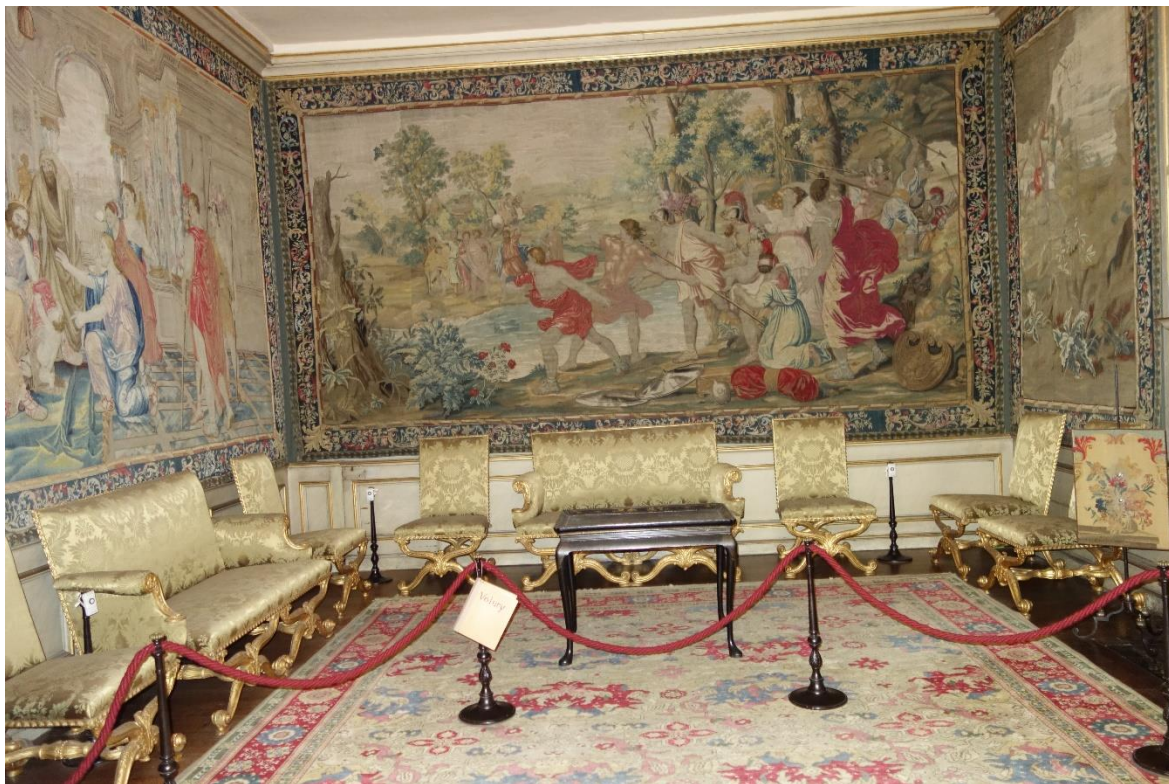
Figure 1. Top: south front of Ham House with the Volury bay windows labelled. Bottom: looking into the Volury from the bay windows

The Volury, a south-facing ground floor showroom at Ham House, was chosen as a case study (Figure 1) of a seventeenth-century (1610–1670s) structure with smaller

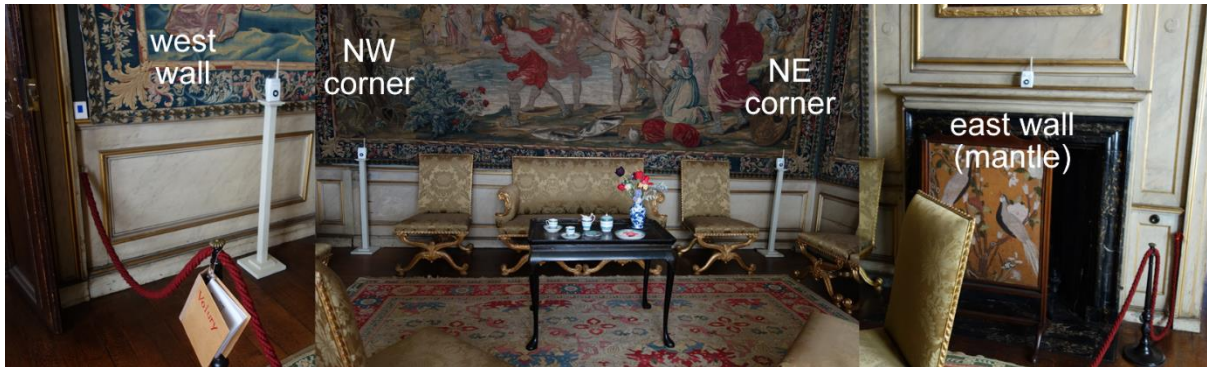
Figure 2. Composite image showing lux sensor locations in the Volury, blue wool dosimeter on the far left of the west wall. The HDR camera was located high up in the south east corner with a view of the north and west walls.

150,000 lux hours being equivalent to annual display in a museum at a level of 50 lux (Bullock and Lloyd 2011). Daylight exposure is monitored using a blue wool dosimeter (BWD) at the lower left corner of the tapestry on the west wall (Figure 2).

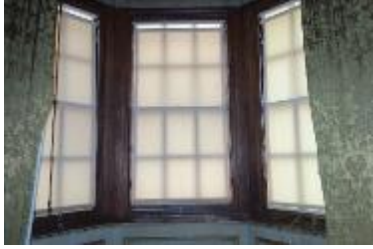
Weather	Holland blind setting	Depiction
<i>Sunny day</i> – clear sky conditions all day	Both blinds fully down on all three windows

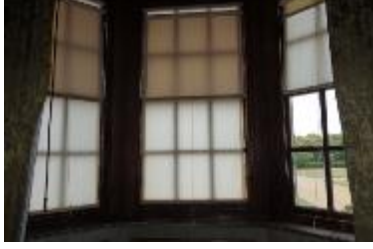
<i>Sunny morning</i> – clear sky and direct sun from the south east	East and centre windows with one blind fully down, second blind ½ down; west window one blind ½, allowing a view out

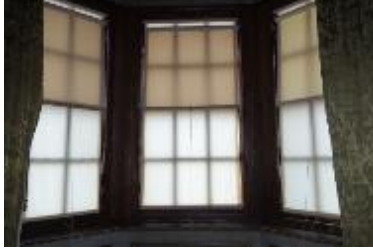
<i>Sunny afternoon</i> – clear sky and direct sun from the south west	West window both blinds fully down East and centre windows one blind ¾ down, second blind ½ down, allowing a view out	 
<i>Dull, some sun</i> – variable conditions with sun likely to break through from time to time, so one blind set fully down to exclude any direct sun	On all windows: one blind fully down, second blind ½ down

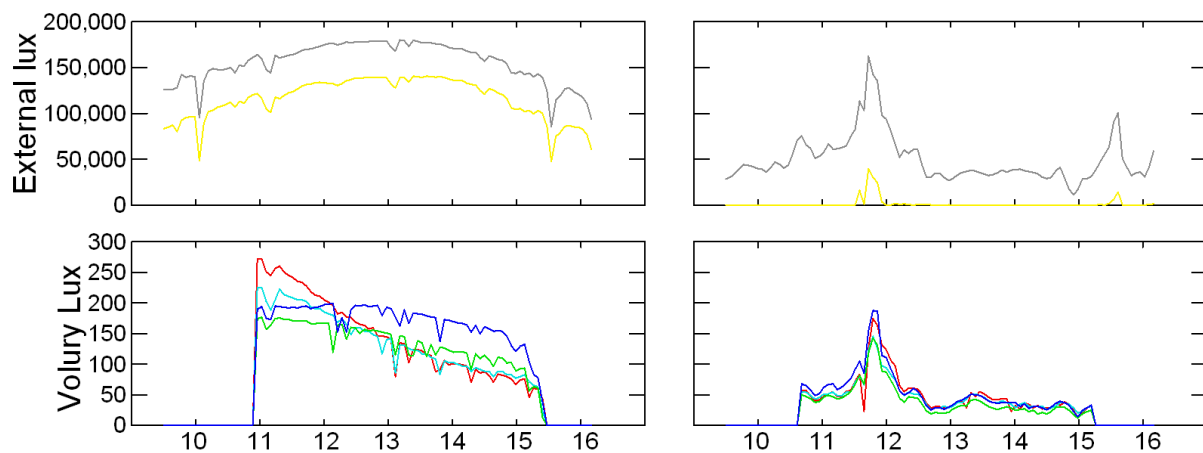
Figure 3. External and Volury illuminances by hour of the day. Left: 28 June 2019, with continuous sunshine and *sunny day* blind setting; right: 19 June 2019, a mostly overcast day with *fully overcast* blind setting. Key to the Volury sensors: west wall (red), NW corner (cyan), NE corner (green), mantelpiece (blue), external sensor total global horizontal illuminance (grey) and direct sun (yellow).

A detailed description of two days, illustrating the range of daylighting conditions, will introduce the broader conclusions drawn (Figure 3). 28 June was a day with continuous direct sunshine as shown by the external illuminance plot. Most of the light received was direct sun with some sky light. There was little variation in the external light level during open hours. In the Volury the two blinds sets were lowered completely to exclude direct sun, so that daylight reaching the interior was entirely diffused by the blinds. In the morning the west wall directly facing the sun received the highest illuminance, over 250 lux. As the sun moved round, the illuminance gradually tailed off, without going below 100 lux. This pattern is mirrored at the NW and NE corner sensors. The mantelpiece sensor on the east wall faces the sun's position for most of the opening hours and shows the least variation in illuminance, around 200 lux for most of the day. At these light levels the interior and tapestries are likely to be well illuminated for visitors.

In contrast, 19 June started overcast and the blinds were, therefore, raised completely. The external data show much lower illuminance, a quarter of that on the

sunny day. The four Volury measuring points track each other closely, with illuminances of 50–100 lux in the morning, rising to 180 lux when the sun came out between 11.00 and 12.00, suggesting direct sunlight was admitted for a short time. In the afternoon the illuminance fell to 30–50 lux. When cloudy, with the blinds fully raised, viewing conditions are mostly adequate but some visitors may struggle to see the room well.
