Review

A Geological Perspective on Climate Change and Building Stone Deterioration in London: Implications for Urban Stone-Built Heritage Research and Management

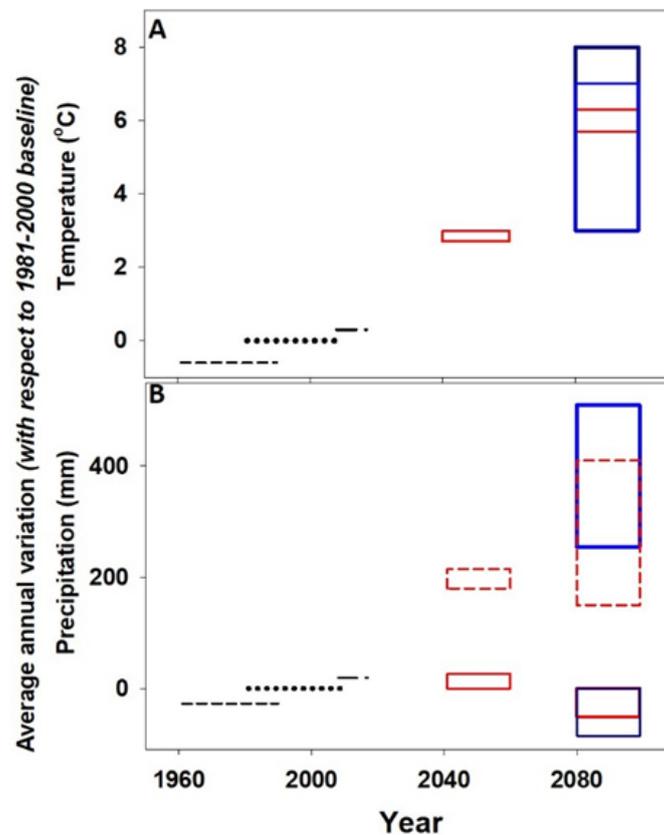
Figure 1. Decadal variation with respect to a baseline of 1981–2000 of annual (A) temperature (B) precipitation marked by dotted (1981–2000), dashed (1961–1981) and dash-dotted (2008–2017) lines, based on UKCP18 projections (Met Office, 2019) [5]. The boxes denote predictions for England (red) and London (blue) with dark and navy for summer and winter, respectively, for London. Solid and dashed boxes mark seasonal projections for summer and winter, respectively, for England. An increase in temperature is observed throughout for England with a predicted significant rise from 2040. This is even more pronounced for London from 2080. A significant increase and decline in precipitation are predicted for London during winter and summer, respectively, towards the end of this century. See text for further discussion.

In London, considering the effect of climate change (Figure 1) with predicted wetter winter months and higher annual precipitation, ion diffusion may become more pronounced as a mechanism of salt transportation and the salts are likely to stay in solution longer [63]. While this will delay the onset of crystallisation of the salts on one hand, on the other hand it may considerably weaken the rock cement by extending further the depth of the wetting front and increasing further the mobilisation and precipitation of the constituent elements of the rock mass. Consequently, when the salt eventually crystallises out of the solution, the rock will be too damaged to withstand any stress and may damage more easily. The decay initiated at the surface, will vary with depth of the material, with some time delay before the onset of decay at the deeper portions of the building material [60]. Biodeterioration can be more pronounced for the mesophilic fungi that flourish under temperature of 20–45 °C under enhanced relative humidity in the future. The biogeochemical effects of organisms can promote salt attack by increasing the moisture content and pore volume while precipitating sulphates and oxalates [68]. On the other hand, it can decrease salt weathering by reducing the effective permeability, preventing pollutant accumulation and altering thermal characteristics and wetting times of stone. With predicted greater seasonal variability in rainfall and consequent relative humidity, the swelling and shrinkage of different clay phases can have different impacts on the mechanical and fracture behaviour of the building stones. High swelling clay phases such as smectite and glauconite can have great influence on the stone properties, even with low moisture content during the summer, while the less swelling chlorite and interlayers of chlorite–smectite can impact only when the moisture content is higher during the winter months [69].

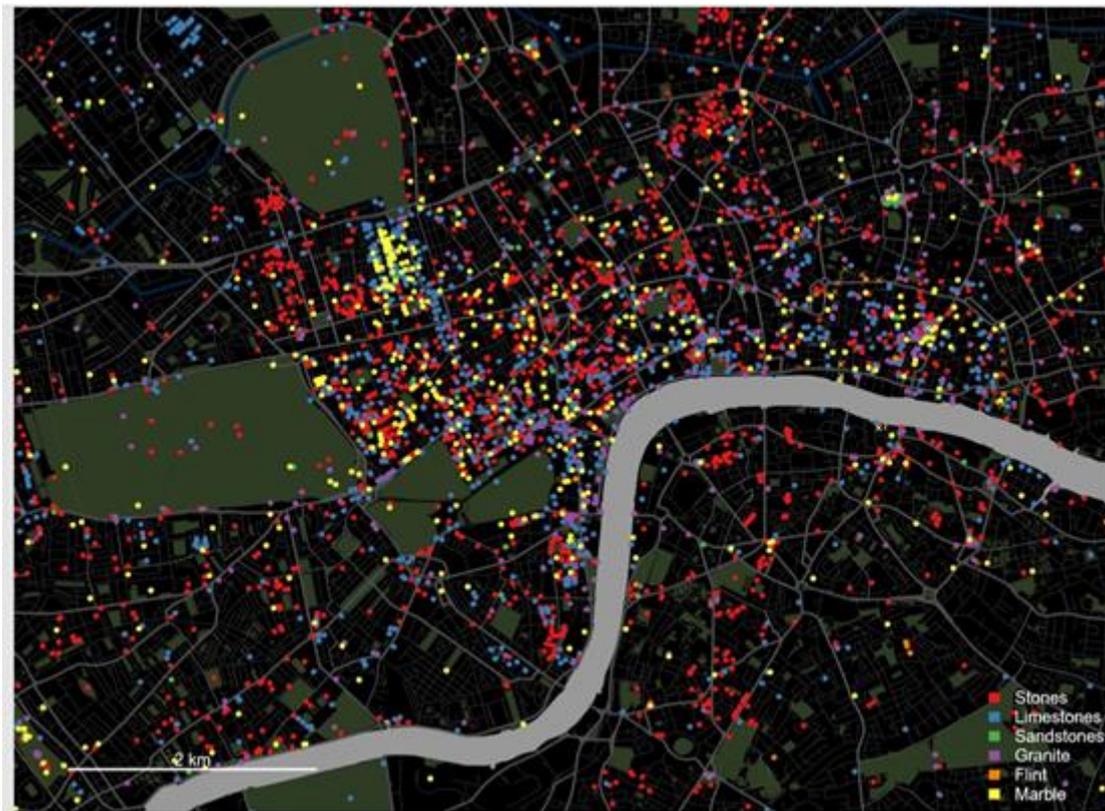
Figure 2. Spatial distribution of common building stones in London including stones (nonspecific), limestone (Portland, Clipsham, Caen and Rag) sandstone (Reigate and others) granite, flint and marble. Portland stone is the most common of the specified varieties.

The durability of building stones can be assessed by their ability to resist weathering so that their original size, shape, strength and appearance are retained over an extensive period of time [16]. Rocks weather by a combination of processes including dissolution, salt crystallisation and freeze-thaw activity that are influenced by extrinsic attributes such as meteorological factors and pollution, as well as intrinsic attributes including the petrological and petrophysical properties of the stones. The effect of air pollutants depends strongly on the physical, chemical and mineralogical properties of the lithotypes under consideration as discussed below. The building stones used for important heritage sites in London are listed in Table 1 and shown in Figure 2.

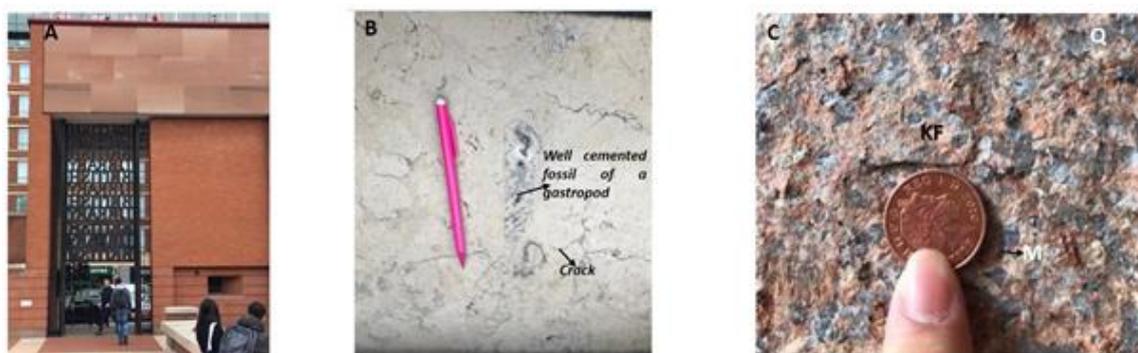
Figure 3. Different building stones used on the British Library exterior, Euston road [17]. (A) Red Sandstone: The red colour, related to its deposition under desert conditions and formation of iron oxide as coatings on the grains makes it aesthetically pleasing. While the pore spaces can provide pathways for water transport and salt deposition, iron oxide acts as a barrier for any reaction with the constituent grains. Laminations are visible, restricting transportation across the layers. Closer inspection is required to comment on its maturity, that will have implications for pore size distribution (unimodal versus bimodal) and consequent ability to transport water by capillary flow. (B) Hauteville Limestone has a crystalline texture and is thereby hard and compact, making it suitable as a paving stone. Compositionally it is homogenous, dominantly made of lime mud which reduces the possibility of differential weathering, except where pits are formed due to preferential removal of uncemented fossil fragments. However, many of the fossil fragments are well cemented, adding to the overall hardness of the rock. The white colour of the rock is partly discoloured to yellow related to salt formation and deposition. The slabs show microcracks due to differential expansion of the carbonate minerals. (C) Royken granite’s interlocking mineral grains result in a crystalline texture that gives it compactness and strength, making it suitable for use as a building block for the steps and facade of the library. The reddish colour of the rock can be attributed to the presence of ~60% potassium feldspar (KF), the most abundant mineral present with quartz (Q) and mica (M). The quartz grains are mm sized with no visible fissures under hand lenses or naked eyes. The potash feldspar and mica can be prone to kaolinisation and effects of weathering which is evident from the diffused boundaries of the discoloured feldspar. Its finer grain size makes it prone to chemical weathering because of the large surface area available. Differential weathering between the micas and the quartz can leave pits on the exposed rock surfaces. Currently unpolished, however, polishing later can fold and deform the micas if the polishing plane is oblique to the cleavage planes of the micas.

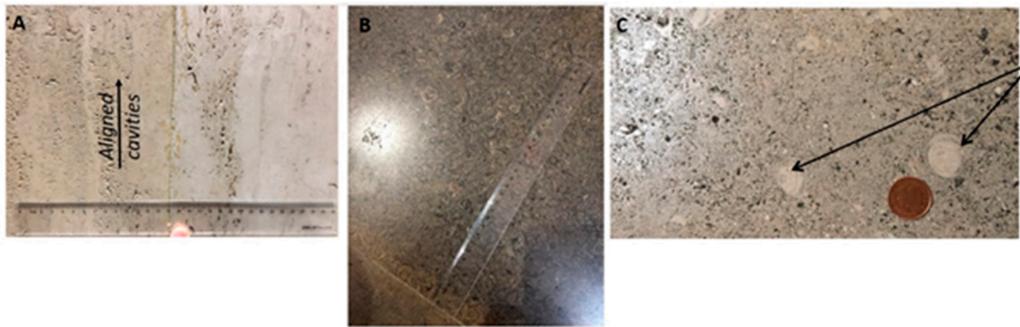
Figure 4. Building stones used in the British Library interior, Euston road [17] including (A) Jura travertine which is a spring deposit from volcanic activity. It is compositionally calcareous, and because of its textural homogeneity, it is advantageously used as a building stone. The macroporosity, arising due to the hollow stems of rushes and plants that flourished in the spring water, attributes a pattern to the rocks due to their alignment and contributes to the total rock porosity while reducing the overall strength of the rock. However, they can still be quite compact where they are structurally massive, lacking bandings and laminations. The macroporous bands act as weak points and, when oriented perpendicular to the load direction, attribute minimum mechanical strength to the building stone [18]. Notably, they do not result in an increase in capillary transport if not connected. At many points, the pore spaces have been infilled with synthetic material to provide a more consistent surface that helps with cleaning. Naturally infiltrated clay minerals result in faint banding adding to the beauty of these stones. (B) Purbeck limestone is highly fossiliferous with abundant fragments of fossil bivalve shells giving it a well patterned appearance. It is dark in colour as deposition occurred under muddy, shallow, freshwater conditions. Because of the hardness, the limestone can be polished and forms a good substitute for more expensive marbles. Cracks are observed but are often cemented. (C) Portland stone is an oolitic limestone, well cemented and compact, and lacks any directional properties making it convenient to cut in all directions. Some calcareous algal pellets are present with some minor oyster shell fragments that have left pits where they were ripped off preferentially by constant foot tread.

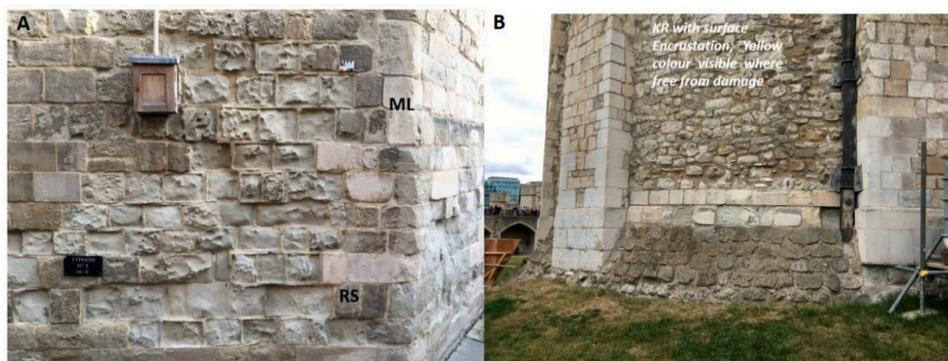
Figure 5. (A) The building stones at the Tower of London including Reigate stone (RS) and magnesian limestone (ML). Although a combination of stones including Caen and Quarr have been used [19], because of surficial damage identifying the individual building stone can be sometimes challenging. (B) The Kentish ragstone (KR) appears damaged with surficial encrustation. Portland stone has been commonly used as replacement blocks identifiable by their sharp boundaries and pale colour. Image credit: Historic Royal Palaces; used with permission.

Kentish ragstone (Lower Greensand Bed) [19]	Kent (~115 to 110 Ma)	Grey in colour, consisting of rounded detrital grains of quartz and the green iron silicate mineral glauconite, with associated bioclasts, cemented by diagenetic calcite.	Hard due to cementing that contributes to the overall strength.	Numerous fractures, identified under optical microscope, distributed throughout the rock contribute towards a high secondary porosity that weakens the rock structure. An inhomogeneous texture and high microporosity that can be attributed to diagenetic recrystallisation contributes to the degradation of the stone.
Sandstone				
Reigate stone (Upper Greensand Bed) [84]	Surrey Lower Cretaceous (105 Ma)	Calcareous sandstone/sandy limestone. Sandy and glauconitic, well cemented with silica and calcite cement. Bioturbation features are common. Beside glauconite, bioclastic debris also comprises the framework, with dominant fine to medium grained quartz.	Variation in the proportion of quartz grains, glauconite and carbonate cement/matrix. Though, if well-cemented, it can be highly durable and requires low maintenance over its life [85]. Additionally, it has a high thermal expansion capacity.	Often soft and weakly compacted and porous, and therefore swells when wet. Exhibits pronounced contour scaling and flaking when exposed (Figure 5) and surface powdering in sheltered areas.

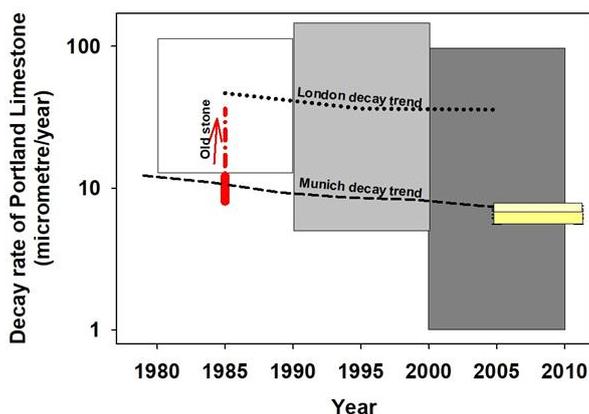
Figure 6. Decay rate of Portland stone in St. Paul’s Cathedral, London, over three decades marked by boxes in white (1980–1990), light grey (1990–2000) and dark grey (2000–2010). The dotted line represents the trend indicating decline of the average decay rate. The decay rate for Mainz (dark yellow box) and Munich (light yellow box) and Trinity College Dublin (orange blob) are shown for comparison. The dashed line indicates the decline of the average decay rate for the stone in Munich. The orange arrow indicates an increase in decay rate for an old stone (relatively weathered rock) as compared to its new stone counterpart. Note that the decline in the trend of the decay rate for both London and Munich are not gentle in spite of the drastic reduction in the concentration of atmospheric SO₂ over the same time period in both the cities. This indicates that other parameters are important in controlling Portland limestone deterioration. For further discussion, see text. Data sources: [27–29].

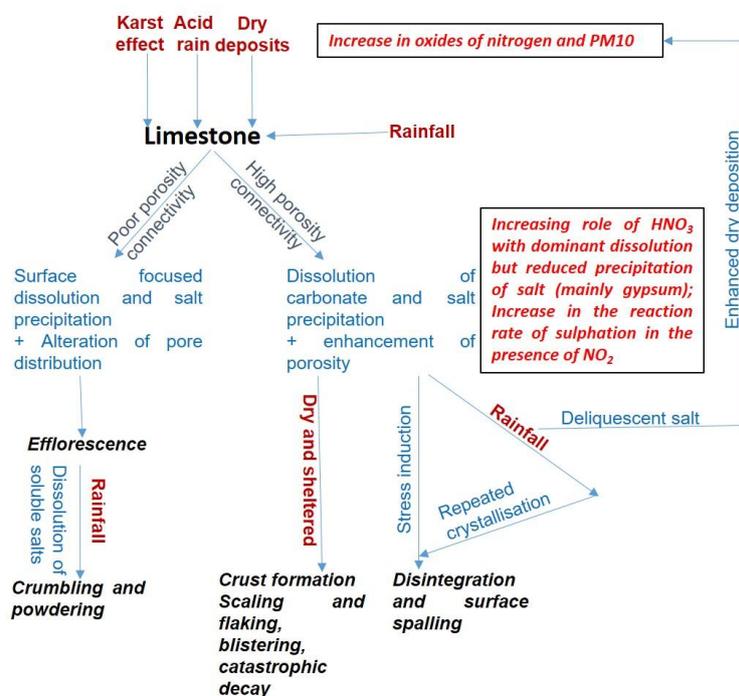
Figure 7. A model of limestone decay in urban settings, modified after [34,42]. Both rainfall and dryness may increase in the future as well as the concentration of atmospheric nitrogen oxides in London and other urban cities (indicated in red font in text boxes) which will affect decay processes (indicated in black font). In marble, microbial communities on stone surfaces are commonly observed. The surfaces can be cleaned by using suitable compounds although they can be subsequently recolonised [43]. Marble is also prone to efflorescence of salt such as sodium sulphate resulting in significant dissolution, with calcite being more susceptible than dolomite, reflected in a loss of gloss [44]. Degradation by microcracking is another major problem for marble, which is more pronounced during cooling than heating. This commences at a higher temperature differential for dolomitic marbles as dolomite has a lower thermal expansion anisotropy than calcite [45]. In addition, microcracking occurs at a larger temperature differential for decreased grain size and increased shape and lattice preferred orientation [45]. However, the effects of grain size and grain boundary were found to be insignificant for some marbles and made no difference even for polygonal grains with interlobate boundaries, but those with strong texture exhibited minimal residual strain following thermal treatment [45]. In the context of London and predicted temperature change, since cooling is expected to decline with time, any microcracking will be relatively limited.

In addition to crust formation, powder efflorescence can also occur, dominated by magnesium sulphate and only minor gypsum [33]. Due to the high solubility of magnesium sulphate, it only accumulates when water run-off is absent, which occurs in parts of structures that are sheltered. This also has implications for the predicted dry summer months in England where magnesian limestones are in use. Limestones are susceptible to soiling due to the accumulation of carbonaceous matter within the pore spaces, although soiling can be undone with cleaning [36]. Soiling can be locally concentrated, being determined by wind direction and protection from the rain, as well as the application of protective treatments that induce greater particle matter accumulation [37]. The process of limestone deterioration is summarised in Figure 7.

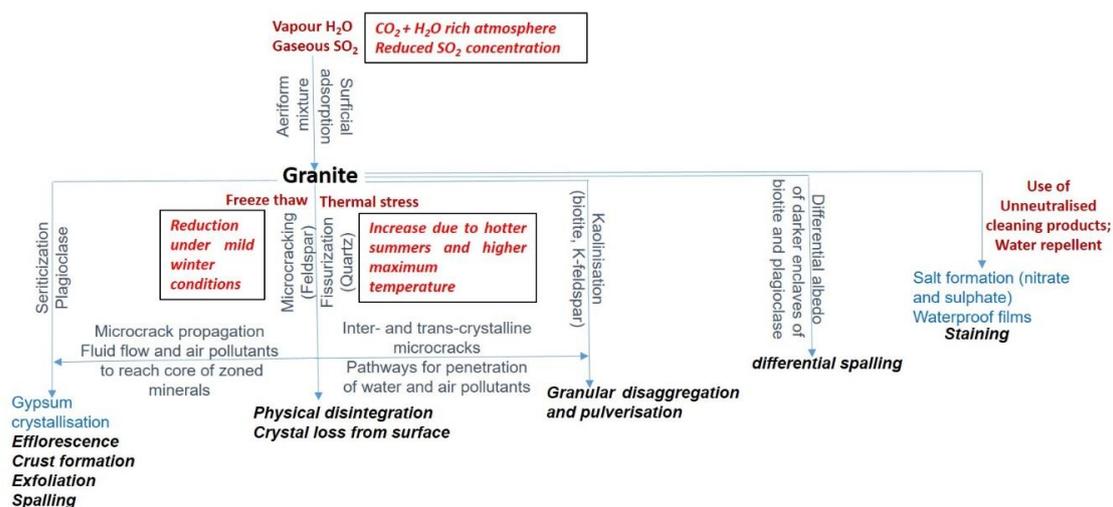
Figure 8. Model of granite decay in an urban setting. Since the concentration of atmospheric sulphur dioxide in London and other urban cities is expected to continue to decrease, the frequency of many decay processes for granite such as kaolinisation and gypsum crystallisation are also likely to be decrease.

suggesting that the biological patina often derives its constituents from the disaggregated granitic surface [50]. As the feldspars, both plagioclase and potash feldspar, undergo microcracking due to physical weathering processes such as freeze-thaw, it results in crystal loss and facilitates chemical alteration processes by providing access pathways to fluid flow and air pollutants [48]. This is in agreement with observations of the higher rate of chemical weathering for plagioclase than K-feldspar, that can be related to the increased rate of physical weathering for plagioclase driven by different mechanisms of microcracking related to their microstructures and crystallographic anisotropies. Zoned, plagioclase crystals with a high number of core microcracks are susceptible to seritisation at the core where there is also more calcium than in the perimeter zone, driven by a combination of deuteritic alteration and physical disintegration. However, under predicted climate change for London, due to relatively wetter but warmer winter conditions [5], freeze-thaw processes may be greatly reduced in the future. Sometimes a heterogeneity in relief can be observed for granitic surfaces with darker, microgranular enclaves appearing to be more weathered than the surroundings. This phenomenon is poorly understood but can be related to the lower albedo of the darker enclaves enriched in biotite and plagioclase, as compared to the remaining rock. This promotes differential spalling with only a thin detachment of the stone where the decay is accelerated by the lower conductivity and the heat capacity leading to overheating of the enclaves [52]. The processes of deterioration of a granite is summarised in Figure 8.

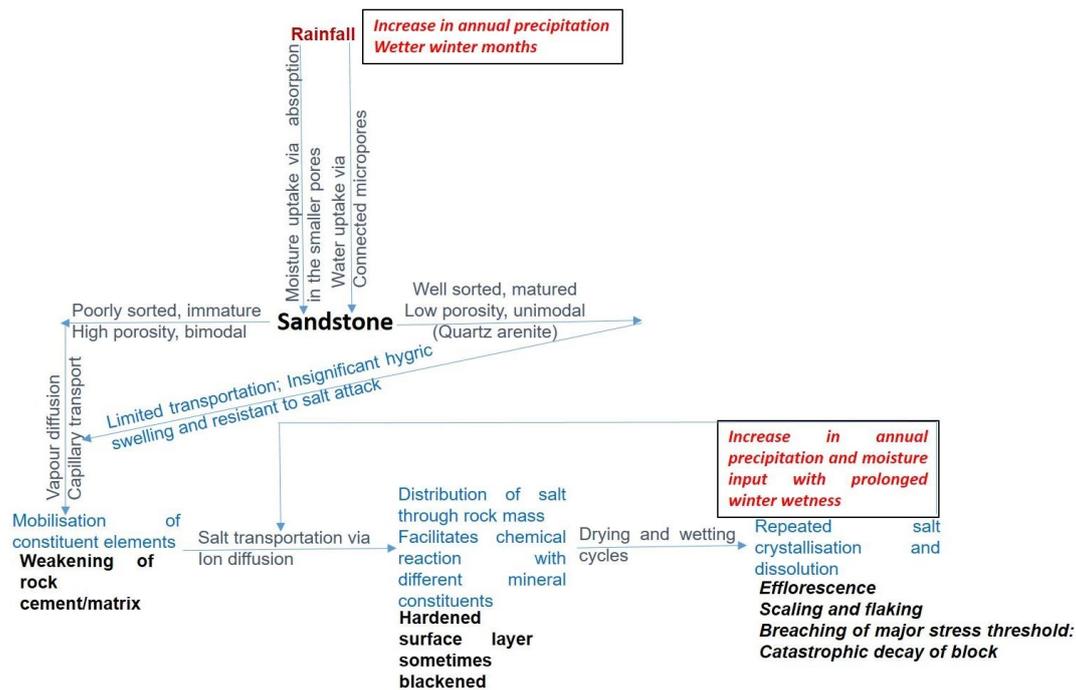
Figure 9. A model of sandstone decay in an urban setting, modified after [34]; predicted overall increase in annual rainfall and prolonged wetter winters for London in the future (indicated in red font in text boxes) can affect corresponding decay processes such as the onset of salt crystallisation and period of wetting.

Salt weathering in a sandstone, controlled by fluctuations in temperature and moisture, occurs when there is frequent wetting and drying in the near-surface zone. This causes repeated crystallisation of salt with complex three-dimensional distribution in the rock mass, that undergo repeated hydration/dehydration and expansion/contraction [63]. It leads to efflorescence and finally, in surface losses in the form of granular disaggregation, scaling and multiple flaking [63]. Although stone surfaces may appear stable for a considerable period of time, the stress caused by accumulated salts can eventually exceed the threshold of stone strength and trigger material loss [65]. The penetrating saline solution can lead to selective silica dissolution thereby weakening the stone matrix and/or the grain boundary cementing. Biodeterioration of sandstone occurs as a result of the dissolution of the constituent silicates and nitrates and particularly the carbonates that often weaken the stone cement, this is due to the action of carbonic acid formed when the surface water reacts with the produced carbon dioxide from microbial respiration [66]. Under increased moisture conditions, with a relative humidity of 80 to >90%, fungal infestation can be particularly enhanced—especially when the porosity is high, and the pores are interconnected. The fungi further proliferate in the presence of black crust and also activate formation of new biominerals [67]. The prevalent deterioration processes of sandstone are summarised in Figure 9.

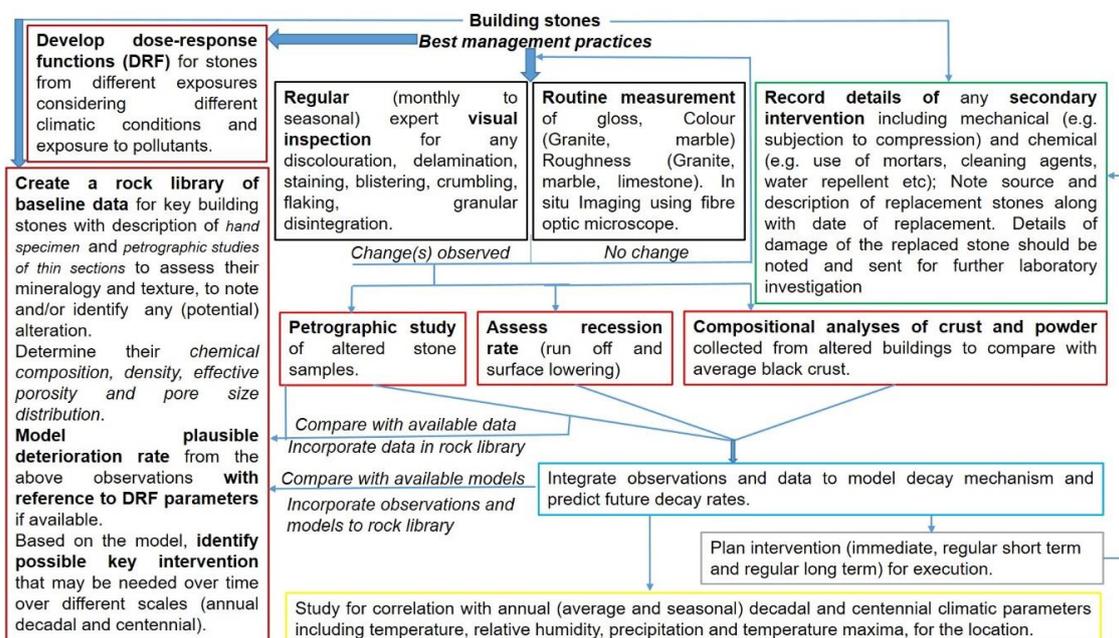
Figure 10. Best management practices for assessment and preservation of building stone deterioration with time.

The key to long-term preservation of building stones is regular monitoring and maintenance to take timely intervention or replacement to reverse, minimise and arrest further deterioration (Figure 10). Some key methods for monitoring are discussed below.
