Eleventh U.S. National Conference on Earthquake Engineering
Integrating Science, Engineering & Policy
June 25-29, 2018
Los Angeles, California

Multi-Hazard Physical Vulnerability Prioritization of School Infrastructure in the Philippines

A. Nassirpour¹, C. Galasso², D. D'Ayala³

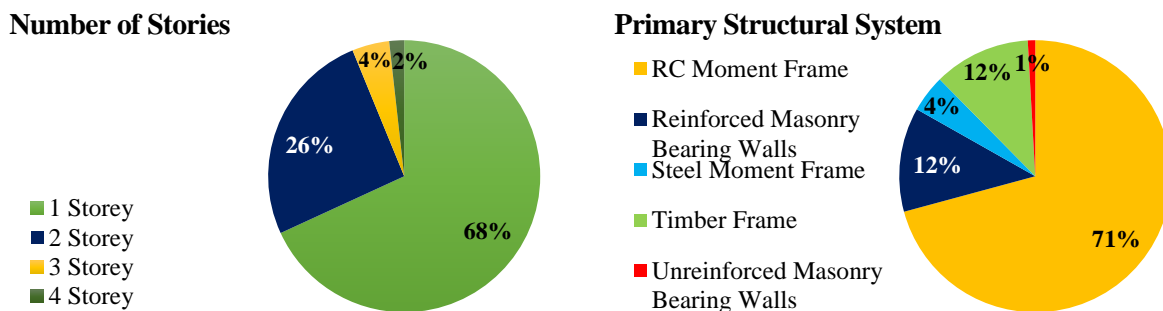
Figure 2 – Statistics on number of stories and primary structural systems of surveyed schools in Cayan de Oro – Philippines

A total of 115 school buildings have been visually surveyed in four days. All the surveyed structures are in elementary grade campuses in different locations of CdeO. A number of surveyed buildings are designated as shelters in case of any disaster. In each school campus, a mixture of buildings with various construction years, material, structural system, and function co-exists. As expected, a variation in the type of materials, workmanship and technology during the construction was observed, even in case of identical buildings. The structural type of the surveyed buildings ranges from masonry with timber roof to reinforced concrete (RC) framed structures, with steel trusses supporting the roof. The typical number of stories range between one to four stories, with a majority being single-story. The plan shapes in most cases varied from regular square to rectangular plan with a few rare cases being L-shaped. Most of the surveyed buildings were constructed after 2010, while a considerable number were from the 1990s.

The construction year was obtained mainly from the school’s registry documents or through interviewing locals. In a few cases (16%), the accurate built year could not be found and was indicated as unknown. As anticipated, signs of decay and poor structural conditions were observed in the structures which have been constructed over long periods of time. Statistical representations of the collected data on schools are illustrated in Figure 2 and 3.

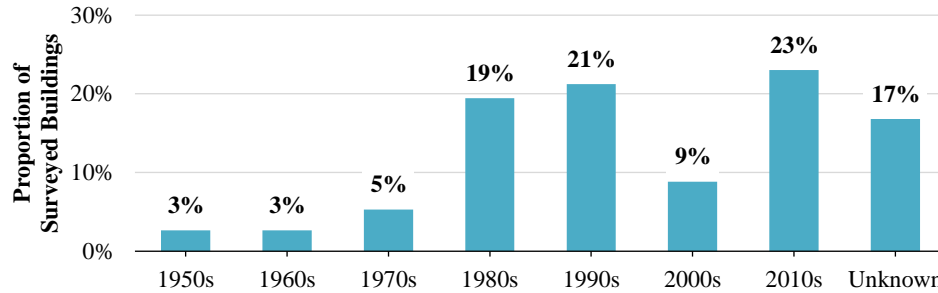
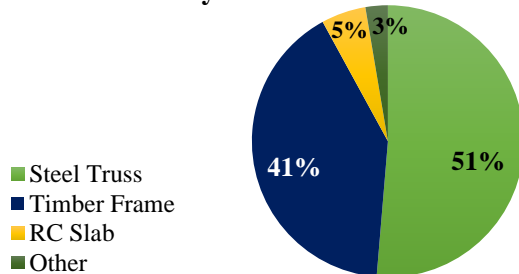
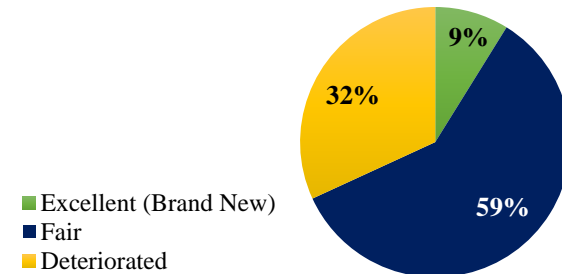
Construction Year

Roof Structural System

Roof Condition

Figure 3. Statistics on construction year, roof structural systems and condition of surveyed schools in Cayan de Oro – Philippines

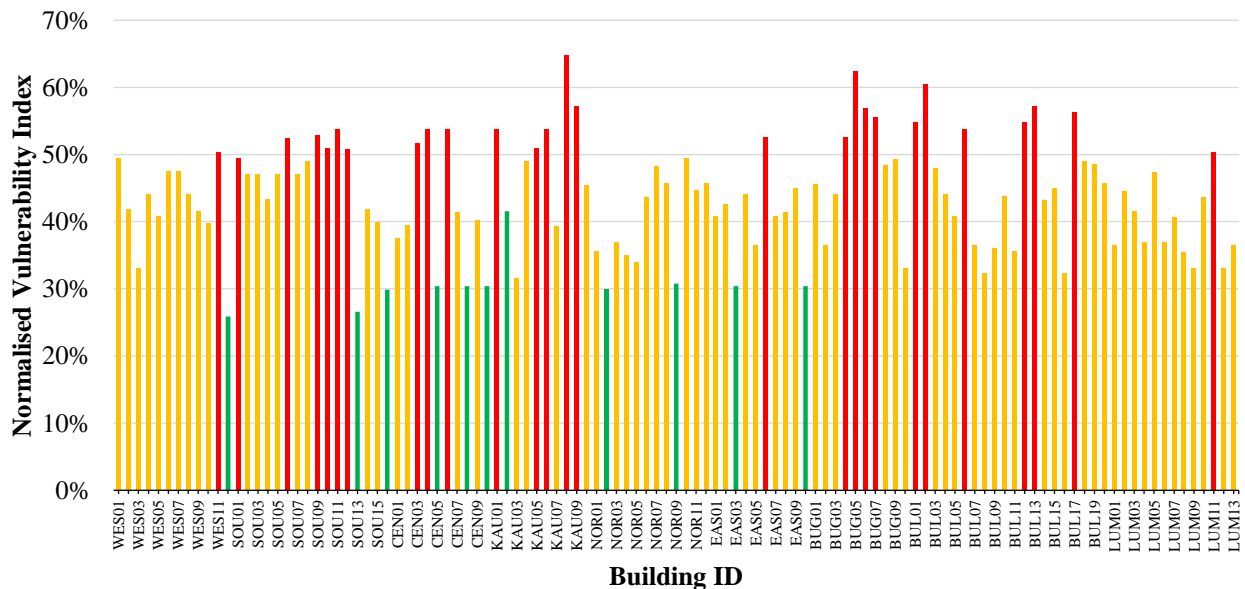
Figure 4. Vulnerability Index of 115 Surveyed Schools in Cayan de Oro - Philippines

As shown in Figure 4, 26 structures (22.6%) have high overall vulnerability ($VI > 50\%$), hence any more detailed structural assessment and retrofitting/strengthening planning should be prioritized for these buildings. The number of schools with moderate vulnerability is 78 (67.8%), while only 11 schools (9.56%) are characterized by a vulnerability index lower than 30%. Accordingly, the most vulnerable surveyed structure is KAU08 ($VI = 64.8\%$), i.e., a highly deteriorated masonry structure with unreinforced bearing walls, built in 1983, and located in Kauswagan Central School (Figure 5-left). Similarly, BUL02 ($VI = 60.5\%$; Figure 5-right) is a timber frame, single story, built in 1985, consisting of one classroom ($9\text{m} \times 4.8\text{m}$) with timber supports for its roof. The general condition of the structure as well as its roof and the connections have been described deteriorated. In both cases, the buildings were susceptible to pounding effect and short column.

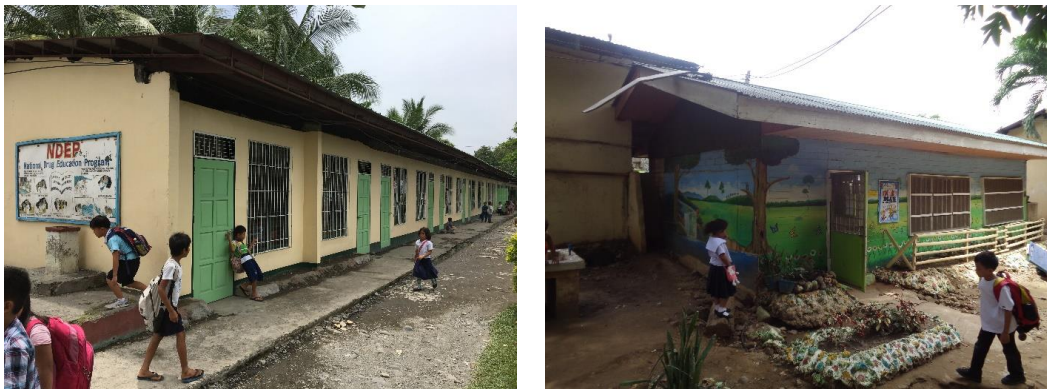
Figure 5. left: Kauswagan Central (ID: KAU08), right: Bulua Central (ID: BUL02)

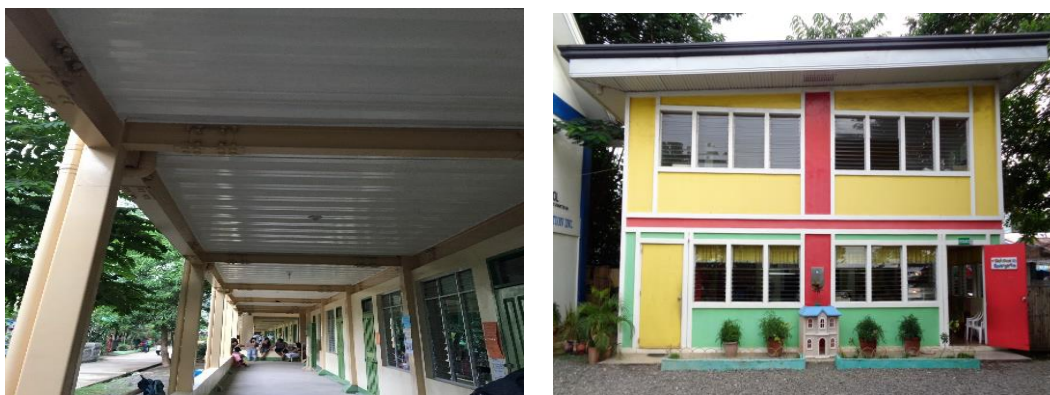
Figure 6. left: West City Central (ID: WES12), right: South City Central (ID: SOU16)

On the other hand, the structure with the lowest vulnerability index ($VI = 26\%$) is an isolated, brand new steel frame building in West city central school compound (ID: WES12). The building consists of two stories ($25.6\text{m} \times 6\text{m}$) and four classrooms in excellent condition and no report on obvious deficiencies (Figure 6-left). Similarly, a RC building, located in south city central school complex scored a vulnerability index of 29.9% (Figure 6-right).

The building was built in 2012, consists of two floors and two classrooms with a steel truss roof. According to the collected data, the building is in an excellent condition with high-quality connections between the columns and the roof and no visible deficiency is observed.

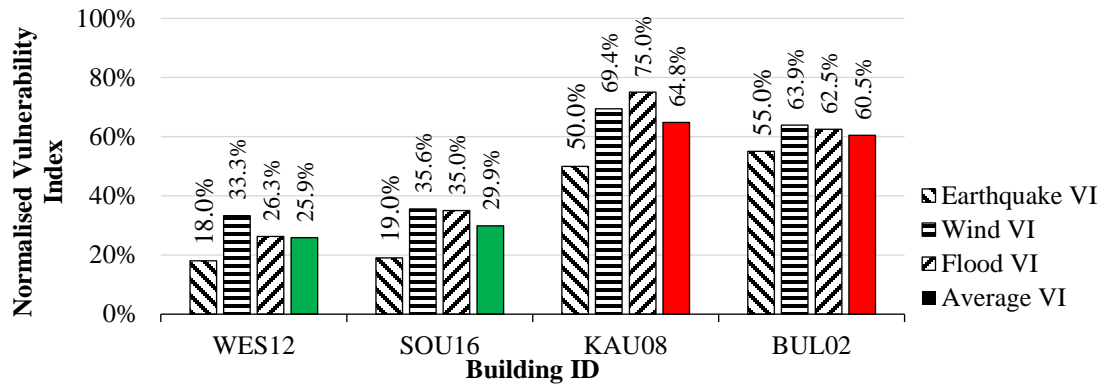
Figure 7. Evaluated vulnerability index of buildings based on the different hazards

Figure 7, illustrates the individual VI values estimated for the discussed buildings with respect to each hazard and the average value.

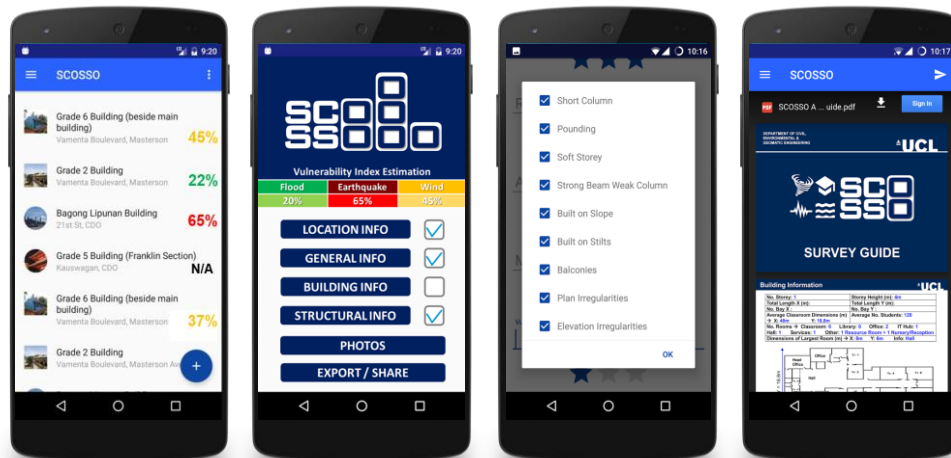
Figure 8. Interface of SCOSSO Mobile Application

A mobile application has been developed to assist the surveyors by increasing the efficiency and speed. The discussed rapid visual surveying form has been implemented completely in the application, featuring a simple and easy to use interface. The app allows users to capture photos of the surveyed structures, store the collected data offline in their device and online in the cloud or share it through email as .csv file. Beside the traditional latitude and longitude location indicator, a built-in locator with a high precision of 3m in 3m is also included. The vulnerability of each surveyed building is estimated in real time and presented depending on the hazard as well as the average. Furthermore, a comprehensive guide is provided, demonstrating visual examples of the factors and options included in the surveying. The SCOSSO mobile application is freely available through the Google Play Store (Figure 8).
