Burton Mill Pond Vision and Work Programme

March 2018

Final report to West Sussex County Council (PR002504)

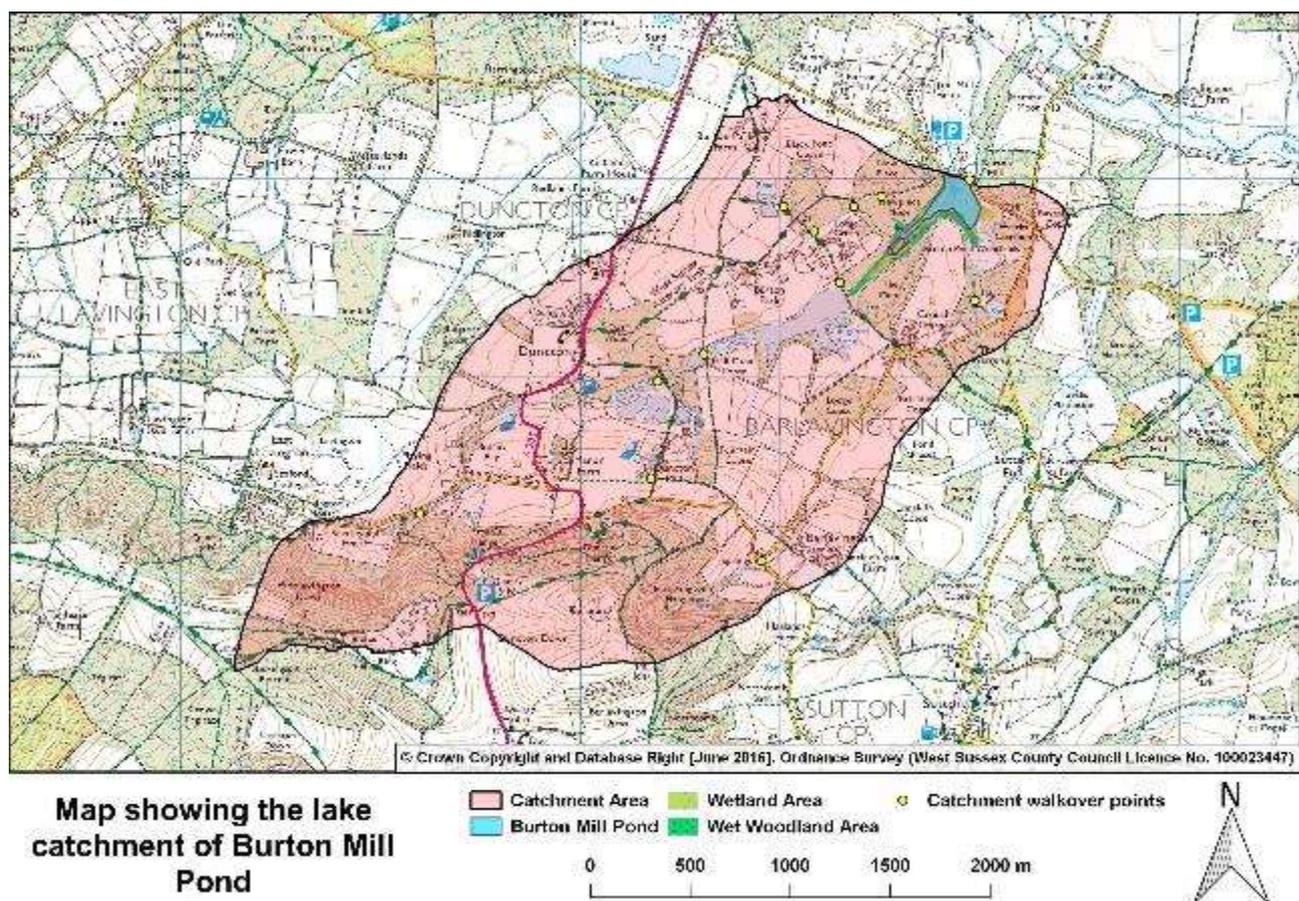
Figure 1 Map of Burton Mill Pond

Burton Mill Pond has a catchment area of approximately 507 ha (Environment Agency, 2016) draining an area mainly to the southwest of the site (Figure 1). The lake itself is underlain by a layer of bedrock which is part of the Folkestone formation, comprising sandstone with other superficial deposits creating an alluvium layer of clay, silt, sand and

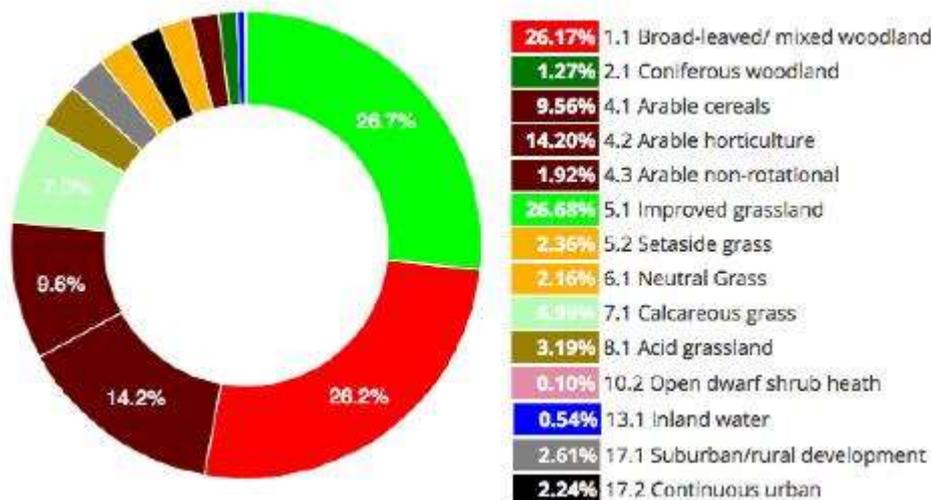
Figure 2 Land use data for the Burton Mill Pond catchment (from CEH 2016)

Land use within the catchment is mixed and, in part, governed by the varied terrain and complex geology. The upper slopes extend on to the South Downs and are dominated by mixed woodland, some of which is managed for timber production, but the majority of the woodland is permanent. Lower down in the catchment, there is a mix of good quality semi-improved grassland and a range of arable usage as well as residential developments.

covers the lower part of the catchment (Figure 2 and Figure 3). It is interesting to note that a significant proportion of the more intensively farmed areas of the catchment are being managed within Environmental stewardship schemes, including both Entry Level plus Higher Level Stewardship and Organic Entry Level plus Higher Level Stewardship, both of which should help to reduce nutrient inputs to the freshwaters.

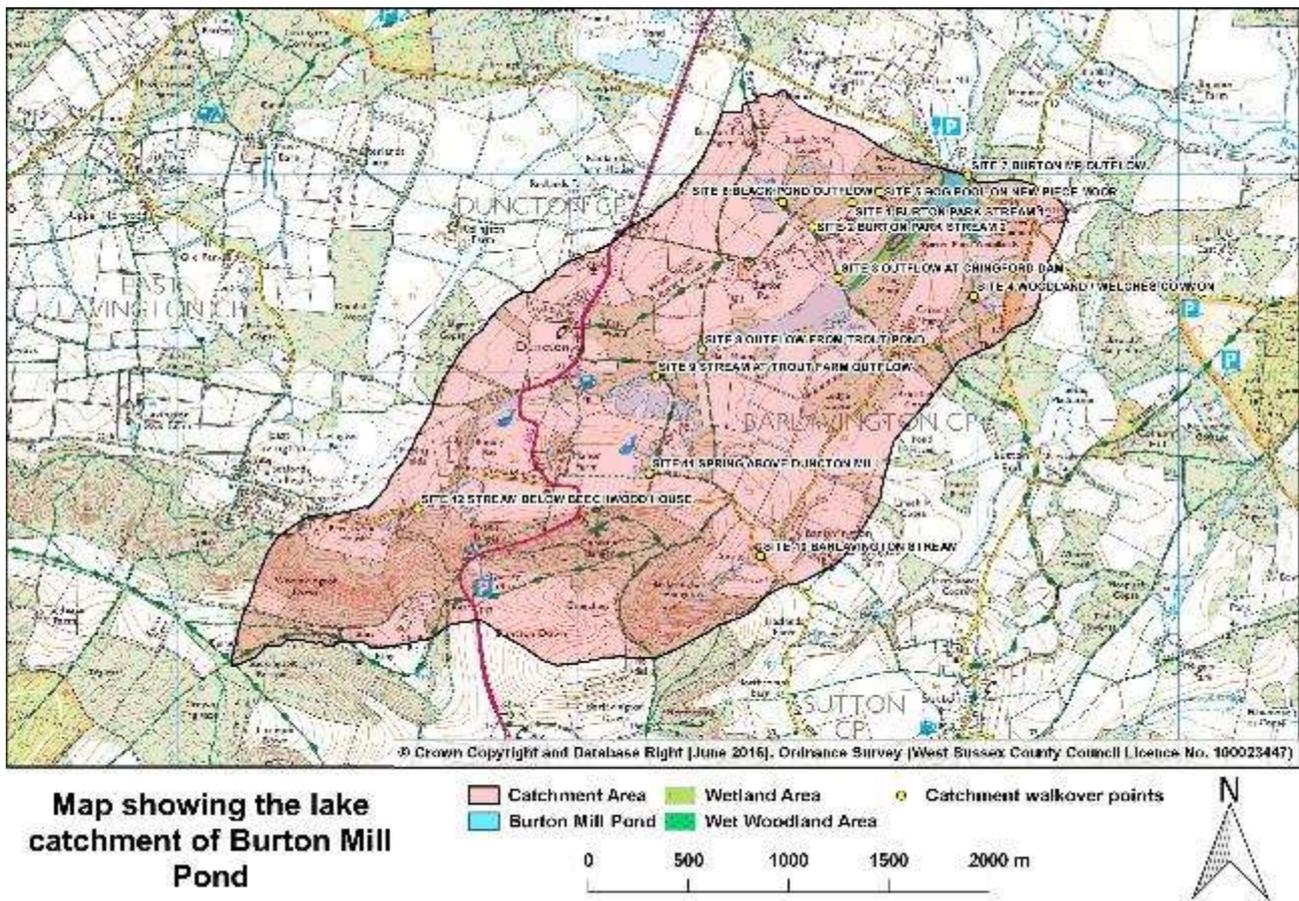
Figure 4 Site locations where water samples were taken.

The sites are discussed below, relative to their location and water quality. There were no concerns raised about significant sediment inputs other than at sites 2 (see below). At site 4, the slight increase in suspended solids was noted at time of sampling as disturbance during the collection of sample from very shallow water rather than any sediment load within the stream.

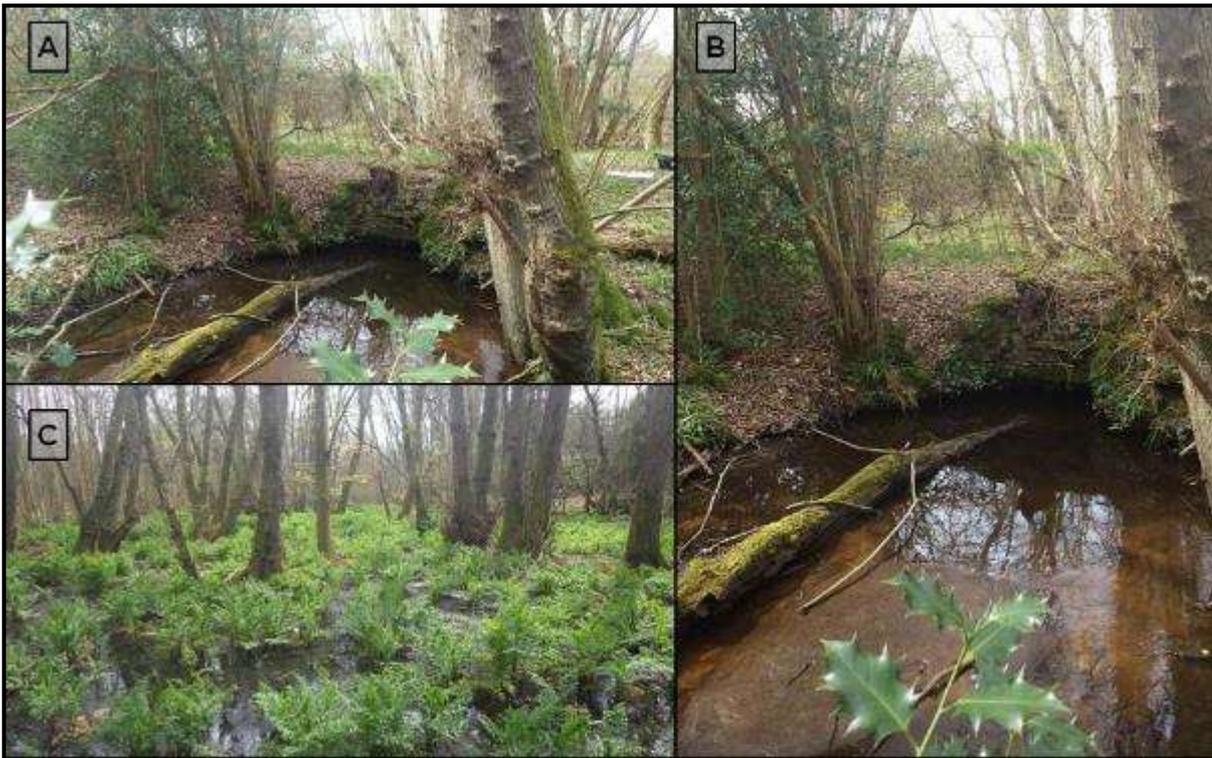
Figure 5 Photos A, B and C, Burton Park Stream (downstream)

A wooded stream, located downstream of Burton House (Figure 5, photos A and B). A water sample was obtained at the culvert, which at the time of the walkover was in poor condition. The stream was heavily silted and within the woodland, provides good habitat where natural obstructions such as fallen trees and foliage cause the channel to split and in places flood the woodland. A large fish (species unknown) was observed in the pool below the culvert. Immediately downstream of Site 1 was an area of wet alder and sycamore habitat, with an understory of *Carex paniculata* and *Oenanthe crocata* (Figure 5, photo C). Analysis of the water samples taken from the stream indicated that nitrate (TON) levels were slightly elevated, at 4.59 mg l^{-1} , and soluble reactive phosphorus (SRP) levels were high, measuring $67.6 \mu\text{g l}^{-1}$. The SRP level exceeds the phosphorus limits set for shallow mesotrophic lakes ($20 \mu\text{g l}^{-1}$) in the UK (JNCC 2015). The pH of the samples was neutral (7.38).

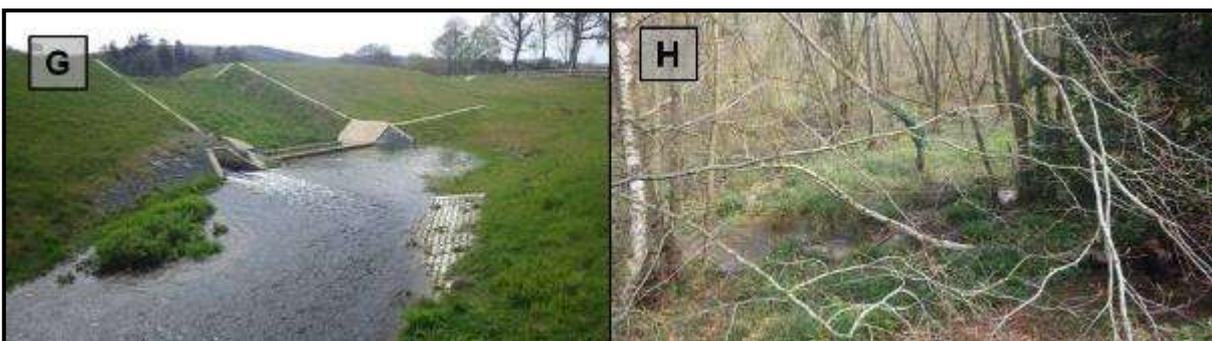
Figure 7 Photos G and H, Chingford Pond Outflow

As a result of the restoration works, the outflow is heavily engineered (Figure 7, photo G) but naturalised below the track, with good clean gravel beds present as the water flows back towards the cascade. The outflow stream continues through a pleasant area of wet woodland and *Carex* fen, towards Burton Mill Pond (Figure 7, photo H). Green filamentous algae (*Vaucheria* sp.) was present at the outflow. Total phosphorus was measured at a moderate $25.7 \mu\text{g l}^{-1}$ (where $20 \mu\text{g l}^{-1}$ is the recommended maximum level for a very shallow mesotrophic lake, JNCC 2015 CSM guidelines), while nitrate was 2.72 mg l^{-1} .

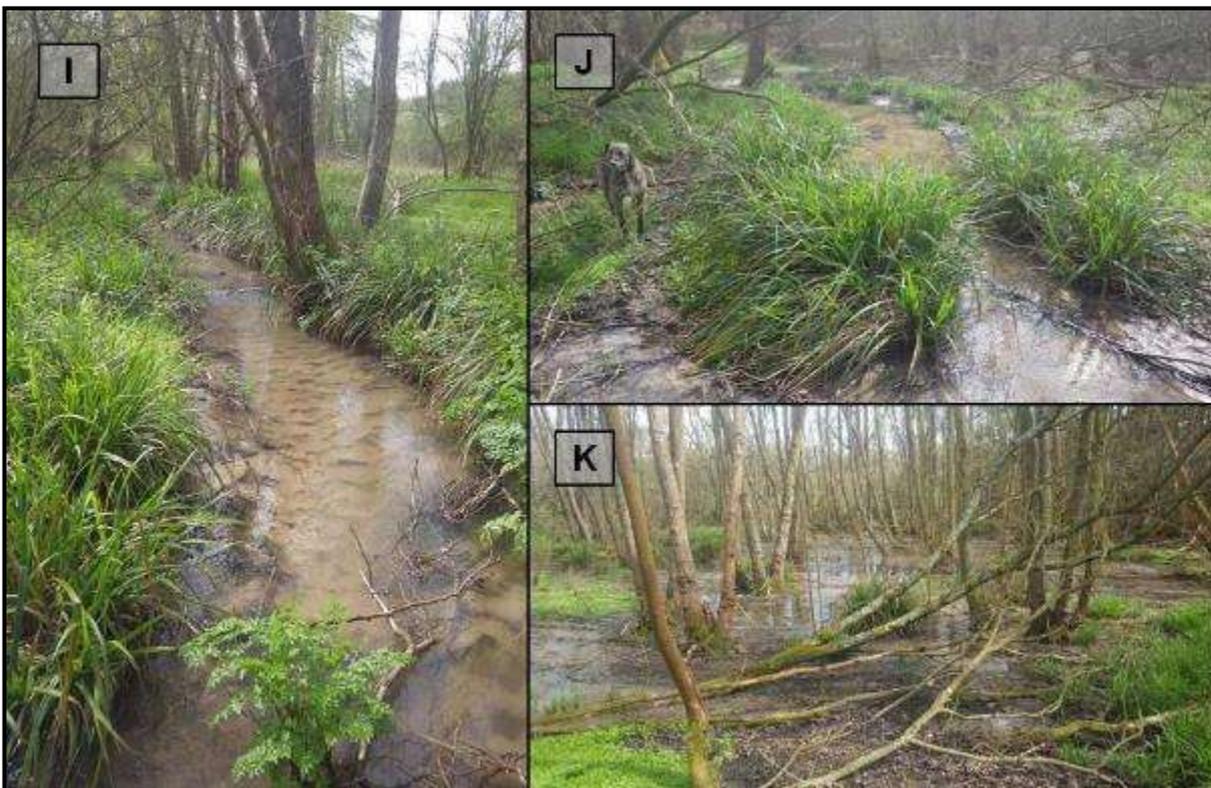
Figure 8 Photos I, J and K, Welches Common Stream/ Woodland

An excellent example of a woodland stream with very clear water and a good rate of flow over a sandy bed (Figure 8, photos I and J). Approximately one metre wide at the sample point, but heavily braided and meandering through areas of wet woodland slightly further downstream (Figure 8, photo K). This is a good example of wet woodland habitat that supports a healthy population of freshwater shrimps (*Gammarus* sp.) within the stream, which is typical in areas of abundant leaf litter. Levels of soluble orthophosphate (SRP) were moderate ($24.4 \mu\text{g l}^{-1}$), while nitrate was rather high, at 6.8 mg l^{-1} . The high nitrate is most likely the consequence of the high groundwater concentrations (see site 10), but the stream also flows adjacent to arable land and improved grassland, which, despite being within low input agriculture, will still contribute nutrients to surface waters, albeit less than from conventional systems.

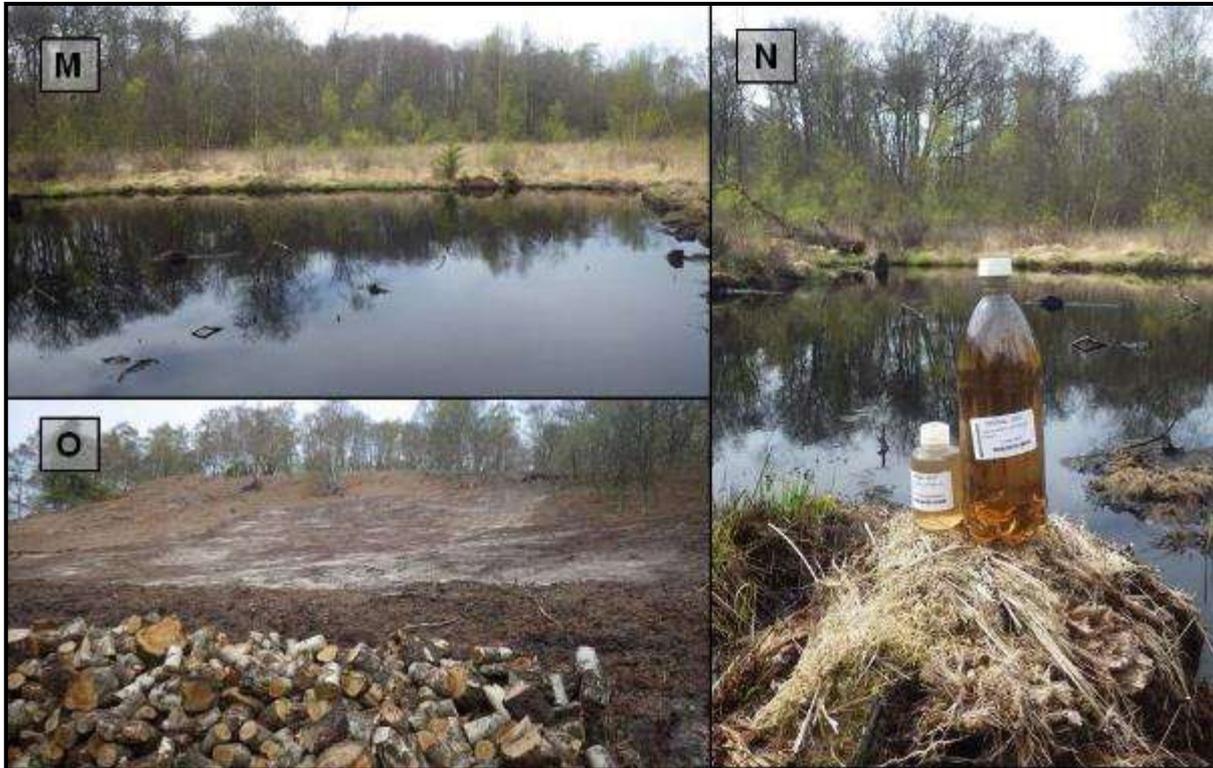
Figure 9 Photos M and N, Black Hole Bog and O, recent management works

Black Hole Bog is a recently cleared bog pool, created by Sussex Wildlife Trust as part of a habitat improvement project within the Burton and Chingford Ponds Local Nature Reserve (funded by Veolia Environment Trust as part of the Landfill Communities Fund). (Figure 9, photo M). The water was noted to be very brown (Figure 9, Photo N), and water chemistry analysis reveals it to also be very acidic, with a pH of 4.15, a natural process on

base poor geology where bogs develop. In addition, SRP levels were moderate, measuring to be $32.9 \mu\text{g l}^{-1}$, while nitrate was virtually absent ($<0.005 \text{ mg l}^{-1}$). Nitrogen limitation is typical of this type of acid, brown-water pool. The slopes above the pool have been cleared of birch and bracken as part of the management within the reserve (Figure 9, photo O). Overall, the area appears to be of excellent habitat creation.

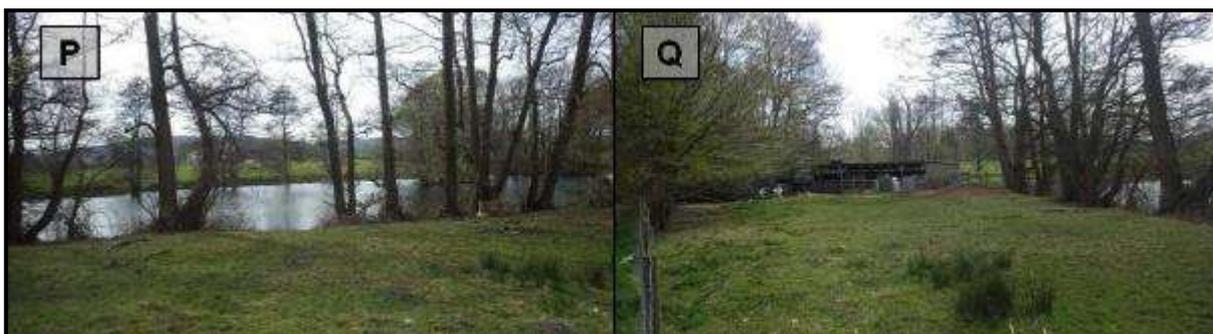
Figure 10 Photos P and Q, Black Pond and stock/hay storage

Black Pond appears to be an artificial impoundment lying between the Park Grounds and Burton Park Farm (Figure 10, photo P). The pond is fringed with Alder and has a small copse to the west, but is otherwise surrounded by improved pasture. There is a small stock shed and hay storage, which are to the east of the pond (Figure 10, photo Q). The outflow extends to the northeast from Black Pond, where a water sample was taken at a small bridge 25 m away from the main water body (Figure 11, photos R and S). No obvious problems were observed, although SRP and nitrate levels are above the desired levels ($41.3 \mu\text{g l}^{-1}$ and 2.38 mg l^{-1} respectively) suggesting some enrichment from the nearby pasture is likely. This should be explored with further monitoring.

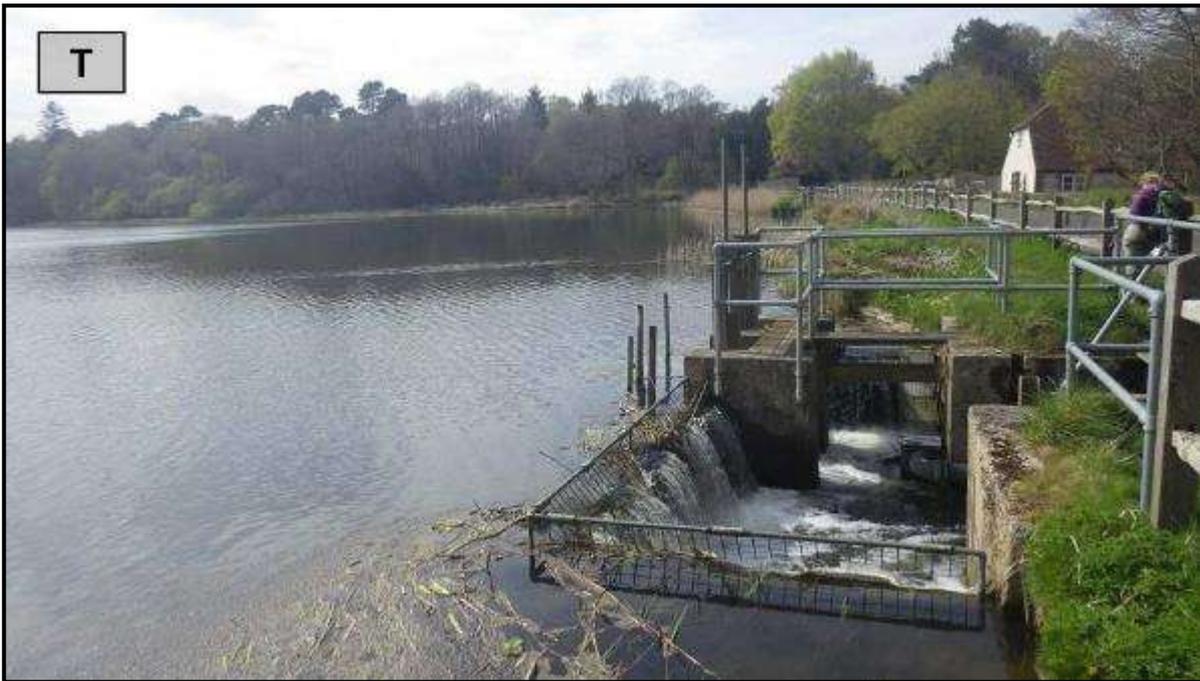
Figure 12 Photo T, Burton Mill Pond Outflow

Figure 12, photo T). Floating scum/ FLAB (Floating Algal Biomass) was also observed, which is mainly phytobenthos (algal biofilm) that lifts from the lake bed due to the rapid rate of photosynthesis during the springtime when there is an increase in light and temperature. This is a natural process, but is exacerbated by nutrient enrichment, which poses a greater risk of the site remaining turbid for longer, to the detriment of the aquatic habitat and quality.

Water chemistry analysis indicates nutrient enrichment, with total phosphorus of $38.8 \mu\text{g l}^{-1}$ and total nitrogen concentrations of 2.88 mg l^{-1} (where maxima of $20 \mu\text{g l}^{-1}$ for TP and 1.5 mg l^{-1} are recommended for mesotrophic waters (JNCC, 2015)).

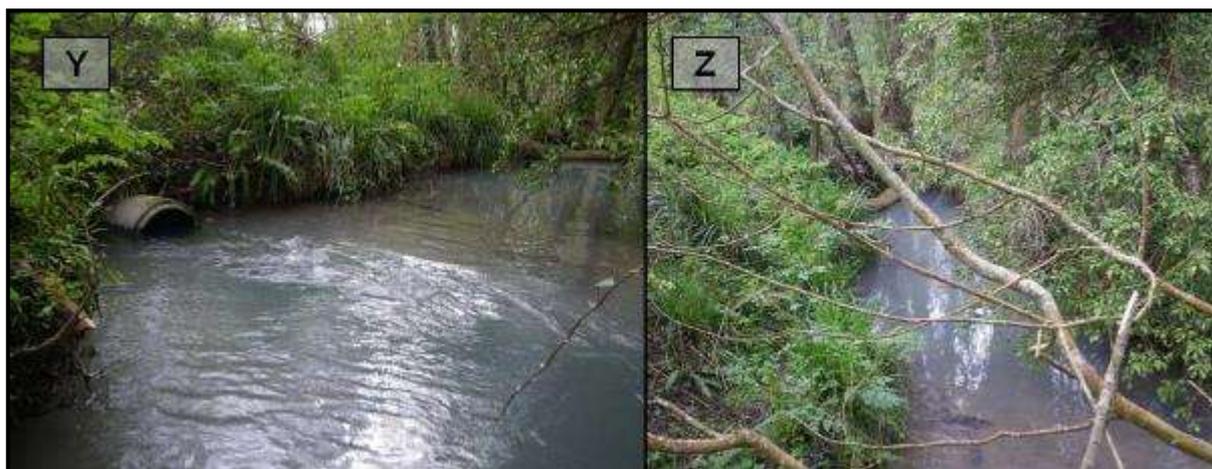
Figure 14 Photos Y and Z, Stream at Trout Farm outflow

The stream had a good flow rate (Figure 14, photo Y). Water from the Duncton Mill Fishery Ponds flows into the stream via a pipe. It is unknown whether this is the only overflow from the trout farm or if there are further outflows to this stream or to the Duncton Mill Stream to the east. The water in the stream and outlet had a slightly milky appearance (Figure 14, photo Z). Total phosphorus concentrations were moderate ($34.3 \mu\text{g l}^{-1}$), while total nitrogen levels were high, at 4.36 mg l^{-1} , which is in line with the ground water supply.

As a commercial fishery, the inflow and outfall of the Duncton Mill ponds are subject to regular monitoring by the Environment Agency to ensure compliance for a range of water quality parameters. As part of this, nitrate, ammonia and SRP are monitored regularly (often monthly, but sometimes weekly) and the data available via the EA Open Government Licence². These data show slight increases in the concentrations of SRP at the outfall, but mostly the difference is below detection limits. Total oxidised nitrogen is high in the system due to high ground water concentrations. Ammoniacal nitrogen increases in the ponds (to be expected from fish ponds), but concentrations are relatively low and diluted further on exit. Furthermore, oxidised nitrogen is overall lower on exit from the fishery.

The fishery appears to be managed at relatively low intensity and there is no evidence that it adds significantly to the phosphorus concentration within the catchment.

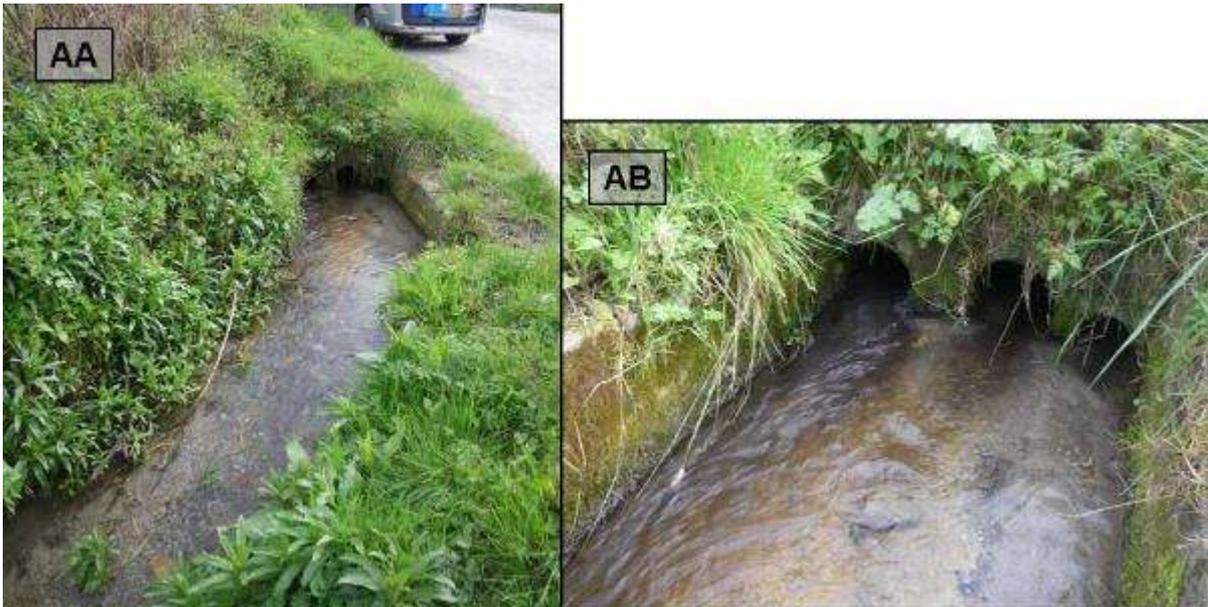
Figure 15 Photos AA and AB, Barlavington Stream

This is a small, clear stream towards the top of the sub-catchment (Figure 15, photos AA, AB). It originates from a spring at Barlavington Hanger (SU9657915885), flows under the road and follows the lane towards Crouch Farm. Water chemistry analysis indicates very low SRP levels ($2.5 \mu\text{g l}^{-1}$), but very high nitrate concentrations (7.98 mg l^{-1}) from the background levels in the groundwater.

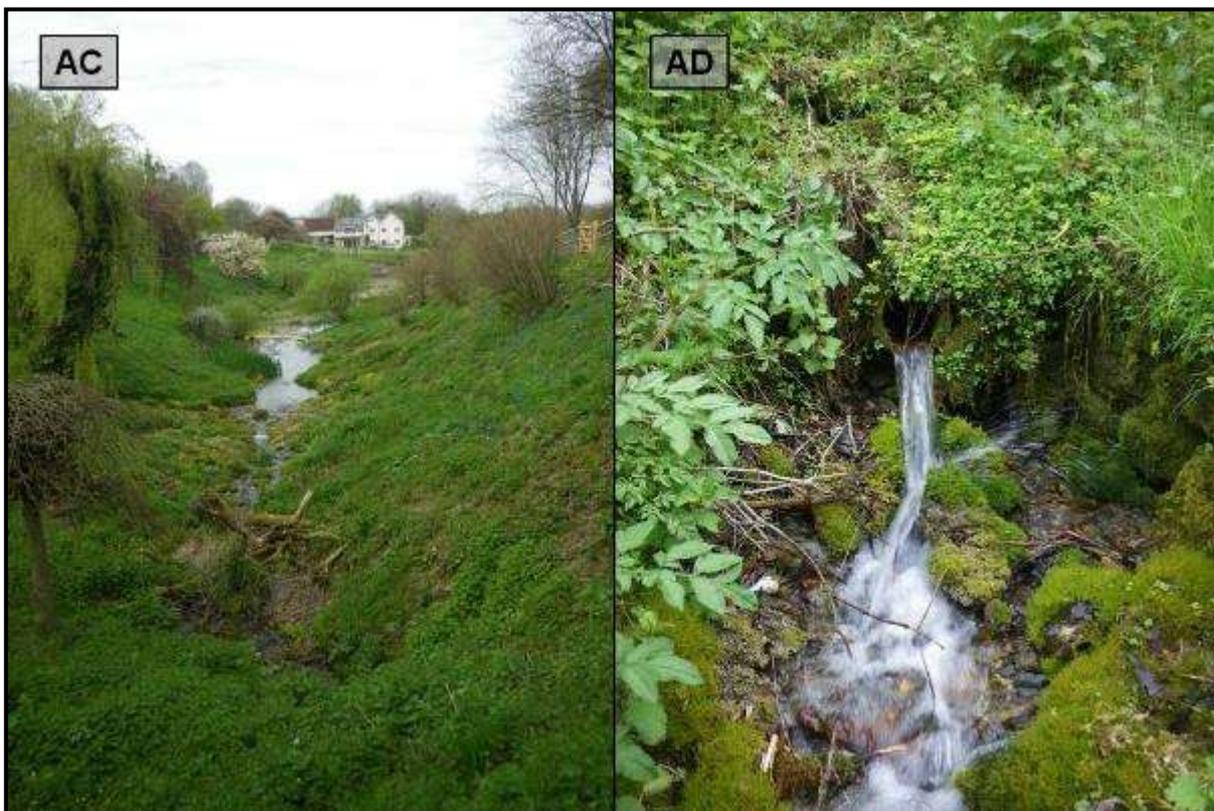
Figure 16 Photos AC and AD, Duncton Mill Spring

This is a spring, originating from directly beneath a high bank (approximately 20 m) into the valley and pond above the Mill (Figure 16, photos AC and AD). The water was crystal clear, with low SRP levels ($9.1 \mu\text{g l}^{-1}$) and high nitrate concentration (4.04 mg l^{-1}).

Interestingly, conductivity was measured to be the highest at this spring out of all the sites analysed in the catchment, measuring $524 \mu\text{S cm}^{-1}$, most likely as a result of localised weathering of the calcareous bedrock.

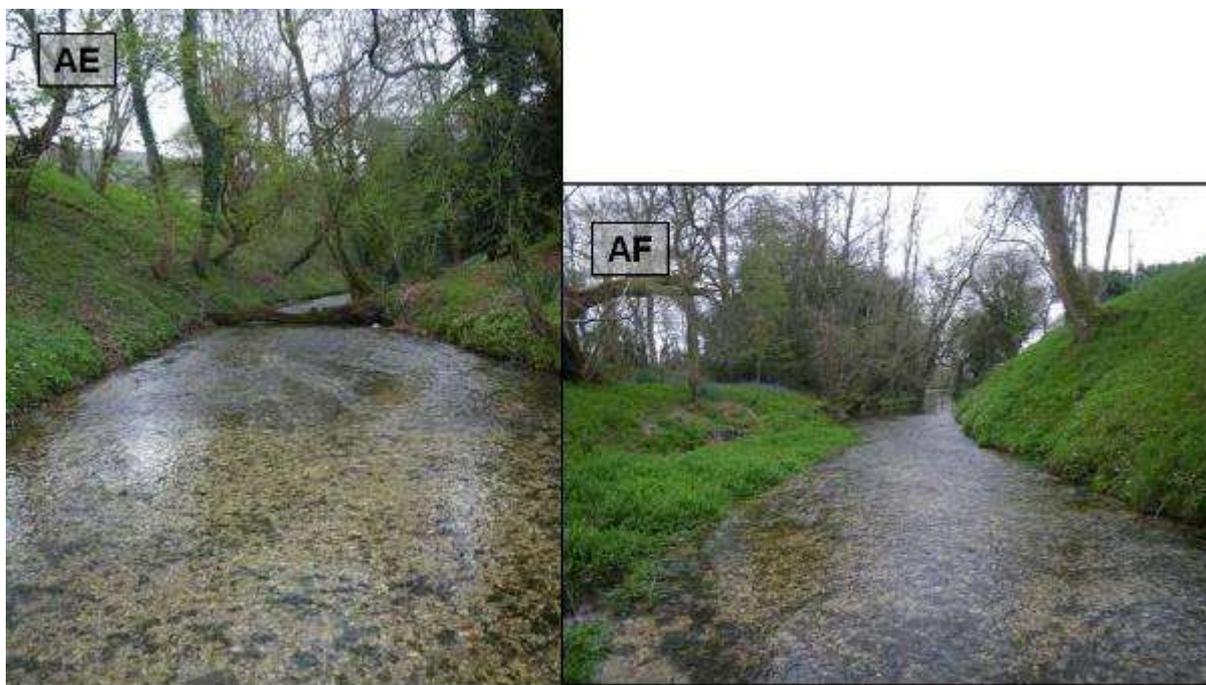
Figure 17 Photos AE and AF, Stream below Beechwood House

This is a wide stream (7 m) which is shallow and heavily shaded at the sample site (Figure 17, photos AE and AF) and has a number of small in-stream impoundments along its course. A gravel bed is present, with a good rate of flow and very clear water. The exact origin of the stream is unclear as the spring is not marked on OS maps and was on private land without access. SRP was low, but nitrate levels from the groundwater high, with measurements of $11.4 \mu\text{g l}^{-1}$ and 4.39 mg l^{-1} respectively.

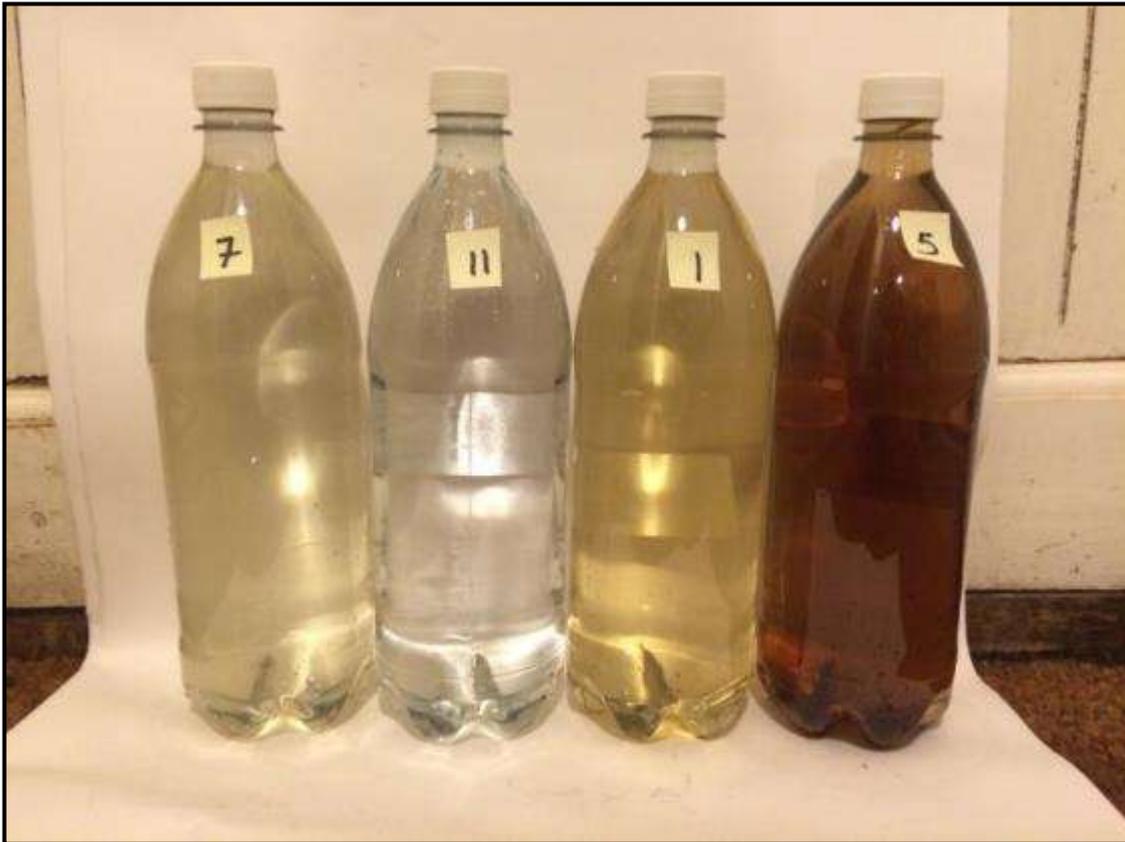
Figure 18 Water samples from four sites. From left: Burton Pond Outflow (7); Duncton Mill Spring (11); Burton Park Spring (1) and Black Hole Bog (5).

Due to the rather unique location of BMP, lying as it does on acid sandstone geology, but with a mainly alkaline catchment, there is a wide range of natural variation in water quality. This is most marked by the difference seen between Black Hole Bog (Site 5), which had naturally acidic, brown water, compared to the crystal clear, alkaline waters of the upper catchment (e.g. site 11) (see Figure 18). The chemistry of BMP along with the observed drainage pattern within the catchment, is indicative of the lake receiving the majority of its water from the main inflow draining the South Downs chalk.

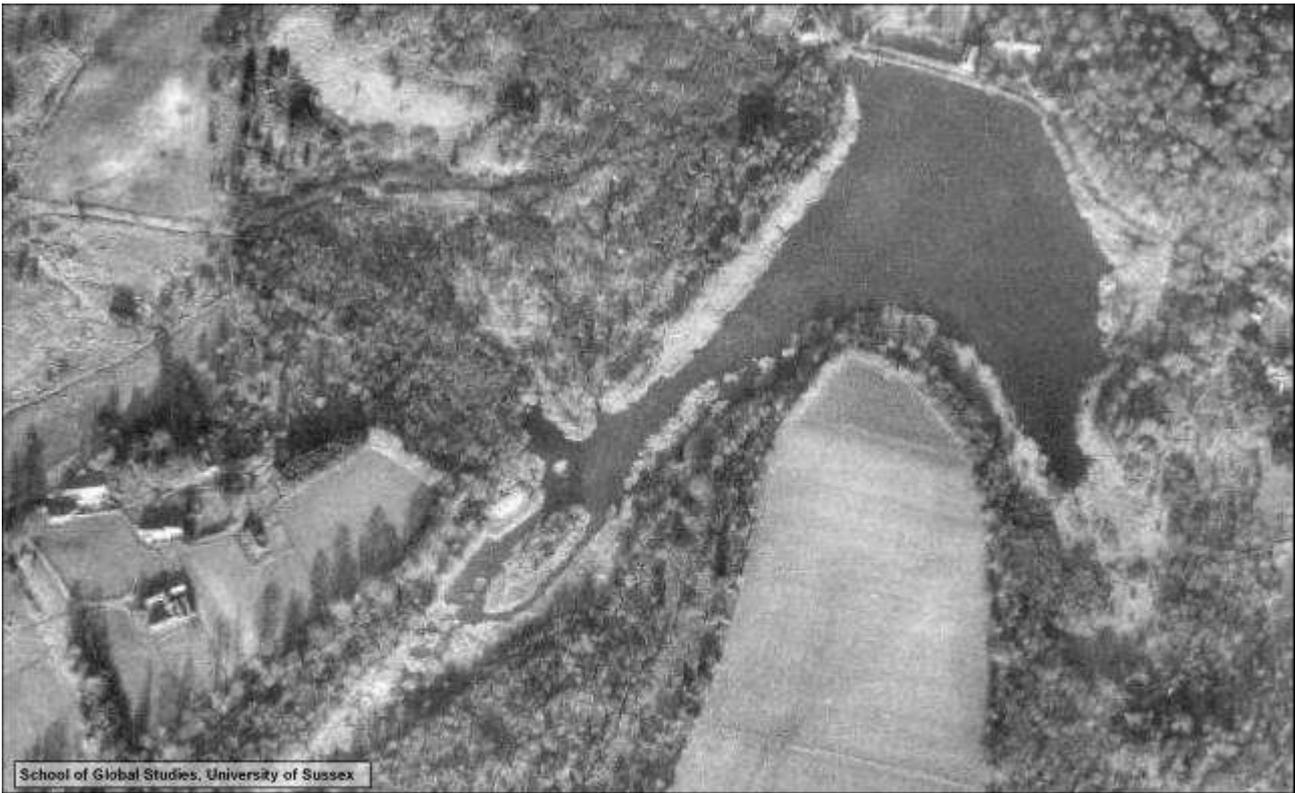
To this end, we were given permission to access hard copies of RAF aerial photography taken in 1956; two years after the SSSI designation of Burton Park (With kind permission of School of Global Studies, University of Sussex). The 1956 aerial image was scanned and geo-referenced using fixed markers (houses, the dam, roads), and the areas of open water, emergent vegetation and woodland digitised using GIS. These were then compared to the latest available (2013) aerial image from Getmapping PLC (see Figure 19).

RAF Aerial photograph of Burton Mill Pond and its wetlands, captured in 1956.

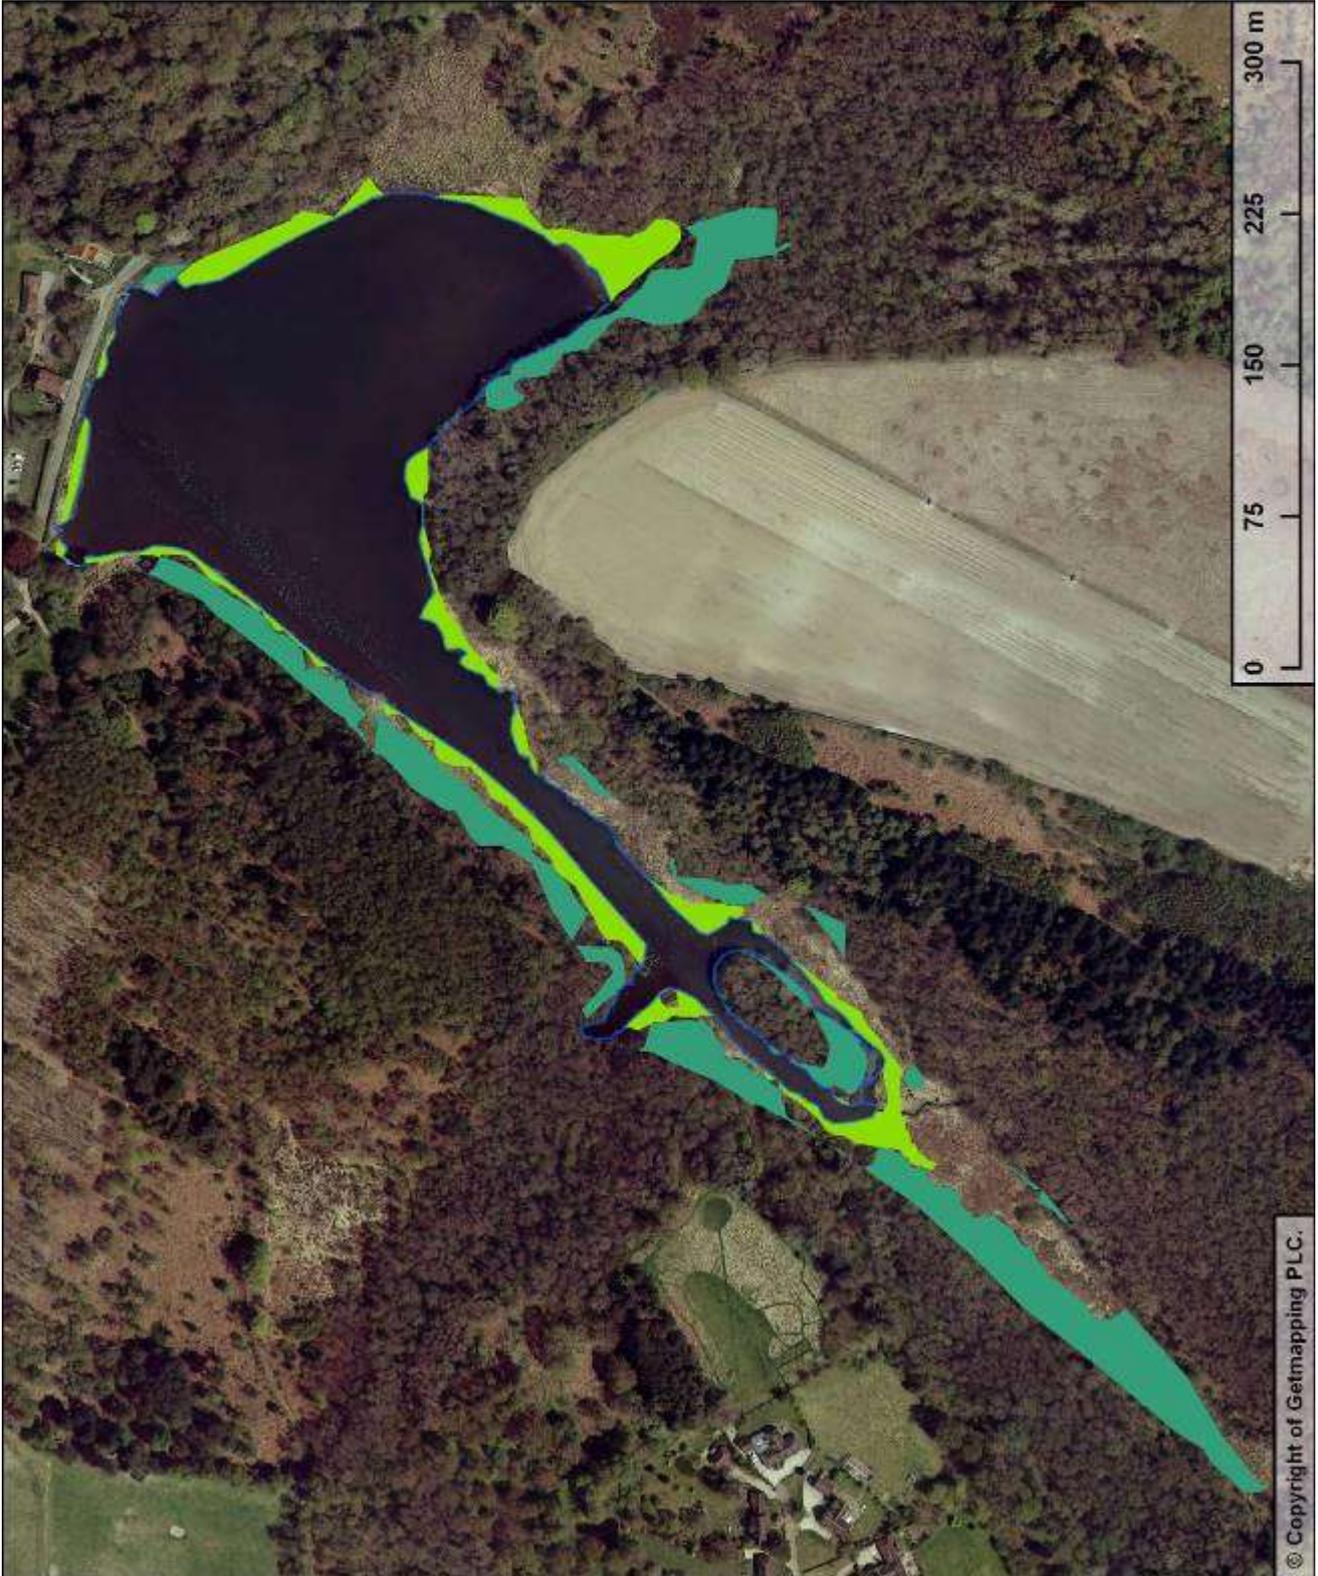
Figure 20 Aerial photograph taken in 2013, showing the extent of habitat change since 1956.

Figure 20 below, shows the latest available (2013) aerial image, with an overlay of the areas that were open water in 1956, but are now wetland, and also the areas that were wetland in 1956, that are now occupied by wet woodland. The total area of open water in 1956 was 5.23 ha (± 0.1 ha), compared to 4.37 ha (± 0.1 ha) derived from 2013 aerial photography; a loss of 0.86 ha (approximately 16%).

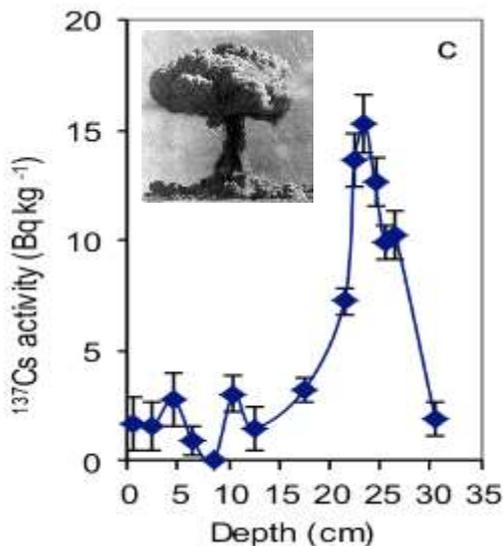
Figure 21 Rate of decay of ^{137}Cs in the BUR Tb sediment core taken in 2013

What we do not know however, is how much sediment was removed from the coring location during the dredging work in 1985. The ^{137}Cs curve in Figure 21 is very similar to the natural signal from other lakes until the upper 15 cm, after which it becomes variable, where normally it would continue to fall. This is indicative of sediment mixing and consistent with the knowledge that the site was dredged and hence highly disturbed in the upper sediments. Despite having a dated point within the core, we cannot derive an accurate sedimentation rate. It is however possible to offer a range of accumulation rates based on the limited evidence we do have.

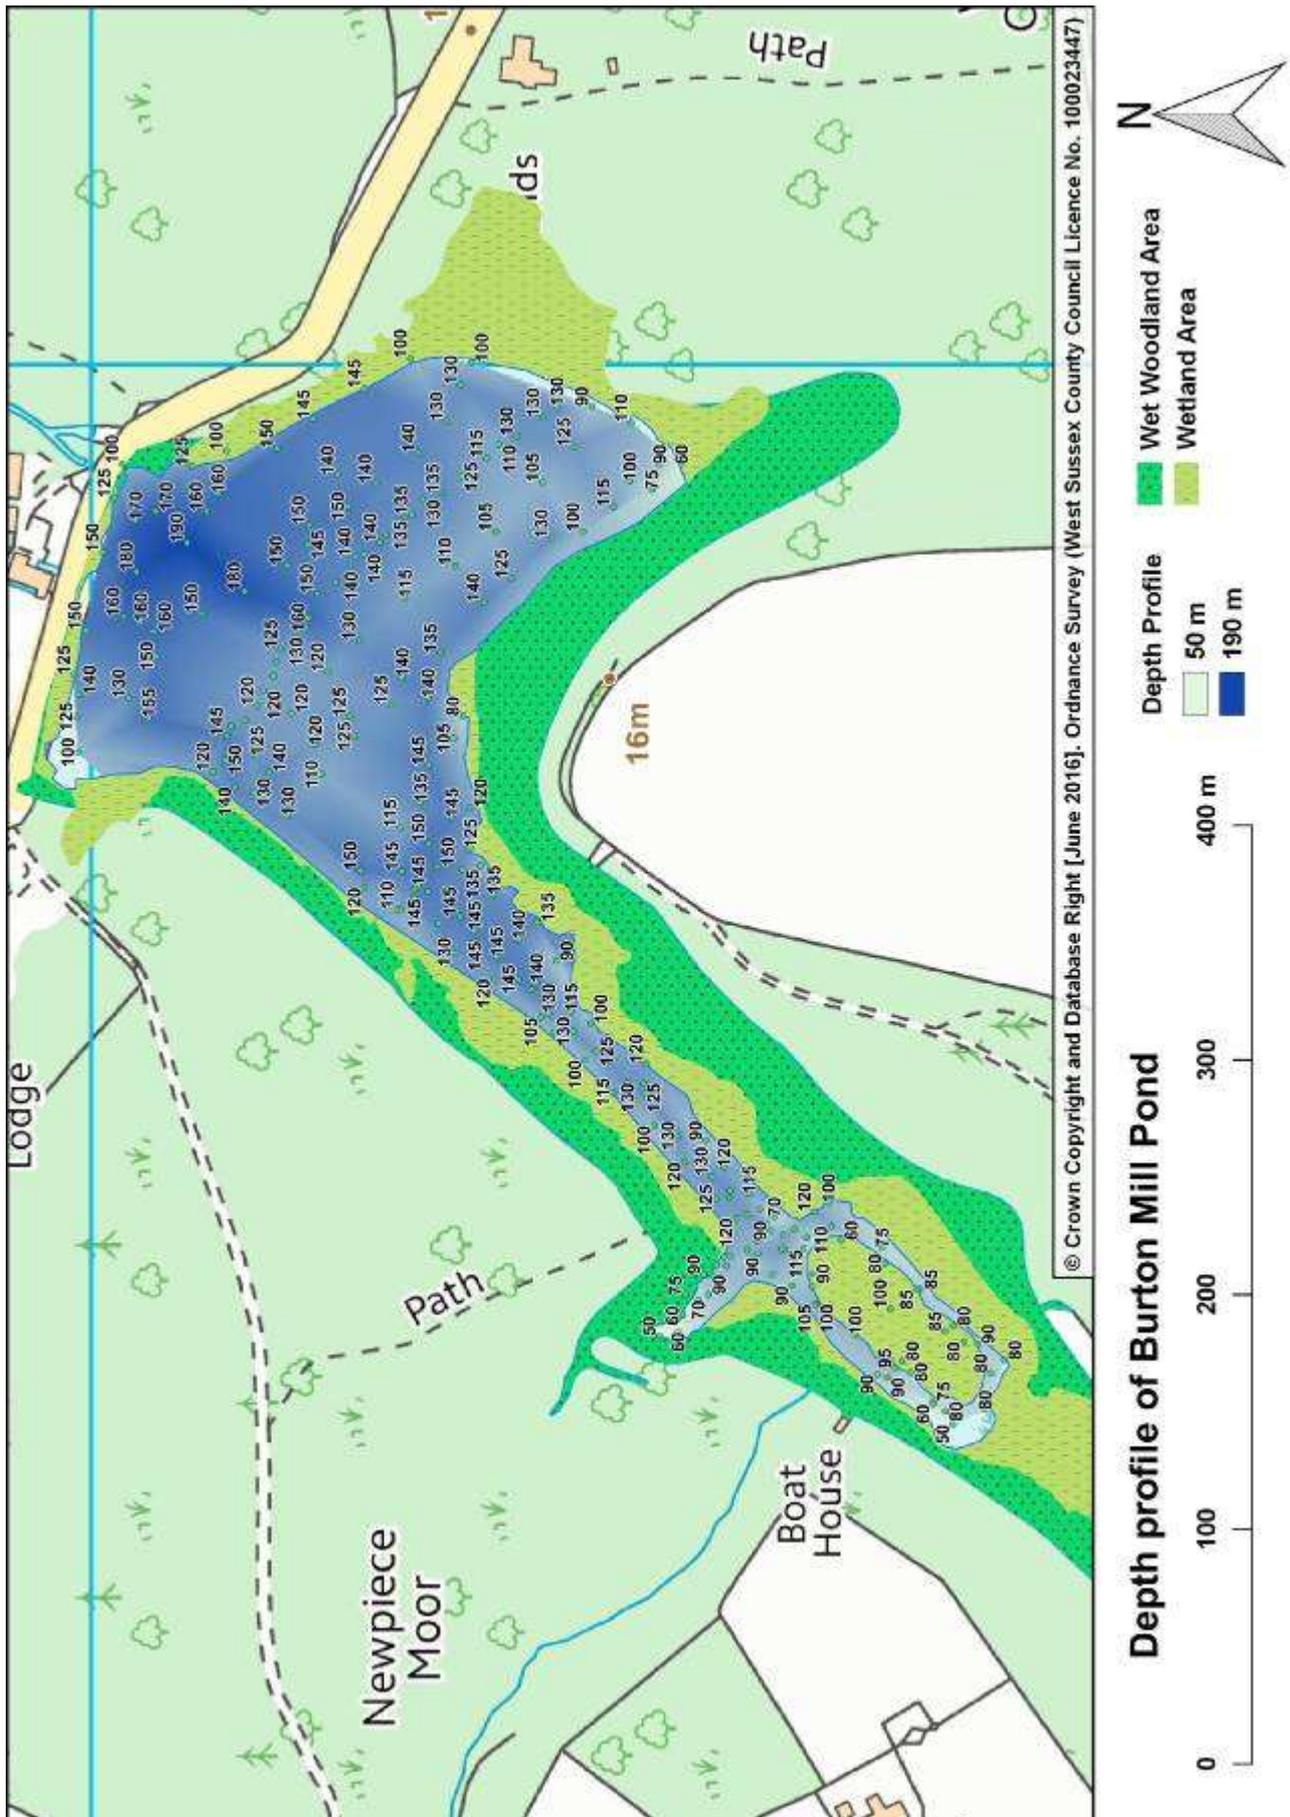
Figure 22 Map of Burton Mill Pond showing water depths as measured in June 2016

Again, we stress here the need to address external problems, particularly nutrients, before resorting to major within-lake restoration measure such as sediment removal. External nutrient inputs drive the productivity of the lake and pose a major threat to ecological function. Current water depths within the open water are mostly between 1.0 -2.0 m and provide adequate depth for aquatic plants to grow throughout the main basin. Figure 22 shows the measured water depths taken in June 2016.

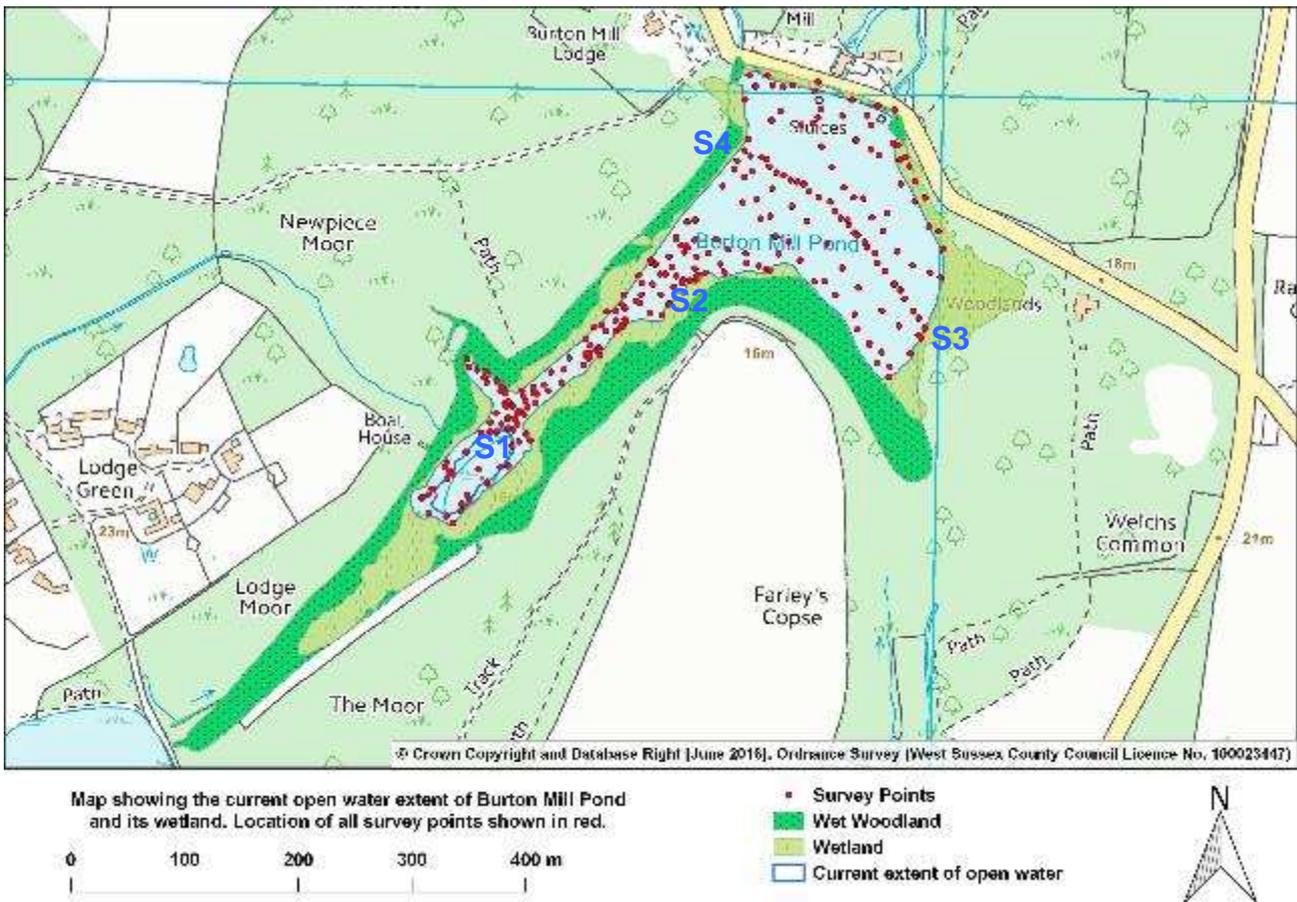
Figure 23 Map of Burton Mill Pond showing macrophyte survey points
