Burton Mill Pond Vision and Work Programme

March 2018

Final report to West Sussex County Council (PR002504)

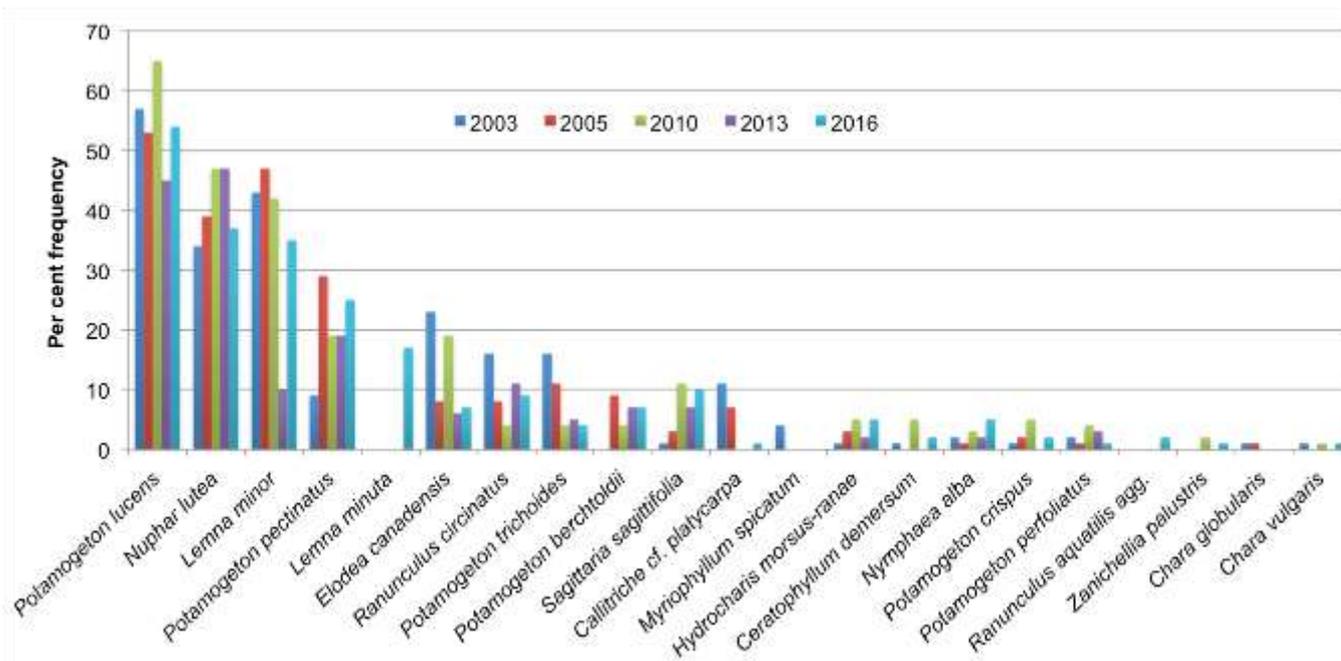
Figure 24 Comparative macrophyte frequency in Burton Mill Pond 2003 - 2016

Ensis has conducted five surveys at BMP since 2003, all using the same sample transects, thus allowing comparisons to be made over the past 13 years. In terms of overall frequency, the site appears to have remained relatively stable (Figure 24). Shining pondweed *Potamogeton lucens* and Yellow water lily *Nuphar lutea* have remained surprisingly stable, and a high cover of lily leaves results in good habitat from Common duckweed *Lemna minor*⁶. Fennel-leaved pondweed *Potamogeton pectinatus* has increased since 2003, but remained relatively stable since 2005. Some of the less frequent species have not been recorded in all survey years (e.g. *Ceratophyllum demersum*, *Myriophyllum spicatum*, *Chara* spp., *Callitriche* sp.), but overall the site shows remarkably little variation over the past thirteen years.

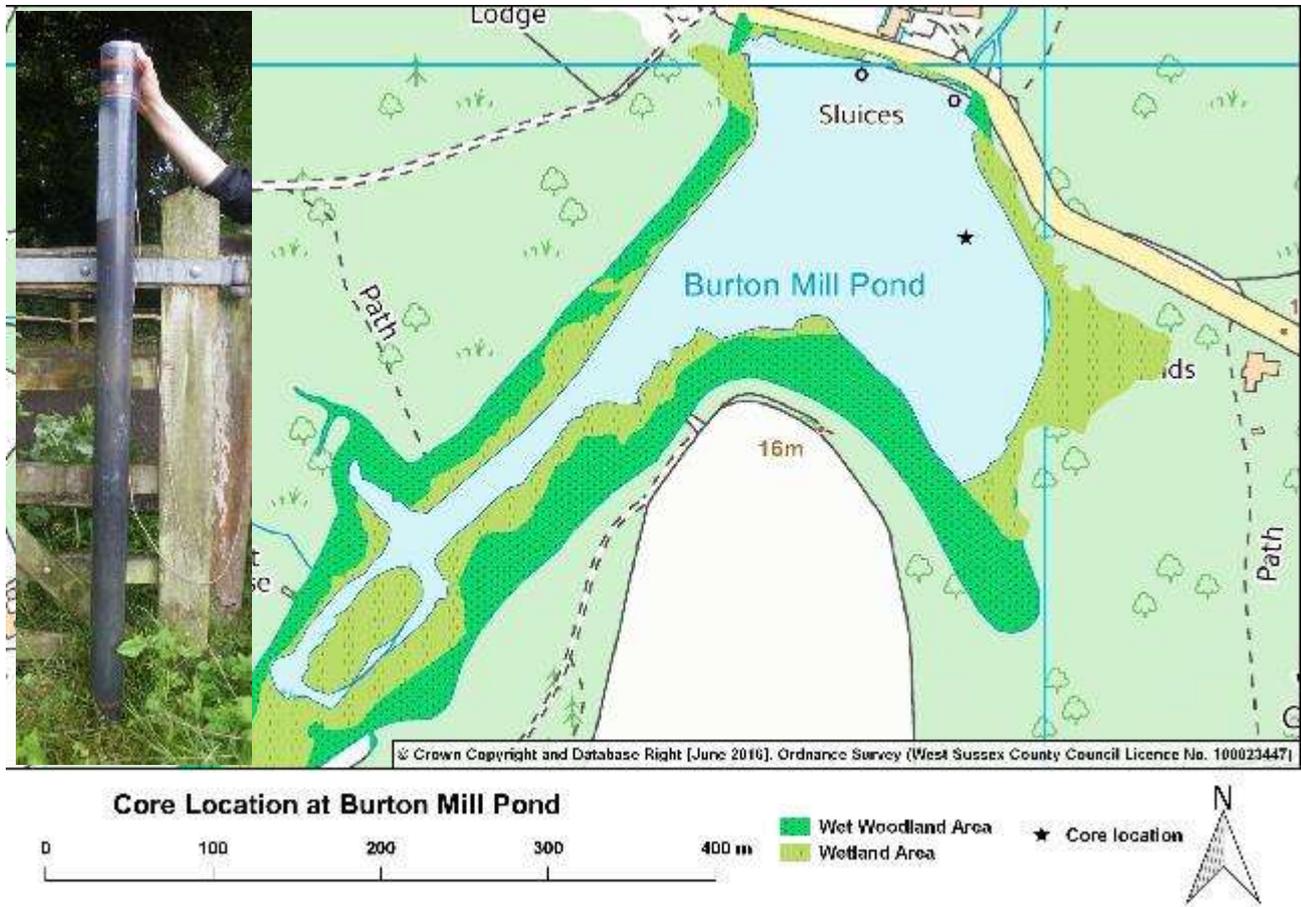
A sediment core of approximately 1 m in length and 8 cm in diameter, was taken from Burton Mill Pond in May 2016. The location of the core was towards the north-eastern end of the lake (SU9795217903 – see Figure 43) in an area close to beds of yellow water lily *Nuphar lutea* and fennel pondweed *Potamogeton pectinatus*. The core was collected from 1.4 m water depth using a lightweight piston corer (Livingstone type – Livingstone 1955) operated from an inflatable boat. The total sediment depth at this point was not determined, but was well in excess of the 1 m collected.

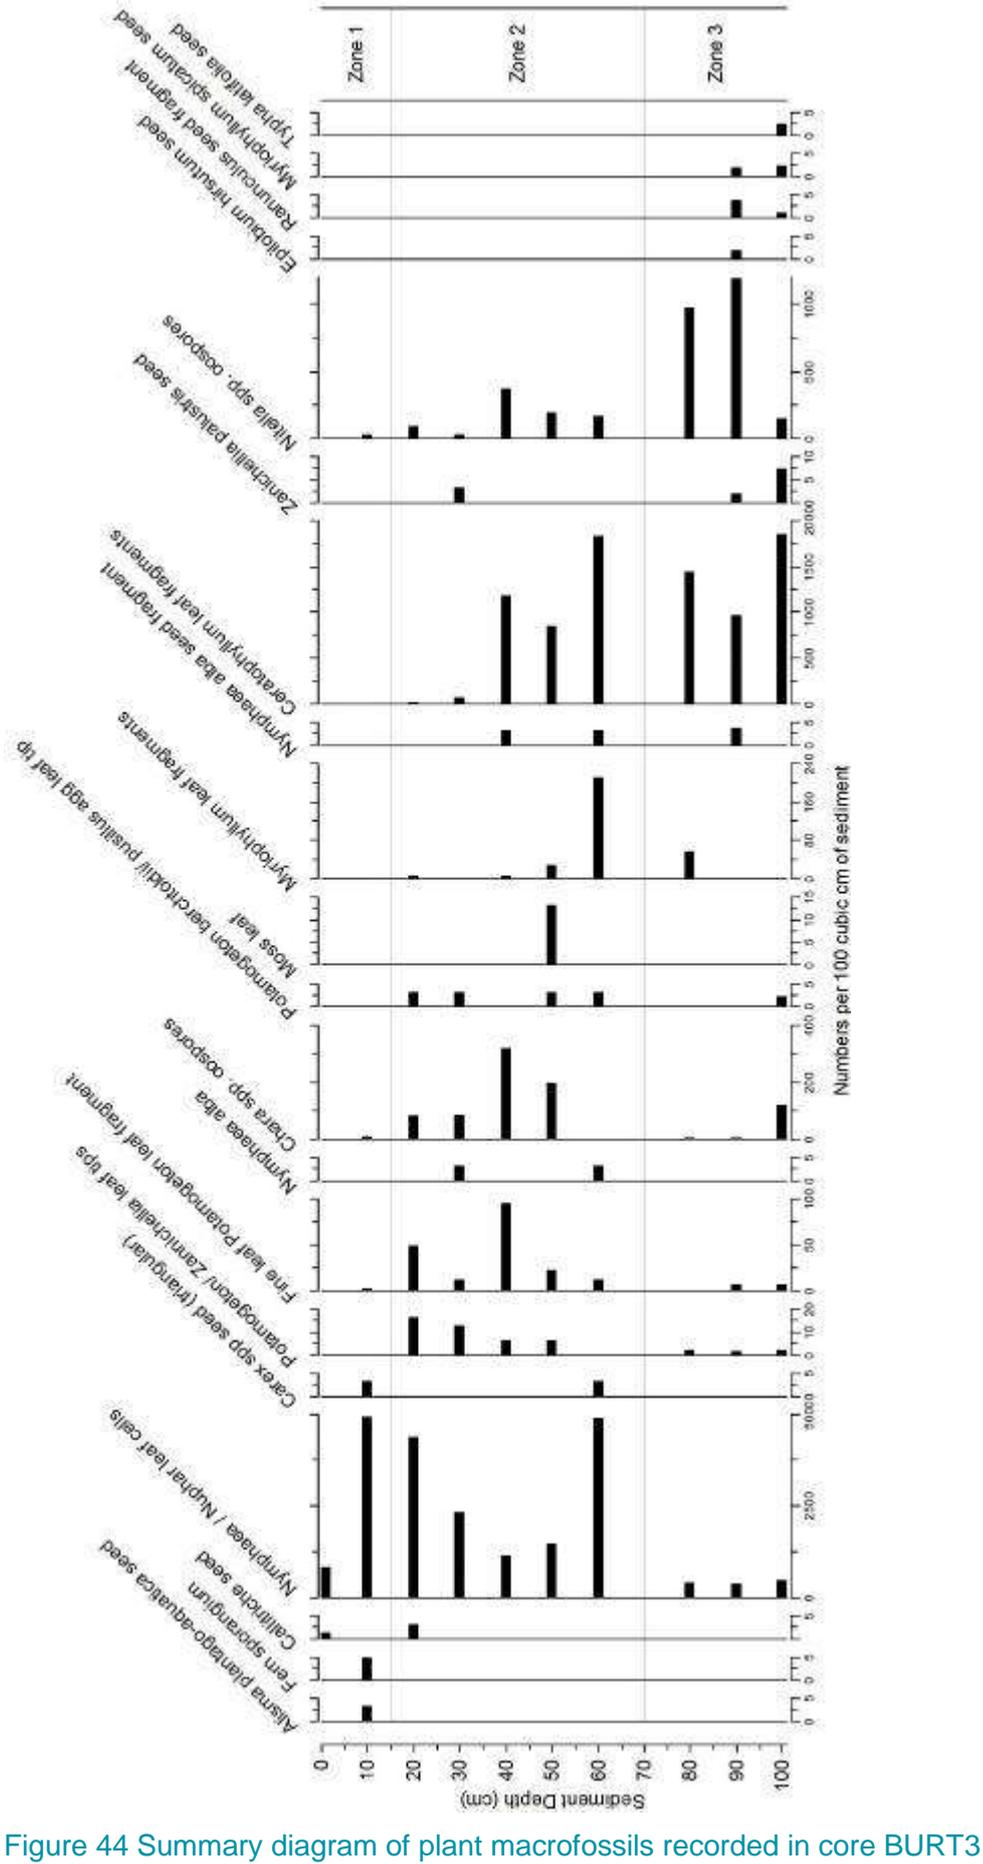
Figure 44 Summary diagram of plant macrofossils recorded in core BURT3

Based on a core taken from the same location, we know the upper 25 cm of sediment represents approximately the past 50 years. Within this timescale, we also have records based on actual survey data, albeit unclear if the species list in the SSSI citation was generated in 1954, or during revision in 1980s. The SSSI citation (NE 1986) detailed a very different submerged aquatic flora to that seen today, and this is apparent in the macrofossil results. The macrofossil diagram (Figure 44) is divided into three zones based on the major changes seen.

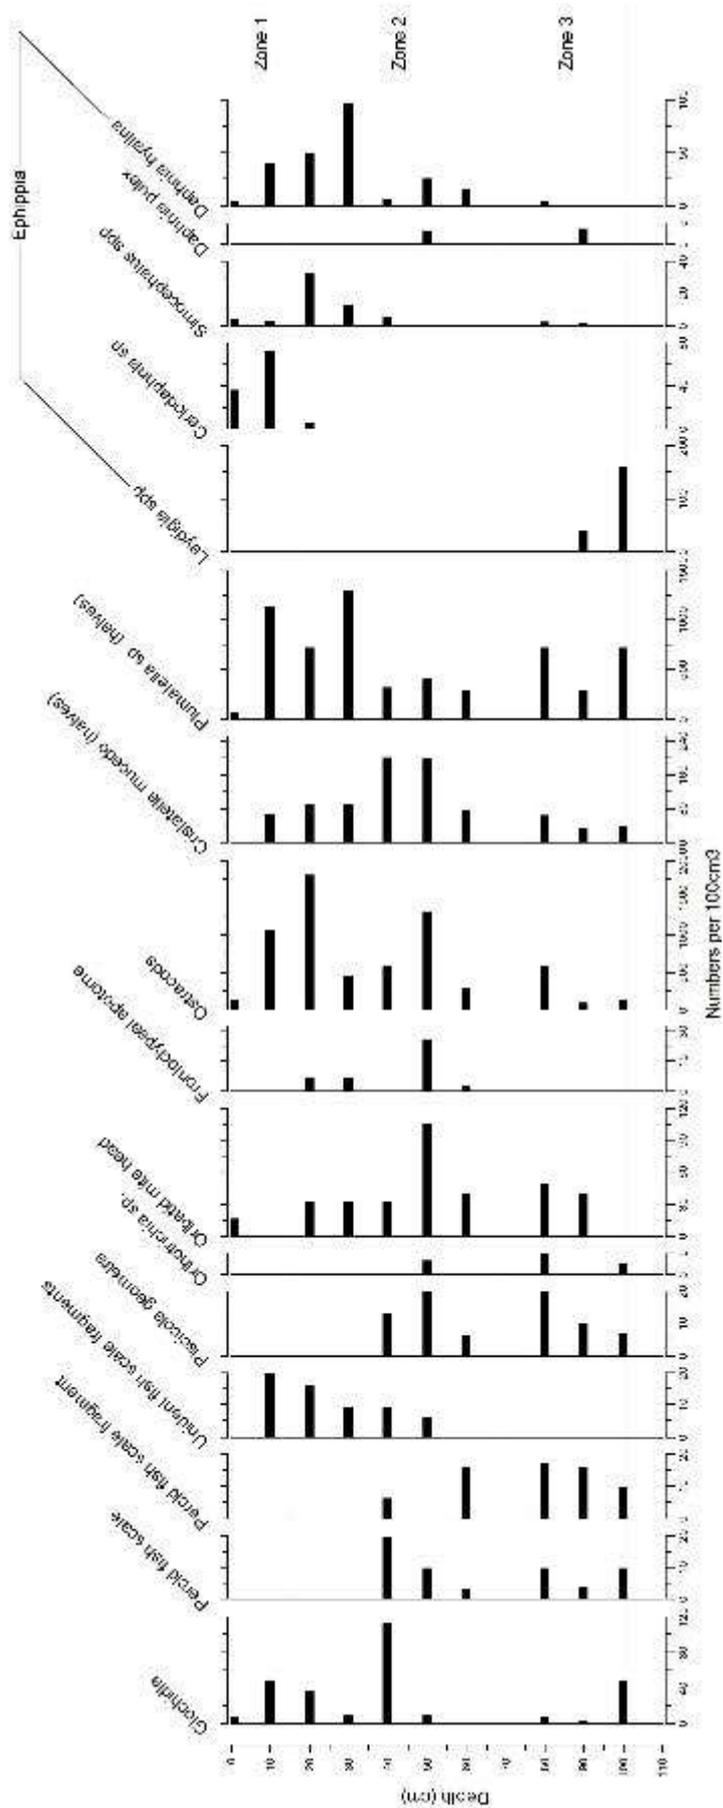
Figure 45 Summary diagram of animal macrofossils recorded in core BURT3

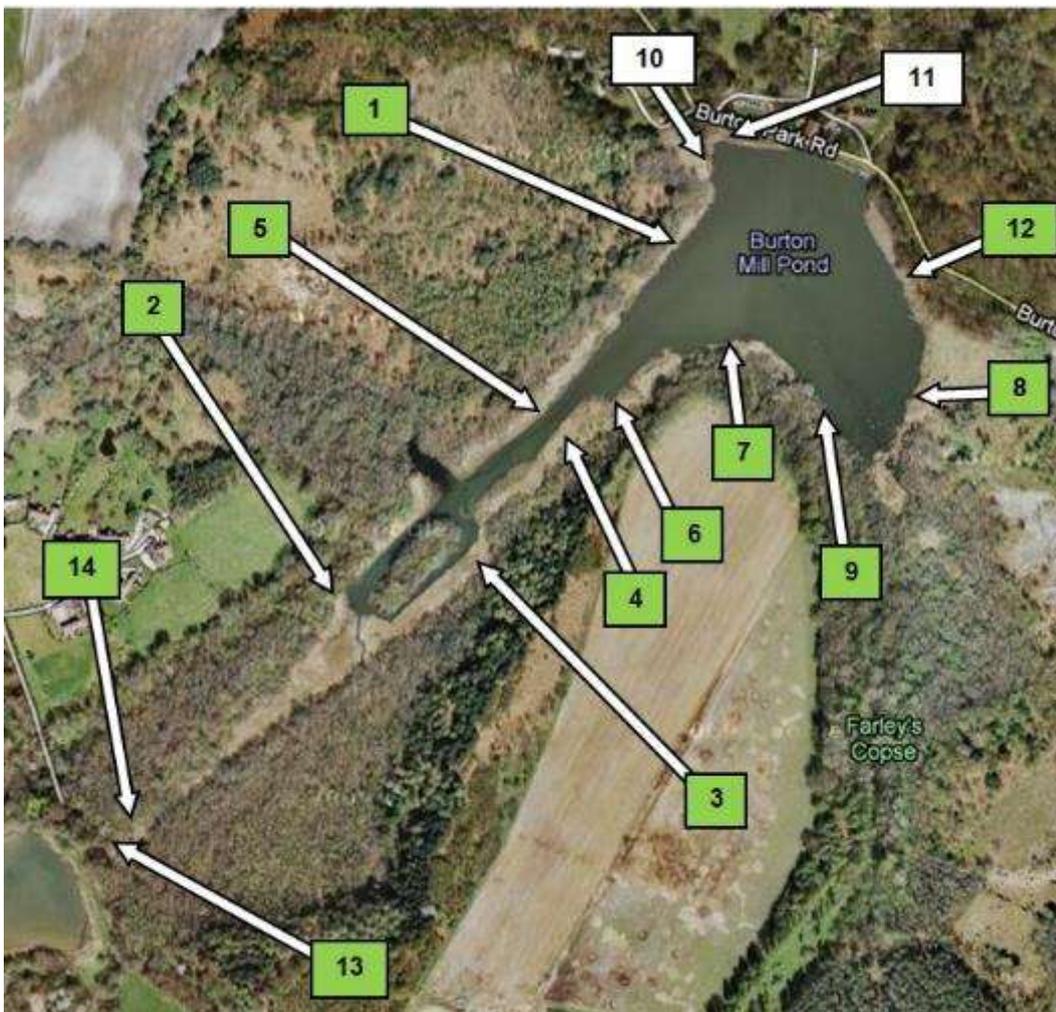
Figure 46 Aerial map of Burton Mill Pond displaying approximate 2016 survey locations (In-filled green boxes = *V. moulinsiana* present)

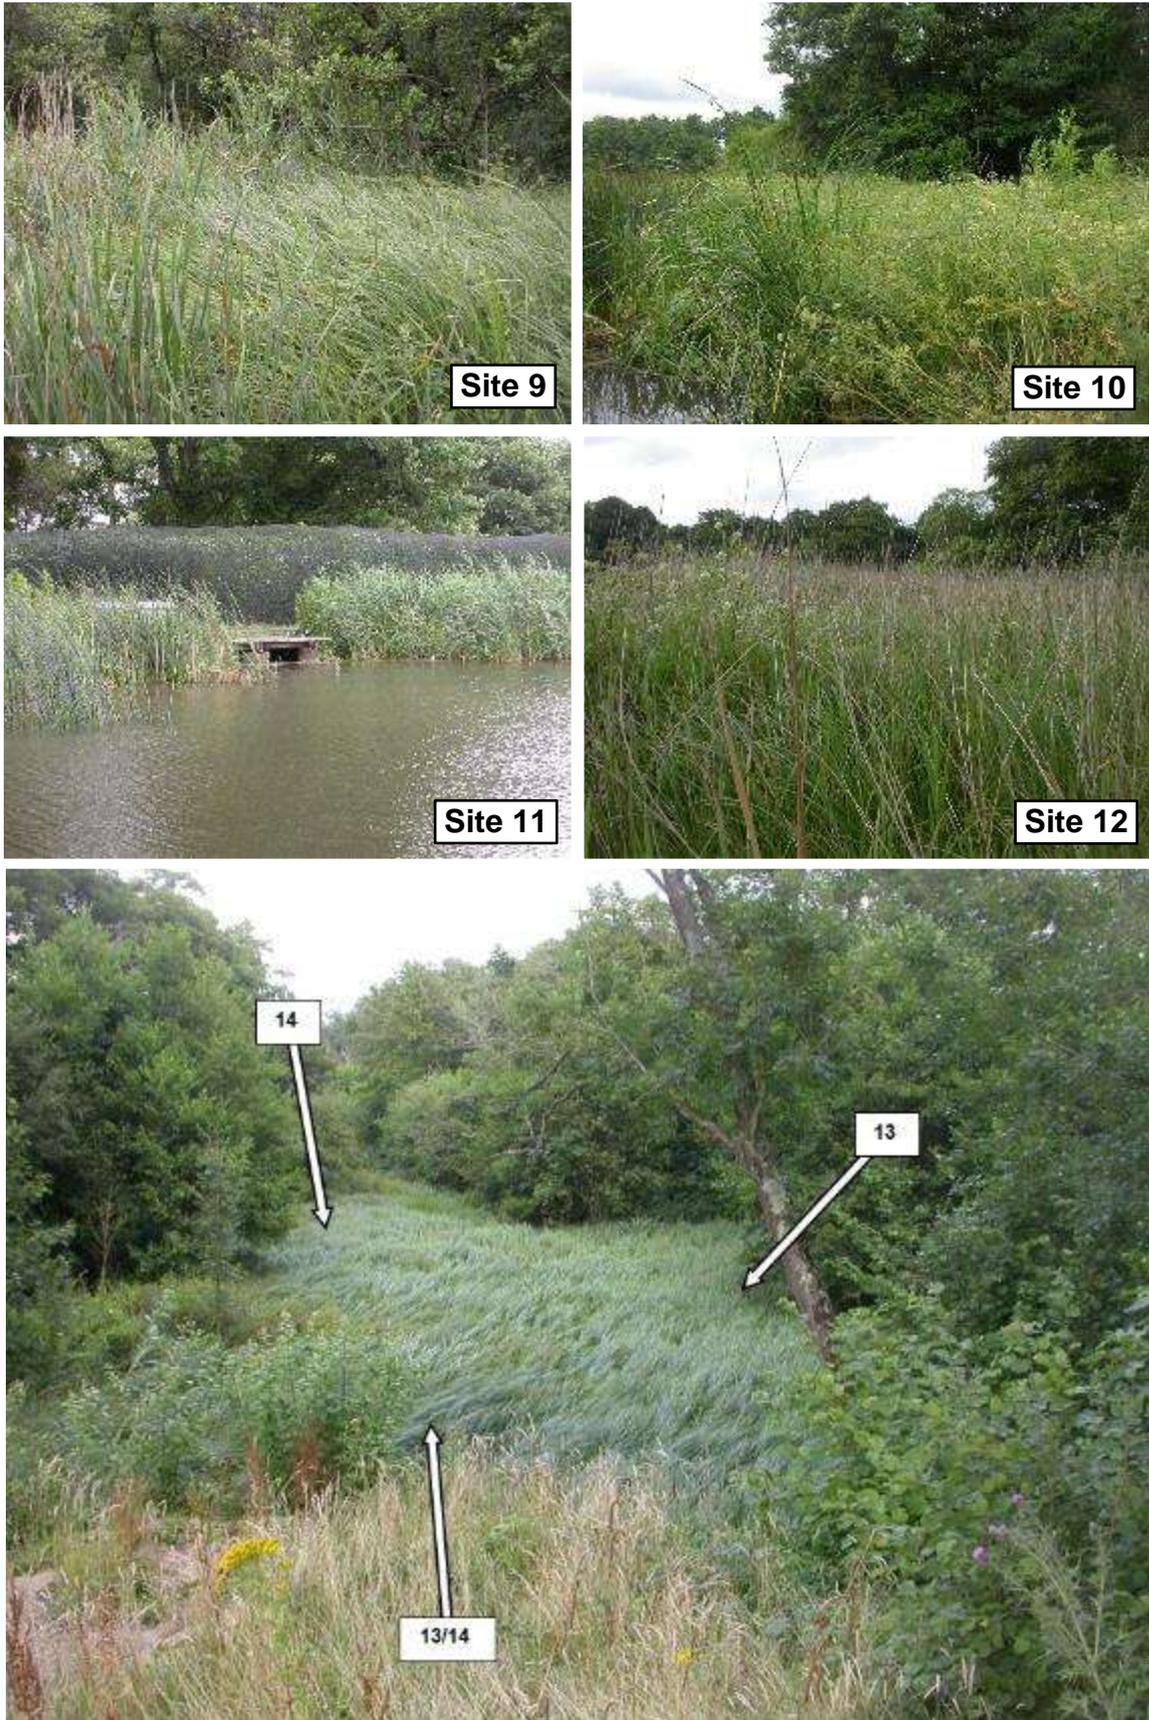
Figure 48 *Vertigo moulinsiana* survey station photos 9 - 14 (2016)

Although the Burton Mill Pond sites 13 and 14 are not directly over-shaded, they are subject to indirect shading from tall trees (e.g. ash, sycamore and alder) lying on the slightly higher ground on either side of the fen at this location (Figure 48). It is possible that this slight shading (most significant in the morning and evening) may have a slight negative effect upon this areas long-term suitability for *V. moulinsiana*. *V. moulinsiana* is mostly found in open, un-shaded habitats (Kerney 1999, Drake 1999, Killeen 2003, Willing 2016). Unfortunately, these populations are at risk from water overspill from Chingford Pond leaving the pond via the newly reconstructed concrete cascade (lying about 10 m from S 13/14).

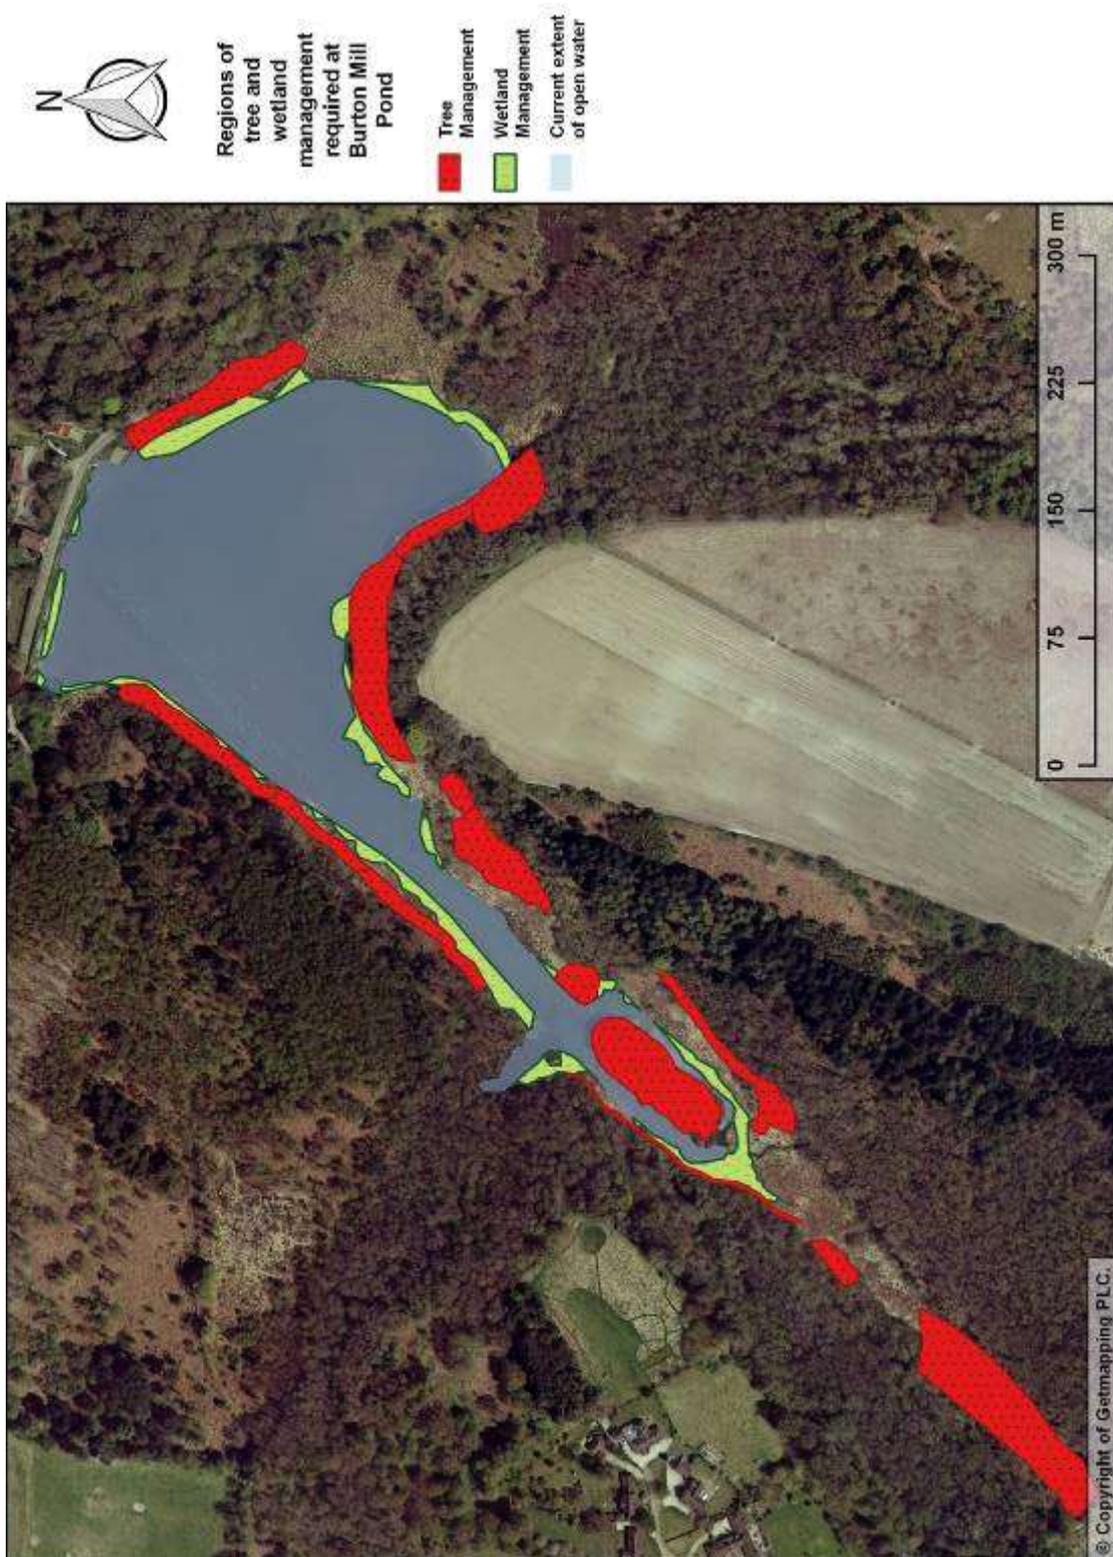
Figure 49 Map of key management areas for reed and tree cutting
