**Llyn Anafon:  
Ecological assessment of the aquatic flora  
to support HRA, 2017**

ECRC Research Report Number 185

November 2017

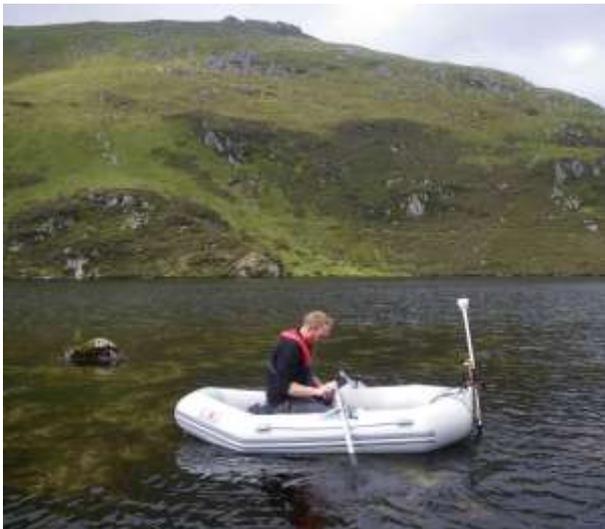
A bathymetric survey was conducted in 2009 and repeated in 2017 using a Lowrance LMS-520 GPS-linked echo sounder mounted on a small inflatable boat (Figure 1). The thousands of geo-referenced depths are then interpolated using a 5.0 m grid to give a bathymetric map with a depth accuracy of approximately 0.1 m using the current TWL as a zero datum. These data provided an assessment of the potential habitat for the aquatic plant species and allow for the extent of potential lake habitat available to aquatic plants under the different water level scenarios

Figure 1 Bathymetric survey underway

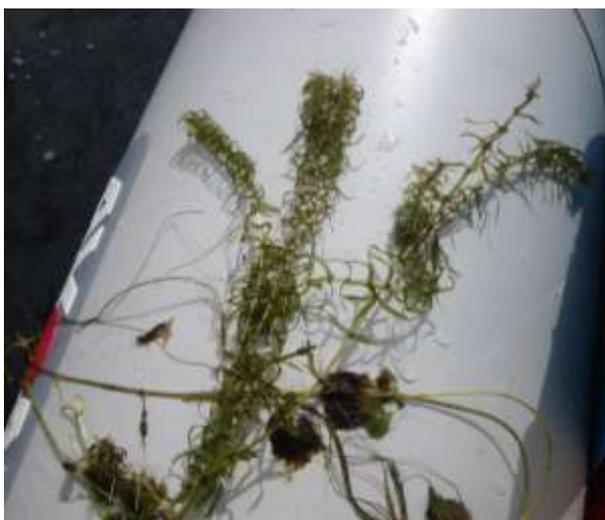
Figure 2 *Elodea nuttallii* at Llyn Anafon 2017

There are two key attributes that place the site at serious risk however, and potentially compromise the favourable status. The first is the recent appearance of the non-native invasive species, Nuttall's waterweed (*Elodea nuttallii* Figure 2). Only a simple population was recorded in the site, measuring less than 1 m<sup>2</sup>, located towards the south end at SH6991869668. This species, a native of North America, was first recorded in the UK in 1966, but is now widespread throughout lowland Britain, where it is mostly restricted to mesotrophic and eutrophic water bodies. It rarely occurs at higher altitudes, the next highest UK record being at 315 m at a small site in

Occurring close to the *Ranunculus* sp. was a small bed of the invasive and non-native *Elodea nuttallii* (Figure 2 & Figure 7). As noted above, if this species were to become established and spread within the site, it has the potential to significantly impact on the characteristic and distinctive elements of the native flora due to its highly competitive habit and dense growth form which smothers lower growing taxa. We are unaware of any other records higher than 315 m, thus it is hoped that the species will not proliferate in Llyn Anafon. Monitoring will be essential to track this species within the site and to determine its impact relative to overall site condition.

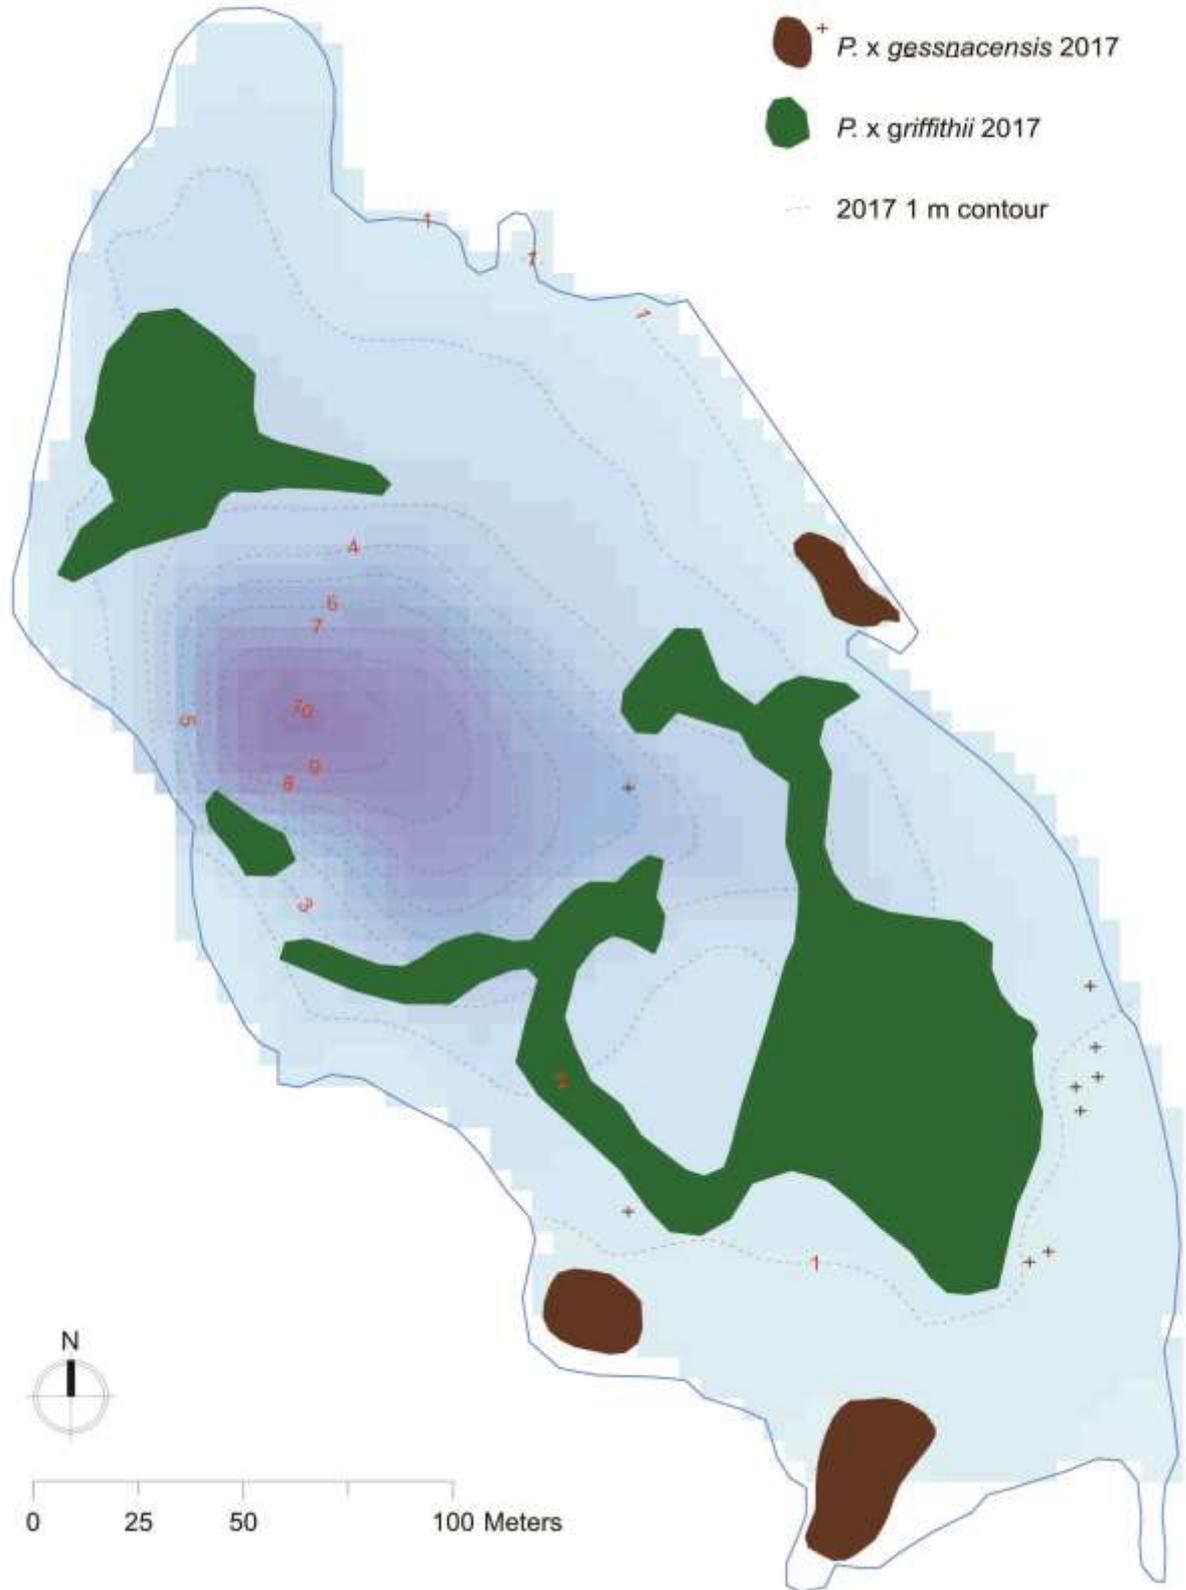
Figure 3 Distribution of *P. x griffithii* and *P. x gessnacensis* in July 2017.

Figure 3 shows the distribution of *P. x griffithii* and *P. x gessnacensis* recorded in 2017, and Figure 4 the comparison between 2009 and 2017. The extent of *P. x griffithii* has changed significantly between the two sampling periods. In 2009, there was a complete band of this taxon growing mostly between 1.5-3.5 m. The 2017 data show the population to have fragmented, and although increasing slightly in area in the south of the site, it has declined in the northern half of the lake. Despite the extent of this species having changed, the depth distribution in 2017 remained similar to 2009, with optimal depth (based on frequency, weighted by abundance) being 2.8 m (Figure 5).

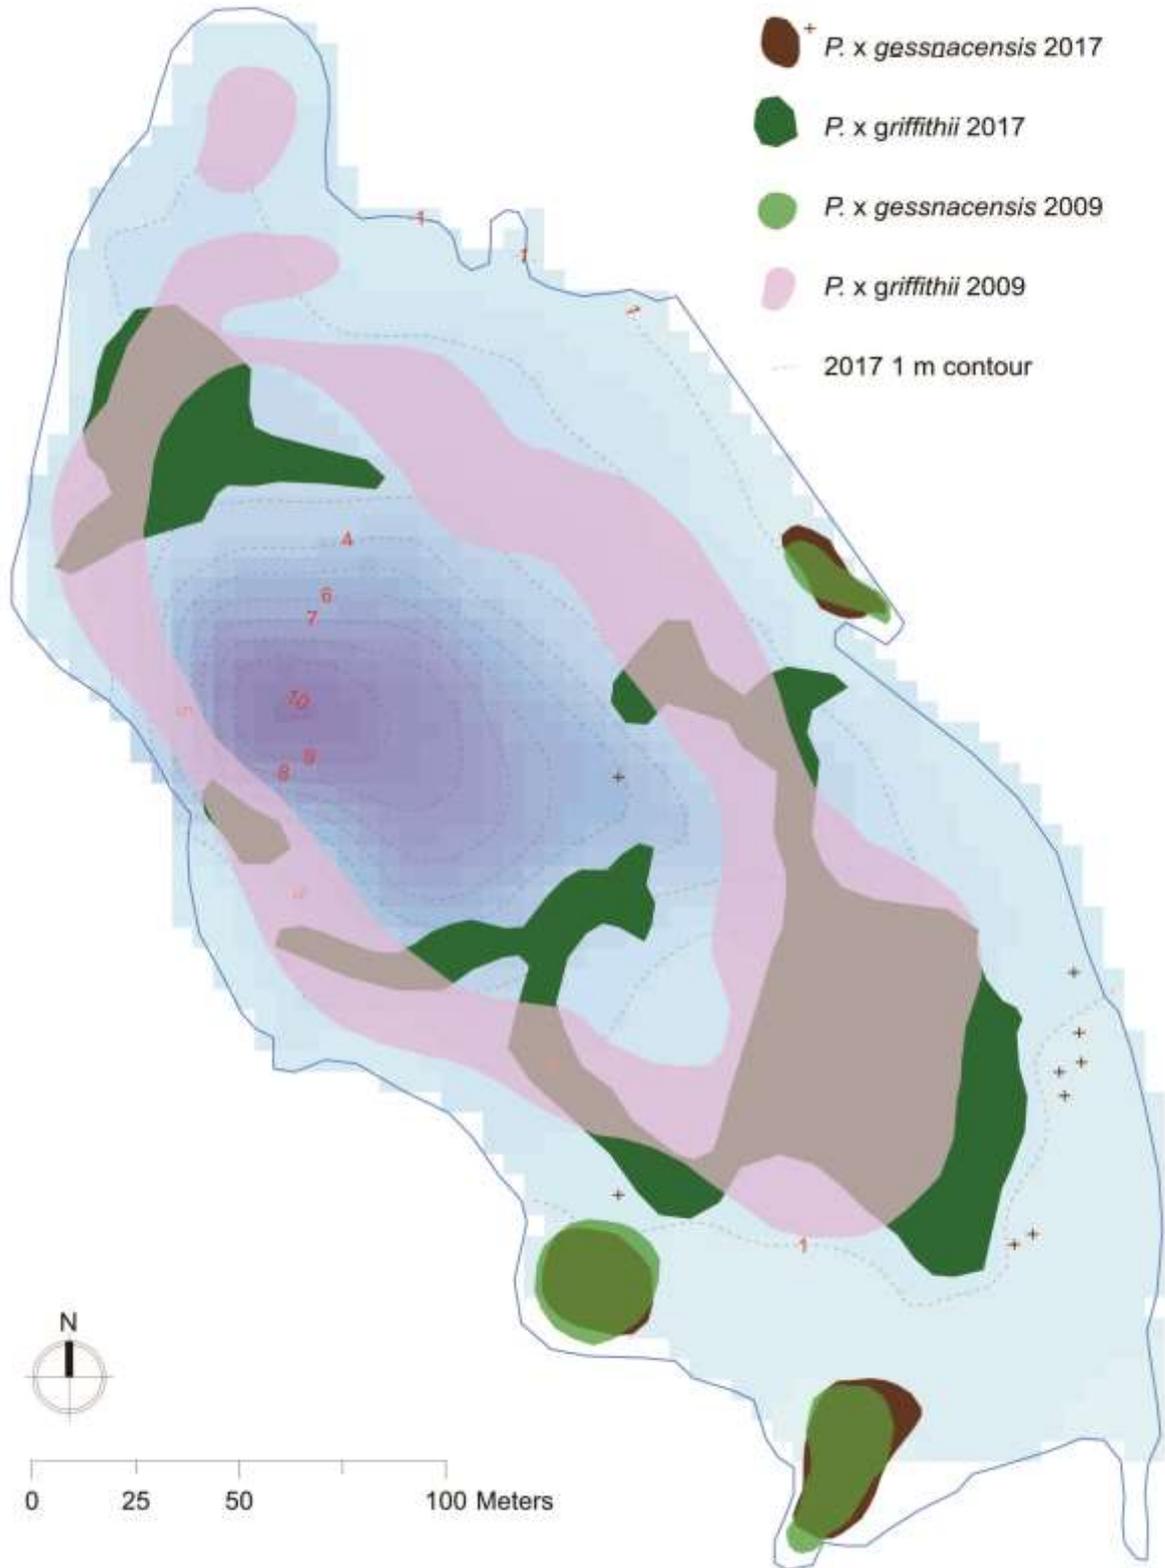
Figure 4 Comparative distribution of *P. x griffithii* and *P. x gessnacensis* in July 2017 and 2009.

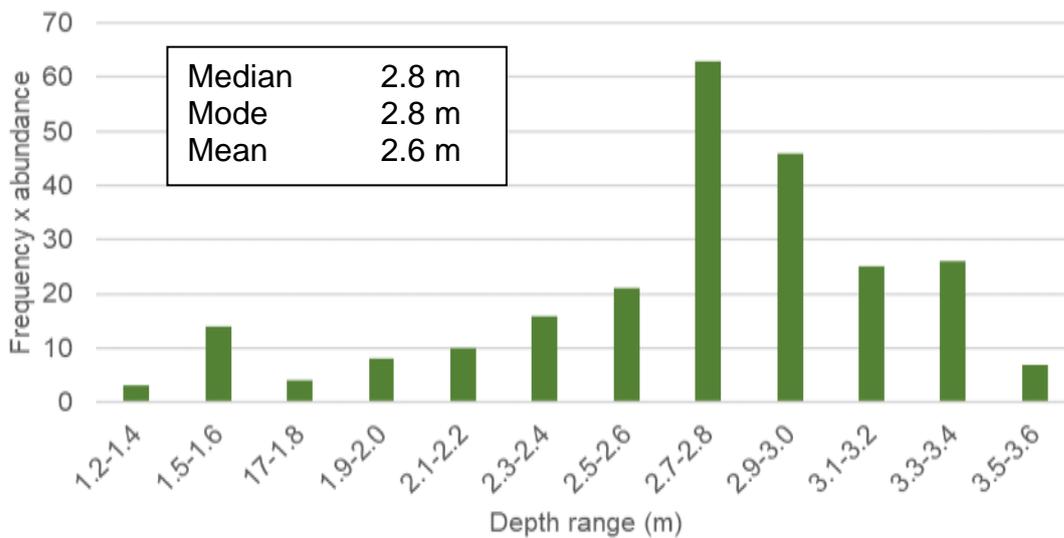
Figure 5 Frequency of occurrence with depth for *P. x griffithii*, weighted by plant abundance

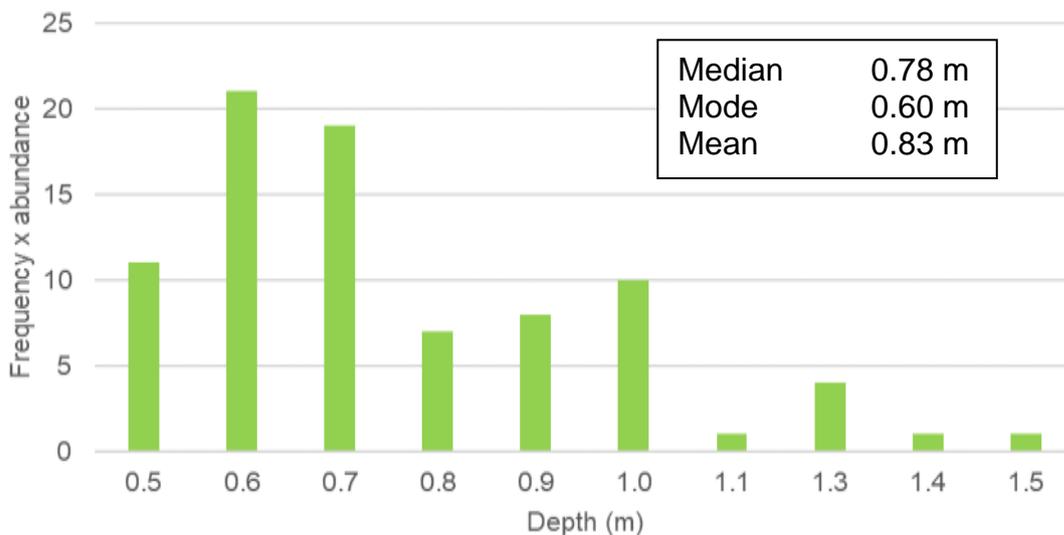
Figure 6 Frequency of occurrence with depth for *P. x gessnacensis*, weighted by plant abundance

*Potamogeton x gessnacensis* on the other hand, shows very little change in its extent between 2009 and 2017. There is a small bed towards the southeast shore that was not seen in 2009, but otherwise the three main beds appear to remain almost unchanged. The distribution of *P. x gessnacensis* was restricted to depths of less than 1.5 m, with the majority of plants being at depths of 0.5 to 1.0 m, performing best (highest abundance) at 0.6 – 0.7 m (Figure 6). While there is seemingly adequate depth habitat within Llyn Anafon, it remains restricted mainly to sheltered embayments, the floating leaves no doubt intolerant of high exposure to wave action.

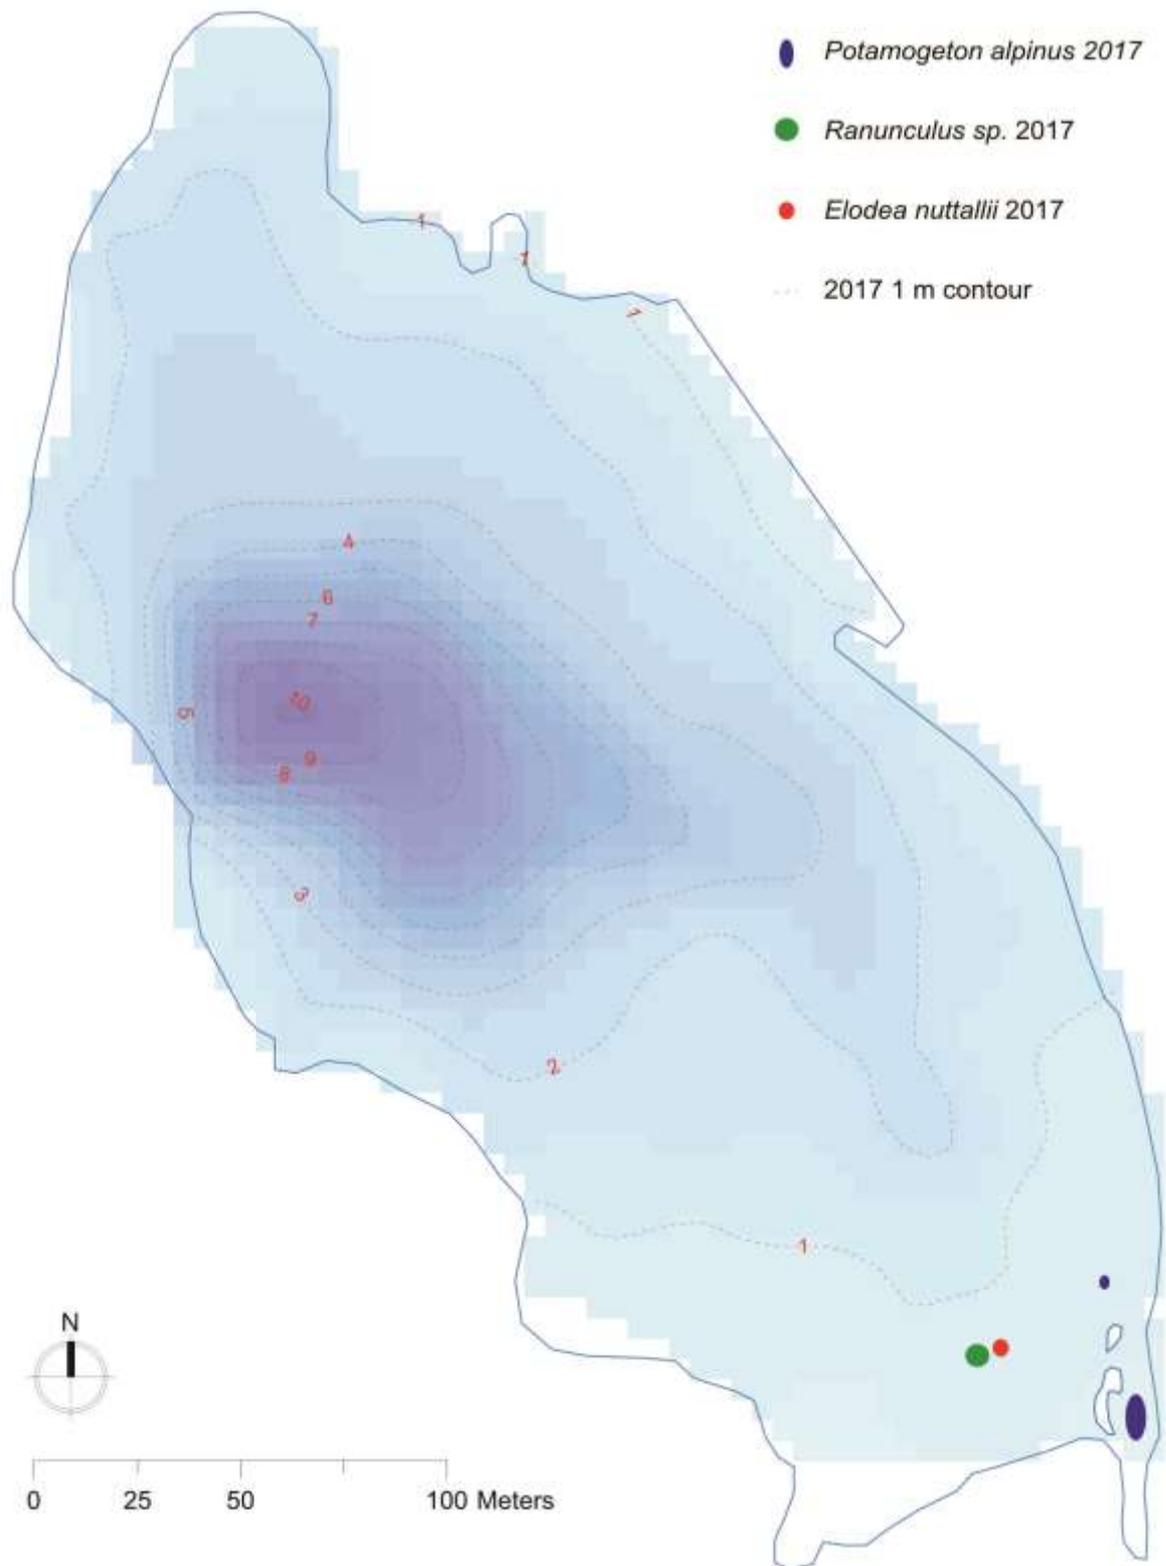
Figure 7 Distribution of *P. alpinus*, *Ranunculus* sp. and *Elodea nuttallii* in July 2017

*Potamogeton alpinus* remains rare in the site and with little difference in distribution to 2009. It is restricted to a small area in a pool (0.7 m deep) formed where the main inflow enters the lake at the southern end, and a small number of plants extending beyond the inflow pool within a channel running out into open water to a maximum depth of 1.3 m.

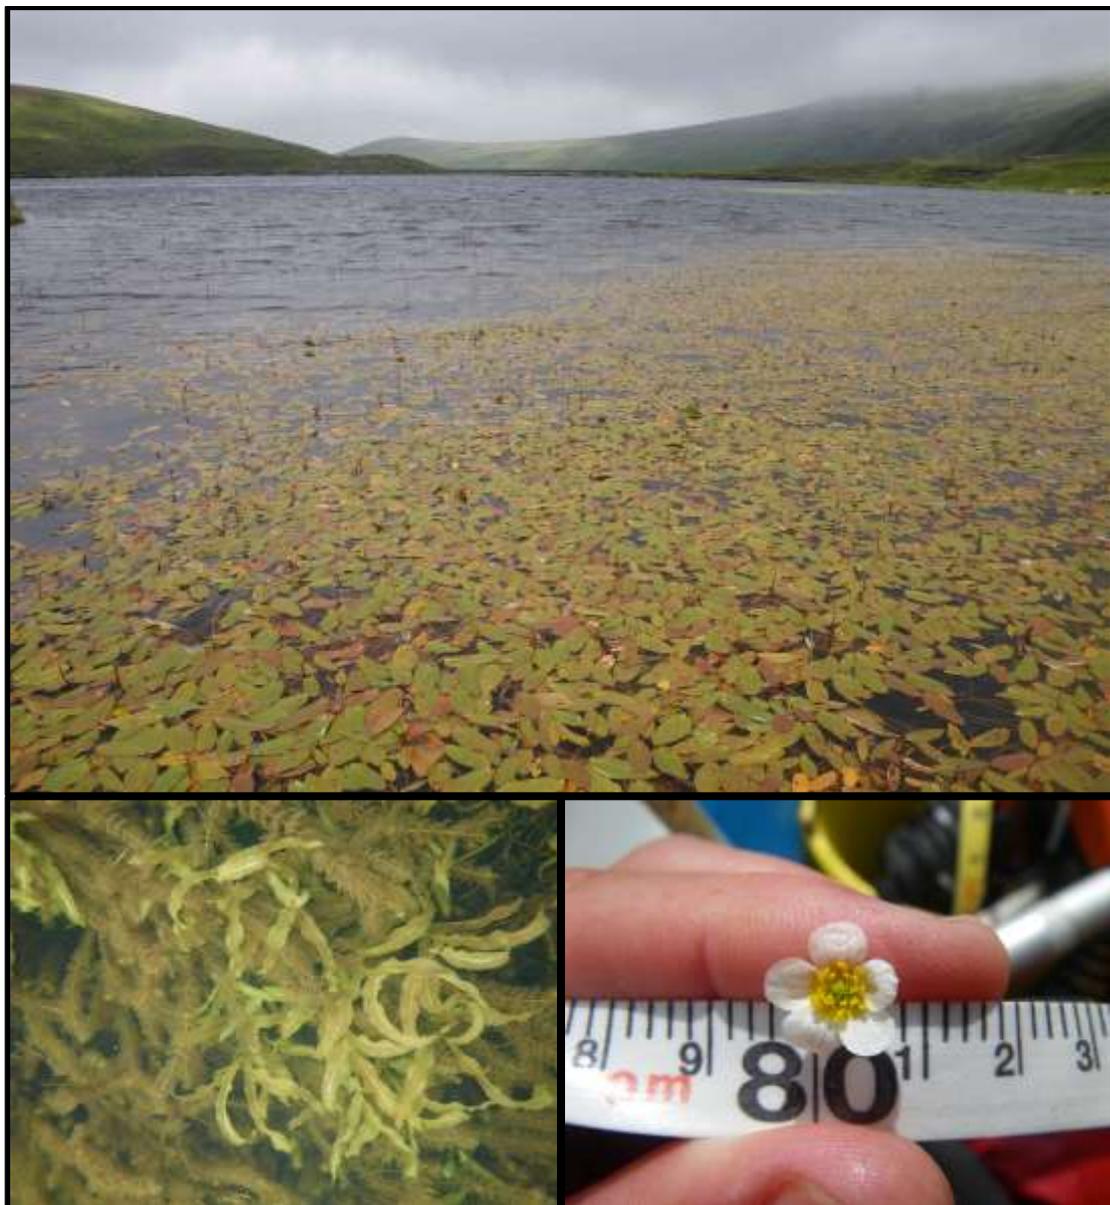
Figure 8 *P. x gessnacensis* (top), *P. alpinus* (lwr. left) and the flower of *Ranunculus* sp. (lwr. right)

Also in this shallow area at the south end, was a small bed of Water crowsfoot (*Ranunculus* sp.). This is an unusual plant to find in the uplands, and the exact identity remains uncertain. The plants had both lamina (3-5 lobed crenate) and capillary leaves akin to *R. peltatus*, but the flowers were small with petals only 8 mm

which is more typical of *R. aquatilis*. The nectar pits were difficult to define, but were more circular than pyriform, thus also like *R. aquatilis*. It is thought likely that this is a hybrid of the two species. The presence of a *Batrachium Ranunculus* at a site of 500 m is unusual, and testament to the unique nature of the site.
