Gaudet Luce Golf & Leisure Complex, Worcestershire
ENSIS Report on aquatic habitats 2017

Gaudet Luce Golf & Leisure Complex, Worcestershire: Report on aquatic habitats 2017

ECRC Research Report Number 186

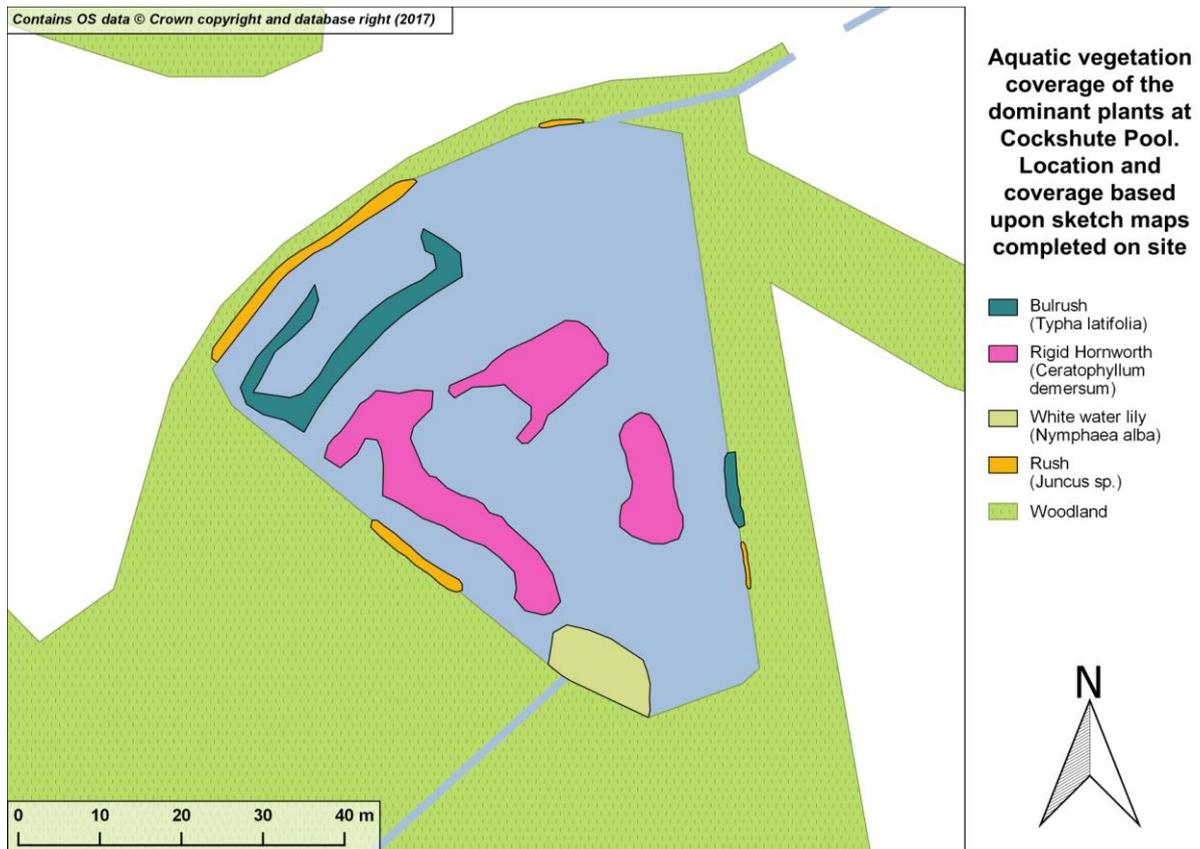
Figure 3 Aquatic vegetation coverage of dominant plants at Cockshute Pool. Location and coverage based upon sketch maps completed on site.

The open water to Cockshute Pool was dominated by Rigid Hornwort (*Ceratophyllum demersum*), which scored a '5' (dominant) on the DAFOR scale. Figure 3 demonstrates the coverage of this species across the pond. Ivy-Leaved Duckweed (*Lemna trisulca*) was frequently recorded, while Common Duckweed (*Lemna minor*) was less abundant, seen only occasionally during the survey. Lesser Pondweed (*Potamogeton pusillus cf.*) and Horned Pondweed (*Zannichellia palustris*) were of equal abundance, both scoring '2' piece on the survey and therefore occasionally seen within the water column. One individual specimen of a stonewort (*Chara sp.*) was recorded at the northside of the pond near the outflow.

Marginal vegetation by comparison was diverse in its range, forming a good habitat. Two species of trees dominating the assemblage: Willow (*Salix* sp.) and Common Alder (*Alnus glutinosa*). Young specimens of these trees were low growing on the western shore amongst the marginal plants, while a mature stand of Willow, Alder, numerous Ash trees (*Fraxinus excelsior*) and large Oaks (*Quercus* sp.) were located on the eastern shore, providing partial shade to the pond. An understory of bramble (*Rubus* sp.), nettles (*Urtica dioica*), wood avens (*Geum urbanum*), hawthorn (*Crataegus monogyna*), hazel (*Corylus avellana*) and crab apple (*Malus sylvestris*) was present in the woodland, with native bluebells (*Hyacinthoides non-scripta*) interspersed within the wetter areas towards Cockshute Pool shore. Greater Pond Sedge (*Carex riparia*) was frequently observed along the southwest shoreline of the pond, as was Great willowherb (*Epilobium hirsutum*), both of which are commonly seen marginal species on the edge of productive water bodies. Rushes were also frequent within the assemblage, specifically Soft Rush (*Juncus effusus*) and Hard Rush (*Juncus inflexus*). Other species which were occasionally observed within the margins include Gypsywort (*Lycopus europaeus*), Water Mint (*Mentha aquatica*), Bittersweet (*Solanum dulcamara*) and Brooklime (*Veronica beccabunga*). Celery-leaved buttercup (*Ranunculus sceleratus*) was recorded only once, scoring a '1' on the DAFOR scale (rare). The marginal and aquatic habitats of Cockshute Pool are shown in Figure 3.

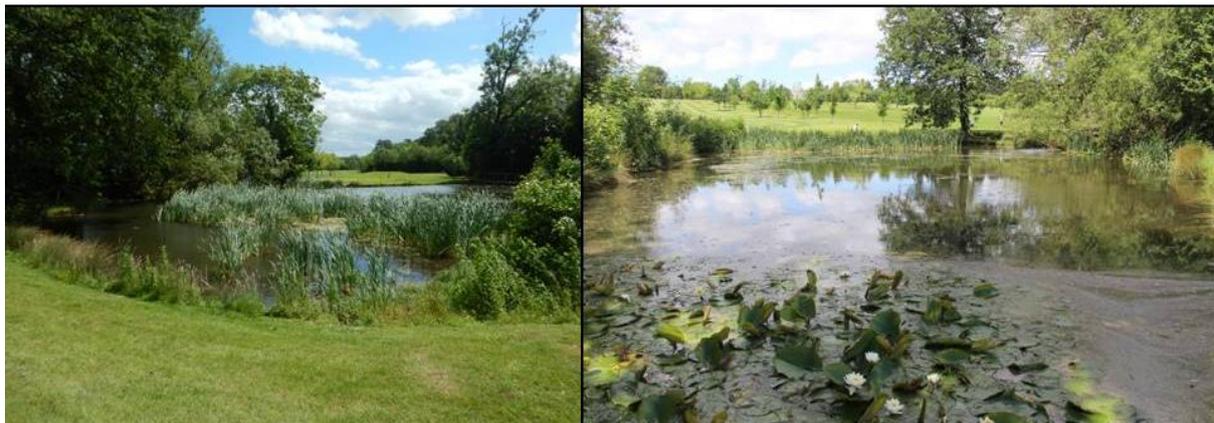
Figure 4 Cockshute Pool, photos taken facing southeast (left) and northwest (right).

The pond is limited in emergent vegetation, supporting only two species. Reedmace (*Typha latifolia*), dominates the open water with a DAFOR abundance of 3 (frequent). This species is concentrated mainly towards the northern margin of the pond and is found occasionally on the eastern and western flanks. The southwest corner of Cockshute Pool is dominated by a population of White water lily (*Nymphaea alba*) (Figure 4).

Although the plant species assemblage at Cockshute Pool suggests a productive, nutrient-rich water body, the pond does not appear to be suffering from the negative effects of eutrophication. Algal biomass was low and the dominance of the most abundant aquatic macrophytes did not restrict light penetration through the water column or impinge on the growth of other submerged plant species, such as Lesser Pondweed. This is supported by the presence of the stonewort *Chara* sp. which suggests that the littoral zone of the pond is receiving sufficient light and oxygen for stoneworts to photosynthesize. The limited growth of charophytes also indicates that nutrients are not at excessive levels.

The Reedmace at Cockshute Pool currently gets cut back by approximately 50-75% every year in order to impede its spread and maintain a clear view across the water body. This management appears to be entirely appropriate for the pond, but could be improved by also focussing on the marginal zones, where the buffer can be widened by approximately two metres. The woodland growth on the eastern shore currently does not require any management, unless the trees become unsafe. In this instance, any fallen or cut wood should be left *in situ* as deadwood habitat.

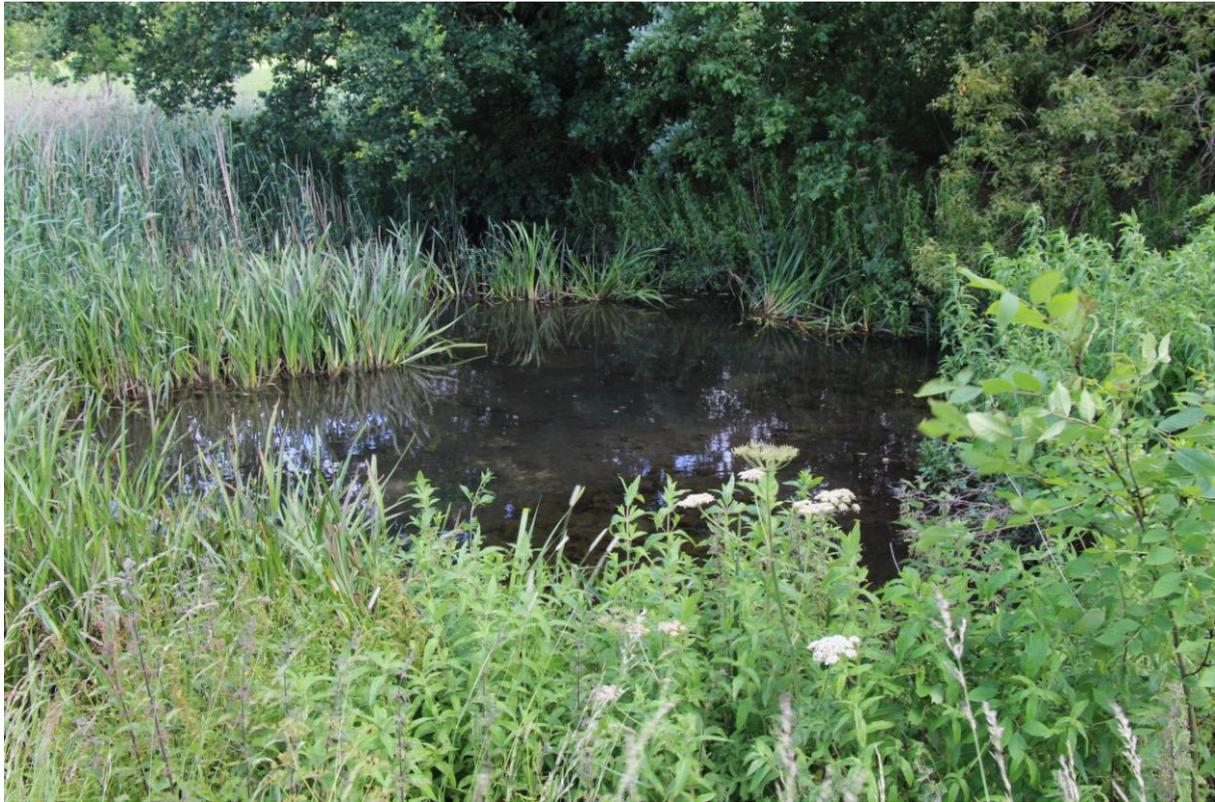
Figure 5 Gilton Brook Pond.

Gilton Brook Pond (Figure 5) was originally installed by Severn Trent and its primary purpose is to collect storm water runoff from the nearby motorway 240 m to the west. It was not possible to access the open water by boat and so submerged macrophytes were recorded by eye. Open water was predominantly located on the northwest arm of the pond, where the water was clear and no submerged plants were observed. Filamentous algae was present in this area, at an abundance of '3' (frequent) on the DAFOR scale. One instance of Curly-leaf Pondweed (*Potamogeton crispus*) was seen growing on the southeast arm of the pond at an abundance of '1' on the DAFOR scale, while Common Duckweed was seen intermittently within the emergent vegetation.

Over time, Gilton Brook Pond has become a well-established, mid-succession water body, dominated by common reed. This development has created a naturally occurring wetland, beneficial to both wildlife and the aquatic ecosystem. The common reed currently receives an annual cut in order to clear the pond and create an opening through the emergent vegetation for the golf players. Cutting back the reeds also serves another purpose: its regular maintenance removes excess nutrients from the system. This is particularly beneficial to Gilton Brook Pond since it functions as a sink for motorway runoff, which contains a multitude of water impurities such as heavy metals. Fertilising the fairways inevitably contributes to the extent of surplus nutrients entering the ponds too. Wetlands such as this have been constructed on a larger scale to control the level of surface runoff and pollutants in urbanised environments, as they act as a filtering system (Shutes, 2001). Since species such as common reed and reedmace are fast-growing species, they can be cut back regularly – thereby removing excess nutrients and pollutants from the local environment and slowing the eutrophication process.

It is therefore recommended that the common reed is cut back on a rotational basis, during the autumn/ winter period, where only less than half of the reed is removed at any one time to allow for the natural recovery of invertebrate populations. It should however be allowed to continue to establish and function as a wetland rather than an open water pond. Seasonal wetlands also provide excellent habitat for breeding dragonflies and damselflies, as well as amphibian species seeking refugia and foraging ground. Damselflies in particular are weak fliers and so therefore tend to rely on the interior of wetlands for protection from predators and the opportunity to deposit fertilised eggs on the stalks of the reeds. Once established, they do not disperse far from their larval habitat and so a permanent wetland would benefit the local populations (Colding and Folke, 2009).

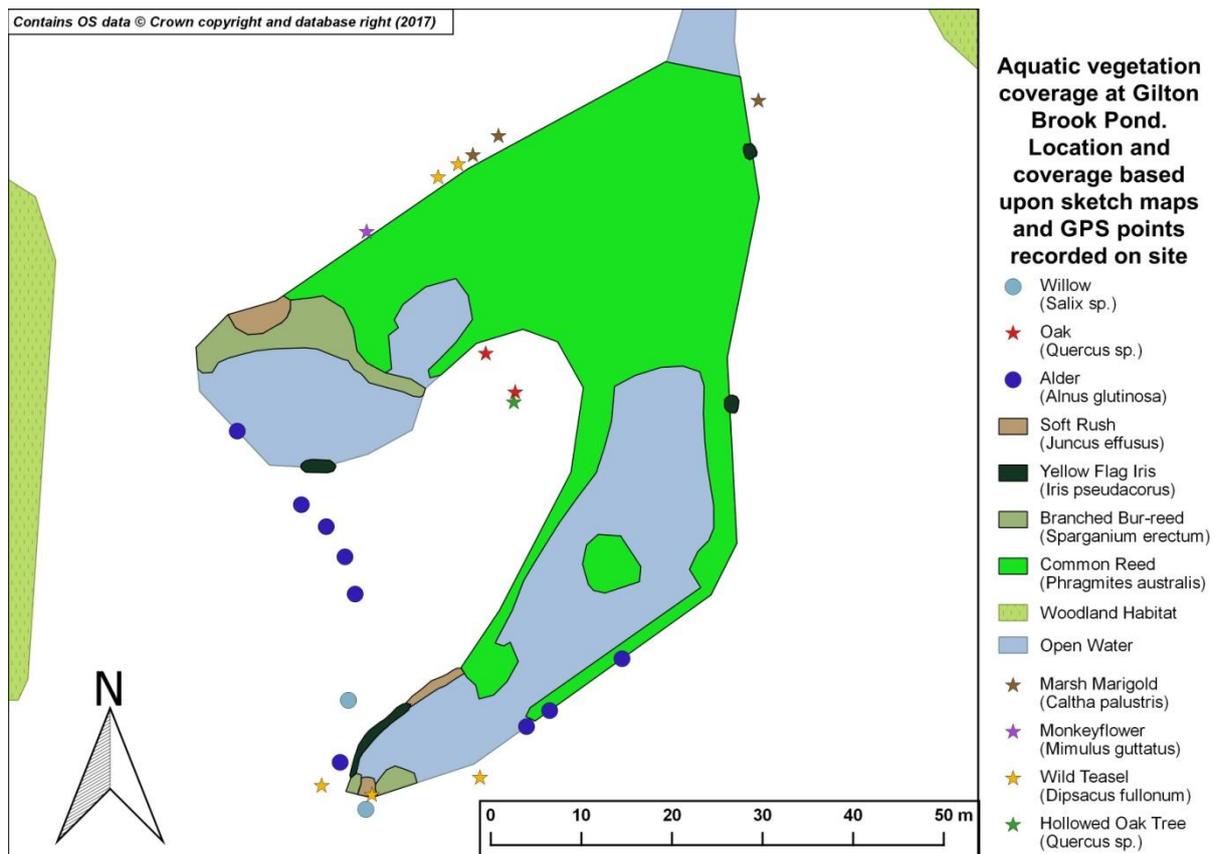
Figure 6 Aquatic vegetation coverage at Gilton Brook Pond. Location and coverage based upon sketch maps and GPS points recorded on site.

The emergent assemblage was dominated by Common Reed (*Phragmites australis*), which formed a monoculture across the majority of the pond, as shown by Figure 6. Although this prevented a corridor of open water and limited light penetration and oxygen to the water column below, the stand functions as a productive wetland. Consequently, the extent of submerged macrophytes was very limited. Towards the edge of Common Reed growth on the northwest arm of the pond, at the interface of open water, Branched Bur-reed (*Sparganium erectum*) was observed growing at an occasional level of abundance ('2' on the DAFOR scale). Similarly, marginal species such as Yellow Flag Iris (*Iris pseudacorus*) and Soft Rush also took advantage of the increased open conditions of the water and were observed growing in small populations. Marsh Marigold (*Caltha palustris*) and the non-native species Monkeyflower (*Mimulus guttatus*) were recorded growing in amongst the terrestrialised Common Reed stands, while Common Teasel (*Dipsacus fullonum*) was intermittently growing within the marginal vegetation, straddling the border of the golf course rough. A very mature, hollowed Oak tree is located on the centrally protruding section of shore (see Figure 6), which provides partial shading to the pond, alongside younger specimens of Alder and Willow.

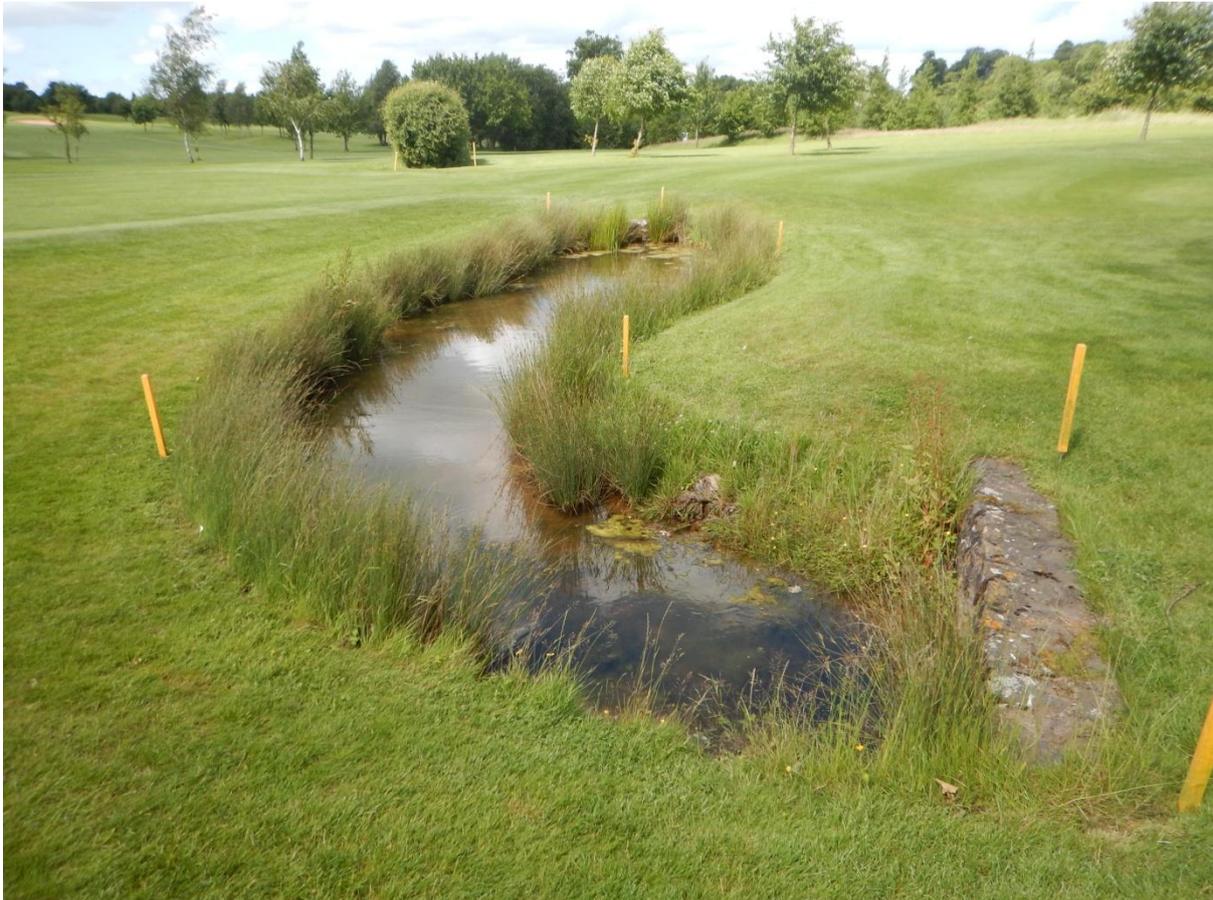
Figure 7 Pond 3.

Pond 3 – otherwise unnamed – is a very small and narrow water body with limited species diversity (Figure 7). Common duckweed and Curly-leaf pondweed were observed in the open water, both scoring ‘1’ on the DAFOR scale. Branched Bur-reed was growing on the very edge of the pond, while the marginal vegetation was dominated by Hard Rush (‘5’ on the DAFOR scale) and occasionally Soft Rush (‘2’). Reed Canary-grass (*Phalaris arundinacea*) was also observed within the marginal assemblage (‘1’), alongside Celery-leaved Buttercup (*Ranunculus sceleratus*).

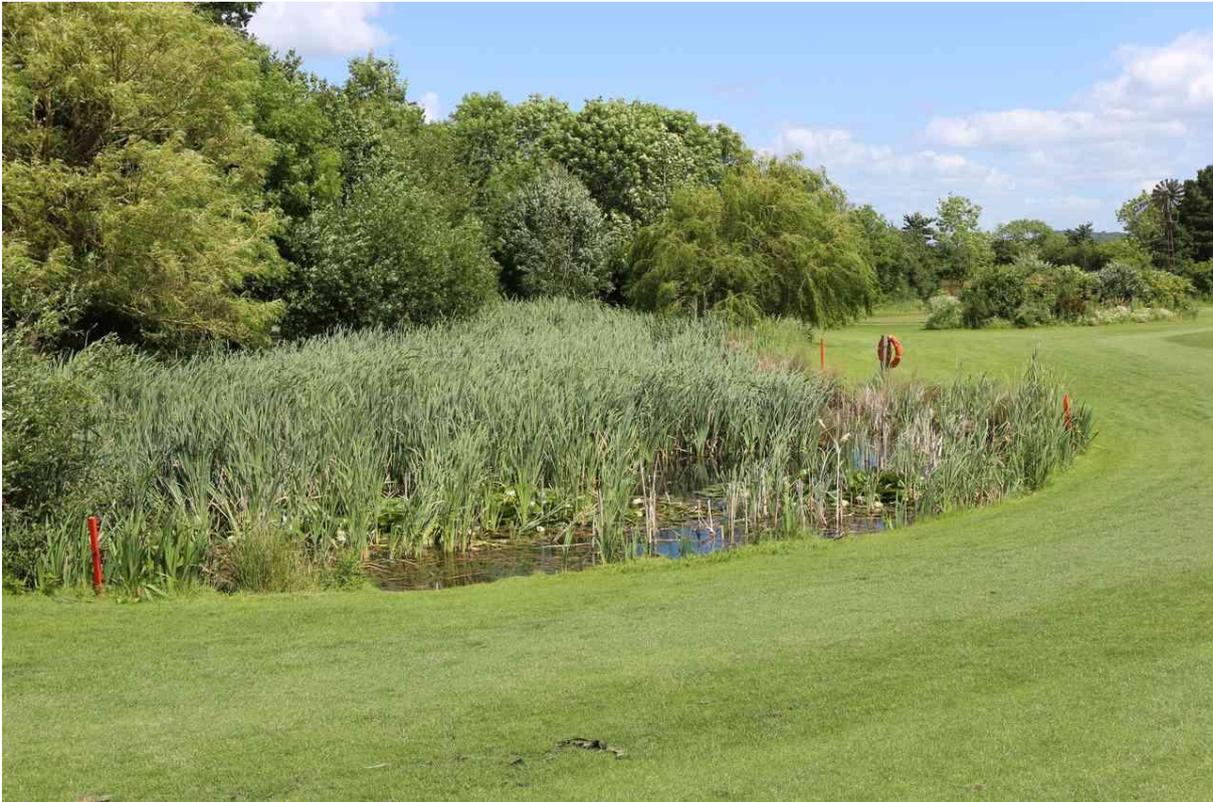
Figure 8 Pond 4

Pond 4 is a very small water body, located to the east of Cockshute Pool (Figure 8). It is dominated by Reedmace, although it was noted that some had been cleared in a 2-3m band around the edge. Submerged plants were not visible, although *Nymphaea* cultivars were present (white and pale yellow). Plants recorded include

Yellow Flag Iris, Soft rush, Hard rush, Water mint, Fool's Watercress (*Apium nodiflorum*), Gypsywort, Great willowherb, Water-plantain (*Alisma plantago-aquatica*), Tufted Forget-me-not (*Myosotis laxa*) and Cyperus sedge (*Carex pseudocyprus*).

Heavier clearance could be carried out if required at Pond 4, which would be to the benefit of open water. The cultivated water lilies as seen at this pond added an aesthetically pleasing appearance to the pond and provides habitat to dragonflies. On the day of survey a Four-spotted Chaser dragonfly (*Libellula quadrimaculata*) was observed at the pond, and a Broad-bodied Chaser (*L. depressa*) nearby.

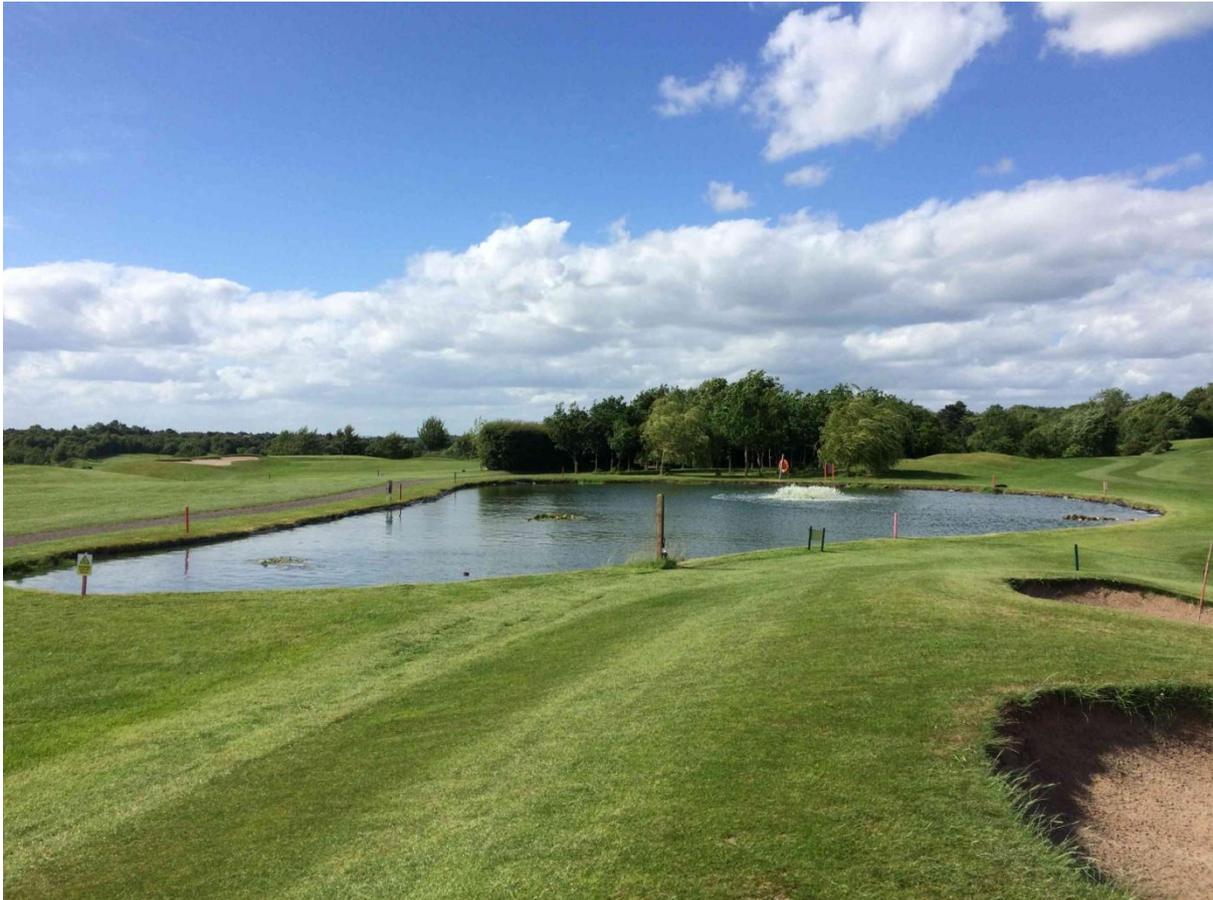
The new pond suffers from a significant coverage of algae and waters were observed to be very turbid. An aerator has been installed which is clearly necessary for the environment created. It appears that Spiked Milfoil (*Myriophyllum spicatum*), Fennel Pondweed (*Potamogeton pectinatus*) and White Water-lily cultivar have been planted.

Figure 13 Pond 5, a newly installed pond, would greatly benefit from the planting of marginal plants and the allowance of a buffer zone around the edge to soften the edges and encourage wildlife to it.

The new pond, Pond 5 (Figure 13), would greatly benefit from the installation of a variety of marginal species such as Yellow Flag Iris, Purple Loosestrife (*Lythrum salicaria*), Flowering Rush (*Butomus umbellatus*) and Marsh Marigold (*Caltha palustris*). In addition, a buffer strip around the water body of naturally established wildflowers and grasses would add an attractive, softer appearance, as opposed to the current regime of mowing to the edge of the pond.

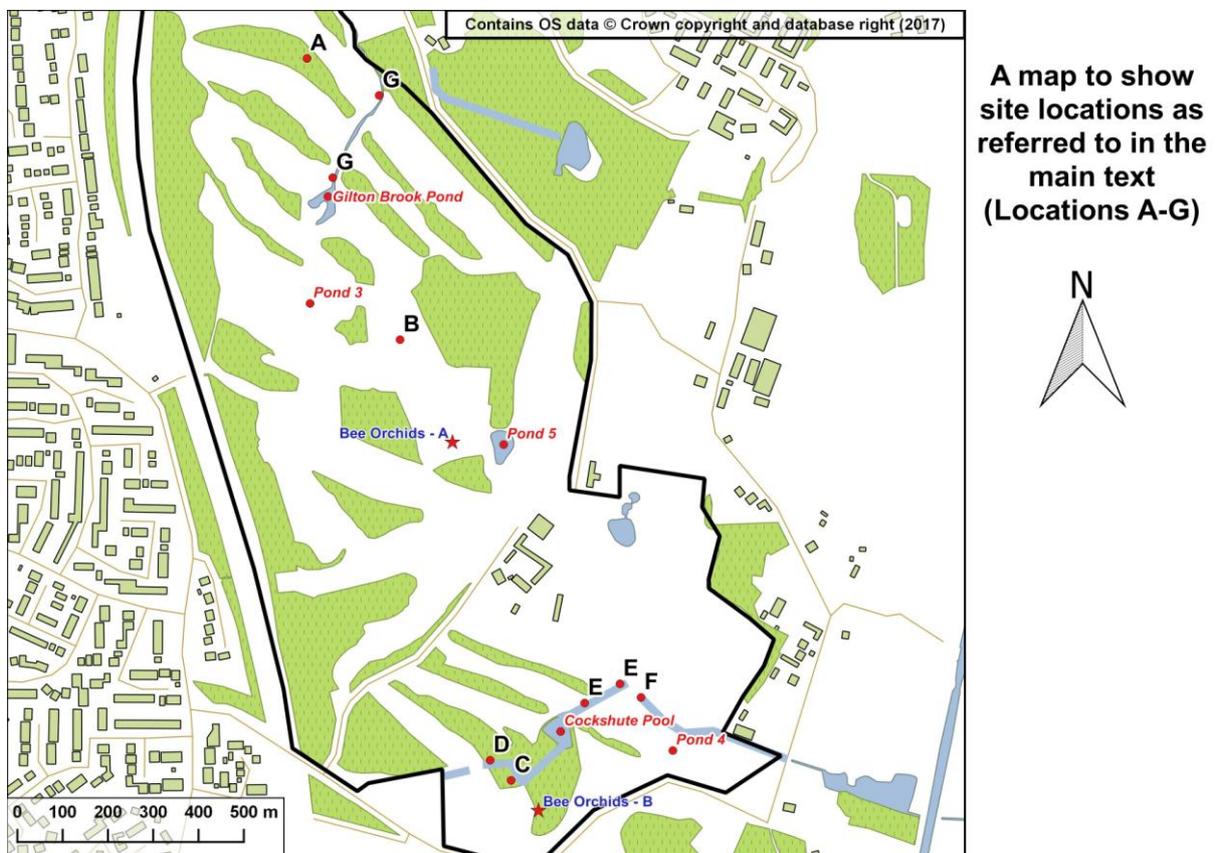
Figure 14 Site locations as referred to in the main text, lettered A-G.

In addition, Bee Orchids (*Ophrys apifera*) were discovered in two locations on the golf course, which are shown in Figure 14. At location A, four individuals were recorded. A further 12 individual plants were recorded at location B, where eight of these were in/about to flower. These were growing on a west facing slope under young Ash, Maple and Birch trees, within a community of rough grassland comprising Hop trefoil (*Trifolium campestre*), Cut-leaved Cranesbill (*Geranium dissectum*), White clover (*Trifolium repens*) and Grass vetchling. The presence of this species was unknown prior to the survey and appears to be maintaining successful sub-populations within this habitat.

Location A on Figure 14 is another area of rough grassland, with planted trees. These areas provide good habitat, although it is clear that soil fertility is high since it was noted that has been dominated by thistles (*Cirsium* spp.). Although difficult to eradicate, it is possible to do so by repeatedly cutting down the top growth of the thistle over a number of years, thereby weakening the plant. This is best done just before the flower begins to colour as the plant will have used the majority of its energy reserves in flower production (RHS, 2017). A mowing regime akin to the wildflower meadows as outlined above would also be suitable in this case; it would be particularly pertinent to remove the cuttings in order to help reverse the soil nutrient enrichment that has already occurred.

The 'wildflower' area of Oxe-eye daisies and Sweet Williams (*Dianthus* sp.) – marked as Location B – although attractive, would perhaps be of greater value to the local wildlife and nearby habitats if it instead consisted of a native wildflower mix. Reputable suppliers can be found listed on the Natural England website⁴.

Many of the ditches on the golf course are currently mowed to the top of the bank. This was noted to be the case at the ditch which flows towards Cockshute Pool (Location C). It is recommended to leave a buffer strip of at least one metre (although ideally five metres if possible) from the bank top, mowing only once or twice between September to March to promote marginal vegetation for invertebrates. This is also applicable to the ditches marked as locations D and E and G. Location F is a heavily shaded, deeply incised ditch which runs southeast along a footpath. A mixed species hedge runs along the ditch, consisting of Hazel, Hawthorne, Dog Rose and Blackthorn (*Prunus spinosa*). Notably, a few specimens of Elm trees were also present, some of which had been killed by Dutch Elm Disease.

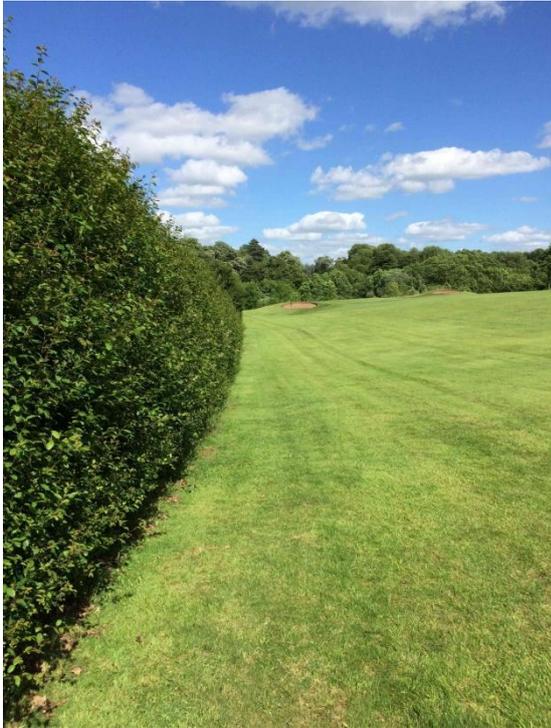
Figure 15 An example of the mowed grass to the hedge base which could benefit from a 2-3 m buffer zone.

It was noted that many of the hedgerows are mowed closely to the hedge base (see Figure 15). It is recommended that an unmowed buffer zone of approximately 2-3 m wide is introduced to all hedges on the golf course, where the rowing regime allows for a cut in the late autumn and early spring. This could be introduced as a stepped, two-tier system, where a buffer of 1 m wide closest to the hedge is cut only once a year, and a further buffer of 1m is cut twice a year at a lower length to smooth the transition into the golf course. This will also allow low growing wildflowers to establish and provide an intermediate habitat for wildlife and

consequently be of an aesthetically pleasing appearance.
