Denaby Ings Lake Sediment Sampling Report for IMC Group

By M.Hughes & B. Goldsmith
For ENSIS Ltd

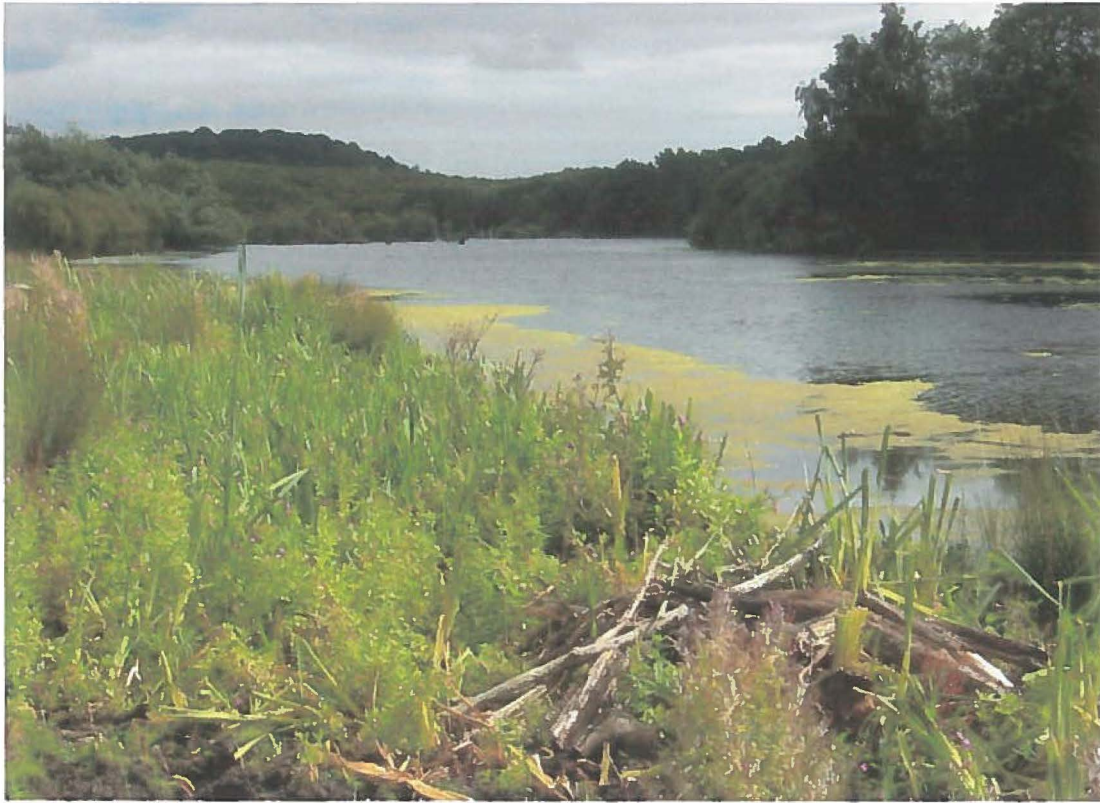
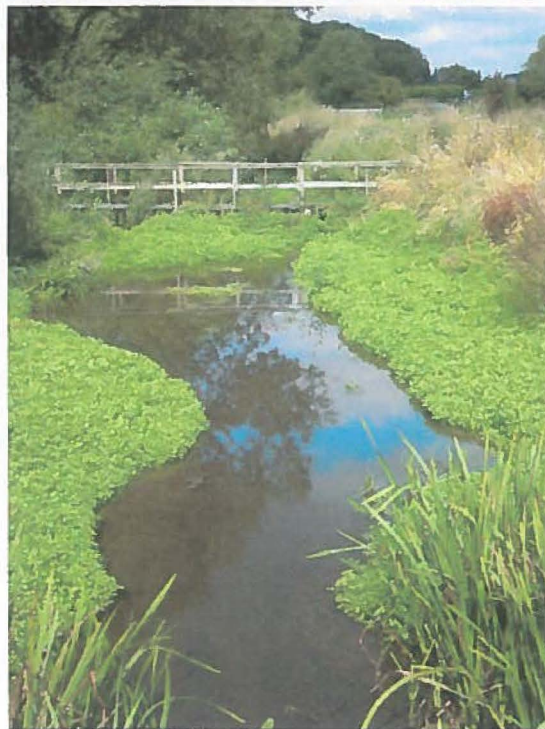
Figure 1. View of lake looking south-east from SE 4997 0097 (top), inside main sluice gate (bottom left) and looking upstream of inflow at SE 5005 0105 (bottom right).

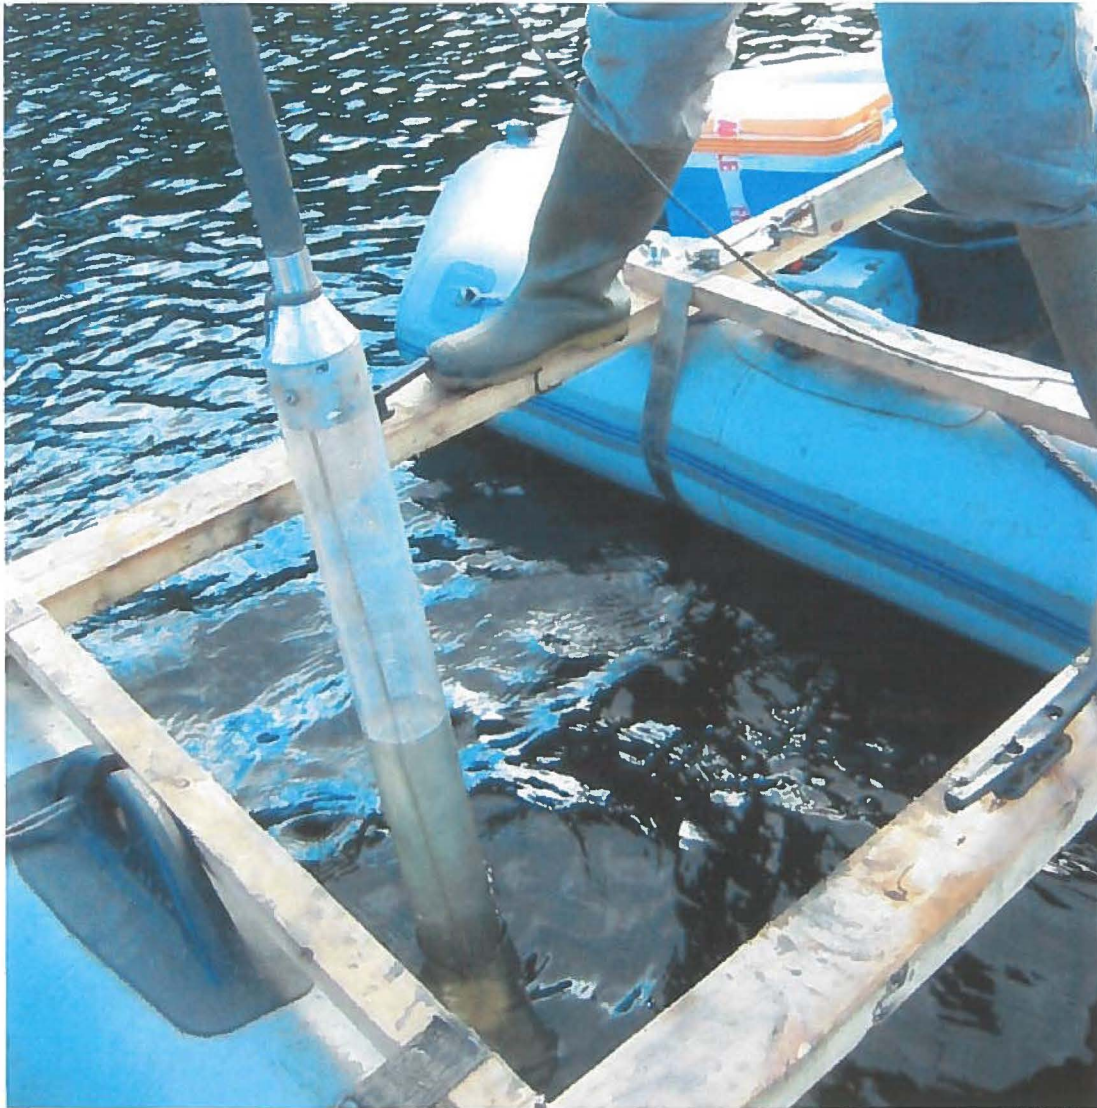
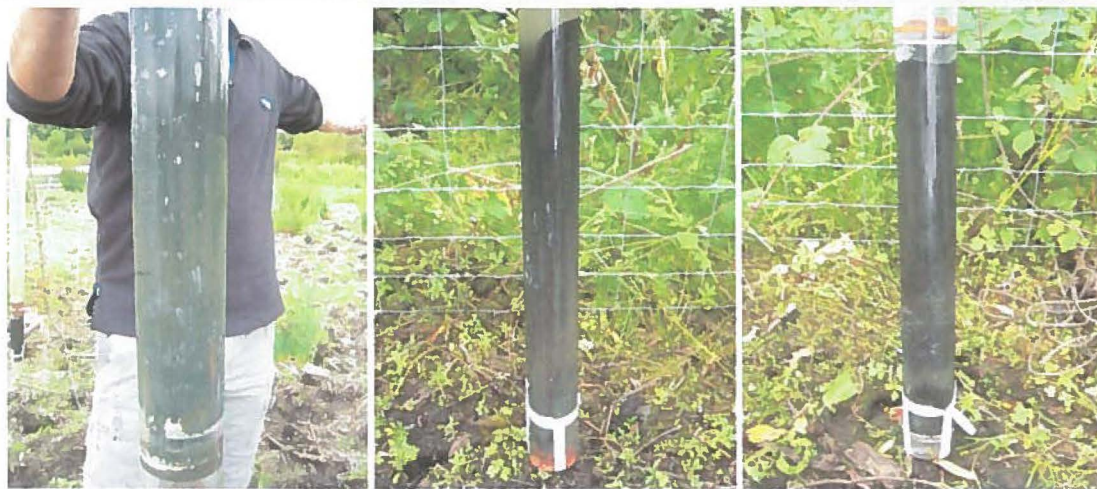
A long Livingstone corer was used from an inflatable platform to take 10 cores from the lake during 19-20 August 2003. Figure 2 shows photographs of the corer in use and pictures of cores from Denaby Ings lake. The location of cores was widely distributed across the lake to try and account for any major variations in sediment depth and composition (see Figure 3). Since the core tube is pushed into the sediment by hand the core depth is determined by the resistance of sediment material rather than actual sediment depth. However, lake sediment is usually soft enough to ensure that a complete record is obtained.

Figure 2. Photographs showing coring apparatus during operation (top) and cores 3, 5 & 6 and from Denaby Ings (bottom, left to right).

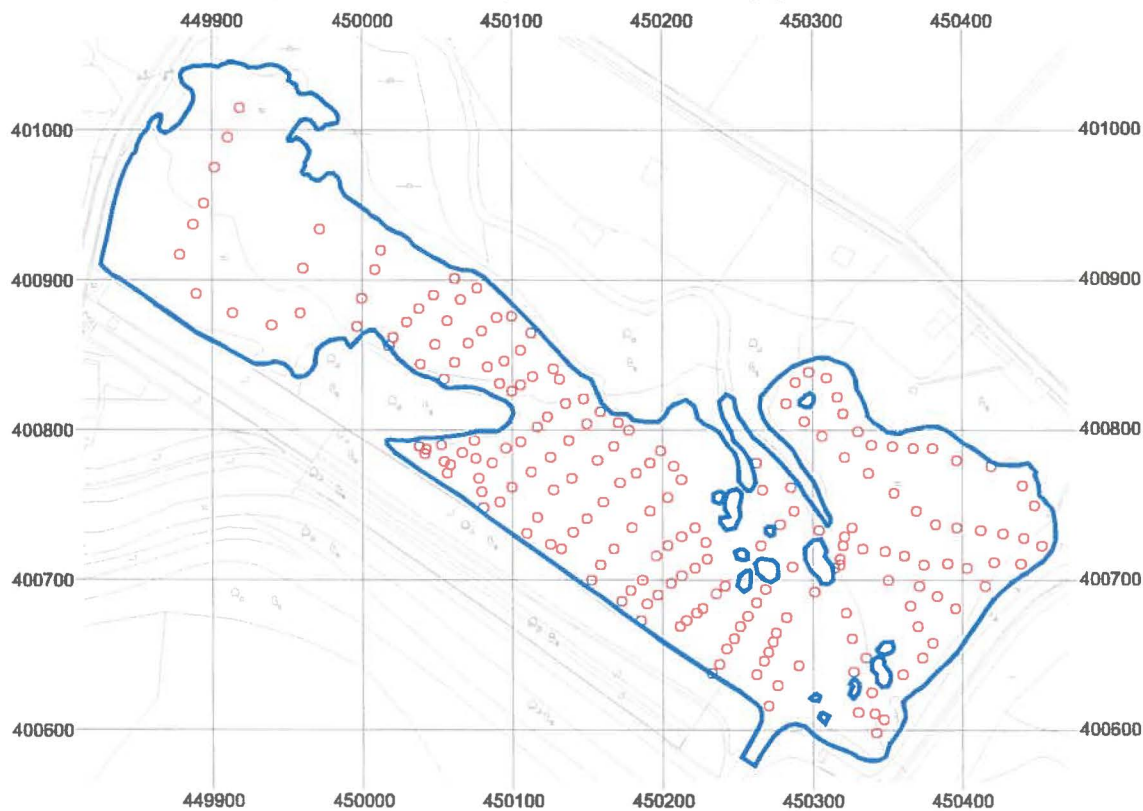
Water depth and sediment depth were measured at over 200 points spread across the lake on 21 August 2003 (Appendix A). Measured points were located using GPS as above. A map showing location of survey points is shown in Figure 4.

Figure 4. Location of bathymetric survey points (○).

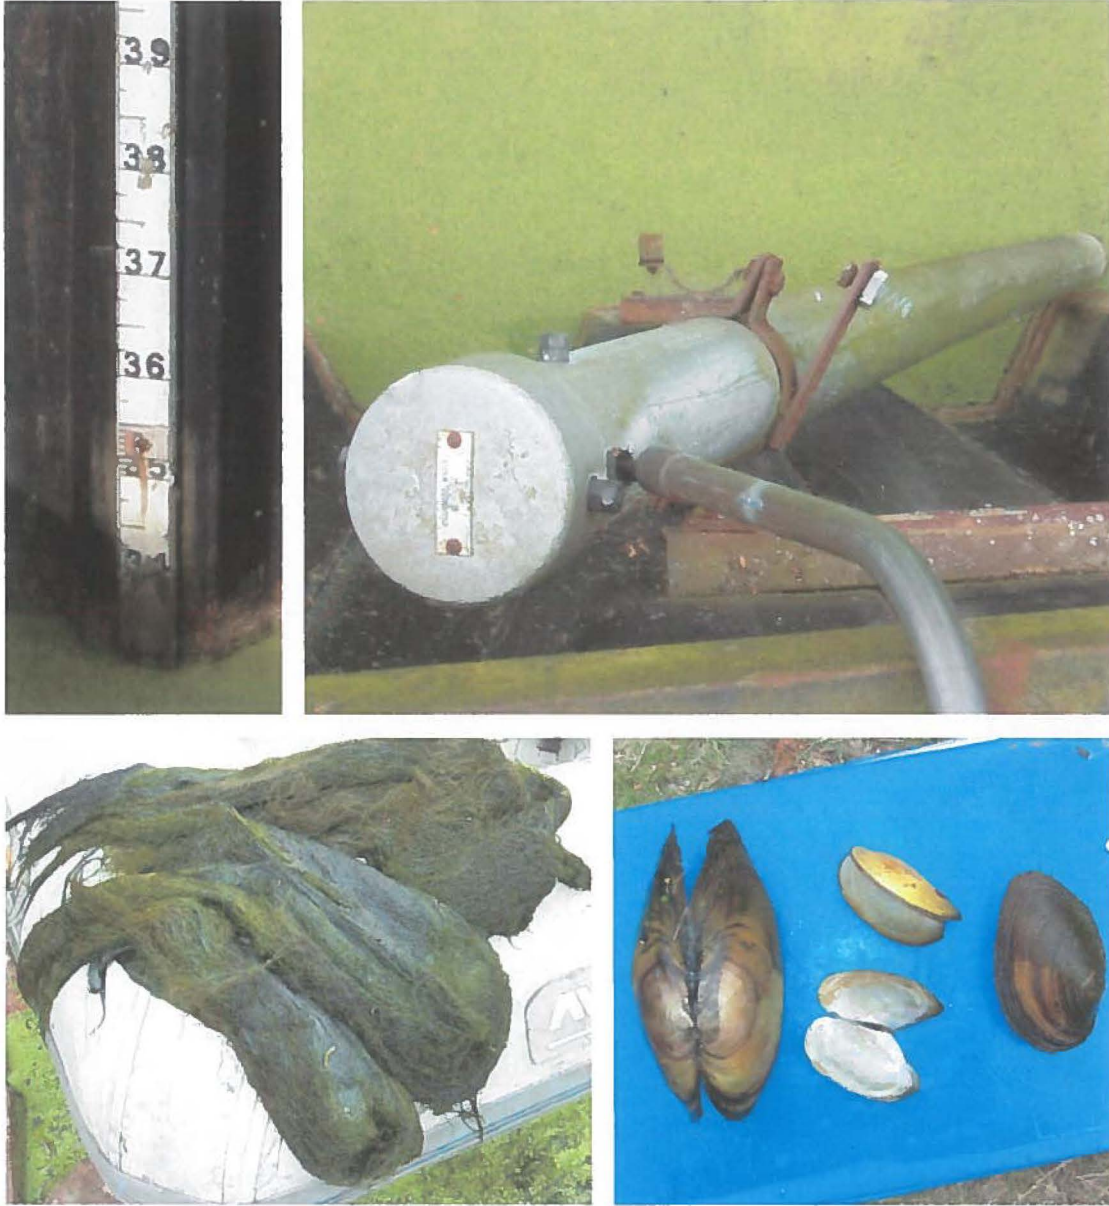
It was apparent from the lake survey that the water level was lower than usual although no lake level data were available for the lake. A stage board and water level meter were identified at the main sluice gate however, neither of these appeared to be in working order. The stage board was unreadable and the meter had come loose from its fixings (see photographs in Figure 8).

It was noted that the lake contained an unusually large amount of blanket weed (*Cladophora* sp.) (see photograph in Figure 8). Whilst this can be useful in a lake to add structure, maintain clear water and provide a habitat for invertebrates it is also indicative of severe eutrophication and often dominates in very shallow lakes. A diverse assemblage of aquatic macrophytes is more desirable since it will support a wider range of invertebrates, encourage a stable clear water state, provide feeding and breeding habitats for fish and be more attractive to visitors.

A large number of swan mussels (mostly shells though some living) were noticed in the lake (Figure 8). *Anodonta cygnea* is the largest of the UK's freshwater mussels and has been used widely in aquatic toxicity studies e.g. to monitor pollution from heavy metals in the Leeds-Liverpool canal.

Figure 8. Photographs of stage board (top left) and broken water level gauge (top right) at sluice gate, blanket weed (bottom left) and swan mussel shells bottom right).
