SEISMIC PERFORMANCE EVALUATION OF THE EXISTING AND RETROFITTED STONE MASONRY HOUSES IN NEPAL

Keywords: 2015 Nepal earthquake, rubble stone masonry, seismic retrofit, strong-back approach, seismic performance assessment

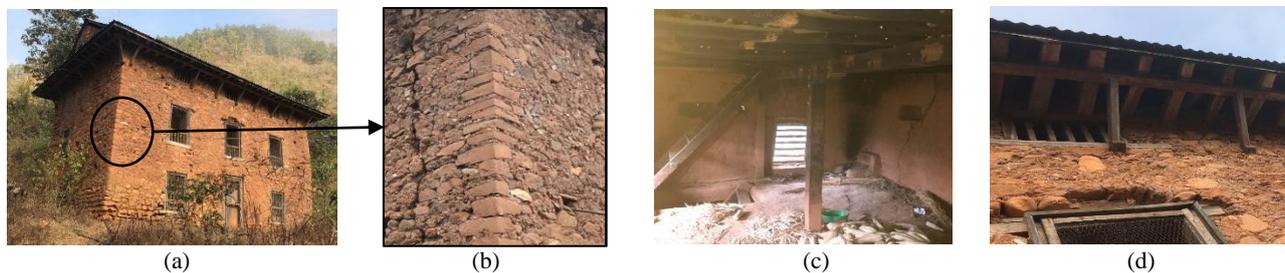
Fig. 1 – Construction characteristics of a typical PRE- SMM building: (a) 3-D view, (b) view of a corner connection, (c) longitudinal timber frame and floor structure, and (d) timber roof system with timber keys and compression struts

Fig. 1 presents photographs of a typical PRE-SMM house in a rural mountainous (i.e. Sindhupalchowk) district, used as an IB representative of this typology in the present study. This building has no internal cross wall in the short direction and is non-symmetric in the longitudinal direction because of the opening distribution. The wall densities in the longitudinal and transverse directions are about 15% and 9%, respectively, indicating that the building is weaker in the transverse direction. The IB has two-stories plus an attic floor covered in a multi-pitched timber roof structure. The cross-wall connections in these constructions are usually built with fairly rectangular shaped large corner stones which improves the cross-wall connections (Fig. 1(b)). Besides the SMM wall load bearing system, a timber frame (although the timber posts are not continuous at floor levels) centrally placed in the longitudinal direction also supports the floor structure, see Fig. 1(c). The longitudinal girder at each floor level, resting over the through thickness of the short walls, supports several transverse joists resting over the through thickness of the long walls, which in turn hold up the mud-topped timber floor structure. However, the connections of the timber girders and joists to the walls are not anchored. The unique timber roof structure, supported by a system of compression struts locked to the masonry by timber keys as seen in Fig. 1(d), promotes the confining action of all walls at the roof level.

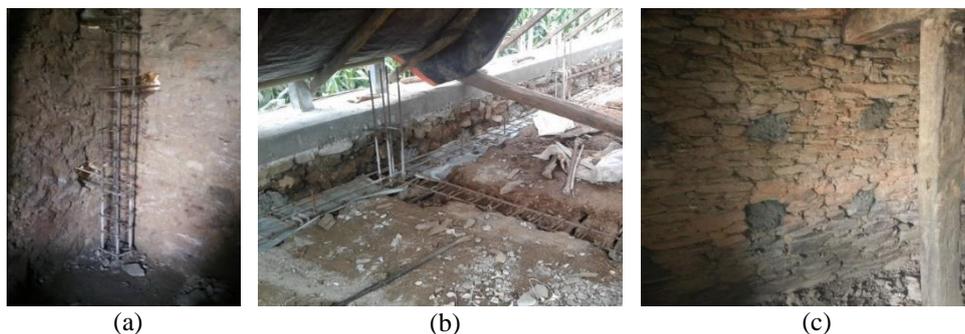
Fig. 2 – Photographs of different retrofit elements installed in an SMM house in Sindhupalchowk: (a) RC strong-back column, (b) RC ring beam and slab strip, and (c) RC through elements (Photos: Jeet K. Chaulagain, Build Change)
