Tests on Prototype Pretensioned Natural Stone Beams

Wendel Sebastian¹, Steve Webb²

ABSTRACT

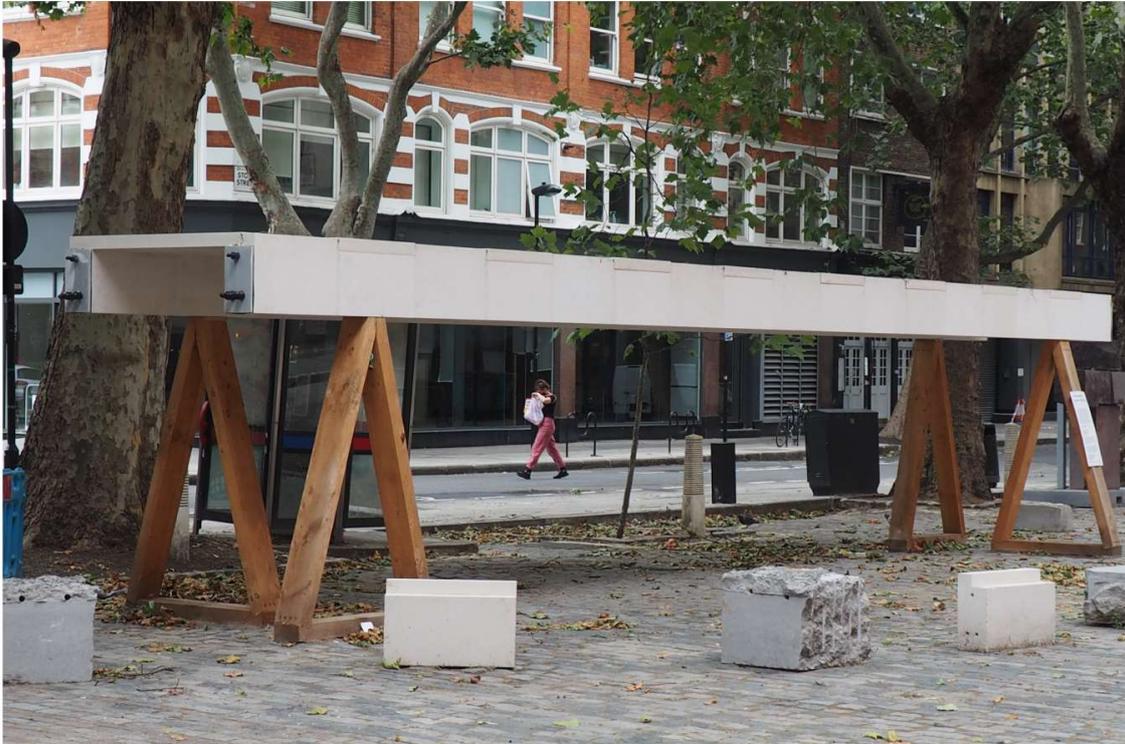
(a) 12 m Long Post-tensioned Limestone Floor Beams

77 The present study considers use of prestressed stone beams for floor applications. Fig. 1(a) shows
78 a recent trial construction, now dismantled and to be re-assembled in a different layout in future for
79 testing at the UCL structural engineering laboratory. As can be seen, the trial structure comprised
80 two 12 m long post-tensioned limestone beams, with limestone slabs spanning 1.5 m transversely
81 between the beams. Post-tensioning is reversible as the strands can be de-tensioned, enabling re-
82 use of the stone. This is a sustainability benefit of post-tensioning.

83 In Fig. 1(a), the exposed steel plates and protruding strands seen at the near-ends of the stone beams
84 can be problematic if space at the beam-wall joint is limited. In such cases it is useful to conceal
85 the mechanism of strand-stone force transfer within the stone, leaving the end faces of the stone
86 members clear of any external anchorage. This concealment is an integral feature of pretensioning.

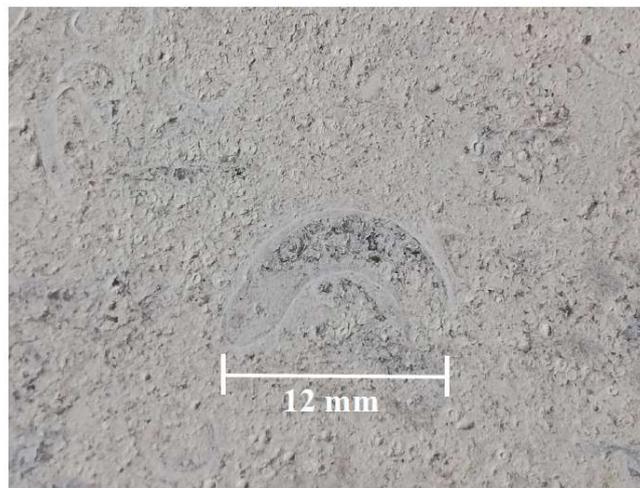
(b) Cut surface revealing C-shaped fossil fragment

157 Valange is an oolitic limestone quarried in the commune of Massangis, located in North central
158 France. It is off-white in colour, with veins and including fossil fragments, Fig. 2(a), (b). The
159 supplier quoted properties for Valange include a compressive strength of 73 N/mm^2 and modulus
160 of rupture of 7.5 N/mm^2 [30]. Samples weighed in the study reported in the present paper gave
161 a density of 2400 kg/m^3 . No elastic modulus was given by the supplier, but a value of 28.9
162 kN/mm^2 was deduced from the present study as described in Section 6.0 of this paper.

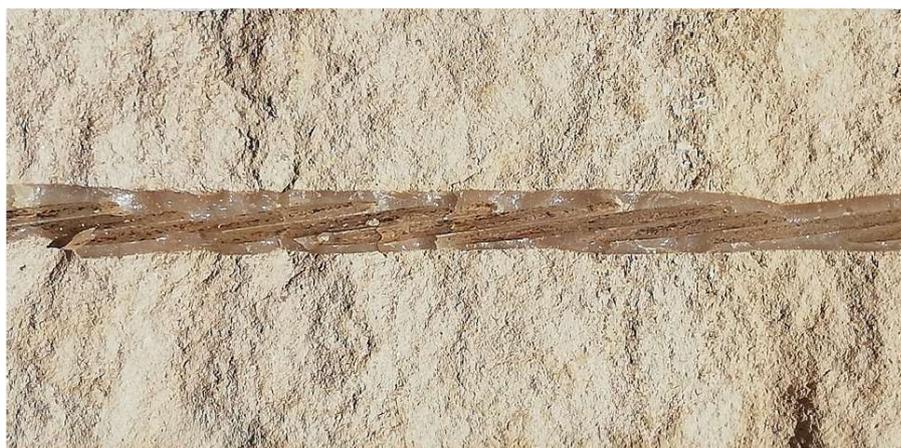
(c) Post-test sample from beam showing cured epoxy that enclosed half of strand section

179 Fig. 2(c) shows a short length of Valange stone which fractured off a beam specimen during a
180 failure test. Note the middle strip of a different colour, which is the hardened adhesive that
181 originally encircled the lower half of the steel strand and which (namely the adhesive) is still
182 embedded in the stone. The inclined grooves in the adhesive are from the wires of the strand,
183 which shows how closely the adhesive fitted around the strand. Overall the image shows that
184 the adhesive flowed into and cured well in the main hole, in the process developing good bond
185 with the stone. These are all testament to the success of the cartridge injection of the adhesive.

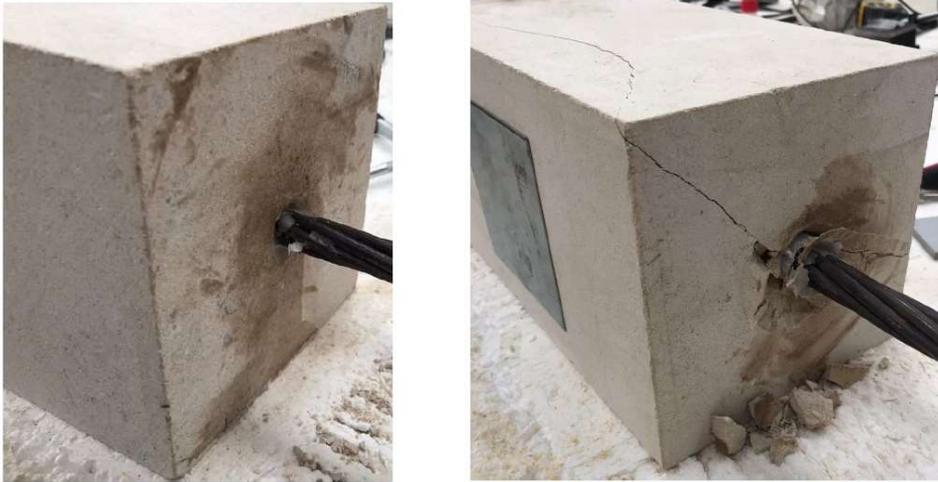
(a) Failure of Specimens P400 (Left) and P600

210 In all cases the bond between the strand and adhesive failed, while the adhesive-stone bond
211 appears to have remained intact. For specimens P200 and P400 there were audible cracking
212 sounds as failure by significant strand-adhesive slip was approached. The left image of Fig. 4(a)
213 shows specimen P400 after failure, note the clear length of pulled out strand without adhesive.
214 For specimens P600 and P800 loud bangs were heard at ultimate. In addition splitting cracks
215 appeared along P600, see the right image of Fig. 4(a) which also shows a small truncated cone
216 of Valange stone pulled off at the front end of the block.

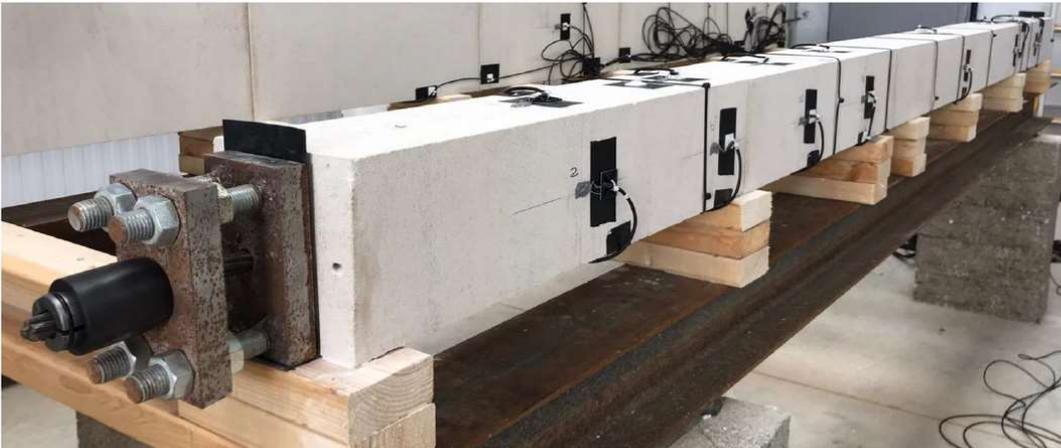
(c) Tensioning stage at anchored end

259 Fig. 5(c), (d) show the pretensioning setup. Fig. 5(c) in particular also shows the strain gauges
260 already installed at the black taped locations. The 7-wire strand had already been fed through
261 the 20 mm diameter hole pre-drilled through the blocks. At the near-end in Fig. 5(c), it is evident
262 that the strand has been locked into place by a barrel-and-wedge system which in turn reacts
263 against two thick steel plates with large diameter studs between them. The outer plate directly
264 equilibrated the load coming through the barrel, while the inner plate distributed the load in
265 bearing to the end face of the stone specimen via a thin rubber pad. Fig. 5(d) shows the pulling
266 end, which was similar except for the presence of the jack and the load cell.

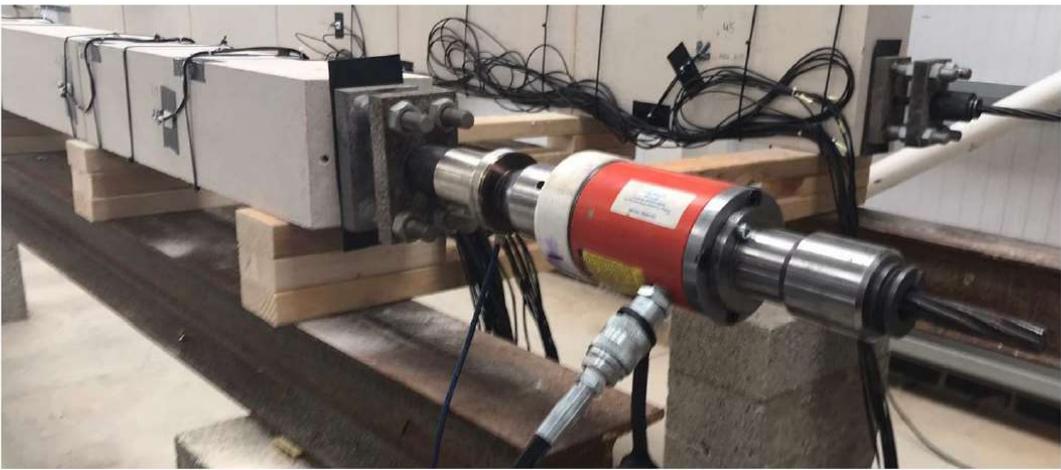
(d) Tensioning stage at jacking end

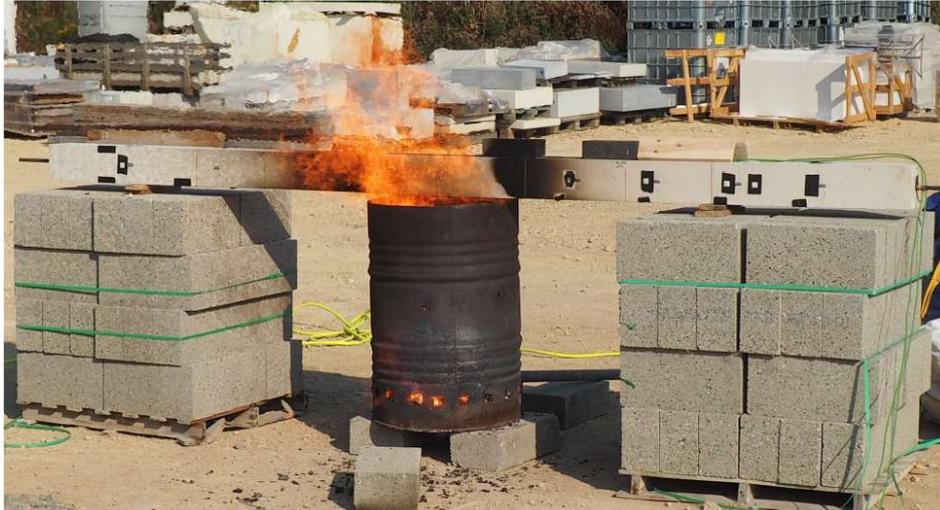
(a) Fire Test in Progress

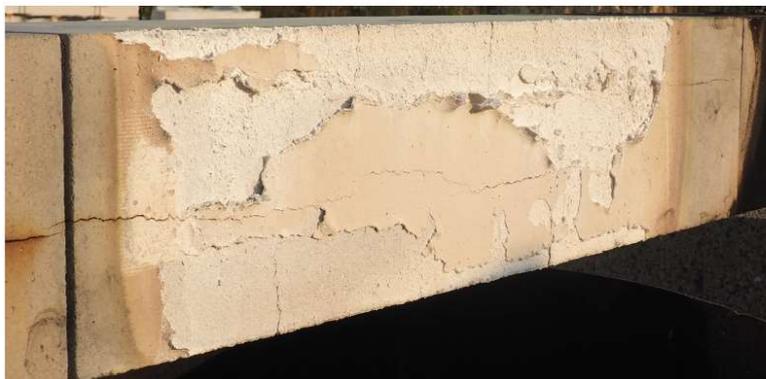
(c) Bottom Face Post Fire : Stone Peeling

354 After the test was over, an approximately 2 mm thick layer was found to have peeled off the
355 bottom face of the middle Valange block which was directly above the fire, Fig. 8(c). Observe
356 also the longitudinal crack on that face, which might've channelled the heat of the flame directly
357 up to the epoxy. Finally, the portions of stone which were directly above and near the fire were
358 broken up with a big hammer to reveal samples of stone, e.g. Fig. 8(d), containing the epoxy
359 adhesive around the strands at the core of the cross section. It is seen that the lower part of the
360 right hand sample (which was nearer the fire) experienced burning of the adhesive, and also that
361 a short length over the upper part of that sample shows the adhesive changing colour from its
362 original white to a yellow-orange, indicating that this short length of adhesive too was near
363 burning. The sample of Valange on the left of the photo shows adhesive exhibiting a healthy

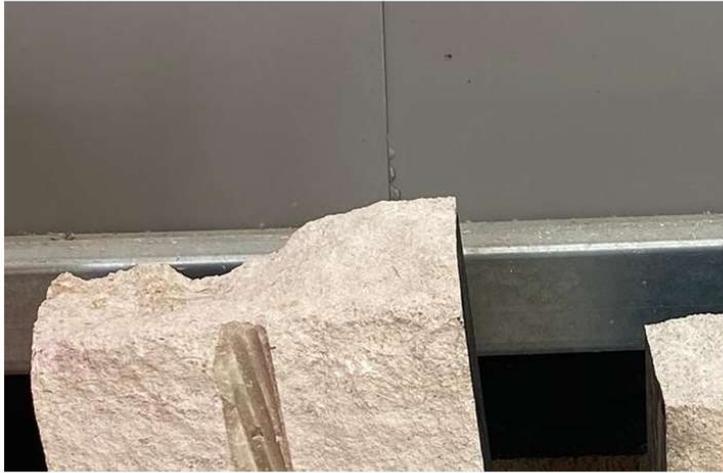
(d) Adhesive Intact (left), Burnt or Degraded (right)

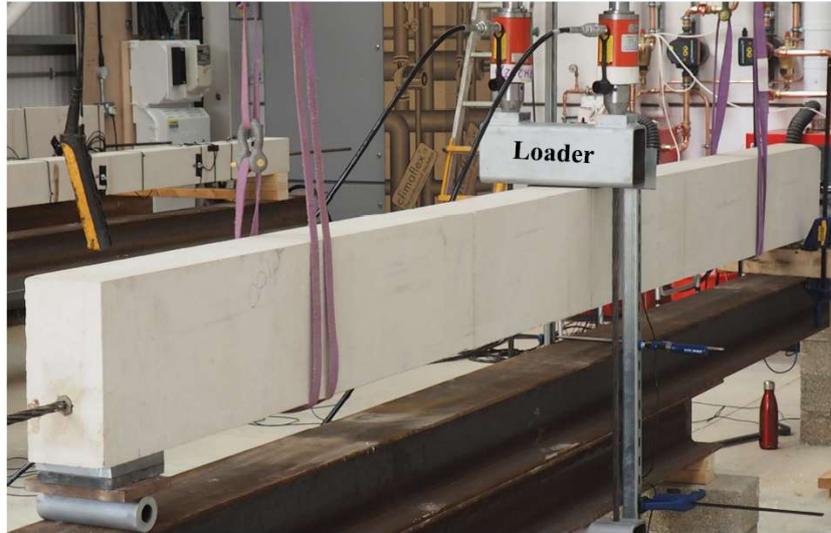
(a) Test setup

460 Of the two eccentrically pretensioned specimens the one which was not instrumented, except for the
461 presence of the load cell, was loaded to failure in three-point bending. Fig. 11(a) shows the test

462 setup. Cracking of the mortar joint between blocks at midspan was first observed at about 40% of
463 the failure load. This delay of the cracking (relative to zero cracking load for no prestressing) is
464 clearly beneficial to serviceability behaviour in practice. Fig. 11(b) shows that the mode of failure,
465 which occurred at 52 kN, was asymmetric about midspan. It was defined by a single dominant crack
466 which progressed from the midspan loading location at an inclination through the nearest Valange
467 block, until this crack reached the level of the strand, at which point it propagated almost
468 horizontally to the near end of the beam. In effect, the strand-adhesive system served as a defect
469 which triggered the horizontal crack. Fig. 11(b) also shows spalling of a large chunk of Valange
470 stone in the flexural compression zone under the midspan load. These features suggest a combined

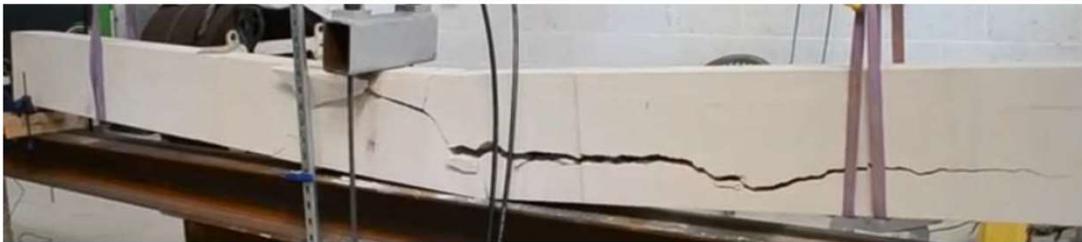
(b) Asymmetric failure crack trajectory

471 flexural-shear failure of the beam. Also, that the crack propagated undisturbed across blocks is
472 testament to the high degree of continuity provided between blocks by the strand and the mortar
473 joints. This form of failure crack has previously been reported for reinforced concrete block
474 masonry beams [33]. Future studies may consider whether the formation of this crack might be
475 delayed using internally anchored vertical bars within the stone blocks.

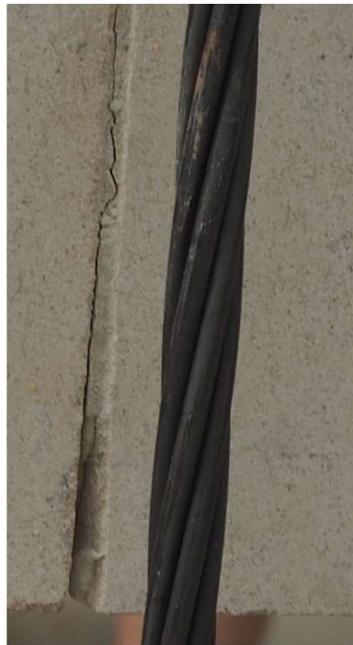
(c) Separation (crack) at mortar-stone interface at midspan

476 As Fig. 11(c) shows, at midspan, towards failure pronounced separation (cracking) was observed at
477 the left mortar - stone block interface near the base of the beam. Higher up this mortar joint the
478 mortar-stone interface remained broadly intact and no crushing of the mortar was observed. In Fig.
479 11(c), the vertical strand was part of the loading setup at midspan, right next to the mortar joint of
480 interest, hence its appearance and the oblique angle of the image.
