**Proceedings of the  
Second International Conference  
on the Archaeology of the  
Fourth Nile Cataract**

## The church US022.A at the Fourth Nile Cataract

*Claudia Näser, Daniela Billig and Mathias Lange*

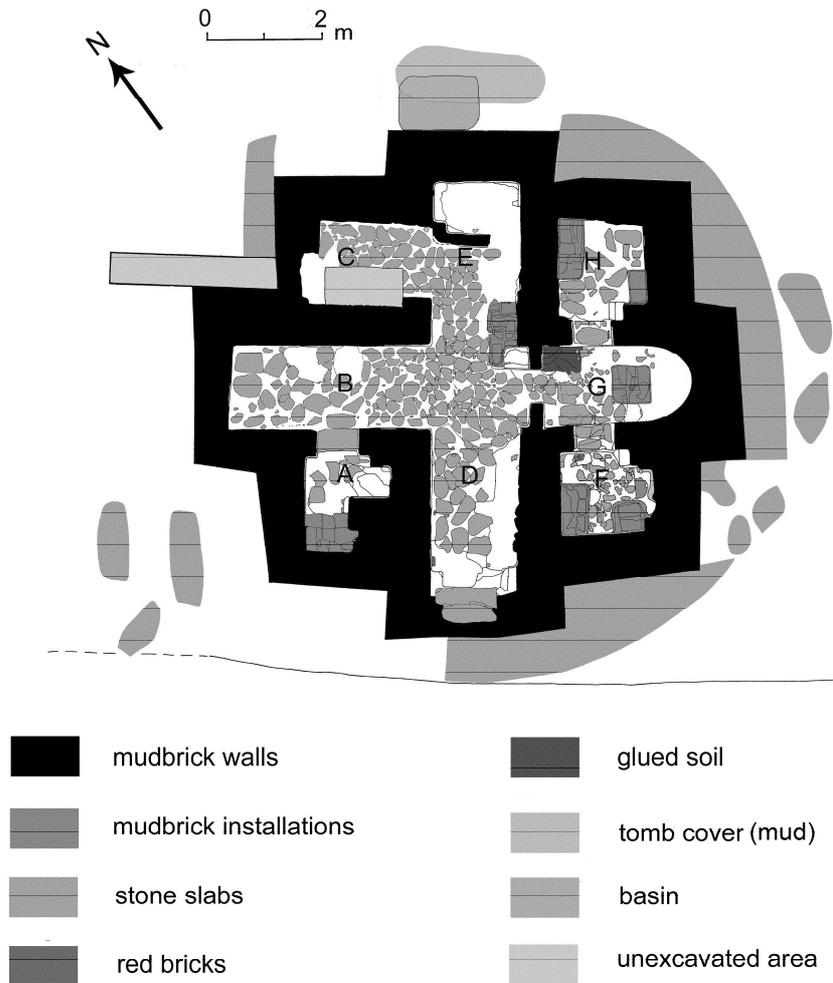
Fig. 1: Ground-plan of US022.A.

The church US022.A has a cruciform ground-plan with an apse at the east end i.e., magnetic southeast (fig. 1). In the following, directions are always indicated according to this ideal orientation. The spandrels of the cross are filled with four small rooms (fig. 1: A, C, F, H). The outer outline of the building has the shape of a square from which the tips of the four cross beams slightly project giving it a stepped appearance. The maximum outer extensions of the building are 8.8 m (north – south) x 9.4 m (east – west).

The main, west-east aisle of the church is 8.0 m long and has a maximum width of 1.5 m (fig. 1). Its west part, designated B, has a thicker layer of mud and fragments of mudbricks on top of the stone pavement, preserved in the western area. It seems to have been the material from a collapsed wall hardened for later use (pl. 6). On top of this layer, next to the wall in the southwest corner of room B, a miniature pottery dish of a polished black handmade ware (colour pl. 50: centre bottom) was found *in situ* upside down next to a shell of *Etheria elliptica*.

The north-south oriented aisle of the church is 7.7 m long and has a maximum width of 1.5 m (fig. 1). Its southern part, designated D, containing the entrance to the church has already been described. The northern end of the aisle is partitioned off by a comparatively flimsy mudbrick wall, constructed in a single row of stretchers (pl. 4). It abuts the corner to room C and then turns in a right angle towards the east. It seems to have been plastered at the same time as the chamber behind it, and thus apparently belongs to the primary building phase.

The northwest corner between the two aisles is occupied by room C (fig. 1). It is the only one of the four corner rooms of the church which did not contain any special architectural installations and which was not partitioned off by a proper doorway. Rather it extends as a corridor of about 1.3 m width and 2.0 m length from room E. Its west part was disturbed by a pit which appeared to have been dug quite recently to extract building material. Thus, of the west outer wall only the lowest courses were partially intact. Room C is the only area of the church which was not fully excavated. A block of its fill was left standing at the south wall, in order to preserve some of the stratigraphy for future study.

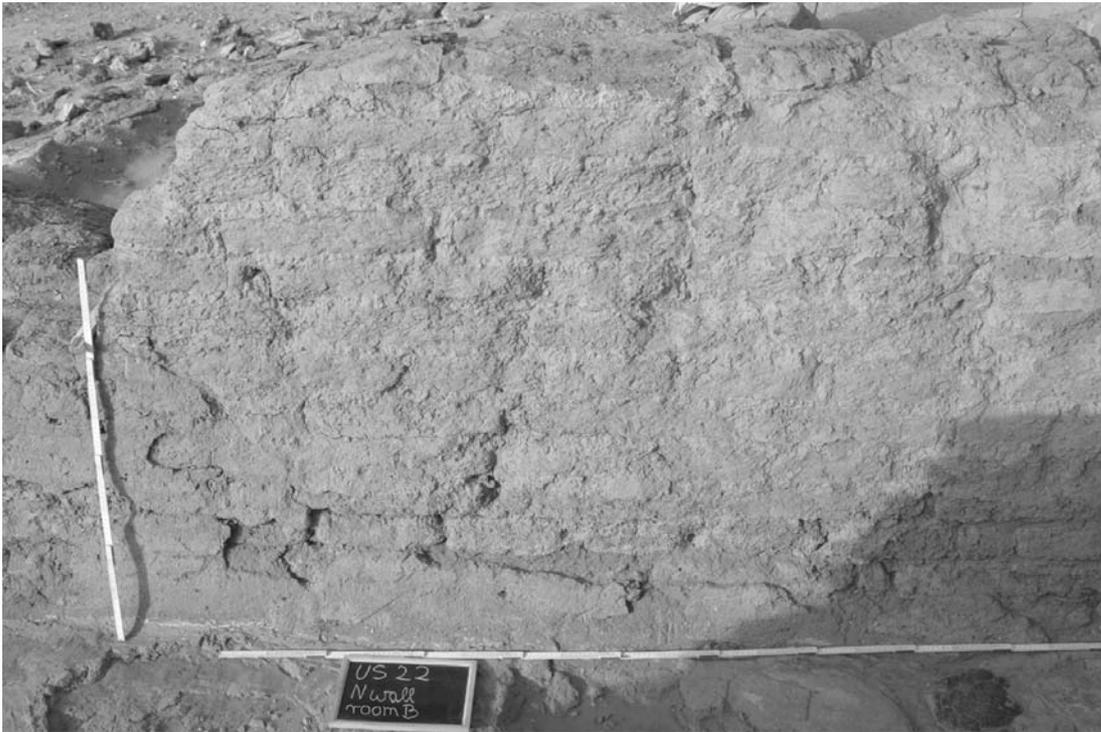
Pl. 2: Aisle B, north wall.

Likewise, all standing walls of the building are of mudbrick. They are up to 1.0 m thick, and still stand to a maximum height of 1.2 m in the north of aisle B (pl. 2). The mudbricks measure 33 x 18 x 8 cm. On the interior, the walls carried a layer of mud plaster with a white-wash, which is preserved in the lower parts of many walls (colour pl. 39). A few fragments of

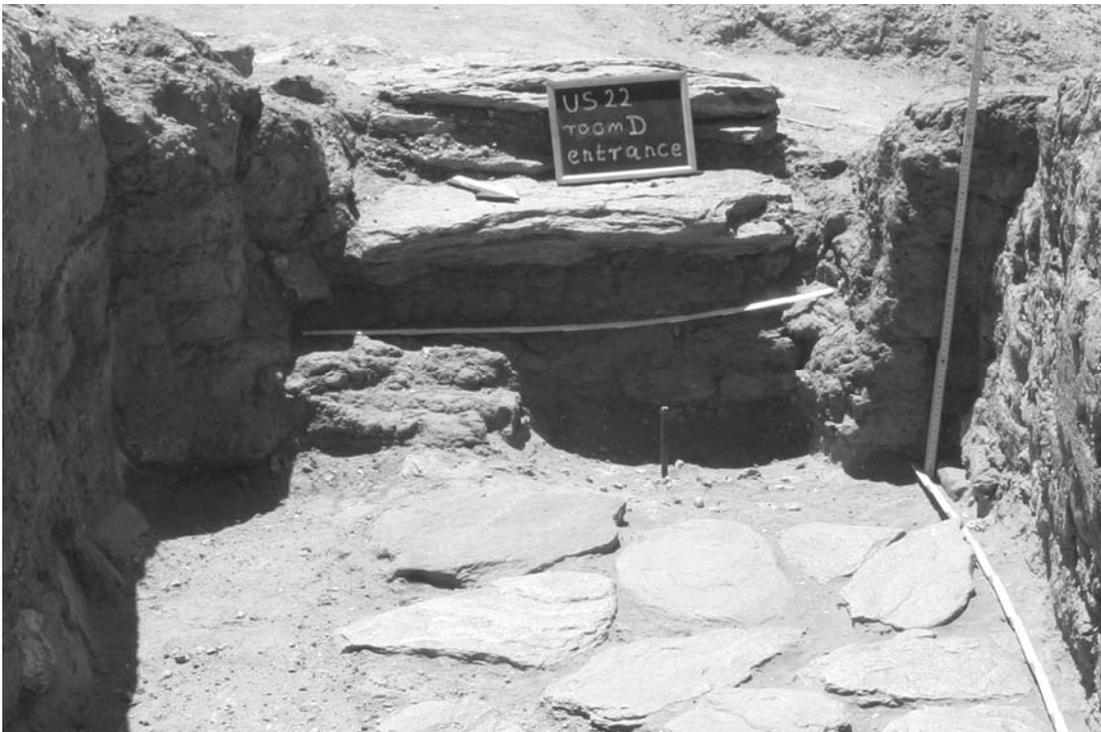
Pl. 3: Room D, entrance with the remaining steps seen from the inside.

The entrance to the church is situated in the southern arm of the cross. In this area, the natural rock outside the building is circa 0.7 m higher than the inner floor level. Probably three steps of big stone slabs, two of which were still *in situ*, led down into the interior of the church (fig. 1, pl. 3). The ancient outer ground surface is marked by a setting of stone slabs in front of the entrance (cf. below p. 153).

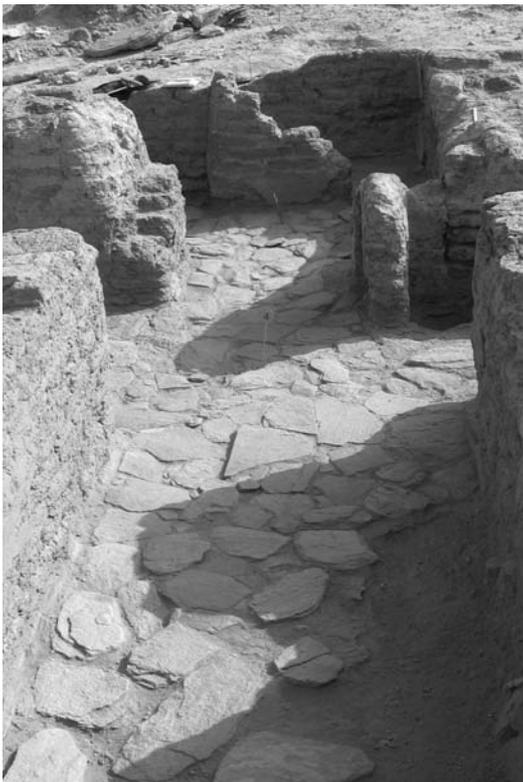
Pl. 4: North-south aisle with central intersection, stone pavement.

Throughout the entire building, the floor was covered with a pavement of small stone slabs, which is intact in most parts (fig. 1, pl. 4). It is missing in the southeast part of room D, where its absence may be due to stone plundering or the secondary introduction of a burial. There, the gap in the paving revealed a compact sandy material mixed with much gravel and shattered stone (pl. 5). Unfortunately time did not suffice to further investigate this feature. The stone pavement is also missing in the north and east part of room E, where the excavation revealed a thin layer of stone shatter on top of the natural rock (cf. below p. 148).

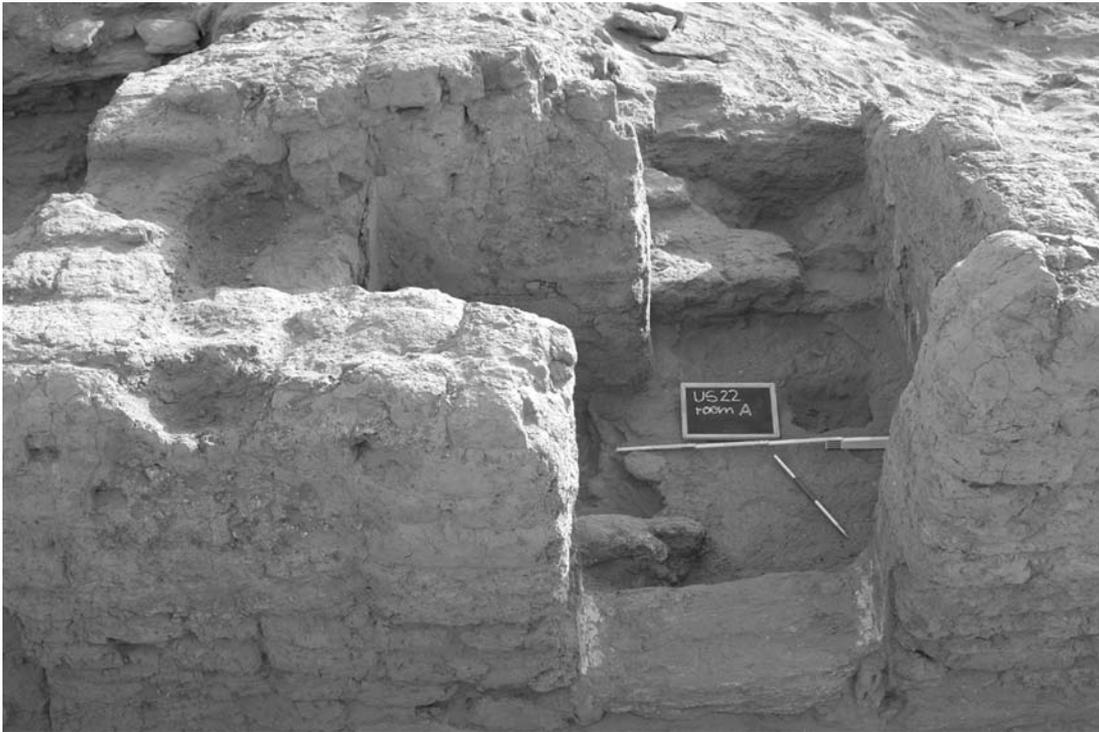
Pl. 7: Room A with the entrance, the projection of the east wall and the mudbrick feature at the rear end.

From the west part of the main aisle, room A can be accessed through a doorway with a raised threshold, which is paved with a single big stone slab (fig. 1, pl. 7). The lower parts of the walls within the thickness of the doorway still preserve their original whitewashed mud plaster, which also draws over the edges of the paving slab. Room A contains a fragmentary mudbrick feature at its south wall (pl. 7). Rather than a *mastaba* – as the installations in the sanctuaries (cf. below p. 151) – this could be the base of a staircase, which originally led to the roof of the building. The solid brickwork formed by a projection of the east wall into the room may have supported the upper parts of this installation. Though the architectural remains in room A do not give any definite evidence for this reconstruction, it is substantiated by the fact that such staircases are commonly found in the southwestern room of Nubian churches of every period.<sup>5</sup> The projection of the east wall creates a small niche in the north-east corner of the room (fig. 1, pl. 8). Its pavement had been broken through, apparently in the search for buried treasure. The mud plaster on the walls of this niche is relatively well

In some parts of the building, especially in the apse behind the altar and in room A, the pavement was covered with a layer of smoothed mud (colour pl. 42, pl. 7). Whether this mud

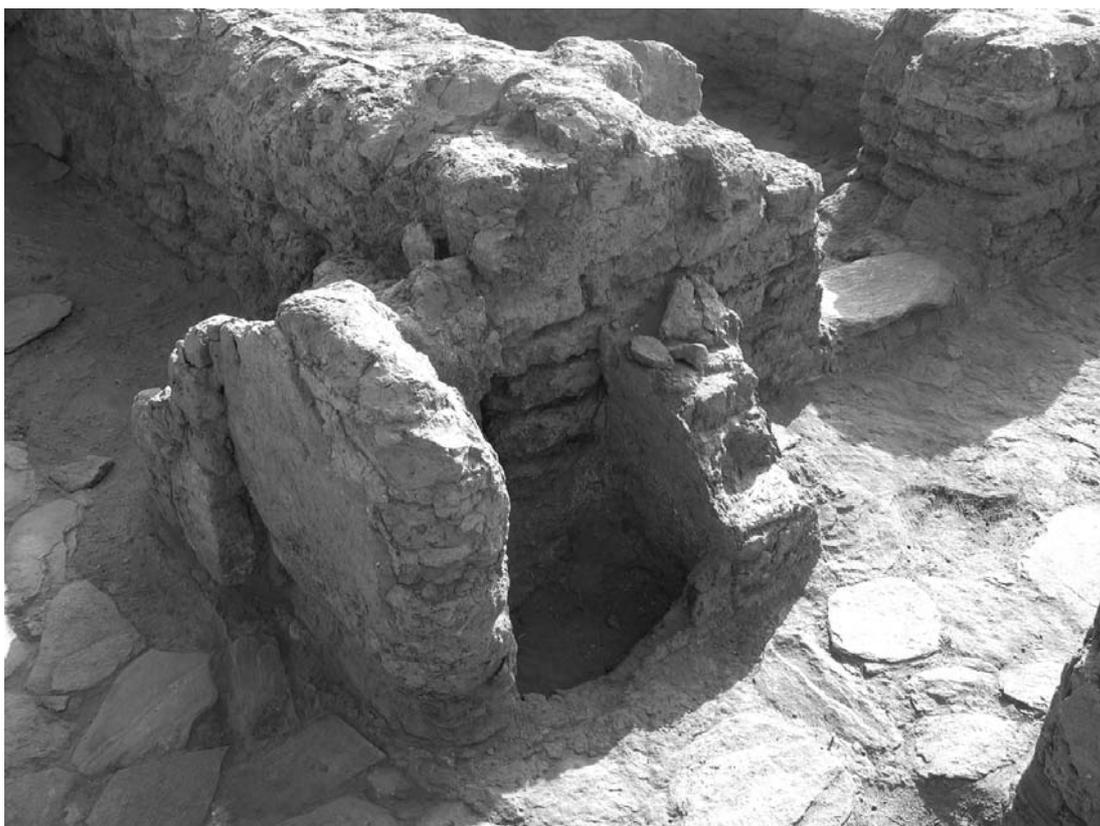
Pl. 9: The ambo.

One of the remarkable features of US022.A is the good preservation of the ecclesiastical installations. A stepped structure of mudbricks, with at least one red brick incorporated, at the northeast corner of the intersection of the aisles represents the remains of the ambo (fig. 1, pl. 9). It consists of a small staircase abutting the east wall of room E and a narrowed supporting wall projecting into the central aisle B/G. As the top of the structure is lost, the dimensions and the constructional details of its upper part, presumably a small platform, are uncertain. It may have extended towards the east and incorporated the northern one of the two small partition walls which separate the sanctuary from the main aisle (fig. 1, pls. 9-11). This construction would be unusual; all comparisons from Nubia show the platform in one axis with the stairs.<sup>6</sup> It would have been the restricted space in US022.A which led to a deviating solution – as well as to the overall small dimensions of the installation: the stepped part of the ambo is only 0.43 m wide. It is preserved to a height of 0.77 m.

There is a conspicuous empty space between the northern partition wall and the supporting wall of the ambo (fig. 1, pls. 9f.). The three walls enclosing this space to the west, north

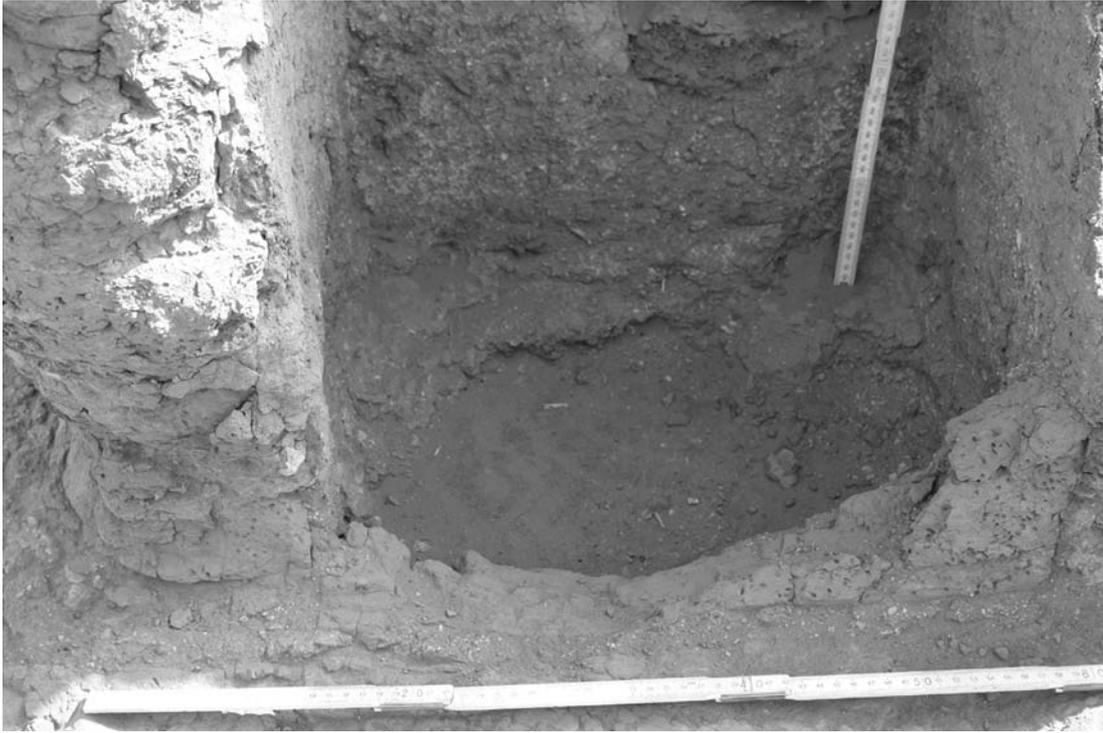
Pl. 10: The niche between the ambo and the northern partition wall of room G.

and east are coated with the usual mud plaster, which is also drawn onto the floor of the enclosed space. Likewise, it extends over what remains from a small mud wall which closed off this space against the aisle. This screening wall is preserved to a maximum height of 0.14 m. Its original dimensions are uncertain. It may well have been confined to the lower part of the opening, thus creating a small storage cabinet. Interestingly, its plaster floor was almost completely destroyed, revealing a loose sandy fill beneath it. It looked as if the screening wall had been pulled down and the floor broken through deliberately at some point in antiquity in search for buried treasure under the ambo.

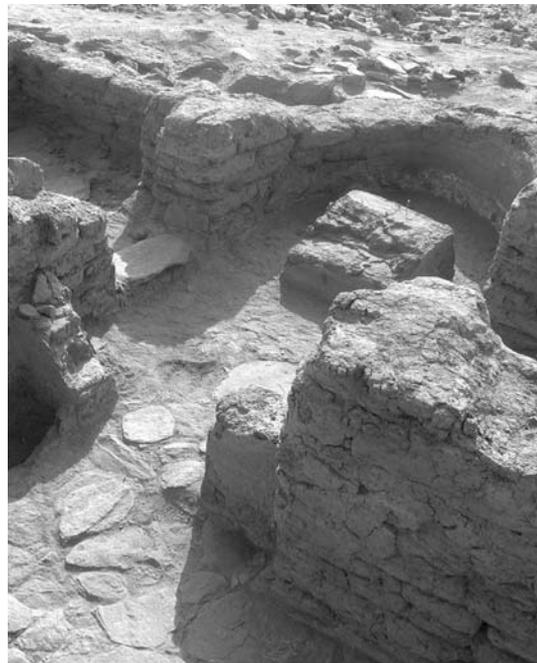
Pl. 11: Room G.

Within the sanctuary, the altar was still *in situ* (fig. 1, pl. 11, colour pl. 42). It was built mainly of mudbricks with a few red bricks in between. It was also plastered and white-washed. A test trench in the apse revealed a remarkable finding: the altar had been founded

directly on a loose layer of sand and gravel which underlay the stone pavement of the apse and sat directly on the natural rock. It could not be ascertained whether this layer represents the natural ground underneath the church, but given its rocky surroundings, it seems much more probable that it was an artificial layer applied to level the building site. However, it is certain that the pavement of stone slabs was then constructed around and against the altar. Since this floor seems to have been part of the original layout of the church and not a later addition, this observation implies a building sequence which – possibly for liturgical reasons – started with the erection of the altar, while the paving of the interior rooms followed only later.

The two sacristies, rooms F and H, are accessed from the sanctuary (fig. 1, pl. 11). Both doorways have raised thresholds paved with stone slabs, which are still *in situ* (pls. 11f., colour pl. 44). The north sacristy, room H, measures 1.6 x 1.7 m (fig. 1, pl. 12). It is equipped with two *mastabas* of mudbrick which were coated with plaster and whitewash. Functionally, room H may have corresponded to the *prothesis* of the Greek Church. Within

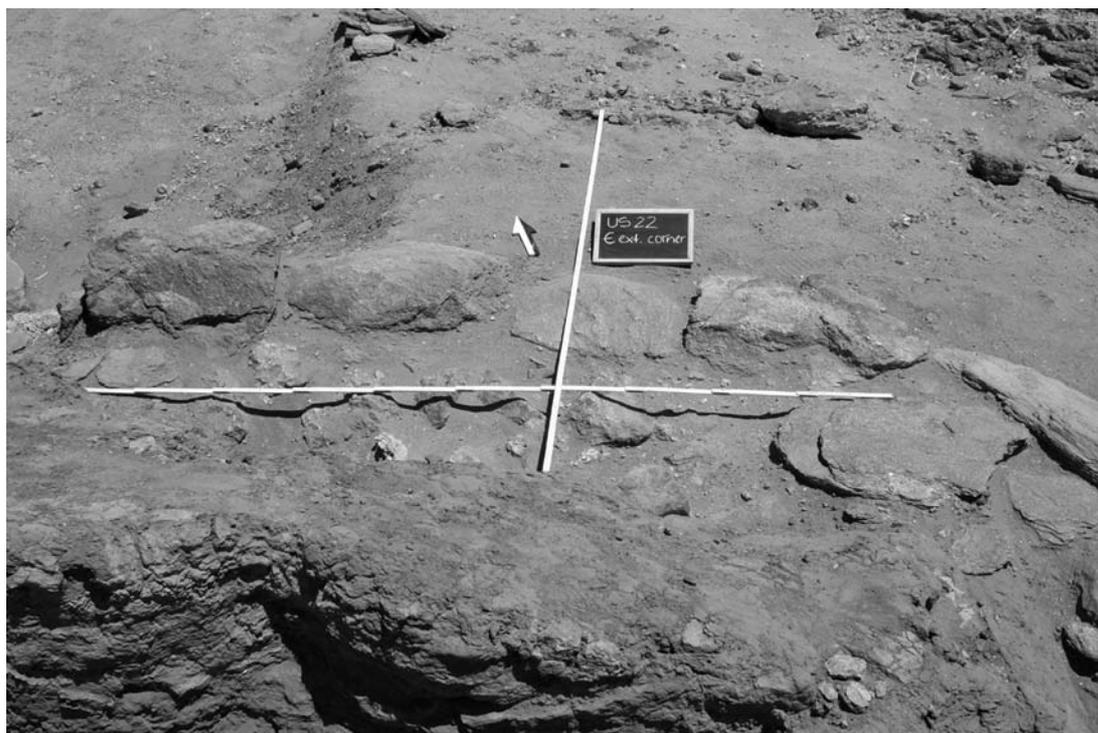
Pl. 13: Packing of stones east of the church.

The entire eastern half of the church is surrounded by a packing of large stones, loosely set in a single layer forming a wide semicircle (fig. 1, pl. 13). They correspond to the ancient ground surface and stratigraphically clearly belong to the primary building phase. The function of this packet is uncertain. It seems to have been built as an enforcement or a protection measure in this slightly sloping area, rather than serving a decorative or any other purpose. Only in front of the entrance on the south side of the church, the stones take the shape of a rough pavement.

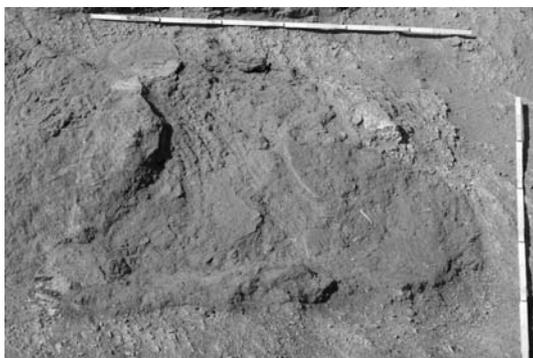
Pl. 14: The grave cover north of the church.

The stone frame of the first basin is aligned to the outer wall of the church on its original ground level and founded on a compact layer of shattered rock material, which we first took for the natural ground. However, a test trench revealed a layer of roughly smoothed mud underneath this stratum, which partially also drew under the basin. Further clearance produced the outlines of a feature, which proved to be the cover of a grave (fig. 1, pl. 14). It consisted of three large stone slabs placed side by side with further smaller slabs at the top and the foot end, sealed by the described layer of mud, which still displayed the smoothing finger marks. After the removal of the basin and the cover, a burial pit came to light which had been cut down into the natural rock. It had an oblong shape with a length of 2.3 m and a maximum width of 0.56 m at the bottom. The cavity had not been filled after the burial, but despite the careful sealing some sediment had seeped in.

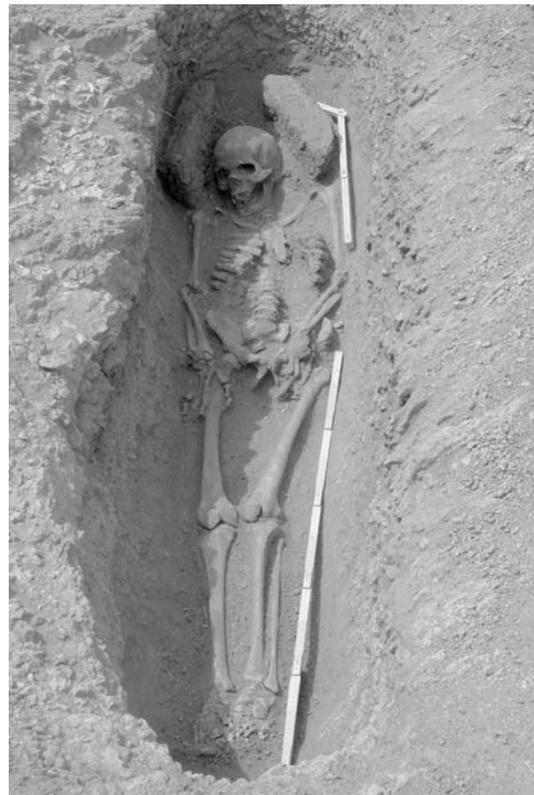
Pl. 15: The intact burial, with the top brick over the head already removed.

The grave contained the intact burial of an adult individual, who had been laid on his back with the hands put together over the pelvis (pl. 15). Three mudbricks had been placed around the head. Anthropological analysis indicated that the dead was a male individual, who had died at about the age of sixty. He had a good health status apart from heavily abraded teeth and some deformations at the lower spine, the femurs and the knee joints, which point to heavy work during life.<sup>14</sup>

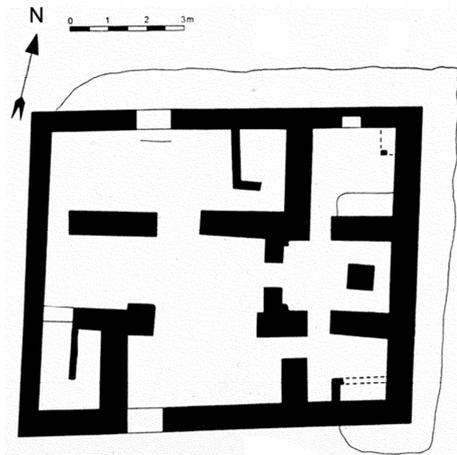
Fig. 2 The South Church of Sonqi (after: Maystre 1970, fig. 18).

The South Church of Sonqi shares the cruciform lay-out with four corner rooms, partition walls in front of the sanctuary and *mastabas* in the sacristies (fig. 2).<sup>18</sup> It measures c. 7 x 8 m. The most conspicuous differences are a second entrance from the north and the missing apse.

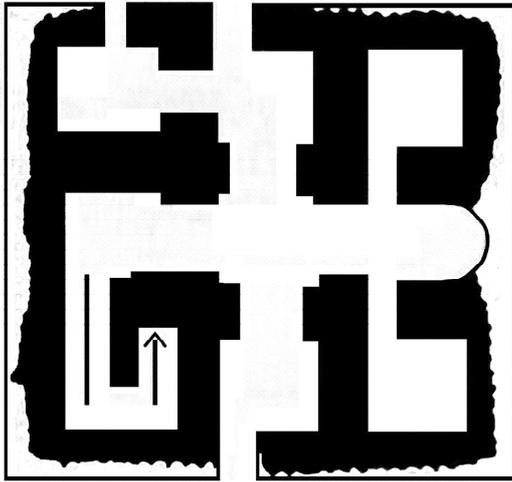
The North Church of Old Dongola has a cruciform design with an apse and four corner rooms (fig. 3). Its size is about 11.5 x 11.5 m. Jakobielski<sup>19</sup> dated it not before the 13<sup>th</sup> century AD.

Fig. 3 The North Church of Old Dongola (after: Jakobielski 2001, fig. 15).

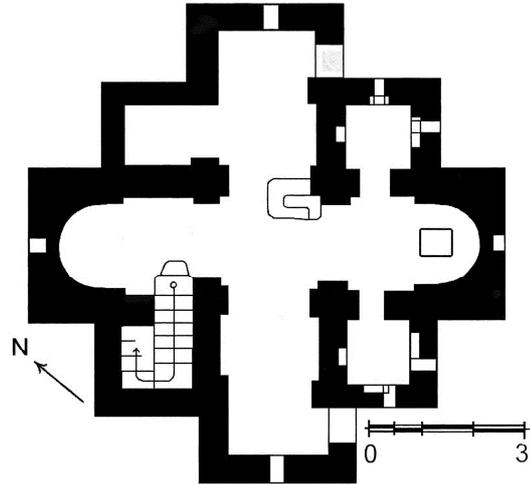
The Church of Angels in Tamit equals US022. A in the ground-plan with the four tips of the cross projecting and a size of roughly 9 x 9 m (fig. 4).<sup>20</sup> However, it has a second entrance in the north and a second apse in the west. Gartkiewicz<sup>21</sup> classified it as his type C3b with a Greek-cross pattern, belonging to his

Fig. 4 The Church of Angels at Tamit (after: Monneret de Villard 1935, vol. 1, fig. 142).

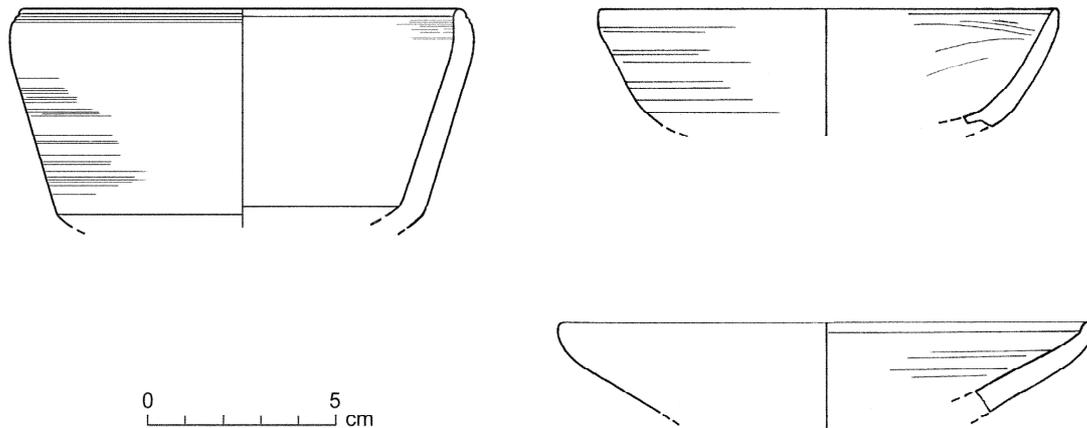
Fig. 5 Fragments of bowls from US022.A: wheelmade, orange slip, polished (US022/42.3, 4; US022/54.1; US022/24.1; drawing: I. Säuberlich).

rare and mainly consist of different bowl types with straight walls and simple rim shapes (fig. 5, colour pl. 49).<sup>24</sup> Less than 5 % of the corpus is slipped – mainly in orange.<sup>25</sup> As Phillips and Klimaszevska-Drabot<sup>26</sup> suggested this prevalence may not only be a chronological indicator but could also reflect a regional preference. There is a conspicuous group of small handmade red- and black-burnished dishes and bowls. Some of them preserve residues of burnt material hinting towards their use as incense burners or lamps (colour pl. 50). Likewise remarkable are many fragments of large pottery objects in the shape of basins and boxes, which may have represented liturgical equipment.
