A review on acoustic emission monitoring for damage detection in masonry structures

Els Verstryngne[†], Giuseppe Lacidogna^{*}, Federico Accornero^{*}, Adrienn Tomor[#]

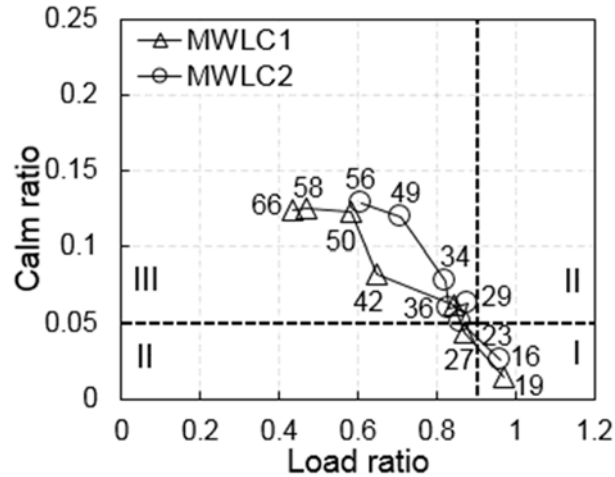
Figure 1: Representative Load-Calm ratios for two masonry wall samples with hybrid lime-cement mortar (MWLC1, MWLC2). Zone I indicates minor or no damage, II intermediate damage, and III heavy damage. Values are normalized compressive loads (in %). Shetty et al. [28].

Load-Calm analysis was used to quantify progressive damage in masonry walls under cyclic compressive loading by Shetty et al. [28], a representative example is shown in Figure 1. By comparing AE and digital image correlation results, damage limits established for concrete were found to be too conservative for masonry and further work is proposed to establish suitable limits for masonry structures.

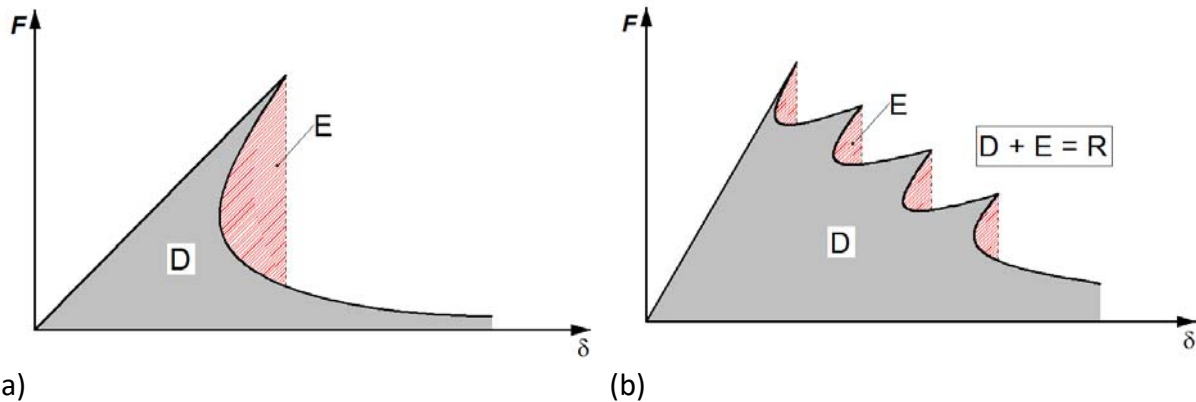
Figure 2: Load-displacement curves representing (a) brittle failure (single snap-back) and (b) softening behavior with multiple local instabilities (multiple snap-backs). Grey areas represent dissipated energy (D), dashed areas are emitted energy (E) which correlates to AE energy. R is the total released energy ($D+E=R$).

The brittle failure of a material is a complex phenomenon which occurs when a structure progressively deteriorates, at first in an uncorrelated way reflecting the intrinsic heterogeneities (dislocations, flaws, etc.), or disorder. As the density of micro-cracks increases, the stress fields of the micro-cracks interact and they become correlated. The micro-cracks eventually coalesce into macro-cracks, developing the so-called quasi-brittle behaviour of the structure [38-40]. This quasi-brittle behaviour, typical of disordered materials, is characterized by well-defined precursors including changes in the ability to sustain stresses and variations in AE trends, announcing the local or global structural failure [41, 42]. As a result of micro cracking, some of the stored strain energy is emitted as AE, see Figure 2, and can hence be used as a damage indicator [43-45].

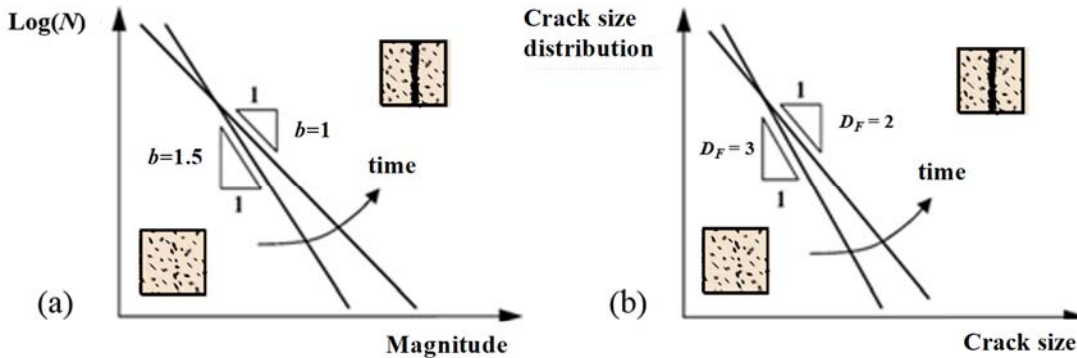
Figure 3: Evolution of (a) b -value and (b) theoretical crack size distribution during damage progress. Coalescence of micro-cracks into a narrow band around the final fracture is illustrated in the small inset figures.

At imminent collapse, crack growth and coalescence take place and the majority of cracks develop near the final failure surface [47, 48]. With the majority of cracks being concentrated in a narrow band around the final fracture surface the constant volumetric density cannot be defined consistently any more. The relationship between D_F and the b -value results in $b = 1.0$. The evolution of D_F and the b -value during a loading test is indicated in Figure 3. Decreasing b -value indicates increasing damage and increased crack sizes.

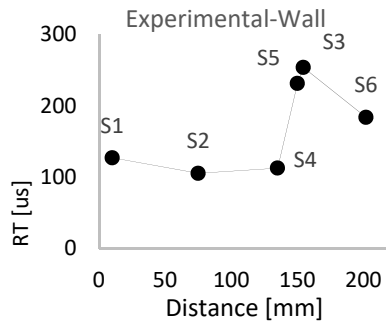
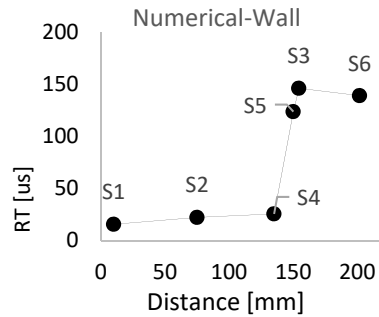
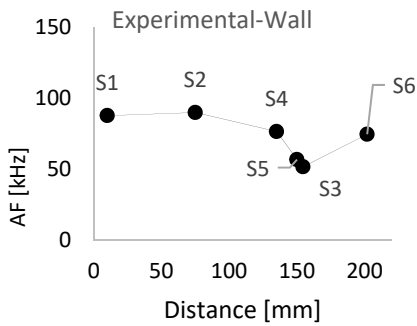
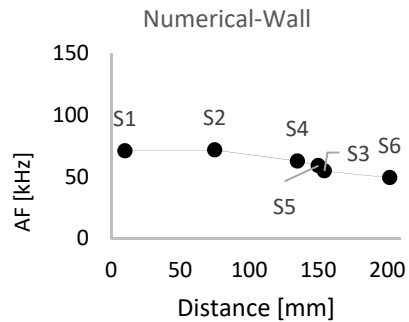
Figure 4: Effect of distance between crack location and AE sensor on Rise Time (RT) and Average Frequency (AF) obtained through (a) compression test and (b) numerical analysis. Figures adopted from [56].

Waveform properties distort with increasing source-sensor distance and number of mortar joint crossings. The effect of an increasing wave propagation path on Average Frequency (AF) and Rise Time (RT) in masonry is shown in Figure 4 [56]. Both experimental and numerical results show increase in RT and slight decrease in AF, that is in agreement with similar studies on cementitious mortars [57]. As RT and AF are often used in simplified signal-based analysis to distinguish tensile and shear fracture, source-sensor distance should be limited and/or waveform distortions should be compensated for masonry structures. A method to compensate such alterations on waveform parameters was proposed for masonry by Livitsanos et al. in [58].

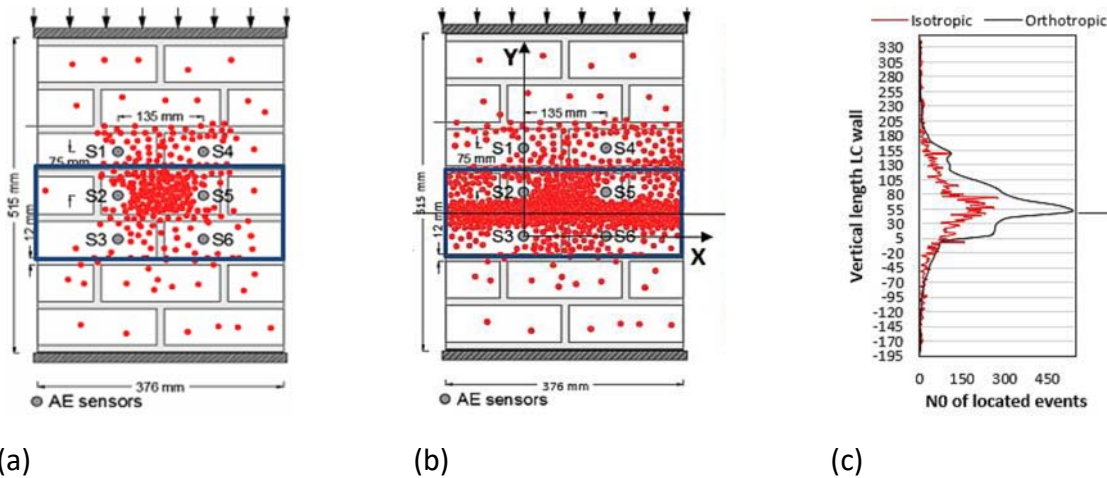
Figure 5: Result of planar AE source location with (a) isotropic and (b) orthotropic wave velocity distributions (red dots indicate located sources), (c) distribution of located AE events along the height of the masonry sample. Figures adopted from [72].

Livitsanos et al. [72] demonstrated that taking orthotropic wave velocity into account increases the accuracy of AE source location for the triangulation technique in masonry. For masonry with solid clay bricks and lime-cement mortar under compression, crushing of the middle mortar joint is properly located with the orthotropic wave velocity scheme (see Figure 5b). By means of pencil

lead breaks, wave velocity along the bed joints was found to be almost double the velocity perpendicular to the bed joints.

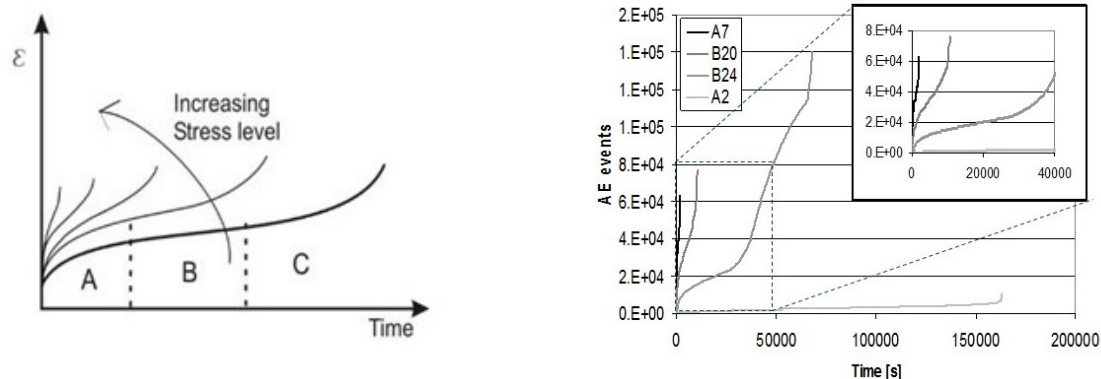
Figure 6: Comparison between a theoretical creep curve on the left (strain as a function of time) and cumulative AE events as a function of time from uniaxial compressive creep tests on four masonry samples on the right. Figure adopted from Verstryngne [11].

A relation can be sought between AE activity during the secondary creep/fatigue phase (phase B in Figure 6) and time/amount of cycles to failure. In Section 2, this approach was referred to as event counting. The AE activity is hereby expressed in terms of the AE event rate or AE energy rate, which is the derivative of the curves presented in Figure 6 and has a “bathtub shape” with Weibull-type statistical distribution [12].

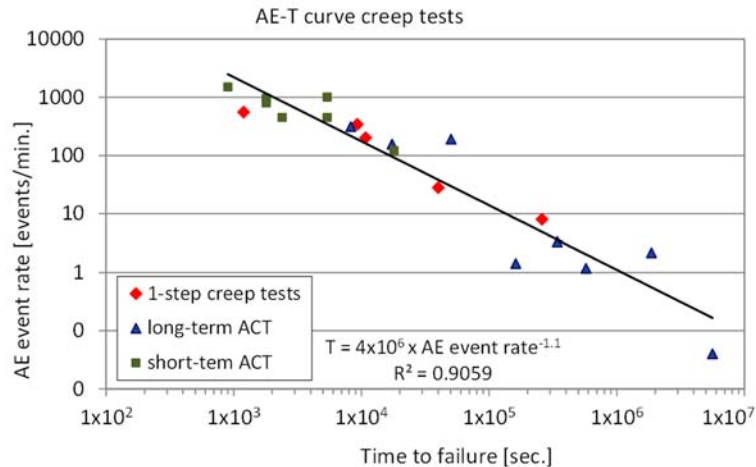
Figure 7: Correlation between AE event rate and time to failure during the secondary creep phase of masonry samples under uniaxial compressive creep loading in an accelerated creep test (ACT). Figure adopted from Tomor and Verstryngne [8].

AE monitoring was used to study the rate of deterioration during the secondary creep phase for various stress levels, quantified as number of AE events per minute against time to failure for small-scale masonry samples as shown in Figure 7 [8, 12]. There is a clear correlation between the AE event rate and time to failure, although values are presented on a double logarithmic scale with decreasing accuracy for increasing failure time. Accuracy may also be reduced for lower stress levels with longer times to failure if the AE activity is of similar magnitude to the background noise. Although values in Figure 7 are for specific masonry types and AE setup under constant environmental conditions, it demonstrates the use of AE monitoring for creep failure predictions. For details on the samples and test setup, the reader is referred to [8, 78].

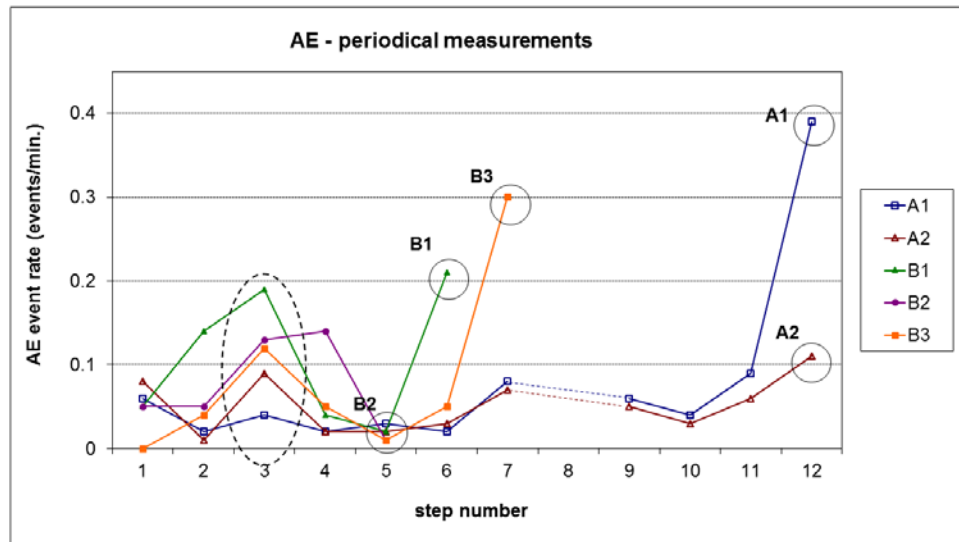
Figure 8: AE event rates monitored from periodic measurements during long-term accelerated compressive creep tests on masonry [11].

During long-term step-wise creep tests, a start load of 40-50% of the average compressive strength was applied, and loads were subsequently increased in steps of 5-10 % every 2 months. The average AE event rates, detected during a period of 24 hours in the middle of each constant load interval (one month after the stress increase step) are indicated in Figure 8. They are presented for subsequent steps for a set of five samples, up to the previous to last loading step. This means that the step after the last stress increase, in which the specimen fails, is not included.

Low AE event rate is detected during the successive constant load steps. Significant increase in the AE event rates was observed by specimens B1, B3, A1 and A2 during the last measurement. Although remarkably higher than the other measurements, these AE event rates are not critical, which is confirmed by the fact that the specimens did not fail until another stress increase step was imposed. Specimen B2 did not display increased activity and failure could not be predicted from the AE recordings. No AE measurement was performed at step 8 due to technical issues. From these observations, it can be remarked that periodic AE monitoring could predict the failure of four out of five specimens even in the load step before the last load increment. Increase in AE

activity in step 3 was caused by temporary increase in relative humidity in the laboratory and indicates that AE monitoring is sensitive enough to record internal changes caused by environmental conditions (e.g. humidity, temperature). This should be kept in mind during site monitoring.

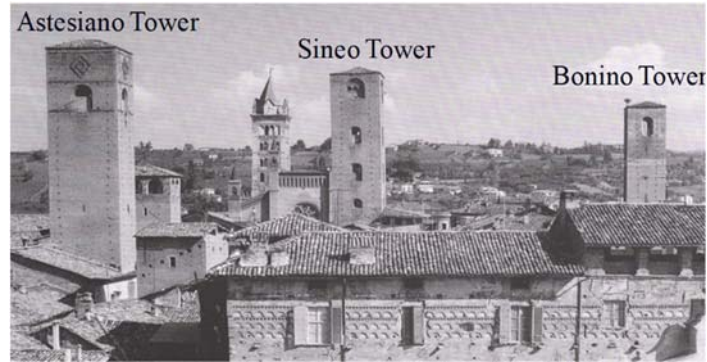
AE technique was also used to monitor the stability of three medieval towers, Torre Sineo, Torre Astesiano and Torre Bonino in the City of Alba also near Turin in Italy (Figure 10) by estimating the energy emitted during the crack propagation [16].

Figure 10: Three medieval towers rising in the center of Alba, that were investigated with AE monitoring. Figure adapted from [16].

The Sineo tower had a range of vertical cracks near openings and two cracks were detected using AE monitoring in the inner masonry layer at the seventh floor. Monitoring revealed slow internal crack propagation inside the brick walls. Crack development had stopped in the area of highest damage as the building developed a new state of structural stability.

The Astesiano Tower had a long vertical crack in the upper part of the southern façade and was monitored near the tip of the crack on the inner masonry leaf at the fourth floor. The cumulative number of AE counts evolved progressively over time. A seismic event of magnitude 4.7 on the Richter scale occurred during the monitoring period after which an increase of AE counts was observed.

In the Torre Bonino, blocked up openings and passageways were revealed by a survey at various floor levels, linking the tower to the adjacent. The historical openings caused significant reduction in the load bearing capacity of the tower. The tower was monitored at first floor level, where the effects of the openings and dead weight was the most critical and AE identified active creep deterioration.

As the three towers are very near each other (Figure 10), the impact of earthquakes on damage evolution was assessed for all the towers [9], and it was found that during the observation period, the towers behaved as sensitive earthquake receptors. For more information on the structural assessment of the towers, the reader is referred to [16] for a general overview, and to [87] for a detailed description of the correlation between AE recordings in the towers and earthquake events.

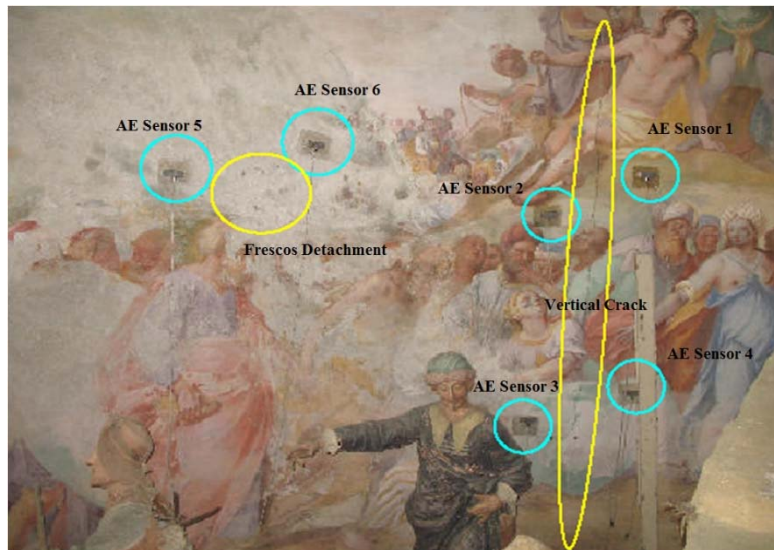
Figure 11: View of the monitored damage zones and position of the AE sensors. Reprint from [17] under Creative Commons Attribution License, <https://creativecommons.org/licenses/by/3.0/>

The preservation of historic frescoes is a complex problem that requires the use of non-destructive investigation methods to assess the integrity of vulnerable tangible heritage without affecting its state of conservation [88]. AE technique was used for monitoring historic frescoes in the Monte Tabor Chapel, in the UNESCO Renaissance Complex of the Sacred Mountain of Varallo in Piedmont by Carpinteri et al [17]. Six USAM AE sensors were used to monitor the damage evolution of the structure and the decorated surfaces of the Chapel. Four AE sensors were positioned around a vertical crack and two near a detached area (Figure 11). Attaching the sensors was a sensitive issue and was carried out by restorers. A film of Japanese paper coated with an acrylic resin was used to form a protective base for the AE sensors, bonded to it with silicone glue.

AE data analysis included cumulative AE events, frequency and b -values, as discussed in Section 2.2. Results indicated that the vertical crack presented a stable condition during the acquisition period with relatively low frequency signals (< 200 kHz) and a b -value in the range 0.95 - 1.15. In this case, it is interesting to note that, since the monitored wall is of large dimensions, a b -value approaching 1 does not imply a substantial loss of load-bearing capacity of the entire wall, but rather the coalescence of micro-cracks along the vertical crack (see also Figure 3 in Section 2.2), which can continue to advance without substantially compromising the stability of the structure. The fresco detachment tended to evolve towards metastable conditions and the signals acquired showed high frequency characteristics (< 400 kHz). Therefore a distribution of micro-cracks in the volume was assumed for the analysed region. Detachment of the fresco caused by the presence of moisture in the mortar substrate was found to be gradual and cyclical.

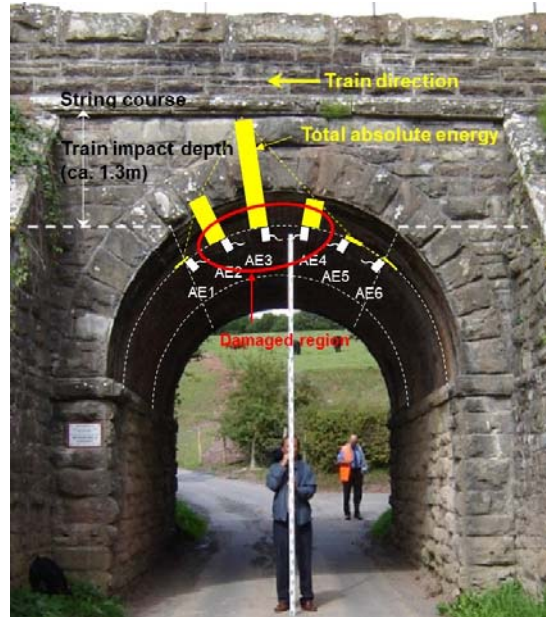
Figure 12: Arch bridge with AE sensor locations

To demonstrate the efficacy of AE monitoring for condition assessment of masonry arch bridges, a 3.6 m span stone arch bridge was monitored under railway loading (Figure 12) [93]. Traffic included light passenger trains and freight trains up to 25.4 tonnes axle weight. The brickwork was in good condition, but three longitudinal cracks were visible on the arch intrados (at the middle of the arch barrel and alongside each spandrel wall). Six acoustic emission sensors (AE1-6) were attached to the intrados using hot melt glue under the tracks. Installation of the sensors and monitoring system took approximately 30 minutes.

As another useful indicator, critical areas of damage can be visualised using the total absolute energy for each sensor as shown in yellow in Figure 12. The greatest accumulated absolute energy was recorded by sensors AE2, AE3, AE4 near the crown. Greatest damage occurs to the left of the crown (near AE4) as the train is approaching from right and the arch is pushed against the backfill to the left. Traffic loading is actively 'felt' by the arch down to ca. 1.3 m from the string-course and fatigue deterioration is likely to be caused by freight trains.

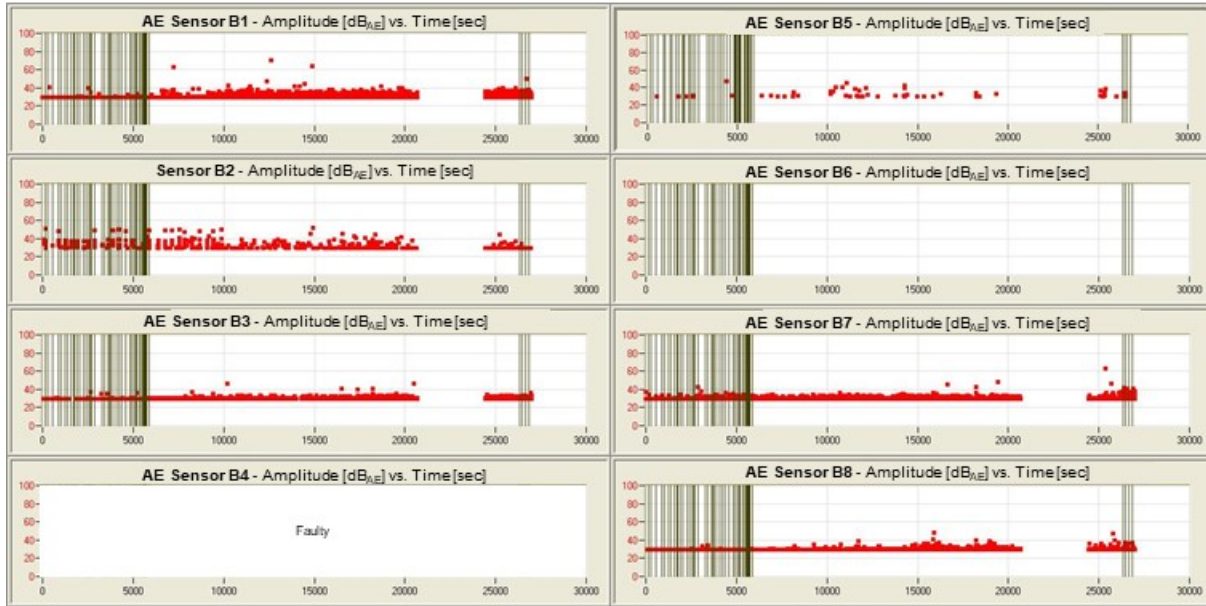
Figure 15: AE recording during 8-h monitoring under normal traffic: amplitude vs. time (screen shot of the acquisition software) [63].

After refurbishment, the bridge was monitored for 8 hours under normal traffic loading. Emission level was below the critical limit of 60 dB_{AE} for all sensors and mostly below 40 dB_{AE} (Figure 15). Grinding and crushing in existing cracks was therefore reduced or eliminated by the repair works. Emission around 50dB_{AE} at AE2 was associated with lorries passing over the bridge, indicating that the nearby hinge is still active and allows flexibility of the (otherwise stiff) arch.

Monitoring can be repeated in future and compared with previous readings. If amplitudes increase over 60 dB_{AE} more investigation will be necessary to identify the origin and nature of damage. AE monitoring can therefore be useful to identify areas of damage, causes of damage and changes in structural condition over time.
