Experimental assessment of an asymmetric steel–concrete frame under a column loss scenario

G. Rovero¹, N. Baldassino^{2,*}, R. Zandonini², F. Freddi³

² *Dept of Civil, Environmental and Mechanical Engineering, University of Trento, Trento, Italy*

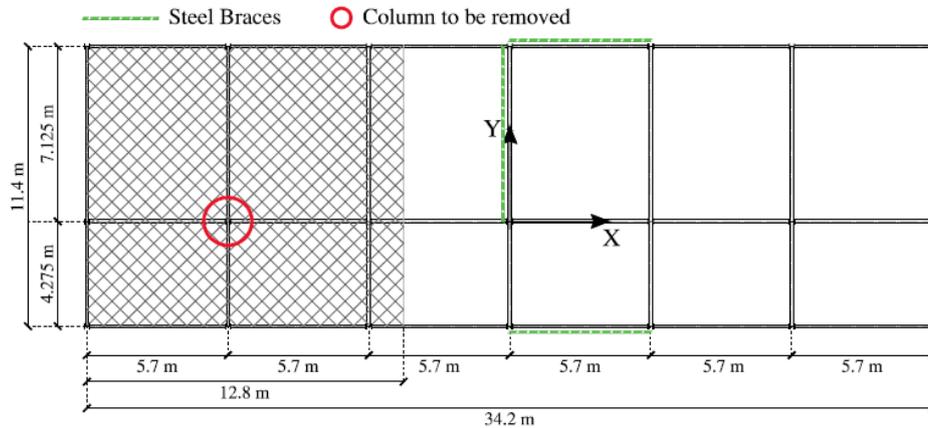
Figure 1. Plan view of the reference structures: the asymmetric case.

The one floor sub-frames tested in the laboratory were extracted from the first floor of a reference five-storey building as described in detail in [4]. The case study is a five storeys composite steel and concrete framed structure designed according to Eurocodes [21–25]. No consideration was made for the accidental loads (*i.e.*, seismic and associated to robustness). The structural design led to select HEB220 for the columns, IPE240 for the beams and a thickness of 150 mm for the concrete slab. The connection between steel beams and concrete slab was designed as full shear connection. A welded wire mesh of $\phi 10/150 \times 150$ mm was located at the bottom and top side of the slab, while additional reinforcing bars were required in several zones [26]. Beam-to-column joints had bolted flush-endplate connections designed according to the component method [25]. Concrete C30/37, rebars grade B450C, structural steel grade S355 and bolt class 10.9 were selected for the materials of the structural elements. While these features were the same for the two buildings object of the study [26], the columns’ layout was different, leading to a ‘symmetric’ and a ‘asymmetric’ case. Fig. 1 shows the plan view of the reference frame for the asymmetric case: the hatched shaded area identifies the substructure for the current study.

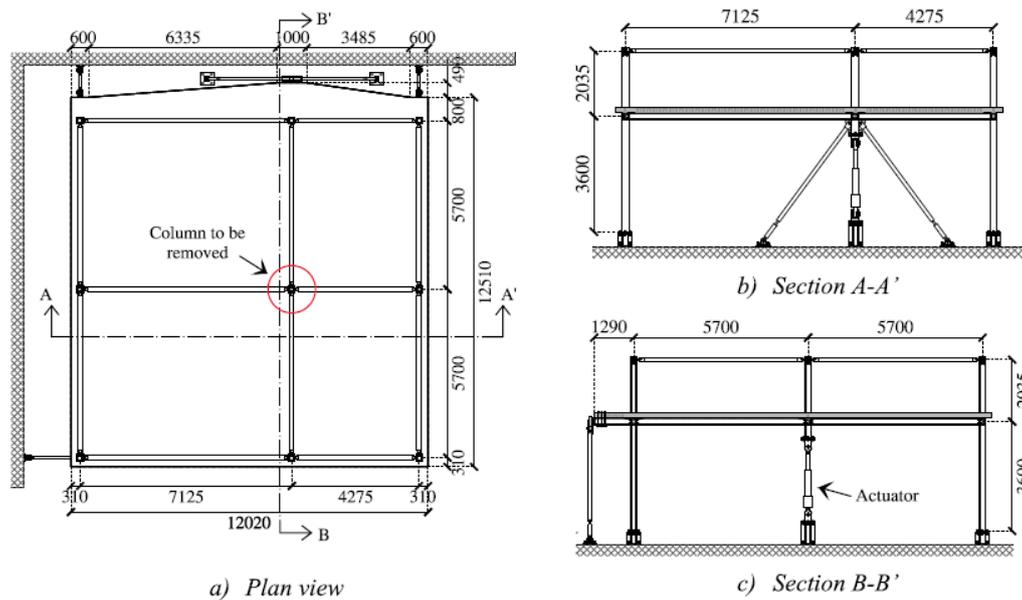
Figure 2. Plan view and cross sections of the asymmetric sub-frame (measures in mm).

Fig. 2 illustrates the plan and sectional views of the sub-frame specimen. The design of the set-up required an accurate selection of the restraining system details reproducing the interaction with the remaining part of the reference structure [26]. To this aim a number of numerical simulations were carried out of the overall reference frames and of the full-scale specimens. The outcomes allowed for sizing the sub-frames restraining system and pointed out the need for extending the subframes columns above the floor and for connecting them at the top with truss sections (see also Fig. 3).

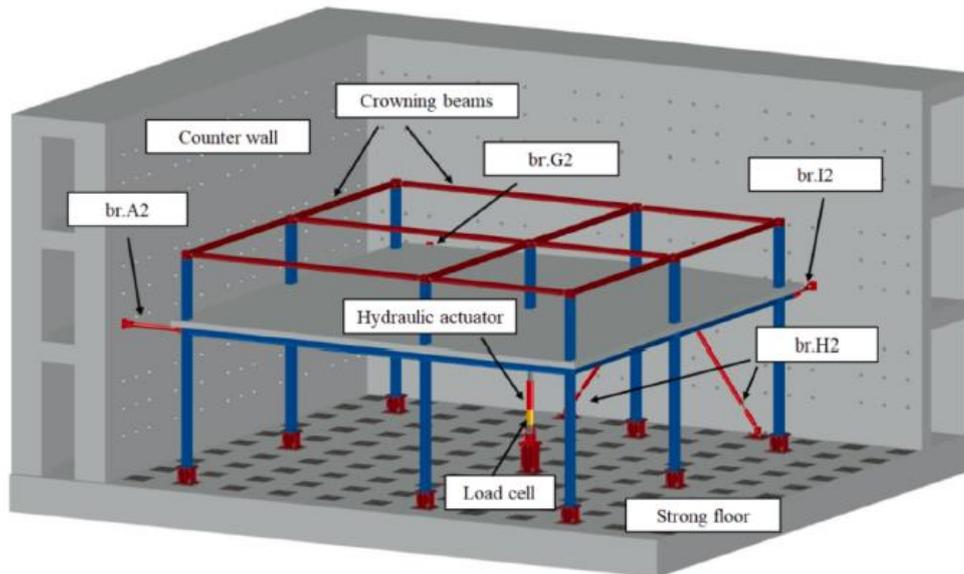
Figure 3. The specimen and the test set-up.

As to the restraining system, suitable connections to the counter walls and to the strong floor of the laboratory were designed [26]: the sub-frame was connected to the counter-wall by horizontal trusses (br. A2, br.G2 and br.I2) in order to prevent horizontal displacement, and to the strong floor by a truss system (br.H2) in order to prevent vertical displacement (Fig. 3). During the test, the collapse of the central column, 'replaced' by a hydraulic actuator (Fig. 3), was simulated. Before the beginning of the test, the load acting on the 'actuator' was carried by a provisional propping system that was removed once the jack was activated.

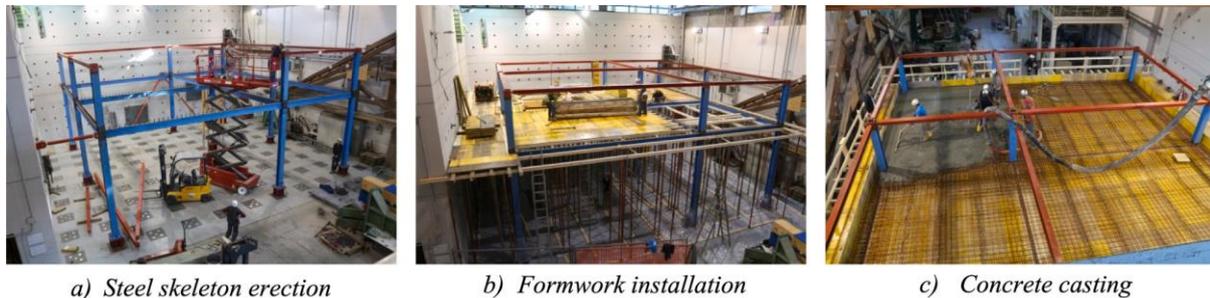
a) Steel skeleton erection

b) Formwork installation

c) Concrete casting

Figure 4. The constructional phases.

The specimen was built inside the Laboratory of Materials and Structures Testing of the University of Trento. At first, the steel skeleton was erected connecting the columns with the strong floor of the laboratory and the lateral bracing system with the counter-wall (Fig. 4a). After the installation of the formwork (Fig. 4b), the reinforcement was positioned and the slab casted in three phases (Fig. 4c).

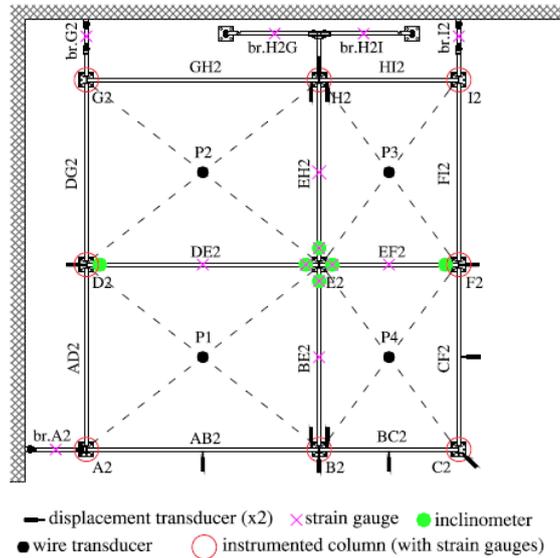
Figure 5. The instrumentation set-up.

The behaviour of the frame was monitored by measuring deformations, displacements and rotations of the main structural elements. An accurate selection of the key parameters to be measured during the test was conducted. Moreover, the results of the first ‘symmetric’ test made possible to improve the instrument set-up allowing a more effective information of the response to be achieved. The instrumentation set-up was installed as illustrated in Figs. 5–7.

As a further behavioural index, the load–deflection curves at the middle of the four slab panels are plotted (Fig. 5, Fig. 12), which point clearly out the structural asymmetry.

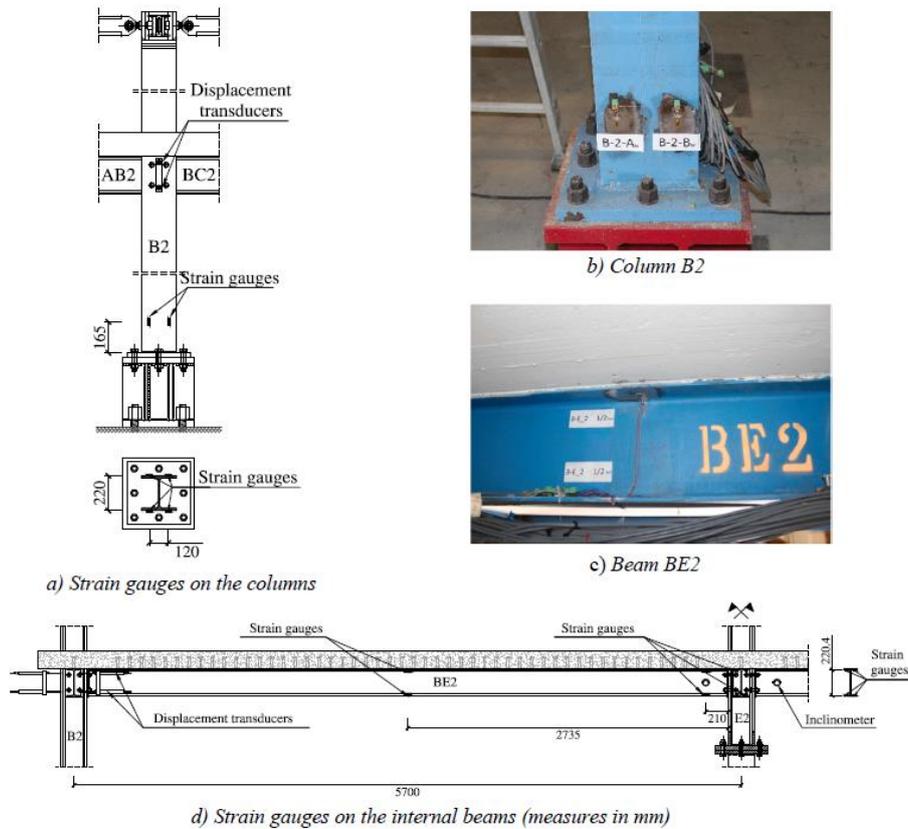
Figure 6. Strain gauges on the steel members.

In particular, all the columns in the asymmetric frame were instrumented with strain gauges at the base in order to comprehensively assess the redistribution of the gravity loads, whereas in the first test the columns instrumented were five out of eight. Furthermore, more attention was paid to the joints between the removed column and the beams. Strain gauges were installed on the upper and lower beam flanges at a distance of 210 mm from the beam end. Further strain gauges were installed in the bolts of the central node.

Within the assumption of elastic material, the strain gauges readings enabled determination the axial force and/or the bending moments acting on a structural element. Fig. 5 identifies the position of the strain gauges in the frame: i) the columns (Fig. 6a and b) were instrumented at the base to measure the average axial strain and the curvature about the strong and weak axis; ii) strain gauges were installed in the internal beams (Fig. 6c) and d) in correspondence of the beams’ mid-span and near the central column E2 enabled determination of the axial strain and the curvature about the strong axis; iii) all bolts of the joints that connect the internal beams with the central column E2 were instrumented and calibrated with strain gauges to measure the axial strain state during the test; iv) strain gauges were also installed in several reinforcement bars close to the central column as illustrated in Fig. 7, in the lateral restraining members and in the crowning beams. Displacement transducers (linearity 0,1 %

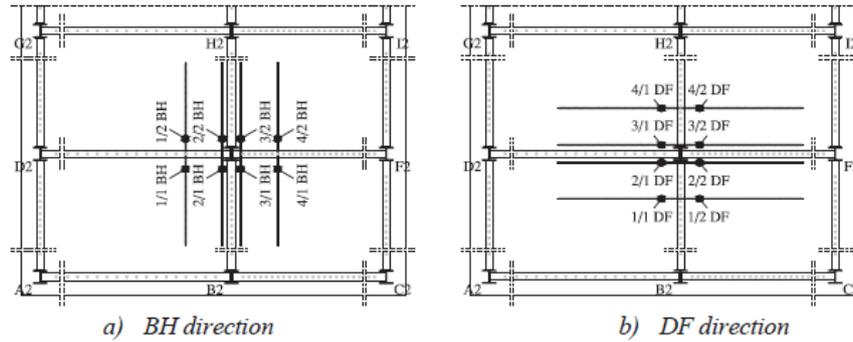
Figure 7. Strain gauges on the reinforcement bars.

The rebars strains (Fig. 7) show the influence of the asymmetry on the concrete slab response near the central joint. The curves in Fig. 22 show that: i) all the rebars are in tension since the beginning of the test (hogging bending moment); ii) during the phases 2 and 3, the rebars in both tests showed first an unload and then a reload, with greater strains in test 2; iii) in test 2 the strains were built up dramatically and the rebars yielded in the vicinity of 'collapse'.

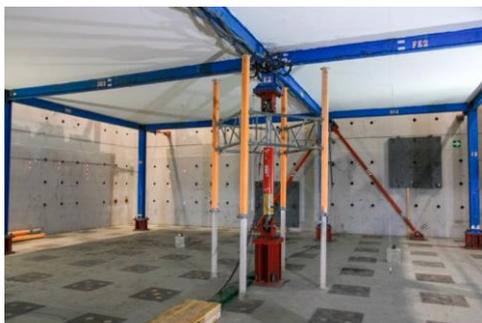
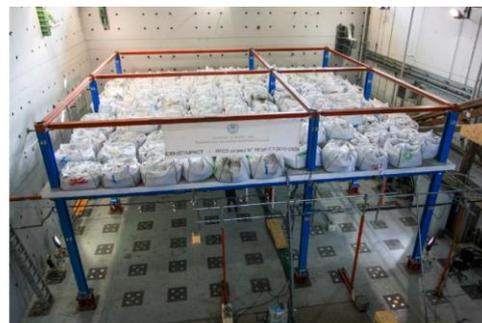
a) The actuator and the propping system

b) The specimen under full gravity loading

Figure 8. Test phases.

- phase 0: activation of the actuator and removal of the propping system that sustained the loads during the constructional phases (Fig. 8a); reading of the axial force on ‘column E’ due to the gravity load;

- phase 1: application of the live loads onto the slab by using sand filled bags (Fig. 8b). The bags were placed on the slab in two layers: the first one was uniformly distributed on the whole surface of the slab (153.26 m² - total load of 932.14 kN), while the second one was applied on a reduced area (74.60 m² - total load of 392.22 kN) as illustrated in Fig. 9. The total live load was hence of 1324.36 kN;

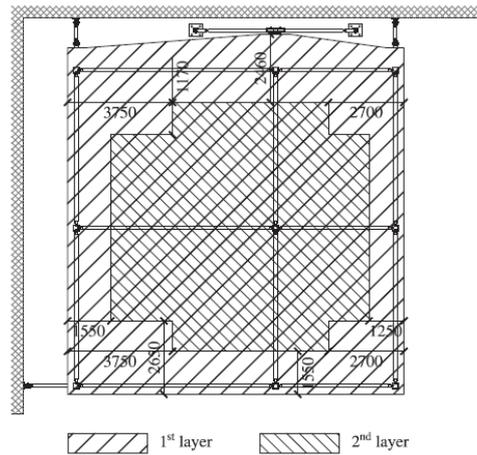
Figure 9. The loading layout.

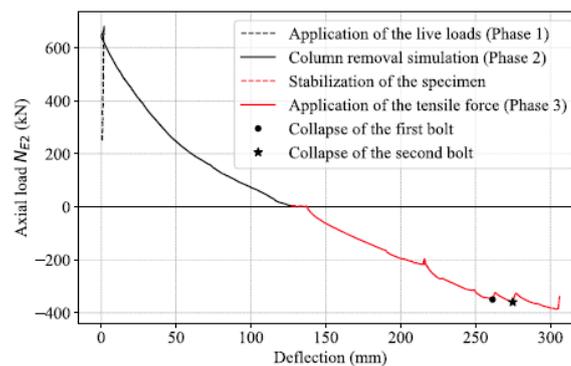
Figure 10. Load-deflection response.

The overall response can be illustrated by means of the relationship between the axial load NE2 on the ‘central column’ and the vertical displacement at this column, as in Figure 10. In the graph, compression is positive, while tension is negative. As a first general remark, the continuity of the curve suggests that the flexural behaviour contributes the most to the response even in the last phase.

At the end of the propping system removal (phase 0), the vertical reaction force on the ‘central column’, associated with the self-weight of the structure, was equal to 250.39 kN. The application of the live load onto the slab (phase 1) increased the reaction force to 681.23 kN, with a vertical displacement of 1.15 mm.

The column removal (phase 2) was simulated leaving the hydraulic pressure of the actuator freely decreasing up to the condition of no axial load, which was associated with a vertical displacement of 126.70 mm. After a stabilization phase, during which the deflection increased up to 136.80 mm, a tensile force was applied to the central node by the actuator (phase 3). When the deflection of the central node reached 261.38 mm with a corresponding value of the reaction force of -349.62 kN, the rupture of a bolt in the bottom row of the steel joint between the central column E2 and the beam EH2 occurred. The reaction force was further increased up to -359.15 kN when the adjacent bolt in the same joint collapsed. The associated vertical displacement was of 274.89 mm. The test then continued up to a load of -386.30 kN and a deflection of 303.64 mm. The significant plastic deformation of the connections between the central column and the internal beams (Fig. 11a) and the local state of ‘distress’ of the concrete slab (Fig. 11b–d) and of the steel beams at the central node and at the mid-external columns (Fig. 11e) suggested to consider the collapse achieved, and to stop the test.

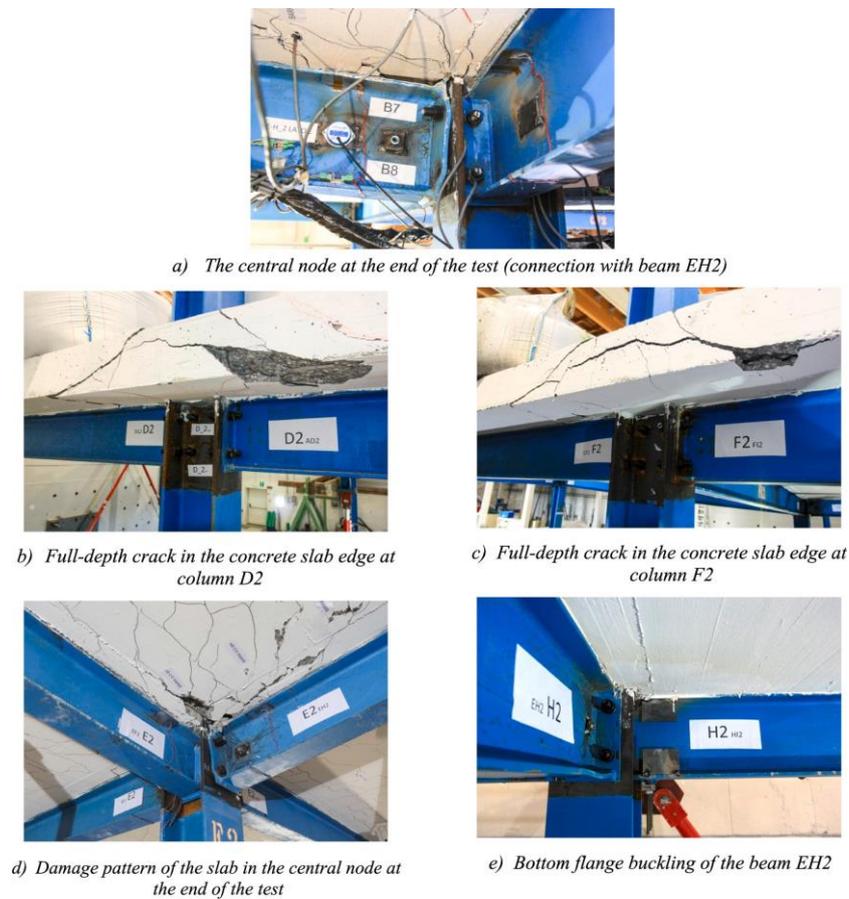
Figure 11. Critical components.

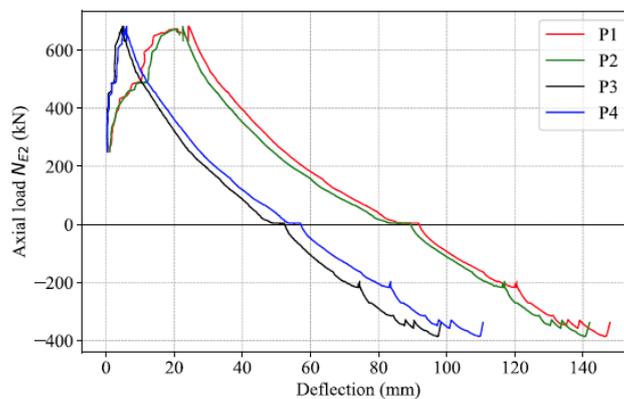
Figure 12. Vertical displacement of the slab panels.

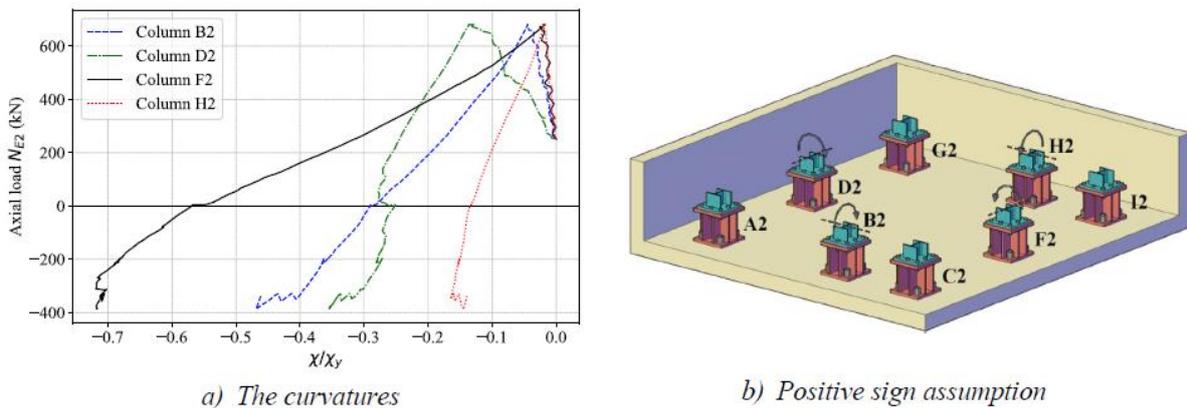
Figure 13. Curvature of the perimeter columns at the base.

As a first assessment of the local structural behaviour, Fig. 13a shows the evolution of the curvature at the column base of the mid-external columns B2, D2, F2 and H2, normalised on the yield curvature χ_y depending on the bending associated with the continuity with the internal beams, *i.e.*, about the strong axis for columns B2 and H2 and about the weak axis for columns D2 and F2. In the transverse direction, at the end of the loading phase 1 (*i.e.*, application of the live load onto the slab) the column D2 curvature is far greater than that of column F2, due to the different span length of the adjacent beams. Vice versa, at the end of the test, column F2 exhibits a curvature more than twice that of the opposite column D2, as a result of the central joints inelastic deformation.

In the longitudinal direction, the restraining system adjacent to column H2 (br.H2) causes the substantial difference between the curvatures of the columns B2 and H2. If the rotation of the columns at the beam level (Fig. 14a) is considered, similar conclusions can be drawn as for the base curvatures. Interesting to note that the rotation of the corner column C2 is almost negligible throughout all the test.

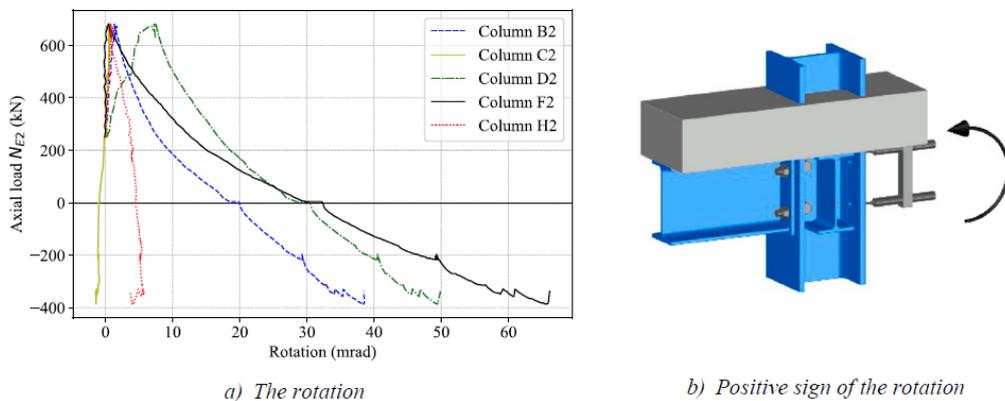
Figure 14. External columns rotation at the beam level.

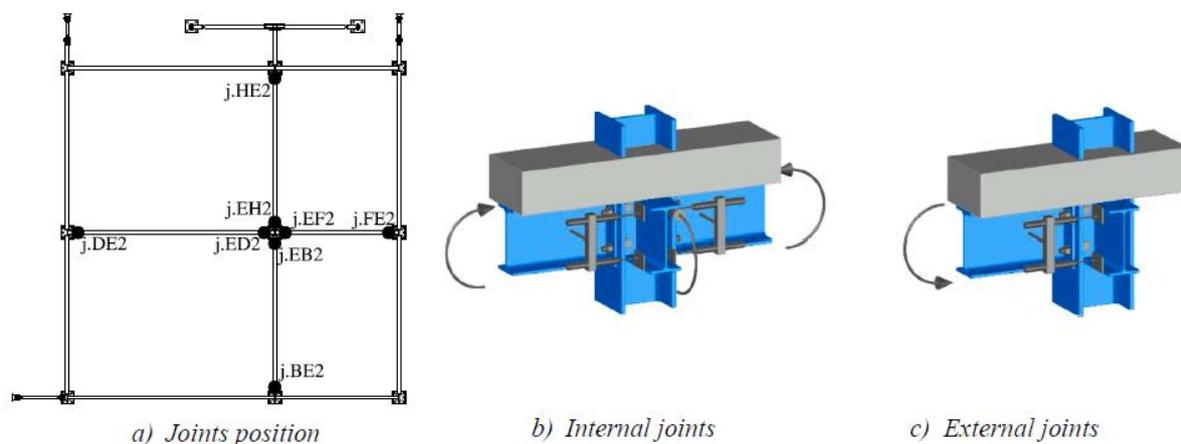
Figure 15. Joints and positive sign of the rotation.

A further index of the influence of the structural asymmetry comes from the analysis of the beam-to-column joints rotation. For clarity, Fig. 15 provides the joints nomenclature and the positive sign of rotation. The responses of the four central joints are gathered in Fig. 16. The sign reversal of the rotations associated with the column removal is apparent, leading to the change from hogging to sagging bending moment in the connections. The rotations of the joints j.ED2 and j.EF2 (Fig. 16a) are quite different due to the transverse asymmetry of the frame. In particular, joint j.EF2 kept unchanged the sign of the rotation (hogging bending moment throughout the test), while the change from hogging to sagging bending moment is well experienced by joint j.ED2. On the contrary, the rotations of the joints j.EB2 and j.EH2 (Fig. 16a) are close to each other during all the test. The plastic deformation of the endplates was the main source of rotation of these joints (Fig. 11a). As to the external joints (Fig. 16b), consistent responses to the ones of internal joints can be observed. In particular, the joints in the transverse direction (with columns D and F) experience the highest rotations. As expected, the lateral joints showed a continuous increase of the rotation, leading to hogging bending moments in the connections during all the test. The curve related to joint j.HE2 is interrupted before the end of the test due to the buckling of the bottom flange of the beam (Fig. 11e) that compromised the proper operation of the instruments. It should be noted that the flange buckling lead to an ‘unloading’ of the joint.

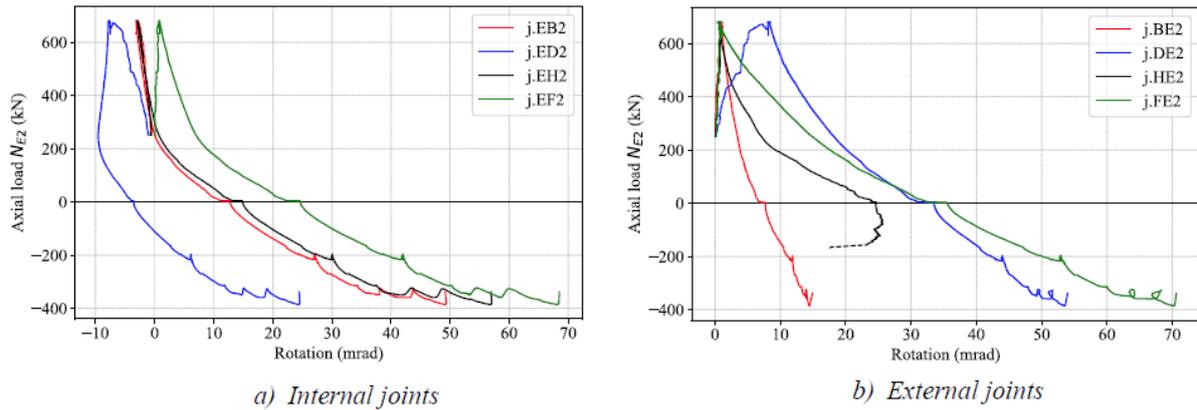
Figure 16. Joints rotation.

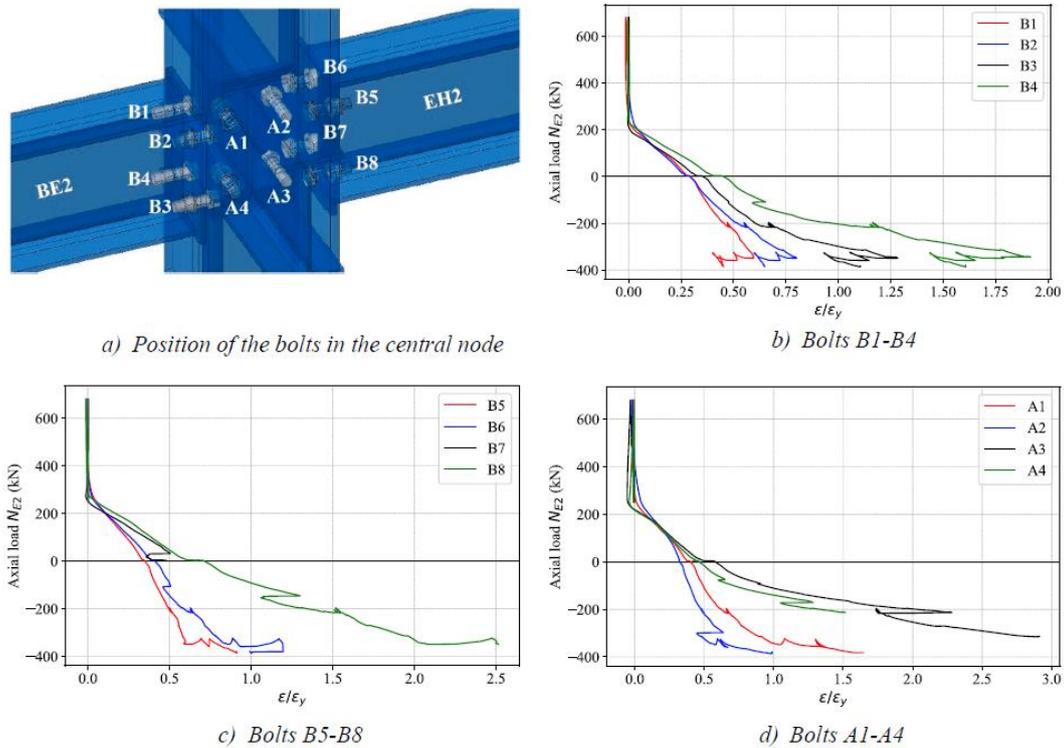
Figure 17. Axial strain of the bolt in the central node.

In the central node, eight bolts were instrumented in the longitudinal direction where the beams were connected to the column flange (bolts B1–B8) and four bolts in the transverse direction (A1–A4) connecting both beams to the column web. Fig. 17 illustrates the central joint, identifying the instrumented bolts position (Fig. 17a) and the strains in the bolts (Fig. 17b and d) normalised with respect the nominal yield deformation ($\epsilon_y = 4500 \mu\epsilon$). The bolts were tightened according to the Eurocode 3-1-8 [25]. In all bolts negligible axial deformations were measured in the loading phase (Phase 1): they were in the compression zone below the neutral axis. The unloading associated with the column removal led to the reversal of the flexural moment, and the bolts entered in the tension range. Consistently, the bottom bolts were significantly more strained. At the end of the test, the yield axial deformation of the bolts was widely exceeded by all the bolts of the bottom rows. These strains combined with the bending due to the endplate deformation caused the fracture of bolts B7 and B8 (note that the strain gauge in bolt B7 stopped working at the end of Phase 2 (Fig. 17c).

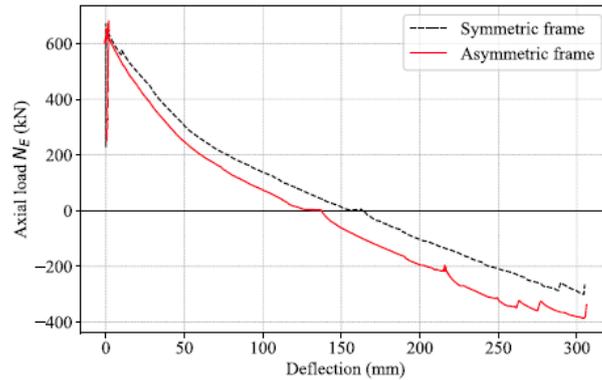
Figure 18. Comparison of the load–deflection response.

The comparison of the quantitative results and the visual inspection during the tests of the asymmetric and symmetric [4] frames allow an insight into differences and similarities in the response mechanisms. The overall structural behaviour of the two tested frames was fairly similar as apparent from the load–deflection relationships of the central node (Fig. 18). In particular, the deflection at the end of the test is very close (303.64 mm and 304.30 mm in the asymmetric and symmetric sub- frame, respectively). However, some dissimilarities can be pointed out as the stiffer response of the asymmetric frame throughout all the loading history. This also implies a higher residual strength: the tensile force applied by the actuator to the central node at the same deflection of about 300 mm was of 386.30 kN in the asymmetric case and of 300.85 kN in the symmetric one.

- the floor asymmetry: i) it doesn’t affect the global behaviour of the tested sub-frames (Fig. 18); ii) it seems to remarkably affect the stress state of internal joints’ increasing the ductility demand in the transverse direction (Fig. 21a) and the strains in the rebars (Fig. 22); iii) it has a limited influence on the redistribution of axial forces in the columns.

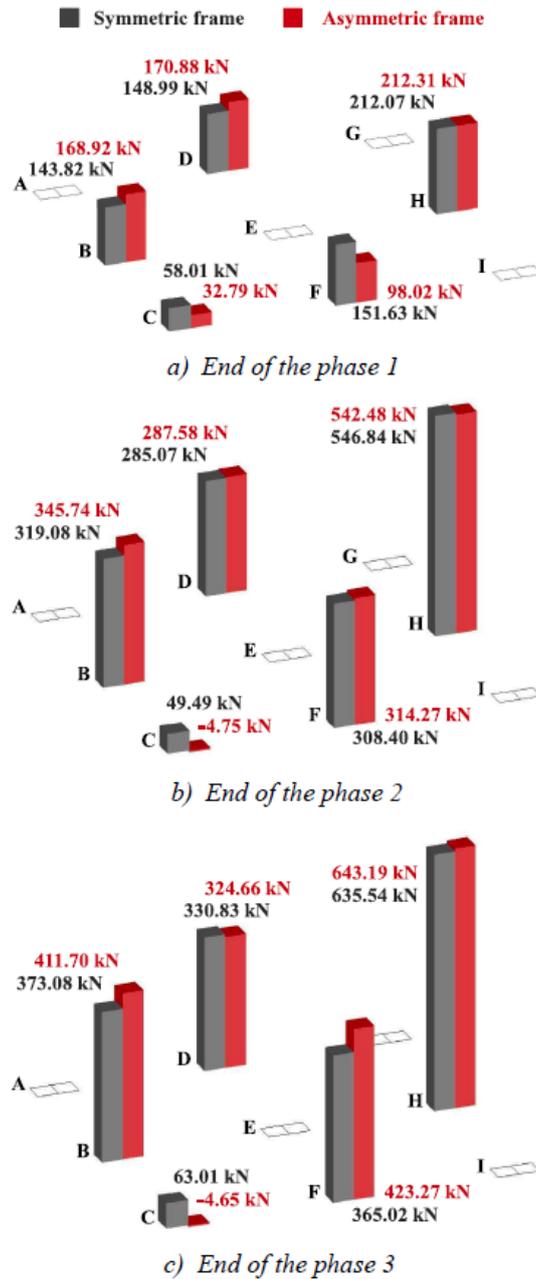
Figure 19. Comparison of the axial force at the columns base.

The axial forces at the base of the columns B, C, D, E, F and H instrumented in both tests, are reported in Table 7 and Fig. 19 for the three testing phases. In the figure, the position of 'column E' is also reported for reading clarity.

Differences in the load redistribution among the columns during the test are apparent. In phase 1, the behaviour of columns B and H was fairly similar, while columns D and F exhibited a fairly different response. At the end of the loading, the load on the actuator was almost 'equal' in the two tests. However, the transverse asymmetry in test 2 led to an axial force, in column D (Fig. 19a) about 70 % greater than the force in the column F. On the contrary, forces in these columns in the first symmetric test are almost equal. These differences between the two frames tends to disappear during the second phase (Fig. 19b), and similar thrusts were observed at the end of the column removal. At the end of the test (Fig. 19c), column F in the asymmetric frame carries more load than the same column in the symmetric one. Inelastic phenomena, such as slab cracking and steel yielding partly counteract the effect of the asymmetry. On the other hand, the corner column C exhibited a quite different behaviour between the two tested frames, confirming the role of the concrete slab for the load redistribution. In the symmetric specimen, the column C unloaded and reloaded during the phases 2 and 3 respectively, while in the asymmetric one the axial force passed from compressive to tensile during the column removal, and kept this value during the application of the tension force (phase 3).

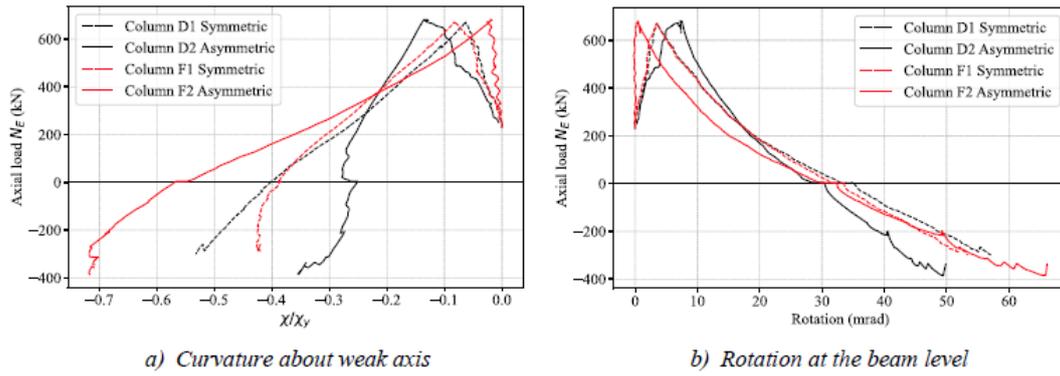
Figure 20. Measurements in the columns D and F.

The influence of symmetry and asymmetry can also be highlighted by comparing the curvature at the base of the columns D and F (Fig. 20a) and of the rotation at the beam level of the same columns (Fig. 20b). As to the curvatures, there is a clear trend to build up higher deformations in column F (connected to the shorter beam) in the asymmetric test, when the central column is lost.

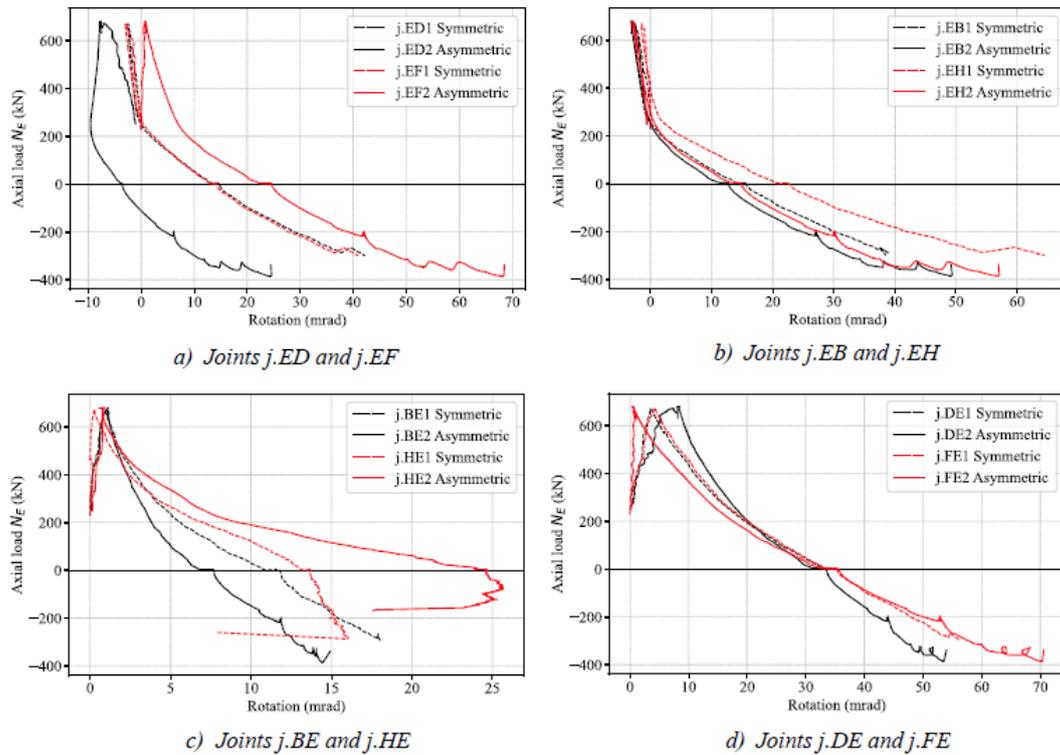
Figure 21. Comparison of the joints rotation.

Joints play an important role in the load transfer when a column is lost and are the key elements to make the alternate path develop. Significant differences between the two tested frames can be observed (Fig. 21). As illustrated in Fig. 21a the internal joints j.ED and j.EF in the asymmetric specimen exhibited a fairly different response since the very beginning of the test, with joint j.EF experiencing positive rotation since the first phase. Besides, joint j.EF was demanded a fairly higher rotation, which became more than double at collapse. In the longitudinal direction (Fig. 21b), where both frames are symmetric, the internal joint responses are close to each other, with joint j.EH deforming the most.

The analysis of the external joints' rotations, reported in Fig. 21c and Fig. 21d, points out that in both tests the ductility demand is more significant in the transverse direction, with joint j.FE in the asymmetric frame achieving the greatest rotation at collapse. In the longitudinal direction, the buckling of the beam EH bottom flange at column H, common to both tests, is highlighted by the response of joint j.HE (Fig. 21c), which, in the second test, experiences a significant rotational reverse.

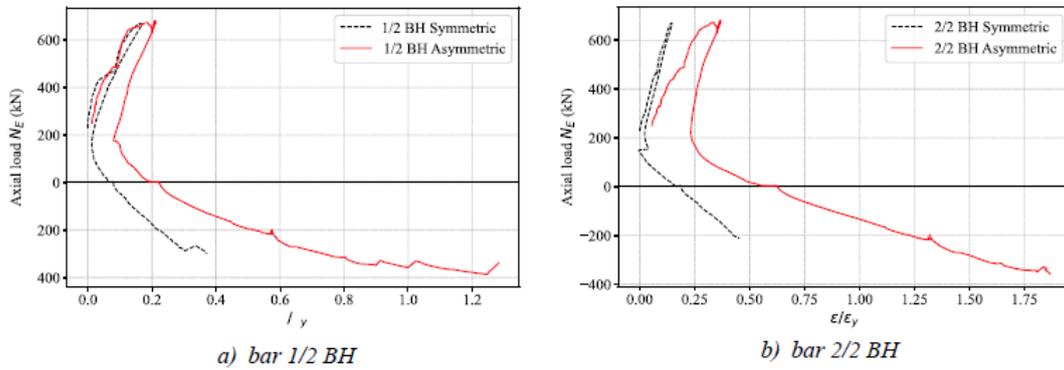
Figure 22. Comparison of the axial strain of the bars.

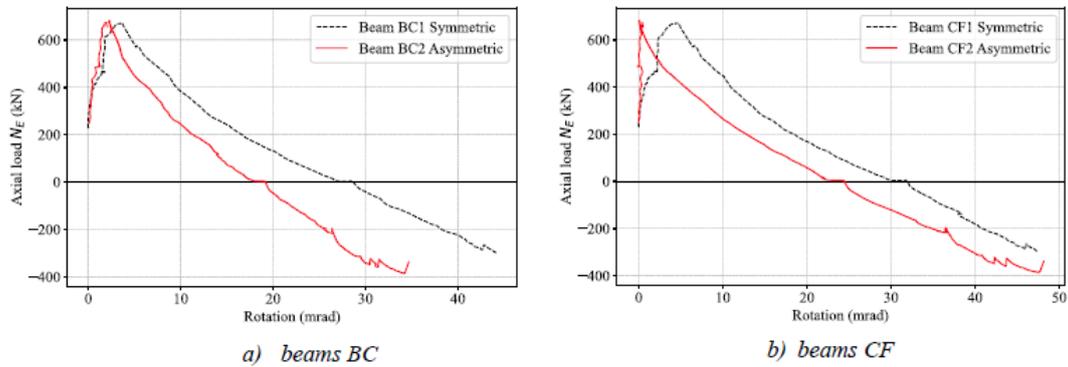
Figure 22. Comparison of the torsional rotation of the beams.

As to the lateral beams, the different slab's configuration resulted in a greater torsional rotation of the beams in the symmetric frame compared to the one in the asymmetric frame as illustrated in Fig. 23, for beams BC and CF. However, the general behaviour of the lateral beams was analogous between the two tested frames.

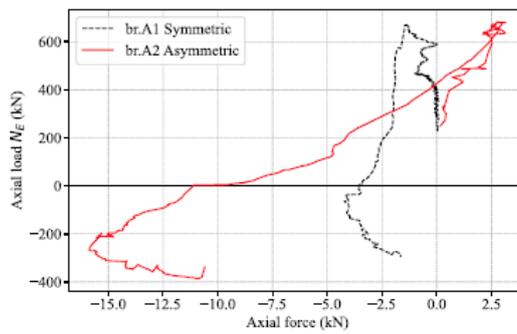
Figure 24. Comparison of the axial force on the restraint br.A (tension positive).

The behaviour of the lateral frame restraints showed modest axial forces, with very close values in restraints br.G and br.I in both the tests. On the other hand, the effect of the asymmetry on the torsional response of the frame is apparent from the significantly higher force in the restraint br.A. (Fig. 24).
