The Wheels of Industry in a Rural English Village. The evolution of Royal Quay, Coppermill Lock, Harefield

By Ian Hogg
With contributions by Rae Regensburg

June 2025

During 2013 and 2014 Archaeology South-East undertook a series of archaeological excavations at Royal Quay, Coppermill Lock, Harefield, in the London Borough of Hillingdon. The excavations uncovered the remains of buildings associated with the various industries which used the site during the last two centuries. From corn and paper milling to copper and asbestos manufacture, the site offers a glimpse of the evolution of industry and its impact upon the local community.

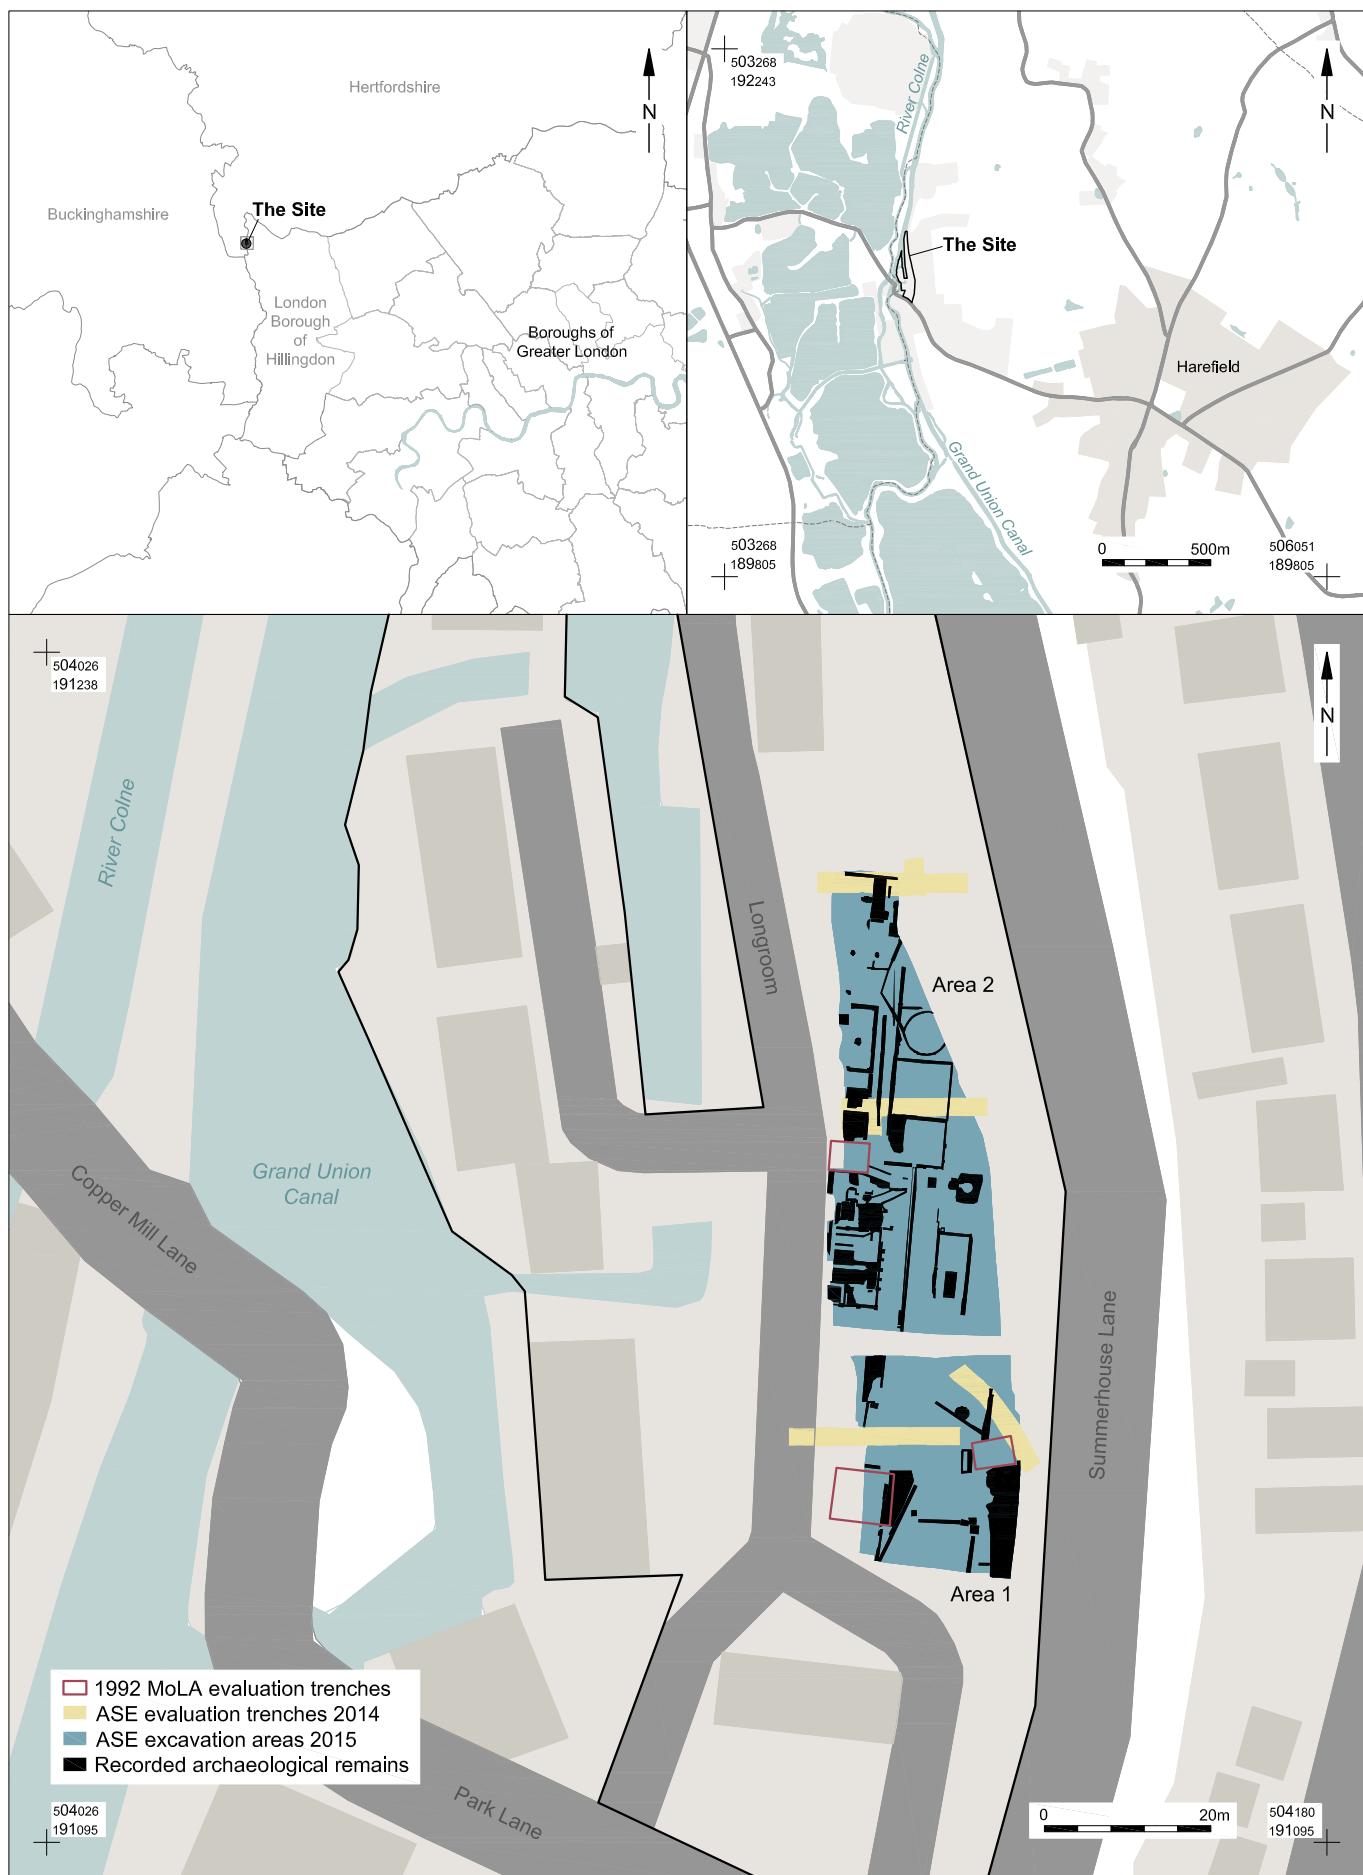
Fig. 1

Figure 1: Site location and plan of archaeological works

Coppermill Lock (Figure 1) lies to the west of Harefield, a village which historically lay within Middlesex but now lies in the London Borough of Hillingdon, close to the boundary of Buckinghamshire and Hertfordshire. The site lies on the eastern side of the River Colne valley with the Grand Union Canal forming the western site boundary.

A subsequent archaeological excavation between December 2014 and February 2015 revealed evidence of the various industrial uses of the site during the 18th, 19th and 20th centuries (Clemente 2015; Figure 1).

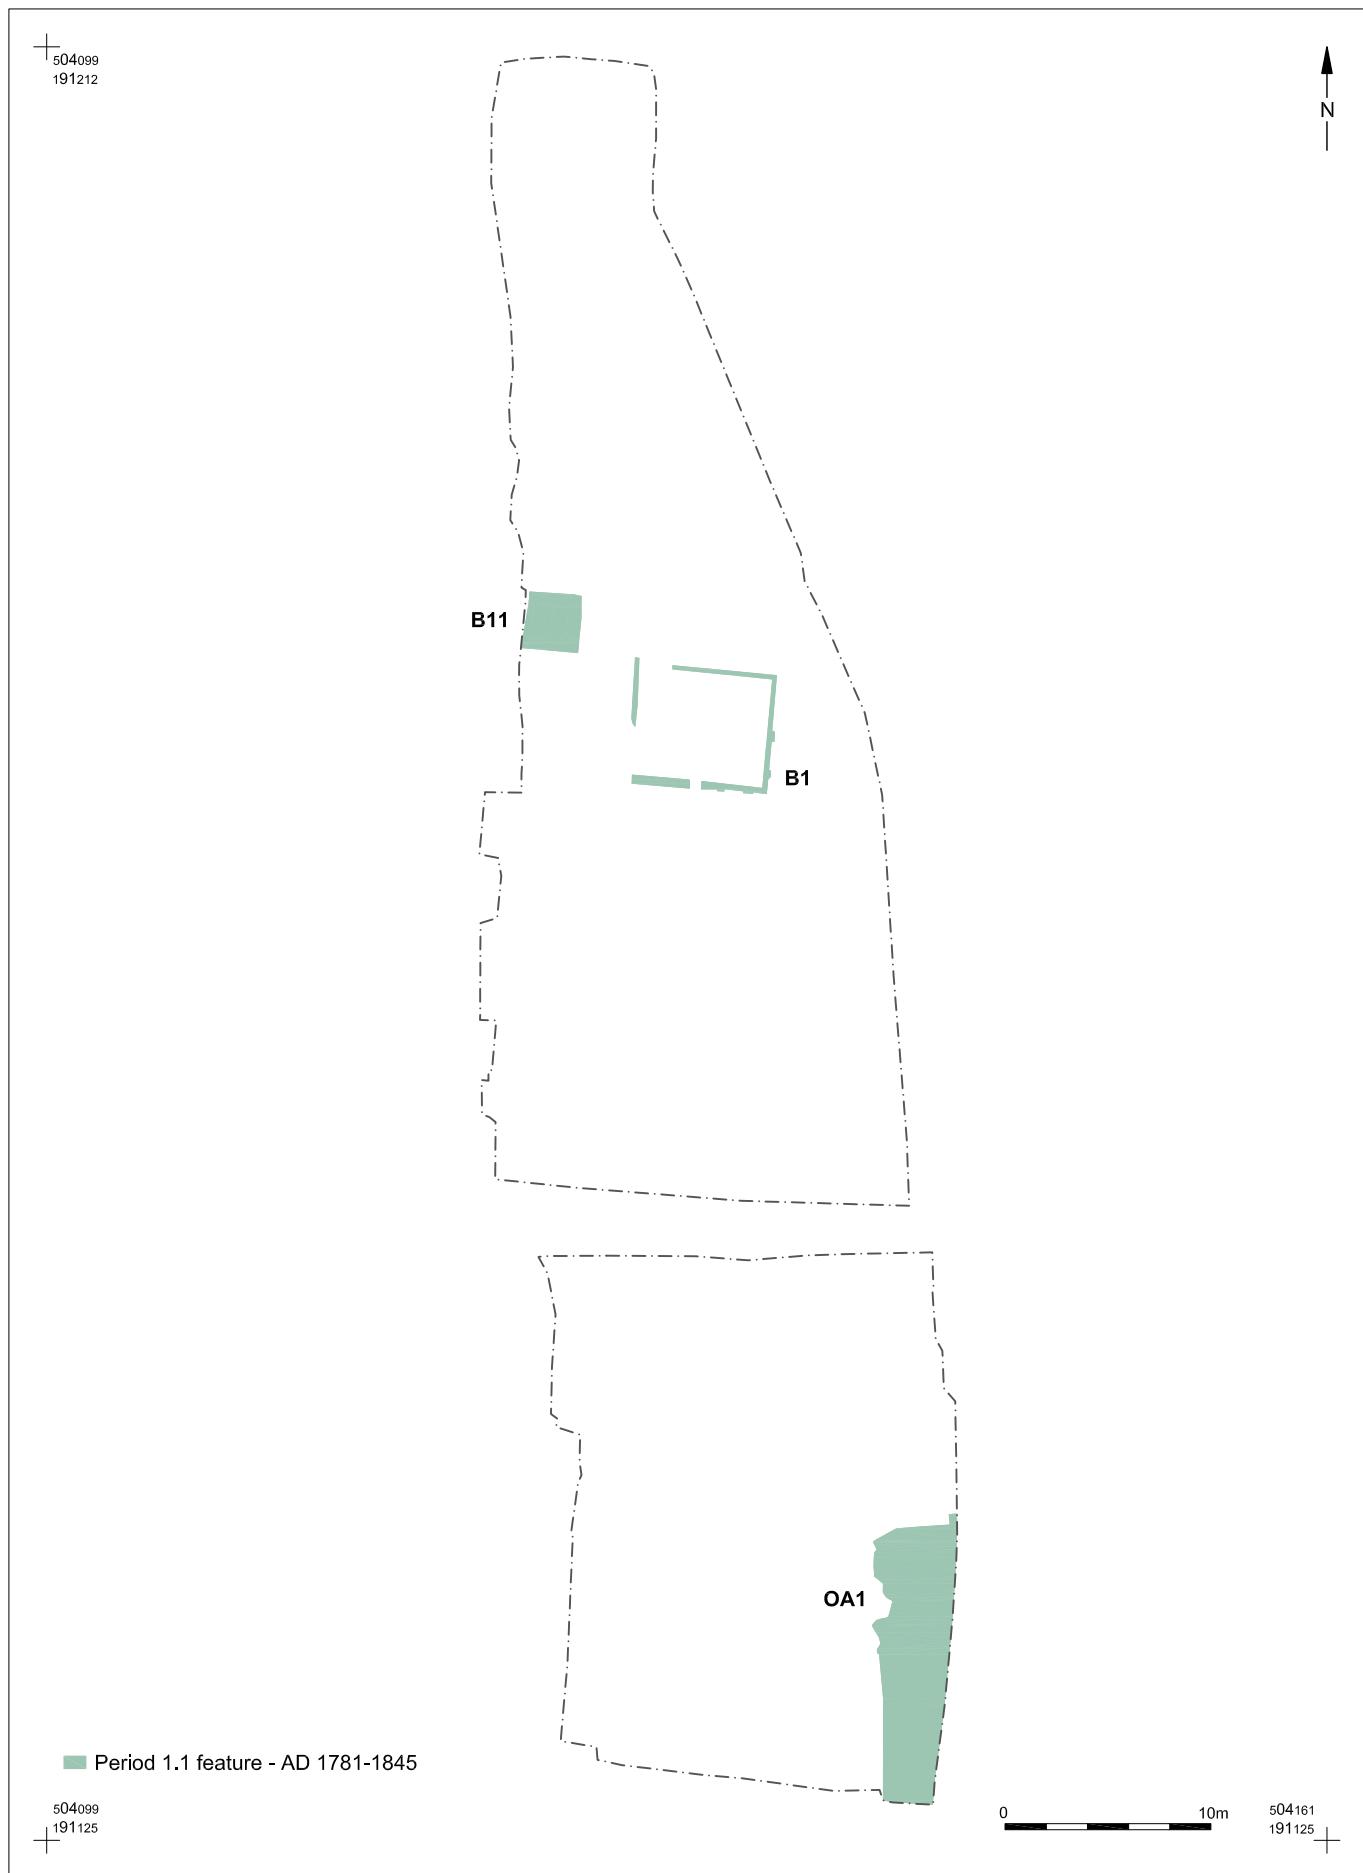
Fig.2

Figure 2. Period 1.1 plan

Demolition and levelling deposits in the south-east of the site (OA1; Figure 2) attested to the clearance of the earlier paper mill that had occupied the site in preparation for construction in this area. These deposits contained some of the earlier brick and tile discussed above, but the majority of the CBM assemblage was later and even included some intrusive material attesting to the continued redevelopment of the site. The pottery assemblage was of 18th to 19th century date while fragments of 17th to 18th century bottle glass were also recovered.

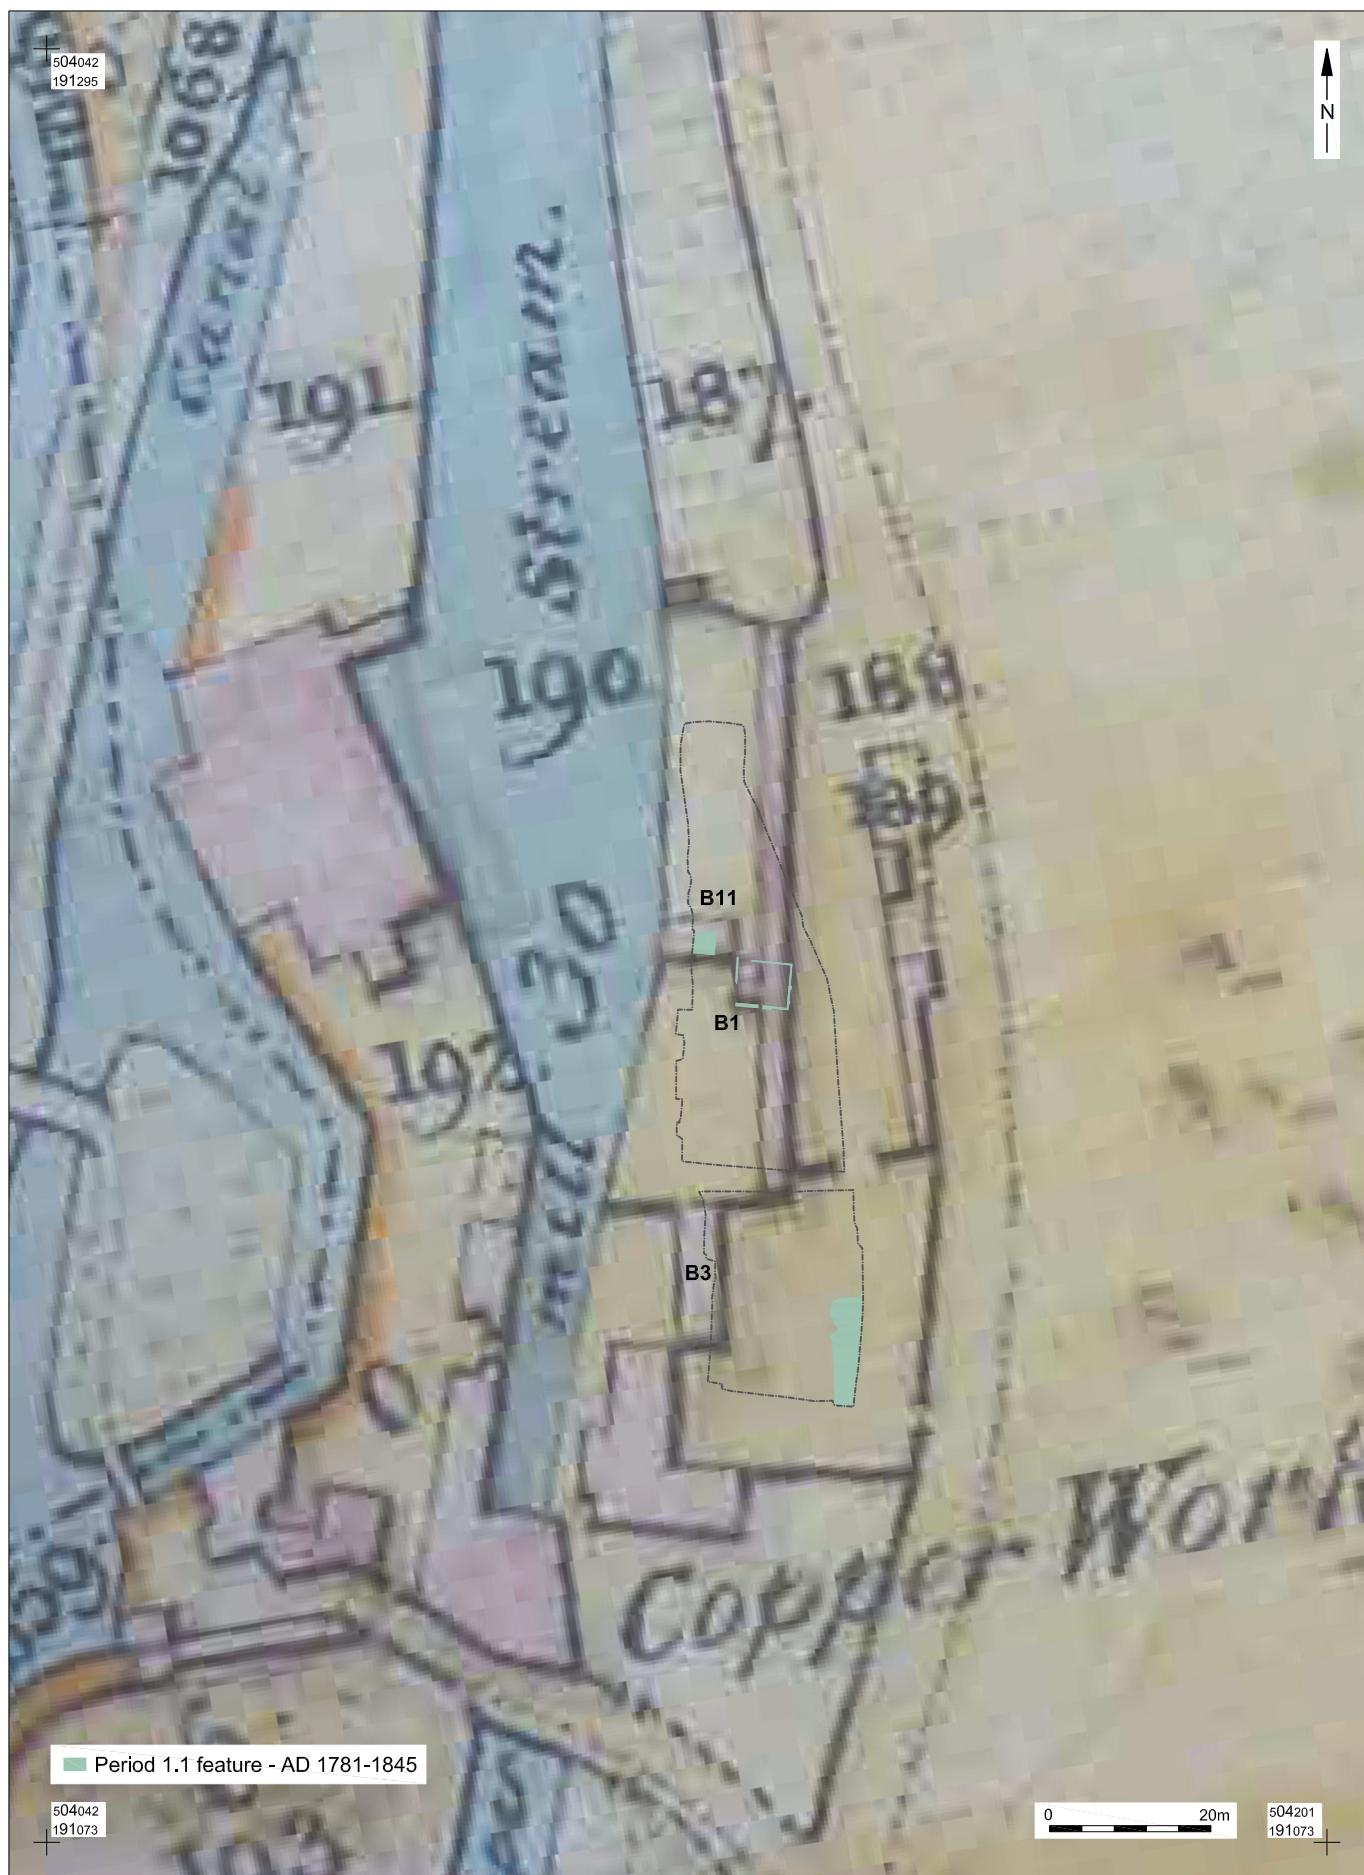
Fig.3

Figure 3. Period 1.1 remains and the 1800 Harefield Enclosure Map

Two further buildings B3 and B11 appear to have originated during this period and are present on the 1800 Harefield Enclosure Map (Figure 3). Building B3 (depicted and described in Period 1.2) lay to the south-east of the excavation area but was gradually extended north and eastwards during later periods. Building B11 lay just to the west of building B1 and had a similarly long lifespan, little remained of the building apart from a brick-built chamber 2.80m x 2.50m in plan and 1.60m deep. Much of the brickwork dated to the 18th to 19th centuries and it seems likely that it was constructed during this period.

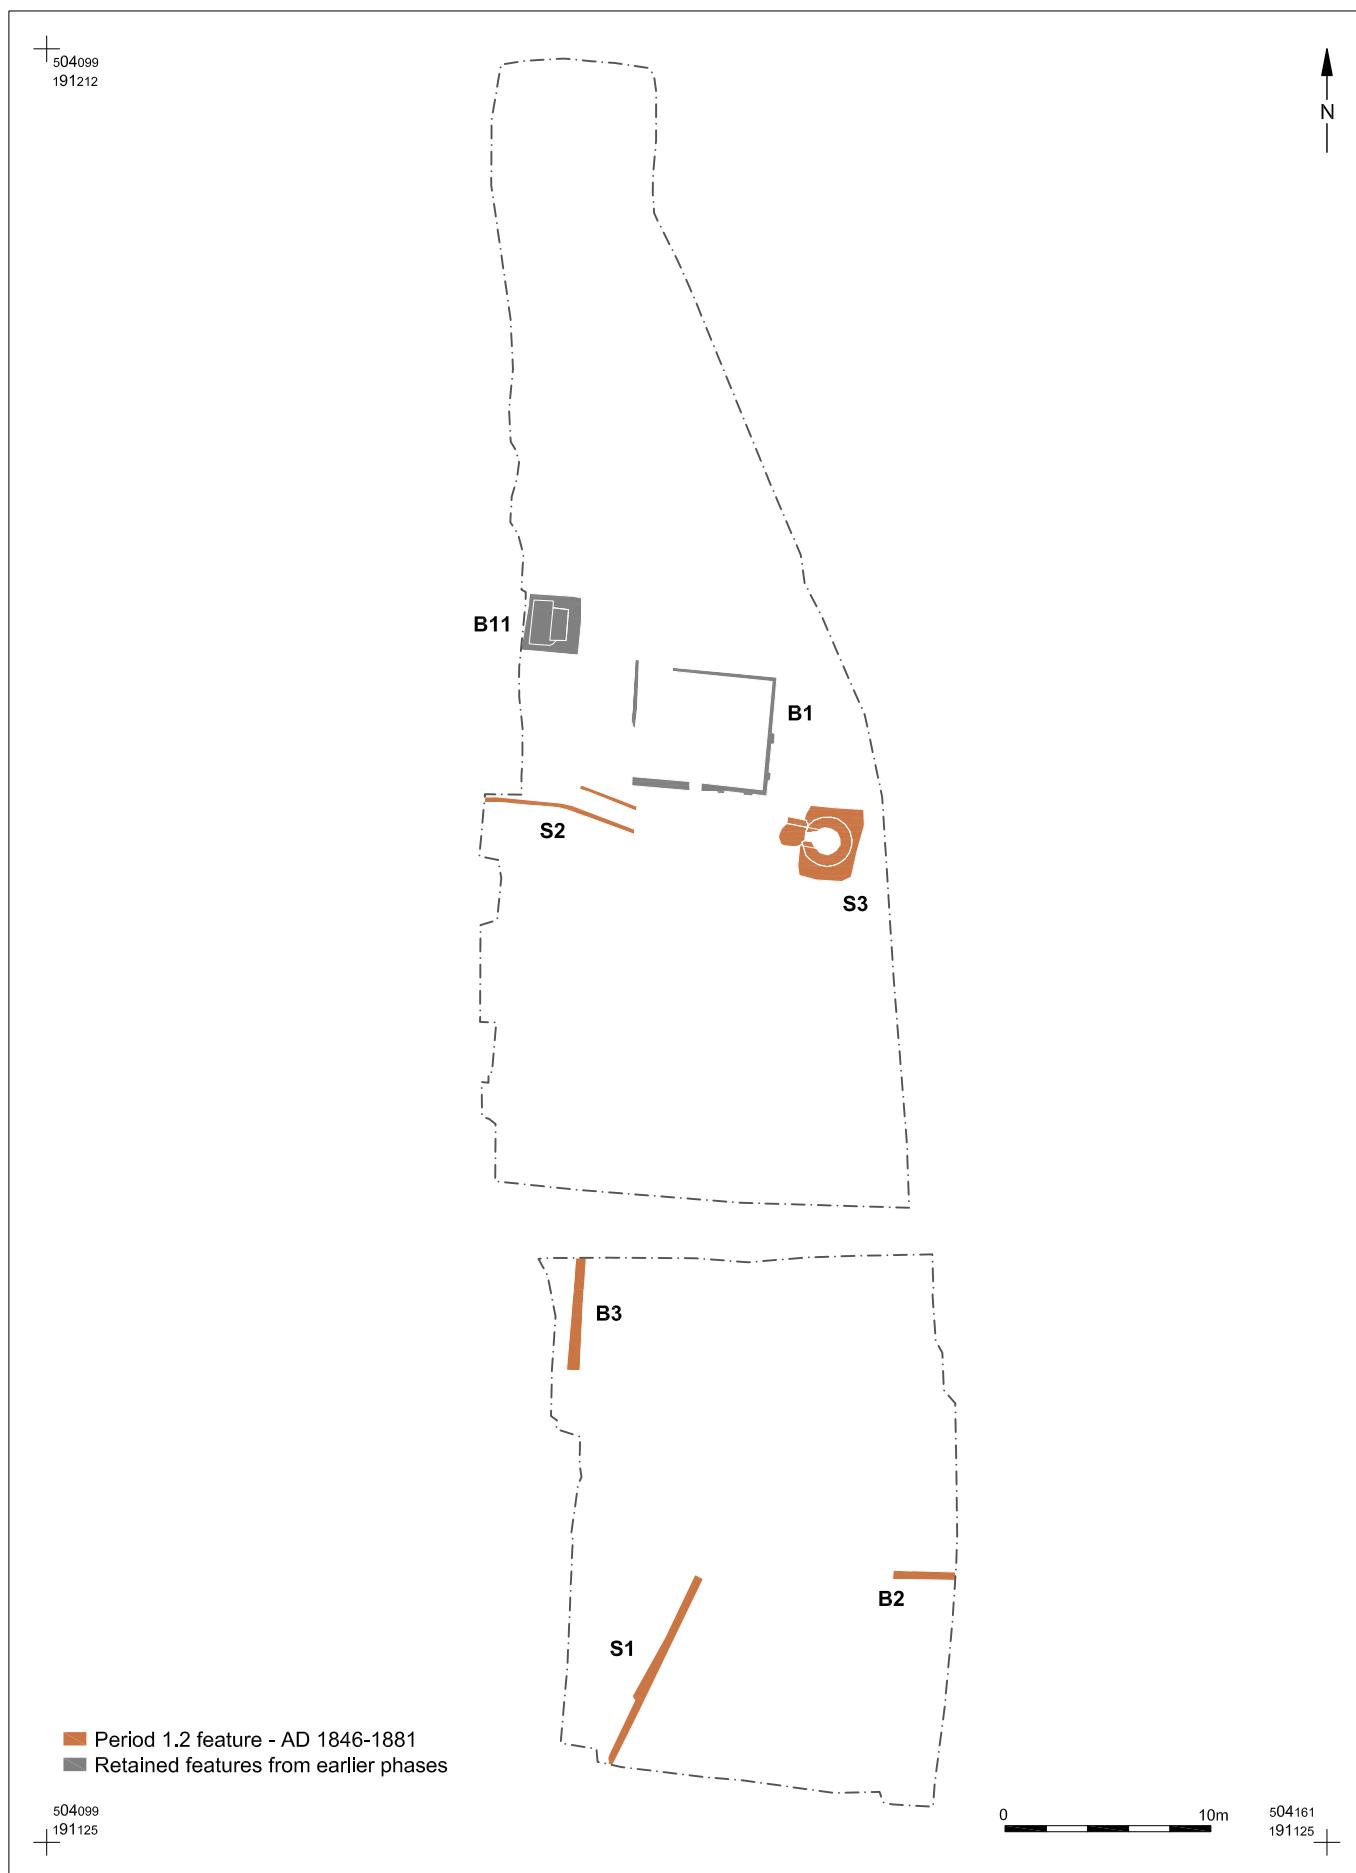
Fig.4

Figure 4: Period 1.2 plan

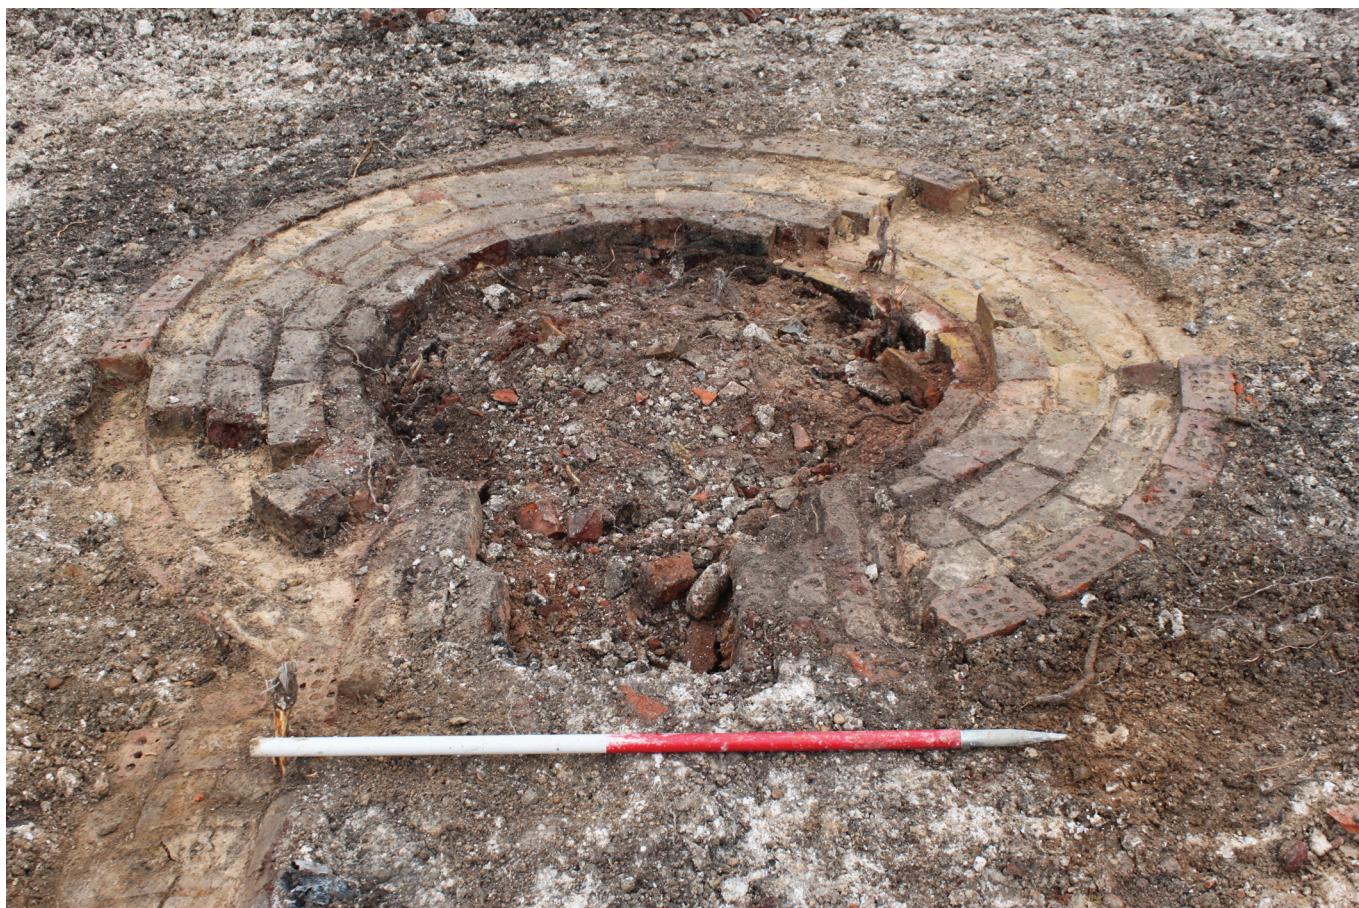
Fig.5

Figure 5: Photograph of chimney stack base S3 looking west (1m scale bar)

The chimney stack had a flue on its western side which linked with a horizontal brick-built flue, S2, which headed westwards, apparently from the chimney stack. These two elements may have formed part of the earliest steam powered mill on the site and were to remain integral to manufacture at the site

well into the 20th century. This is supported by the bricks of this structure being of 19th to 20th century date, one of these was a refractory brick.

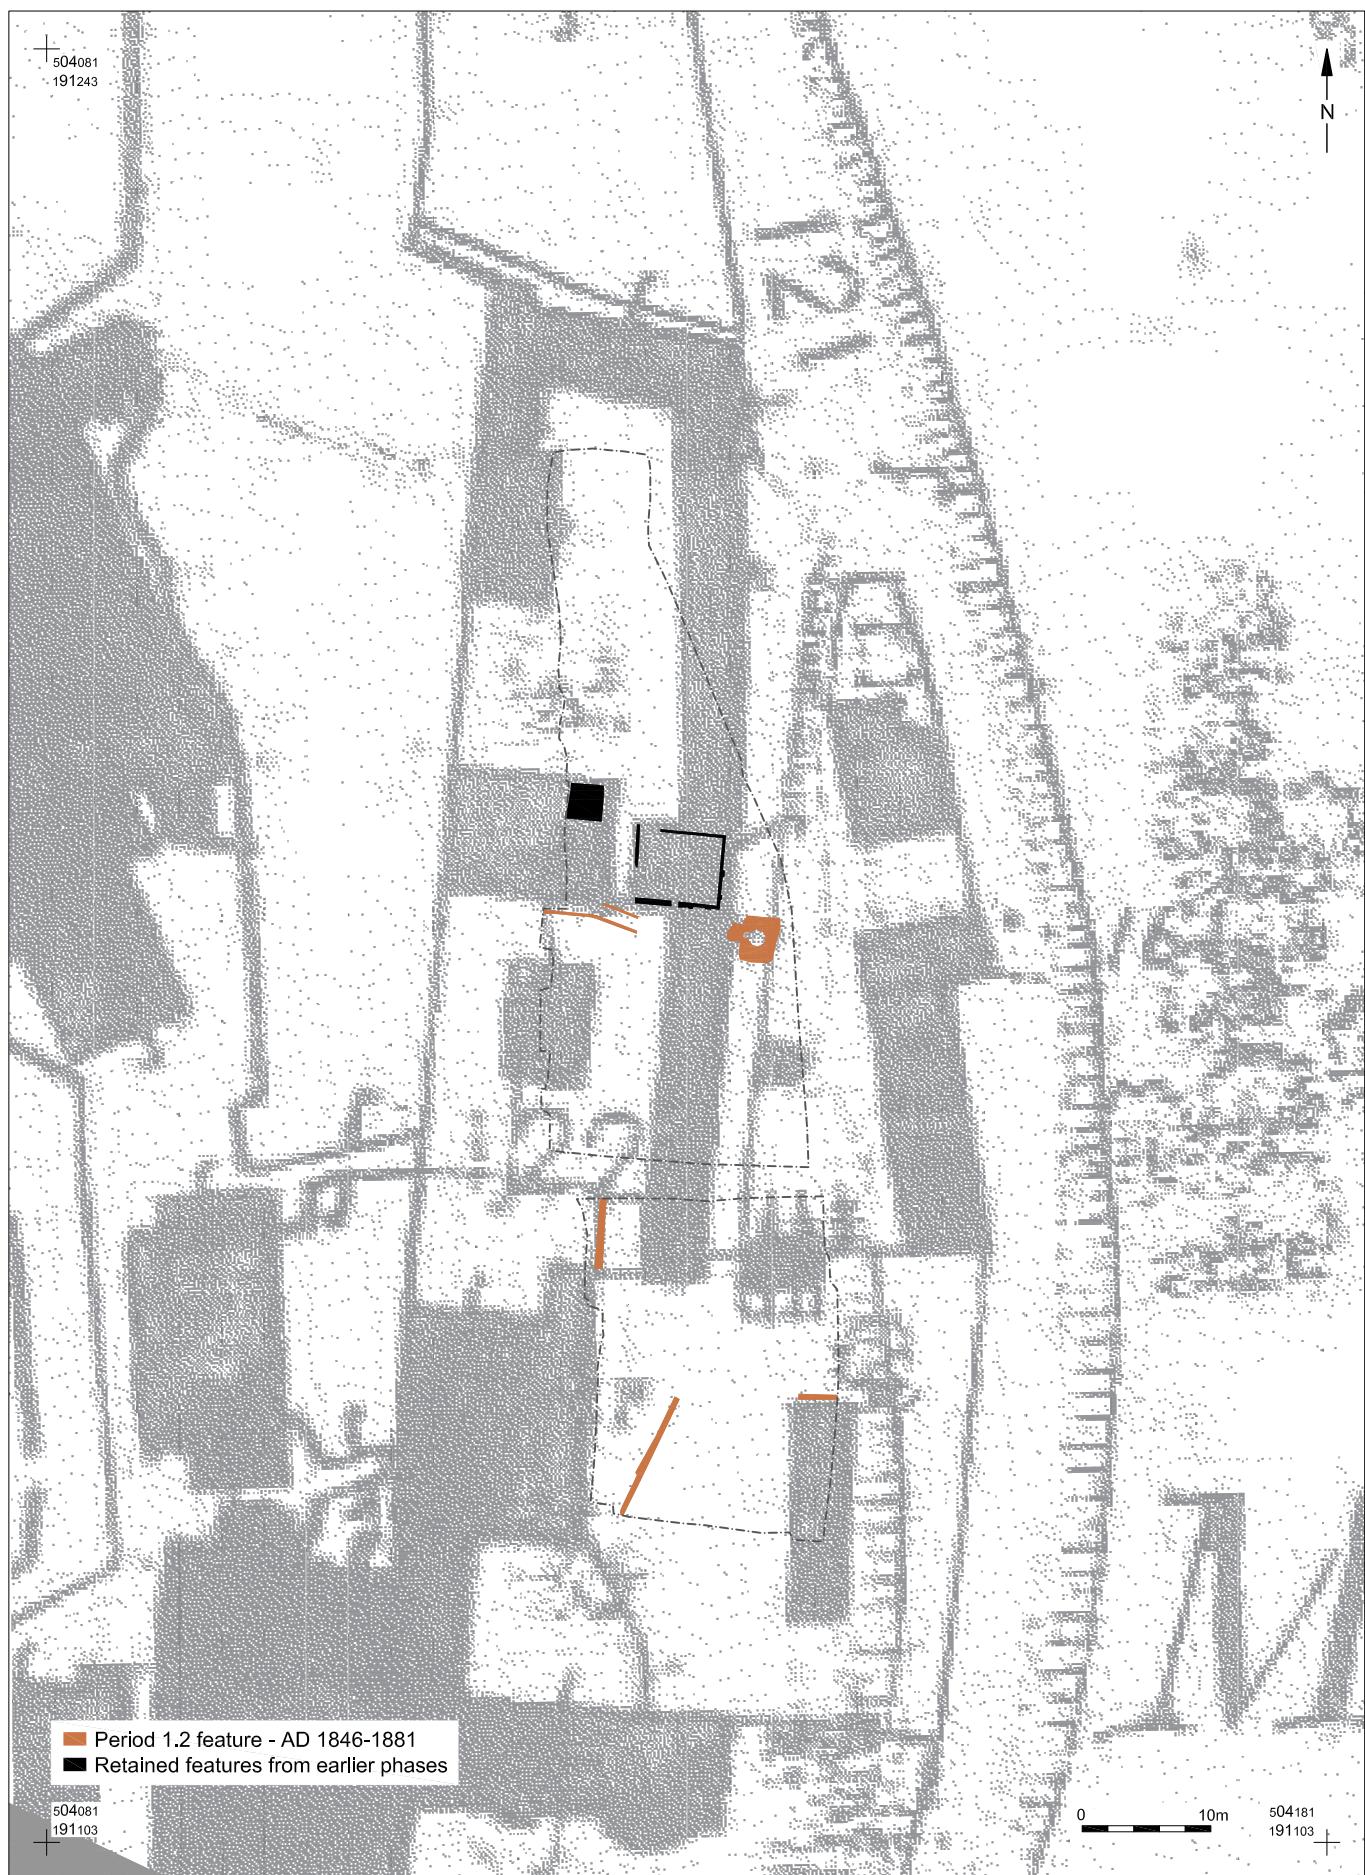
Fig. 6

Figure 6: Period 1.2 remains and the 1864 Ordnance Survey map

Historic mapping shows that further buildings were added in the south of the site at this time with building B3, being extended northwards twice into the excavation area. The first extension appeared on the 1864 Ordnance Survey map; it was apparently extended again by 1881 (Figures 6 and 7). Only a single portion of frogged red brick wall remained of the building as well as a brick-built drain (S1) which ran north-eastward from the building and appears to have served it. The drain was constructed from 19th to 20th century bricks indicating it remained in use for some time and was repaired during its lifespan.

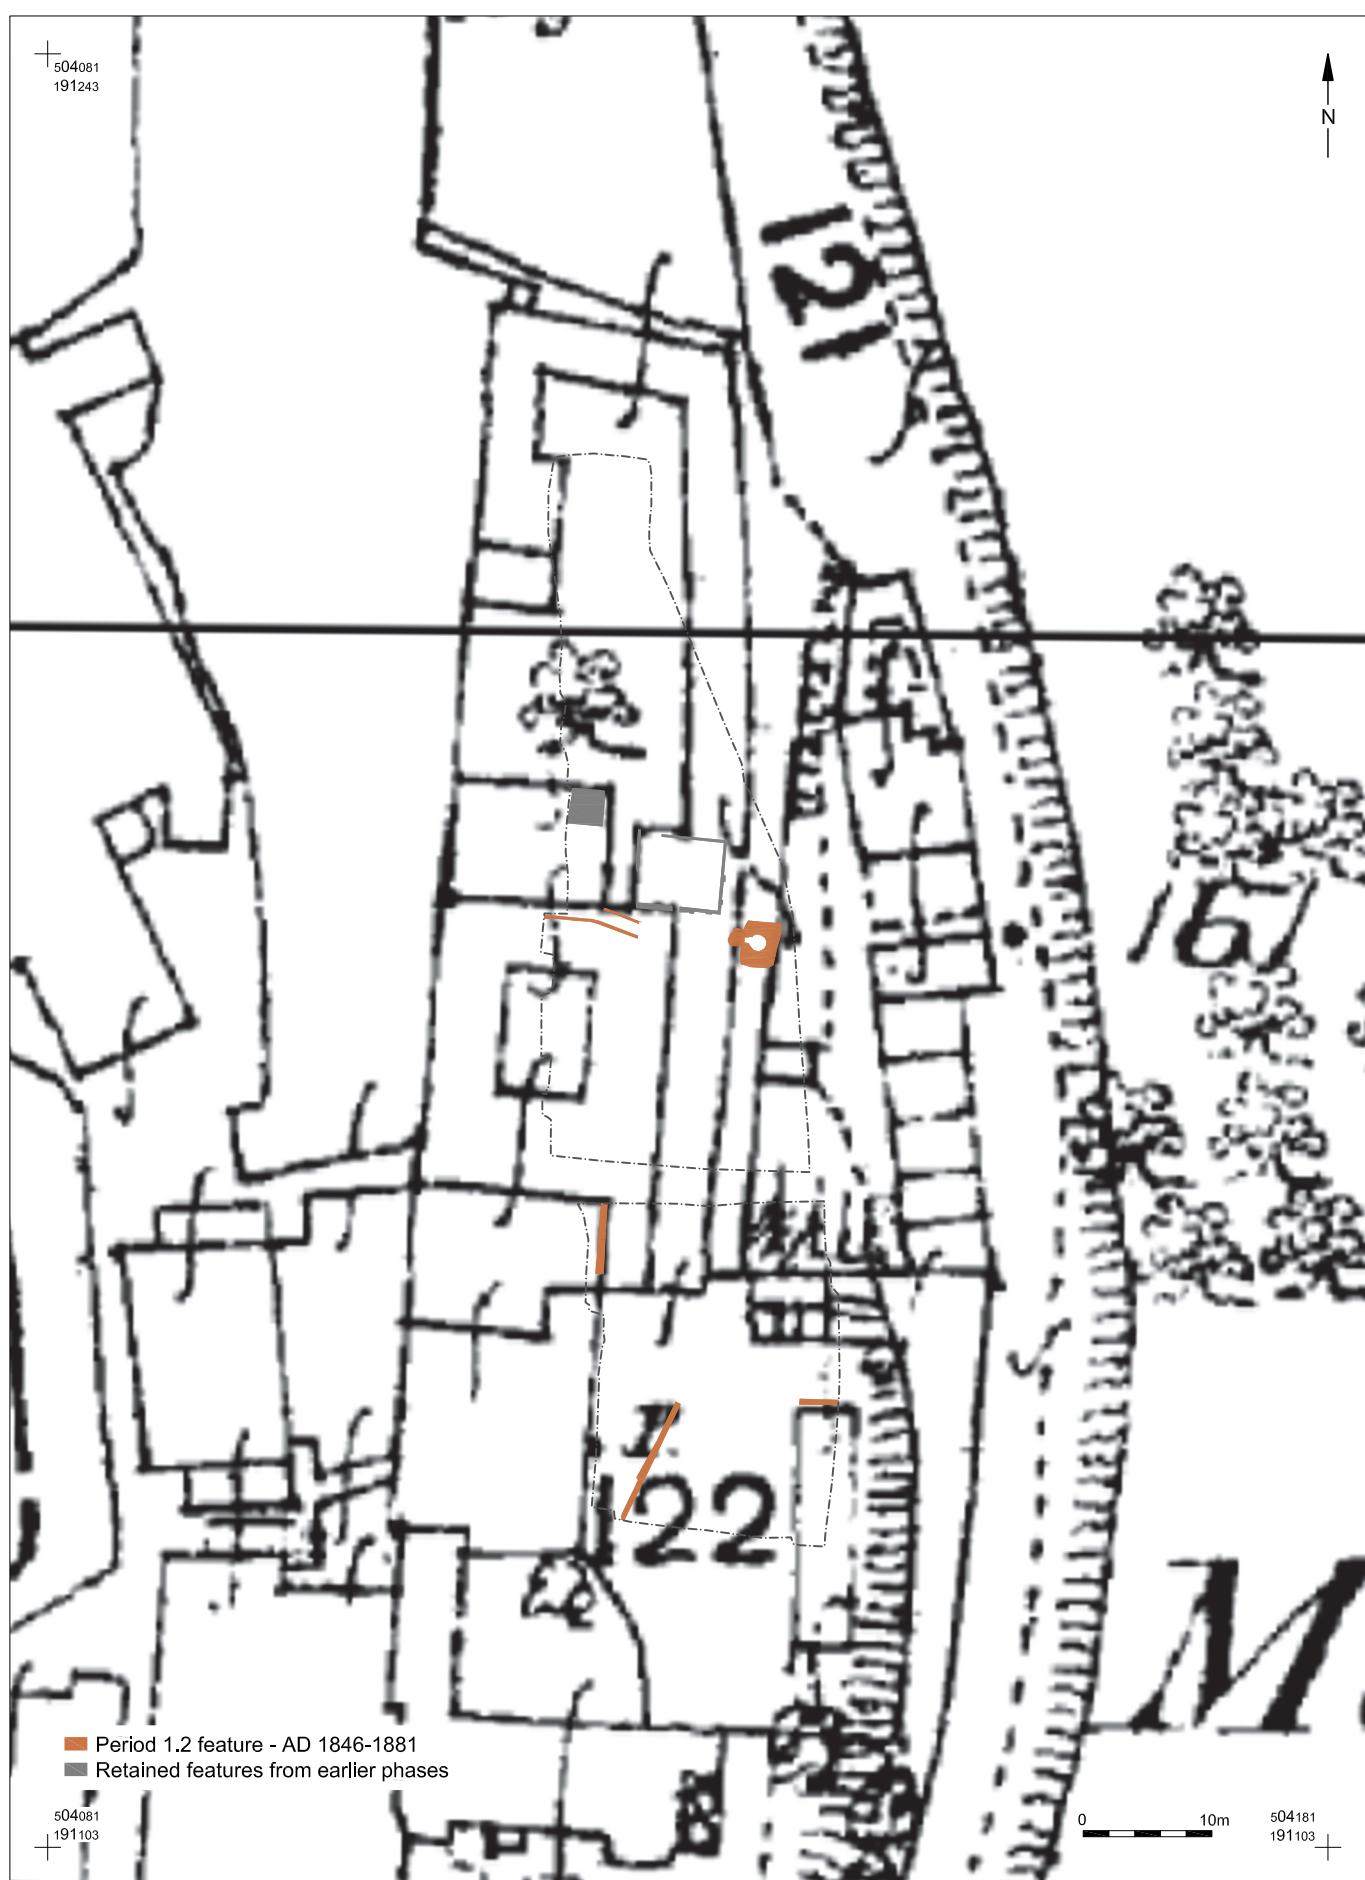
Fig. 7

Figure 7: Period 1.2 remains and the 1881 Ordnance Survey map

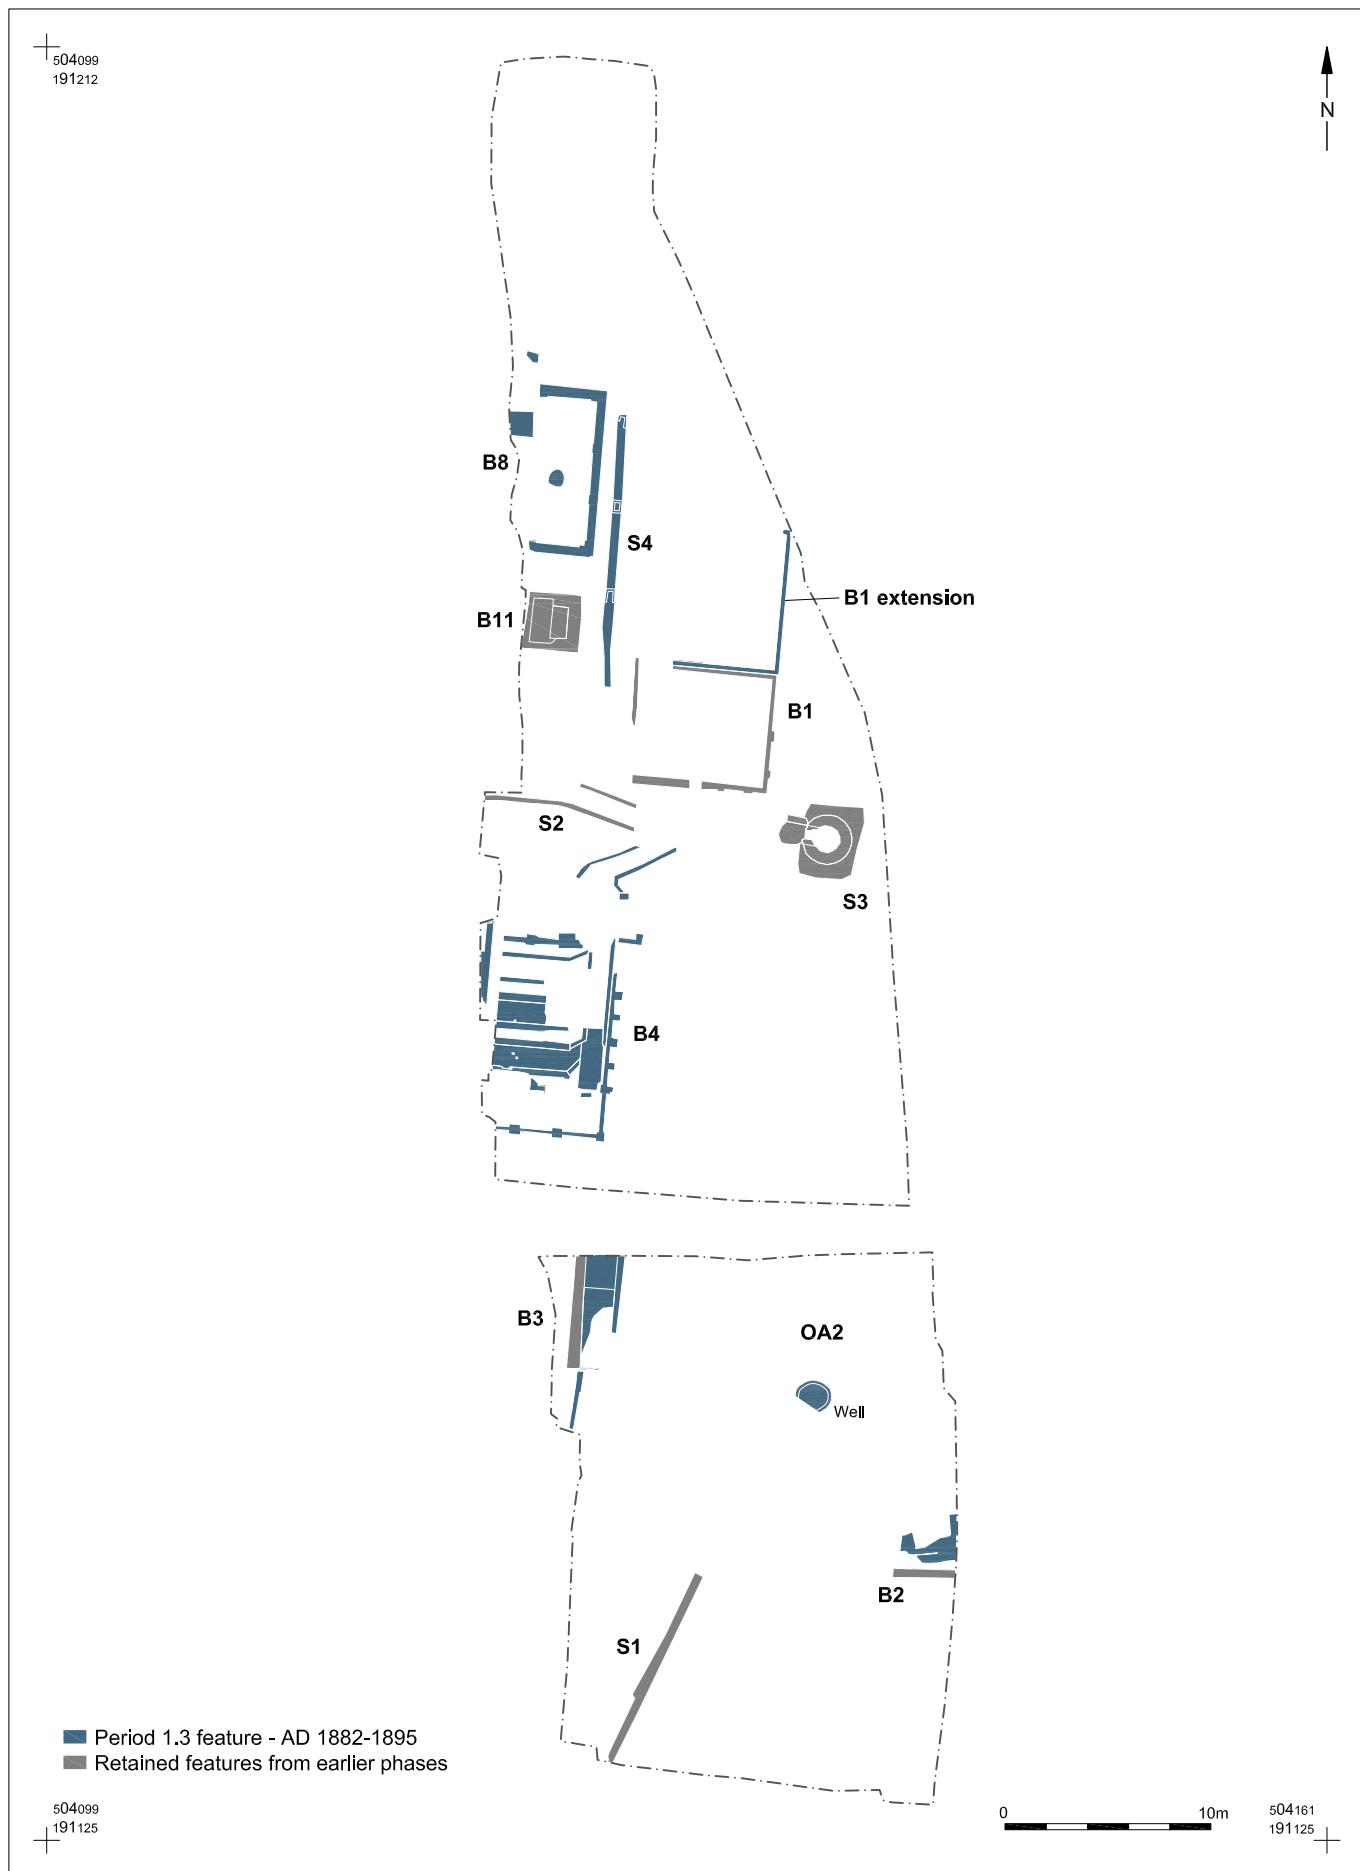
Fig. 8

Figure 8: Period 1.3 plan

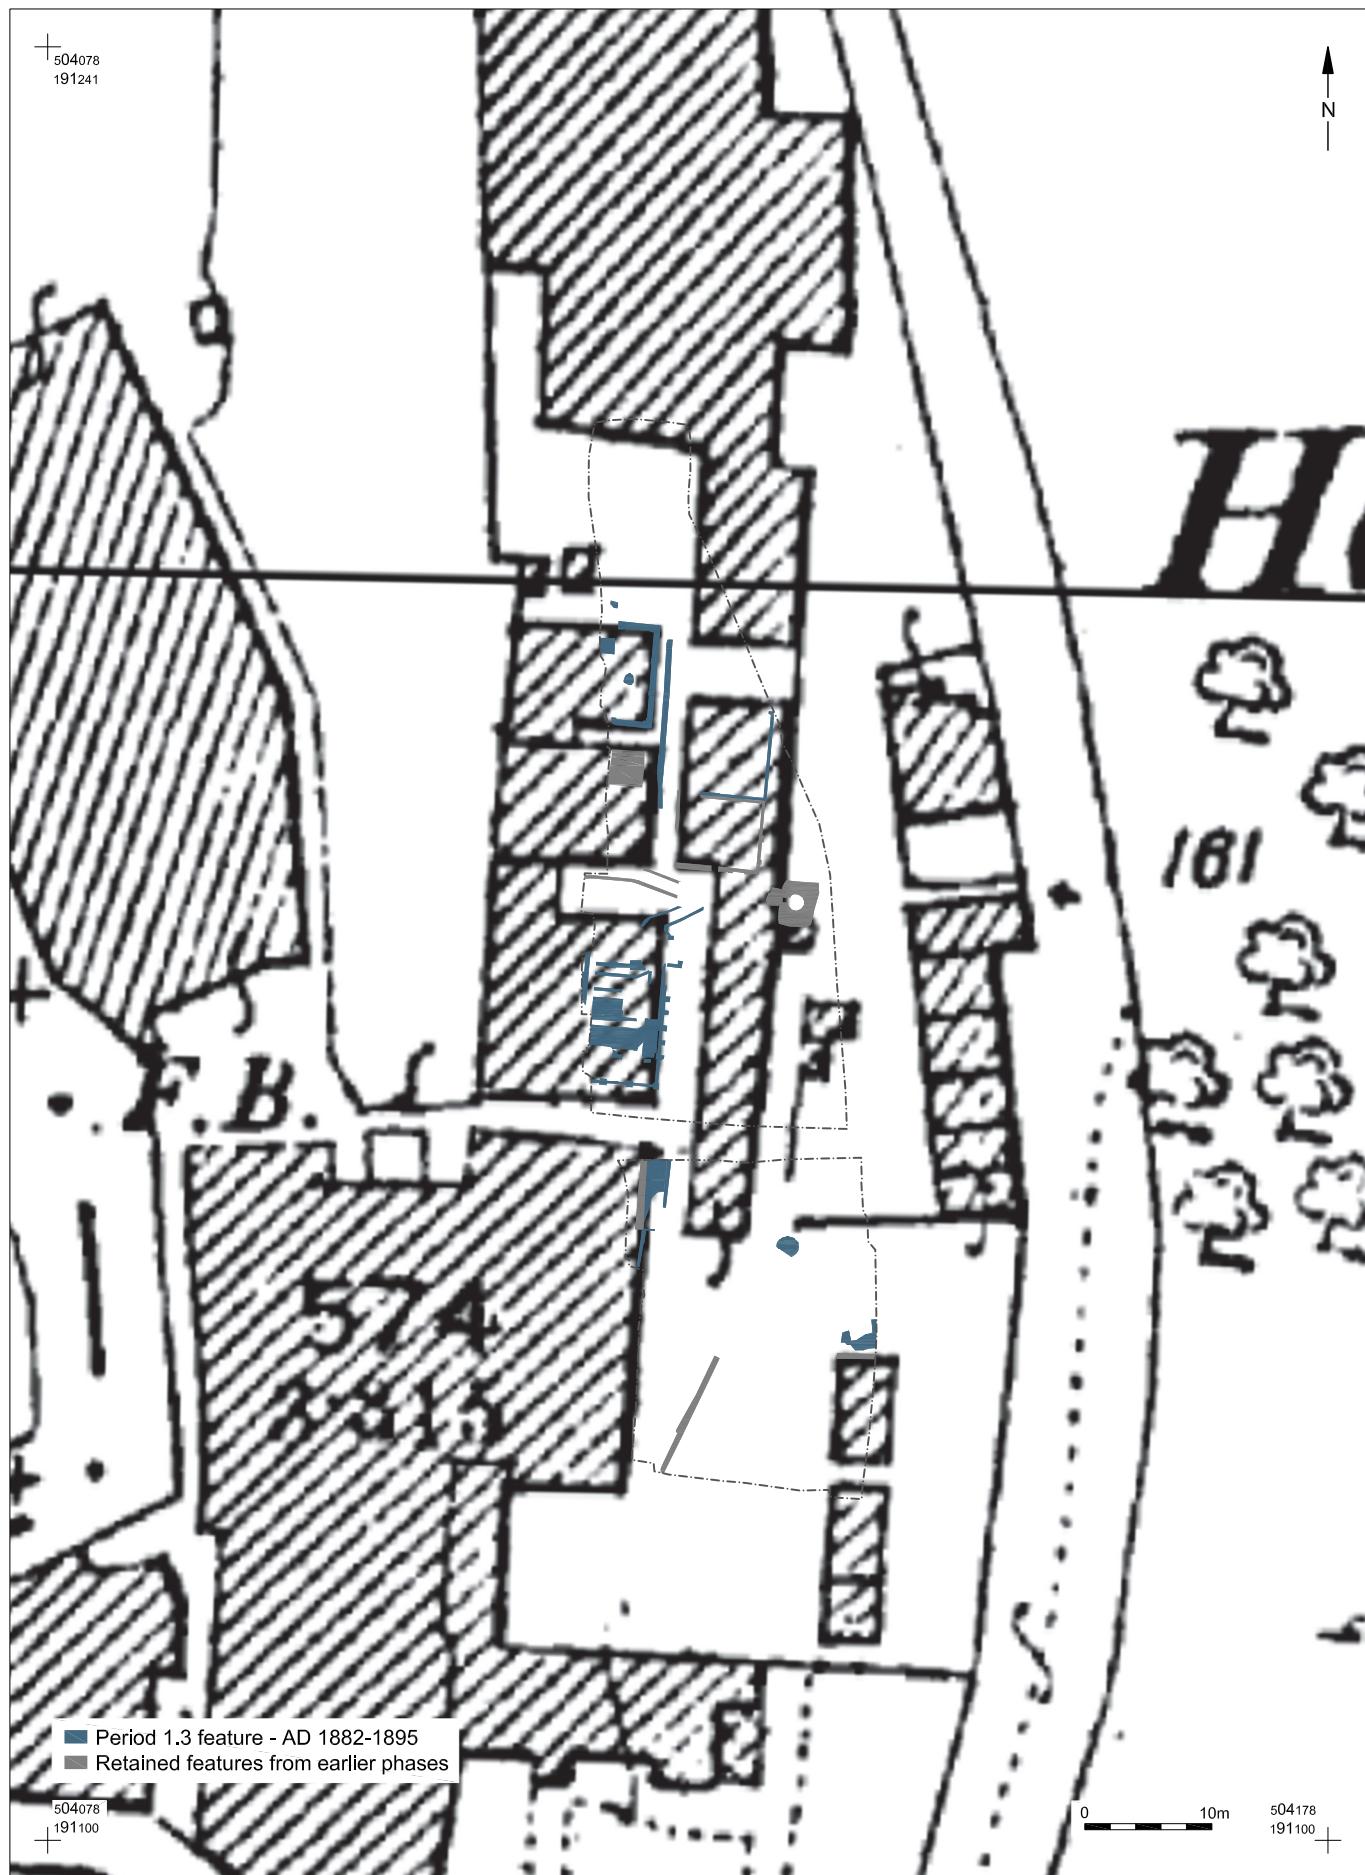
Fig. 9

Figure 9: Period 1.3 remains and the 1895 Ordnance Survey map
