The Wheels of Industry in a Rural English Village. The evolution of Royal Quay, Coppermill Lock, Harefield

By Ian Hogg
With contributions by Rae Regensburg

June 2025

During 2013 and 2014 Archaeology South-East undertook a series of archaeological excavations at Royal Quay, Coppermill Lock, Harefield, in the London Borough of Hillingdon. The excavations uncovered the remains of buildings associated with the various industries which used the site during the last two centuries. From corn and paper milling to copper and asbestos manufacture, the site offers a glimpse of the evolution of industry and its impact upon the local community.

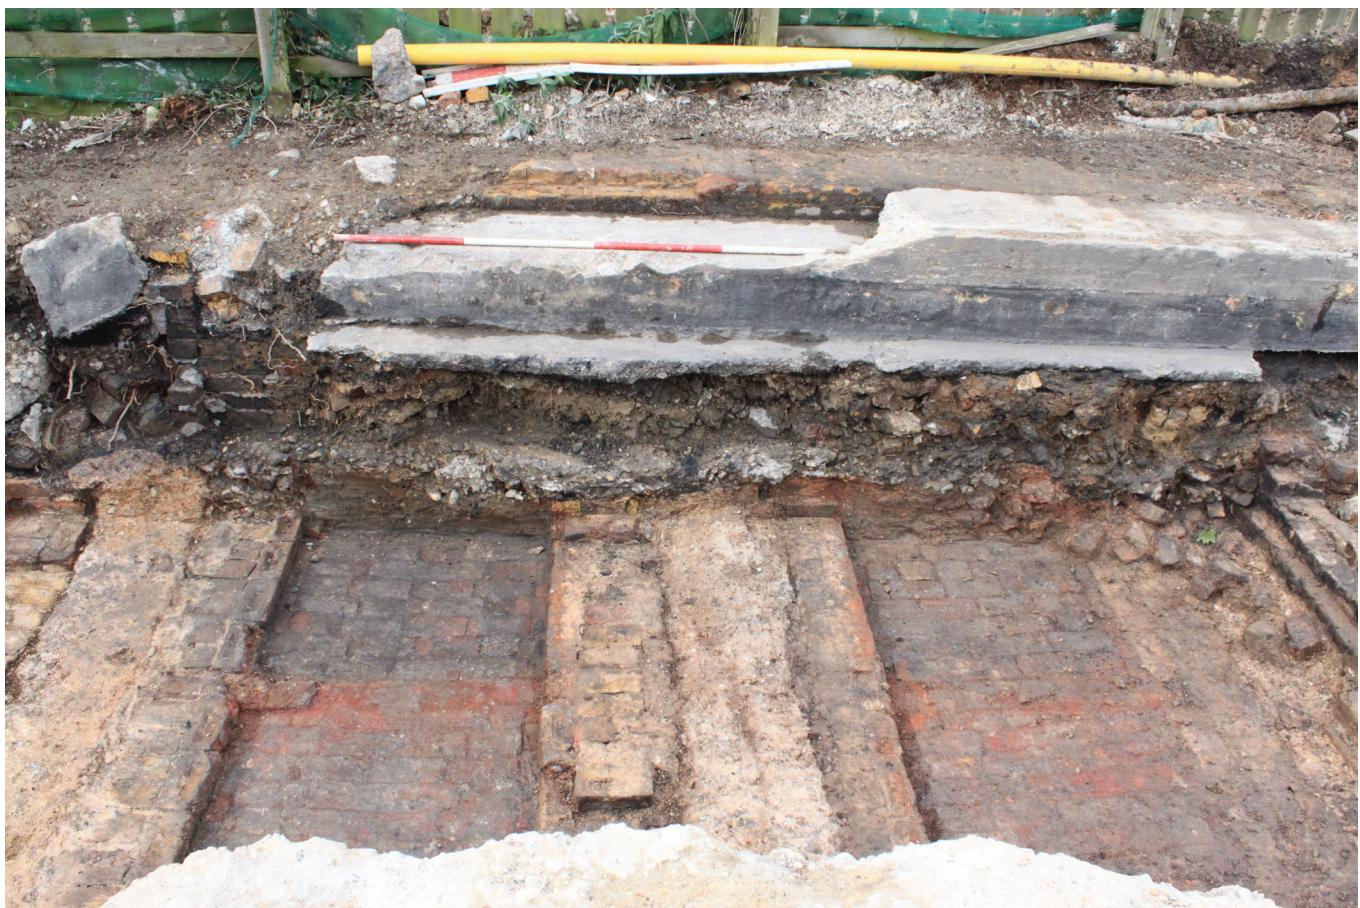
Fig. 11

Figure 11: The northern room in building B4 looking west (2m scale bar)

To the south of B11, new building B4 was a substantial, rectangular structure with cellars throughout, measuring c.9m x 6m and up to 1.5m in depth. Its external walls were built atop a stepped foundation with regular buttresses on its external sides. Internally the building was divided by an east-west partition wall into two rooms. The northern room (Figure 11) contained a red brick floor with a series of low walls forming three plinths upon which boilers for a regenerative furnace would have been housed. Finds from the backfill of these boiler housings included fragments of coal, fuel ash slag and hammerscale perhaps suggesting some smithing activity in the immediate area. The presence of refractory bricks again attested to the function of the building. To the south of the partition wall lay a single room, the full width of the building, the backfill of which contained abundant charcoal suggesting it functioned as a coal bunker. A brick flue ran along the eastern side of the cellar and fed into the existing flue, S2. The flue showed signs of vitrification confirming the building's role in heat generation.

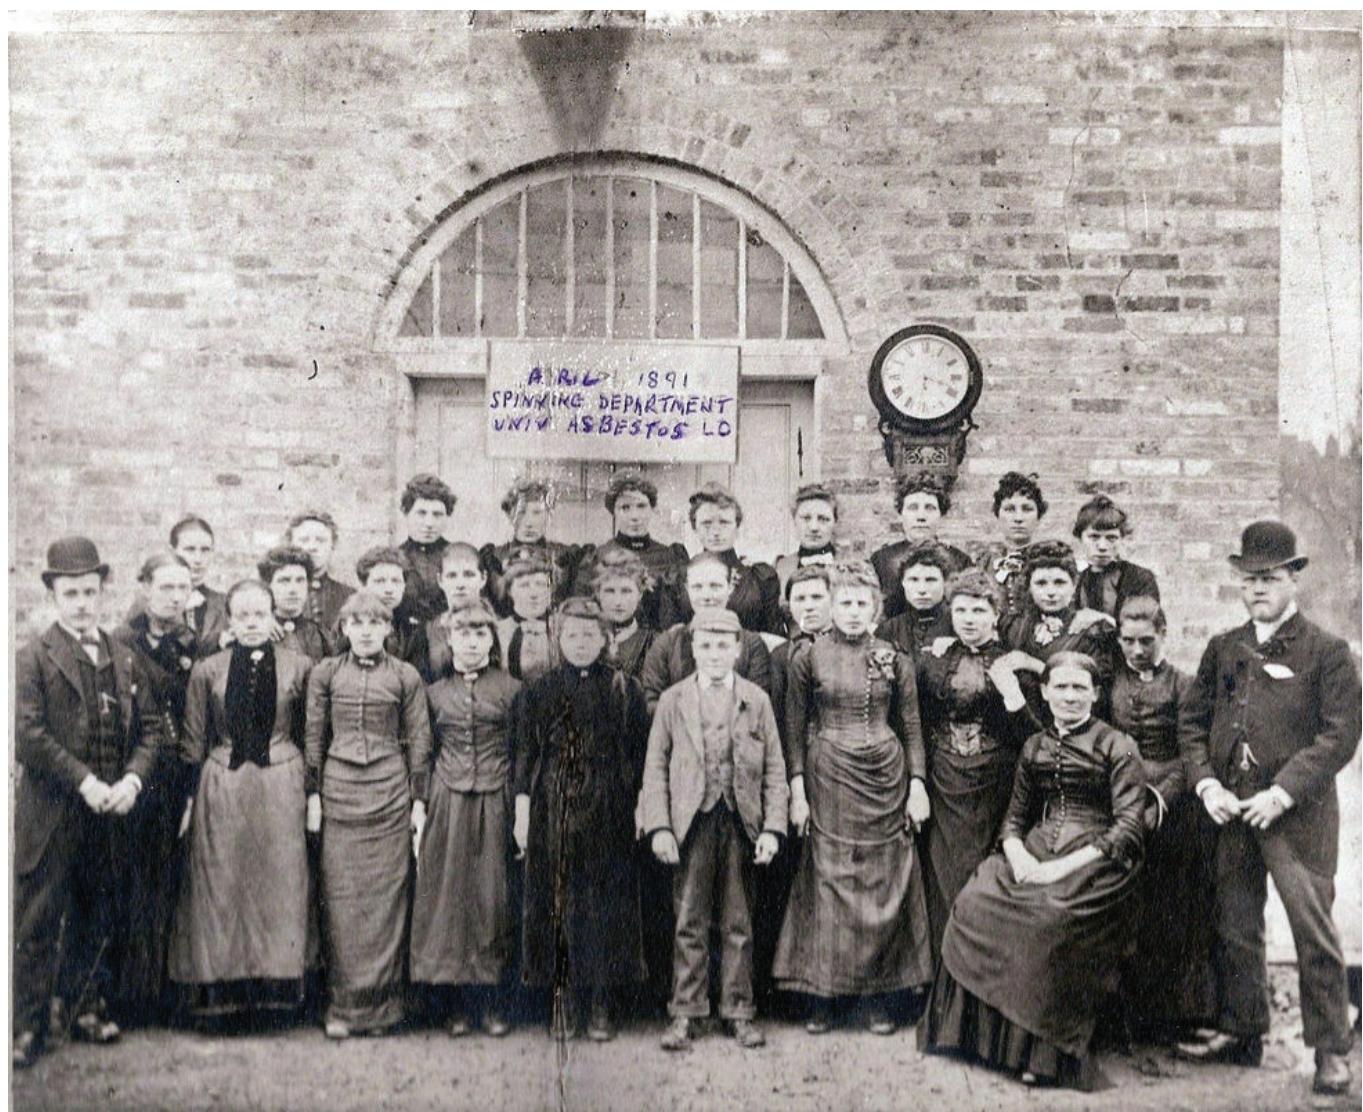
Fig.12

Figure 12: The spinning department in 1891 (permission granted by the Harefield Historical Society. Donated to them by Reg Neil)

The demographics of the workforce was reasonably broad, the 1911 census showing that 85 of the 214 employees were female (Piercy pers. comm.). The vast majority of women were young with nearly half being aged between 14 and 19, this is a much higher proportion than in males where it was 22.5%. The number of women and girls employed was partly down to the nature of the industry where weaving and textile manufacture were integral. Photographs of spinning department in 1891 and of mattress production in the 1910's show primarily women (Figures 12 and 14).

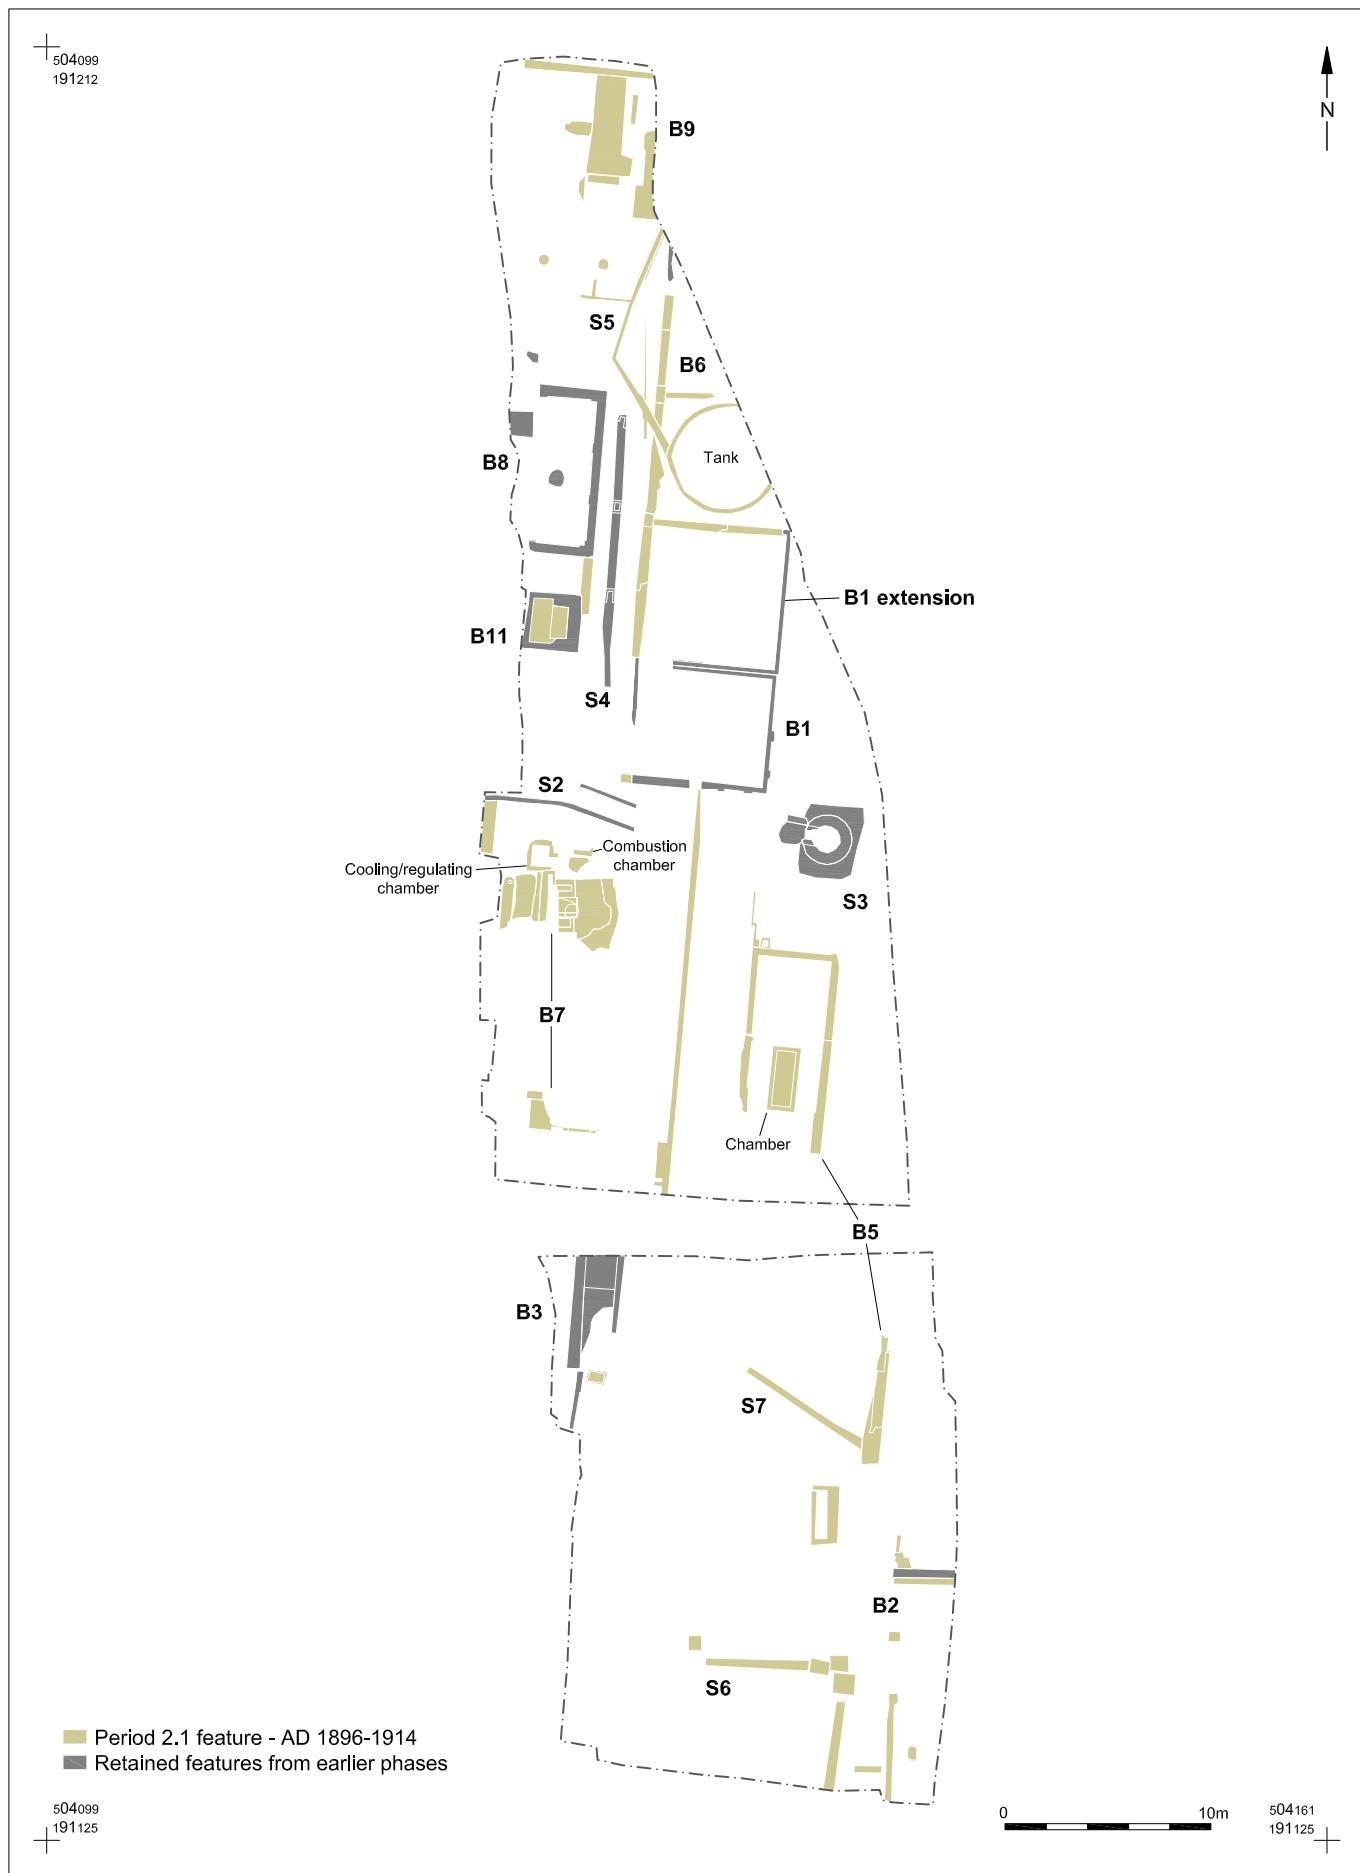
Fig.13

Figure 13: Period 2.1 plan

the time of the merger with Bell's rather than before. The most major change within the excavation area was the demolition of building B4 and its replacement by a larger, building B7 (Figure 13), which was single storeyed with a double pitched roof. The previous building was demolished with its cellar partially backfilled. The new rectangular building was constructed from red and yellow brick; the new footprint extended eastwards to abut building B1. A new cellar in the north-west of the building reused portions of the previous cellar with the addition of a new red brick floor surface. Two chambers lay to the north of the floor, one appearing to be a combustion chamber that showed signs of burning. The second chamber had an iron pipe extending from it and may have functioned to regulate the temperature of the gases produced, another refractory brick was recovered from this chamber. A brick base for a now lost piece of machinery was also recorded within the cellar. A second cellar was recorded in the south-east of building B7 comprising red and yellow brick walls and a concrete floor with no indication of the room's function.

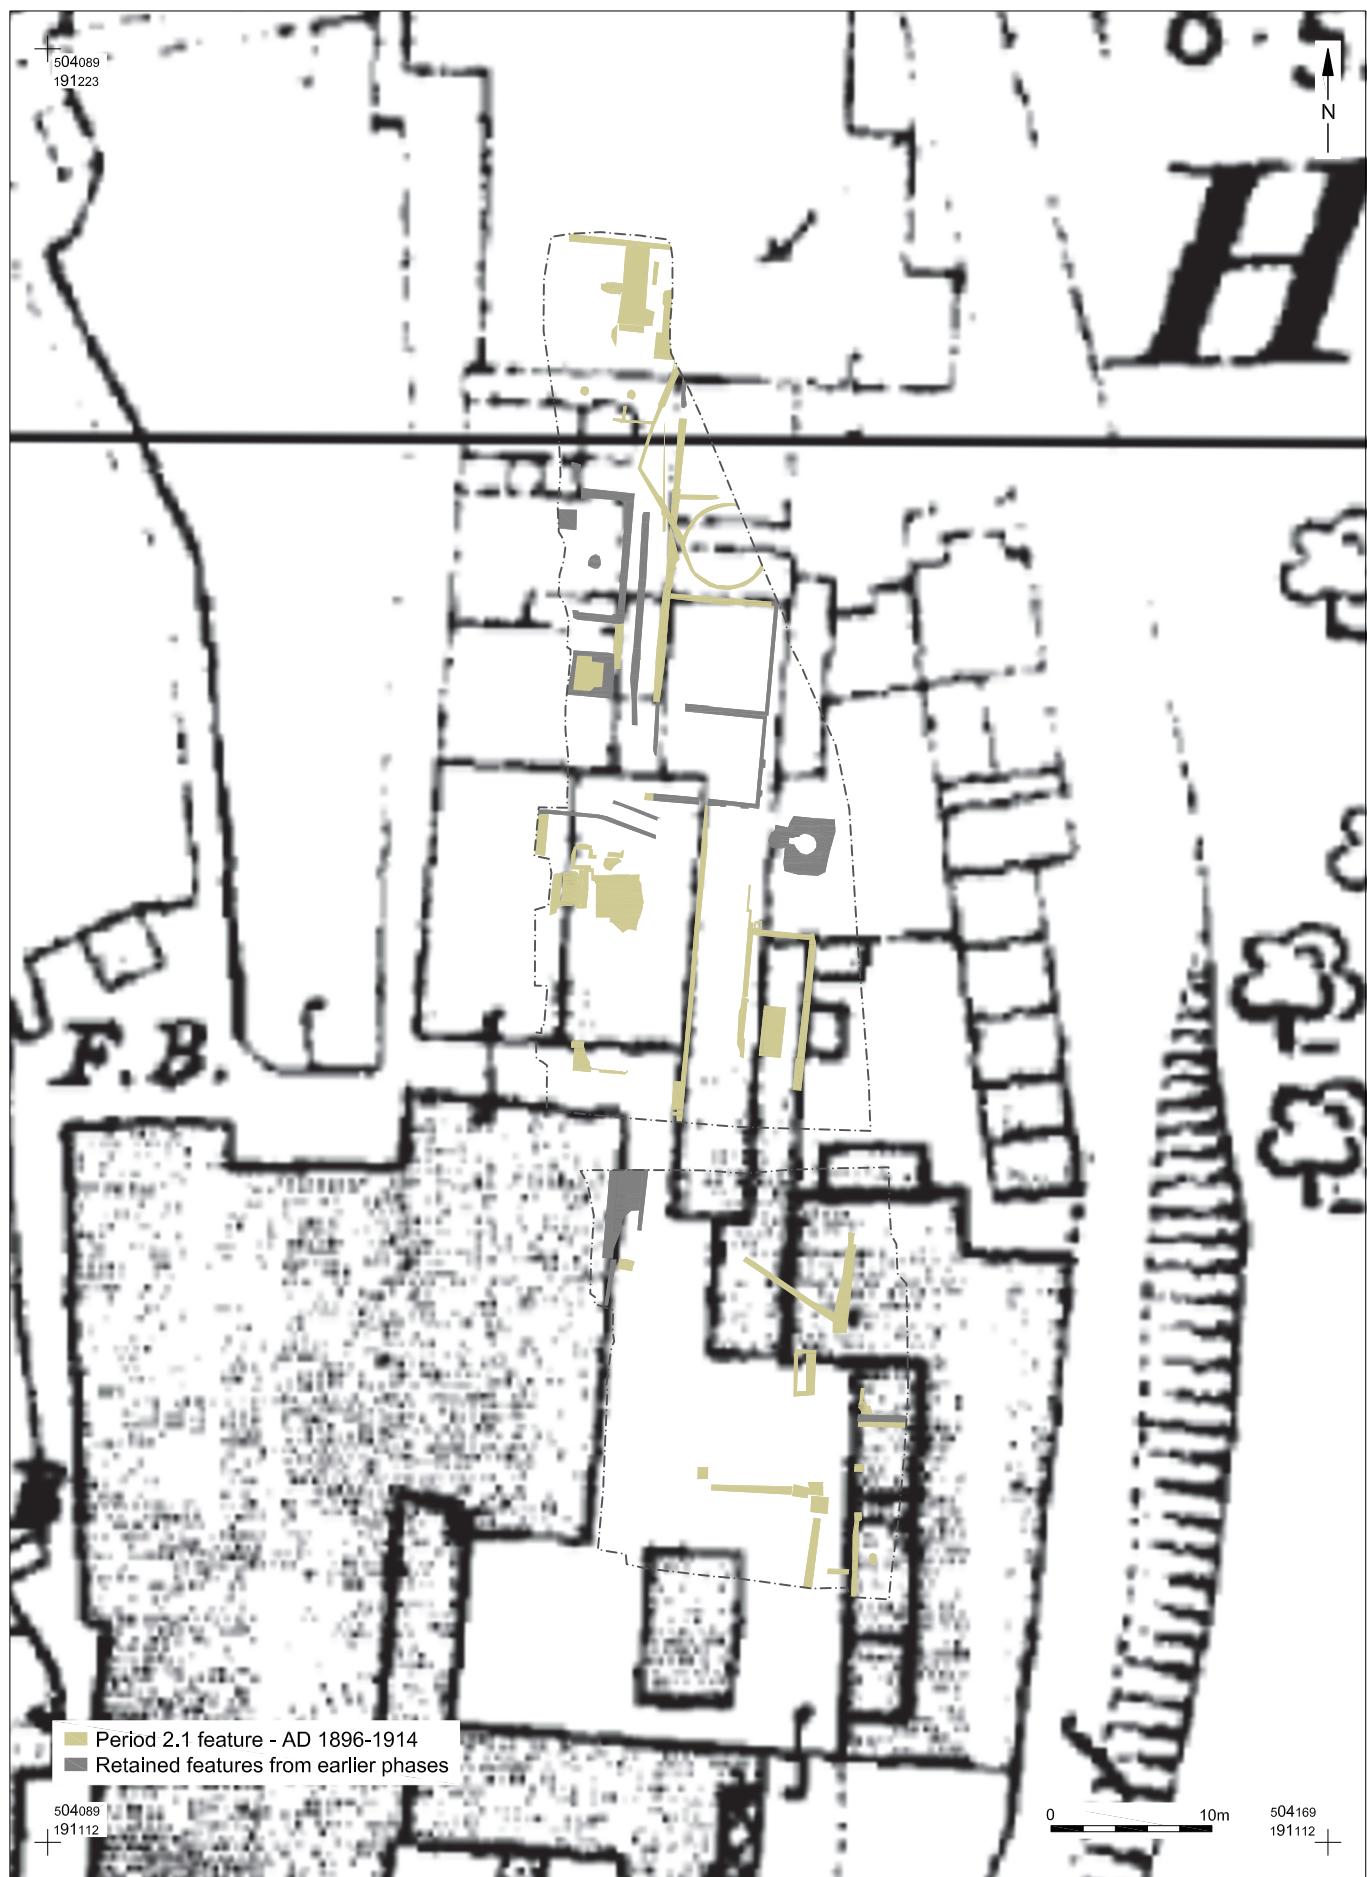
Fig.15

Figure 15: Period 2.1 remains and the 1914 Ordnance Survey map

The 1914 Ordnance Survey map (Figure 15) shows some significant alterations from the 1895 map. It is unclear precisely when these occurred, although the Harefield Land Valuation begun in 1909 used the 1896 map so it would be fair to surmise that many of the structural changes occurred around

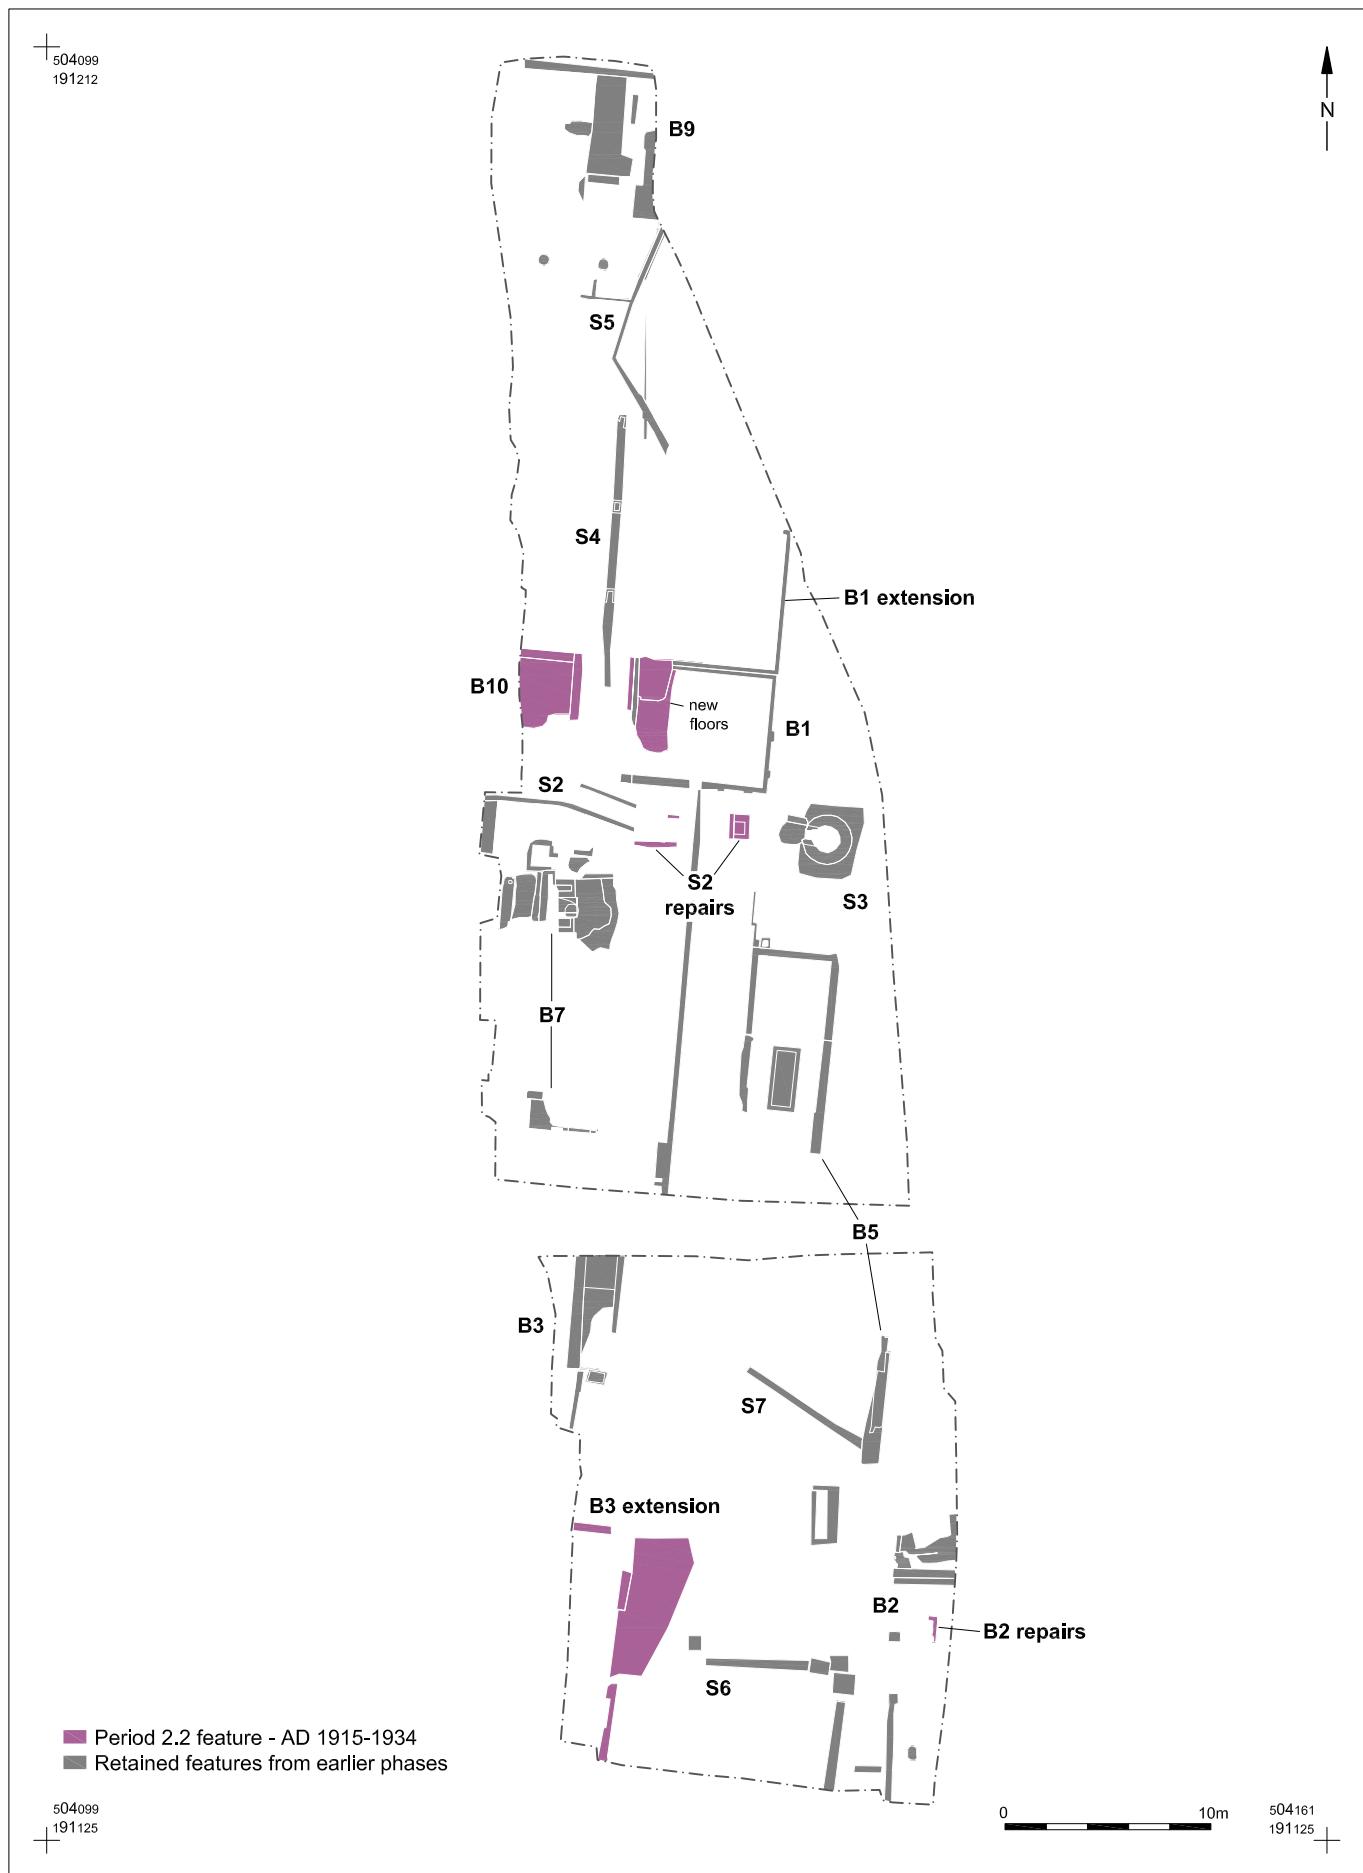
Fig.16

Figure 16: Period 2.2 plan

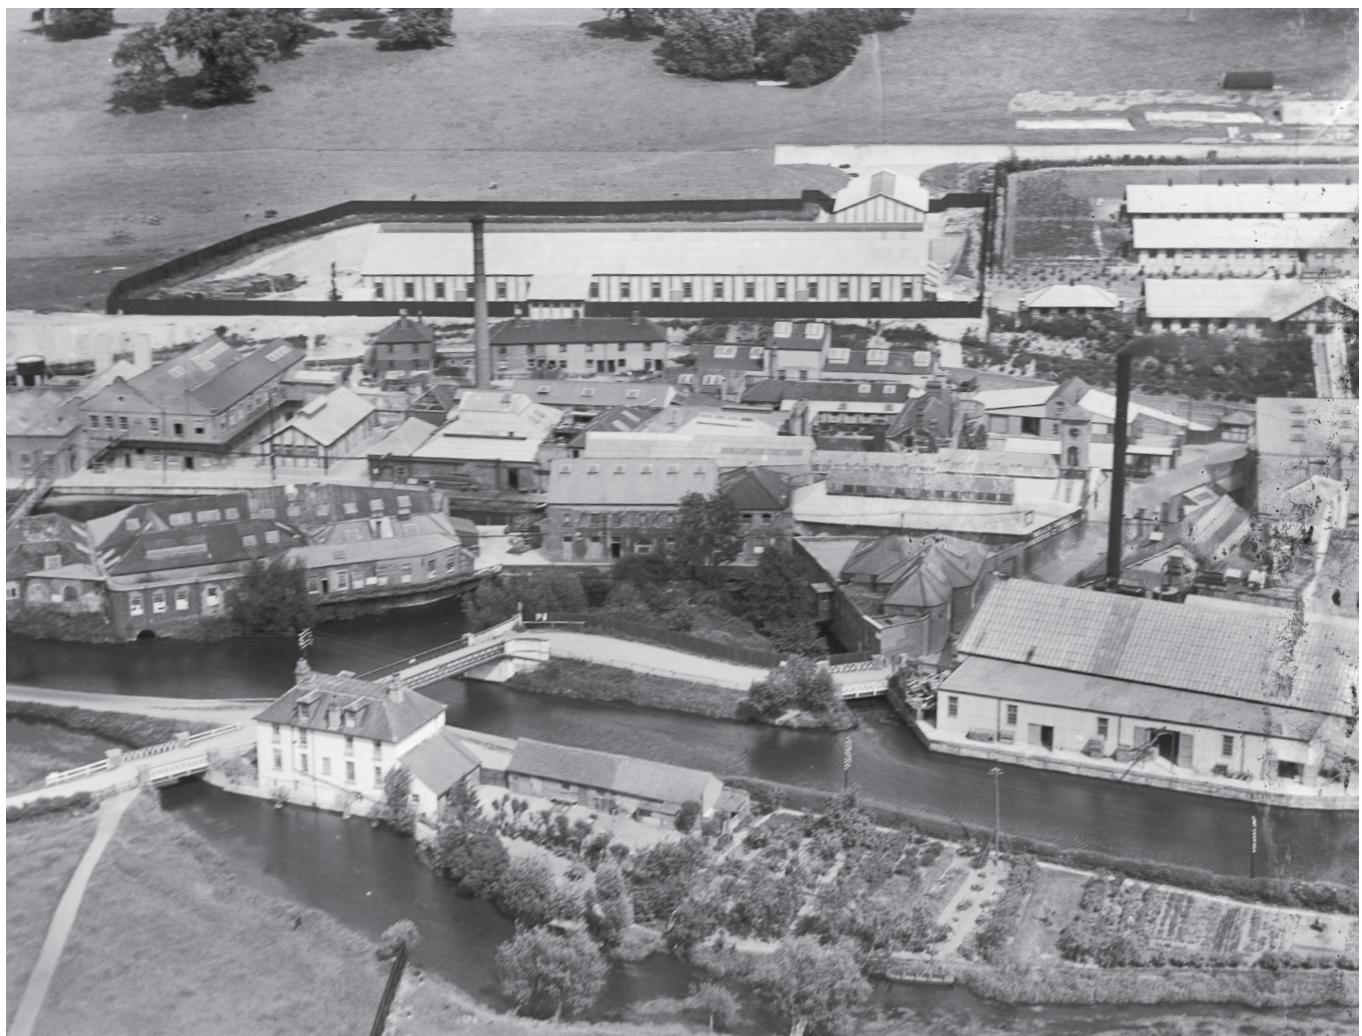
Fig.17

Figure 17: Photograph of the Bell's United Asbestos Works in 1921 viewed from the west (Historic Environment Scotland. [EPW006657] Bells United Asbestos Works, Harefield, 1921. Historic England)

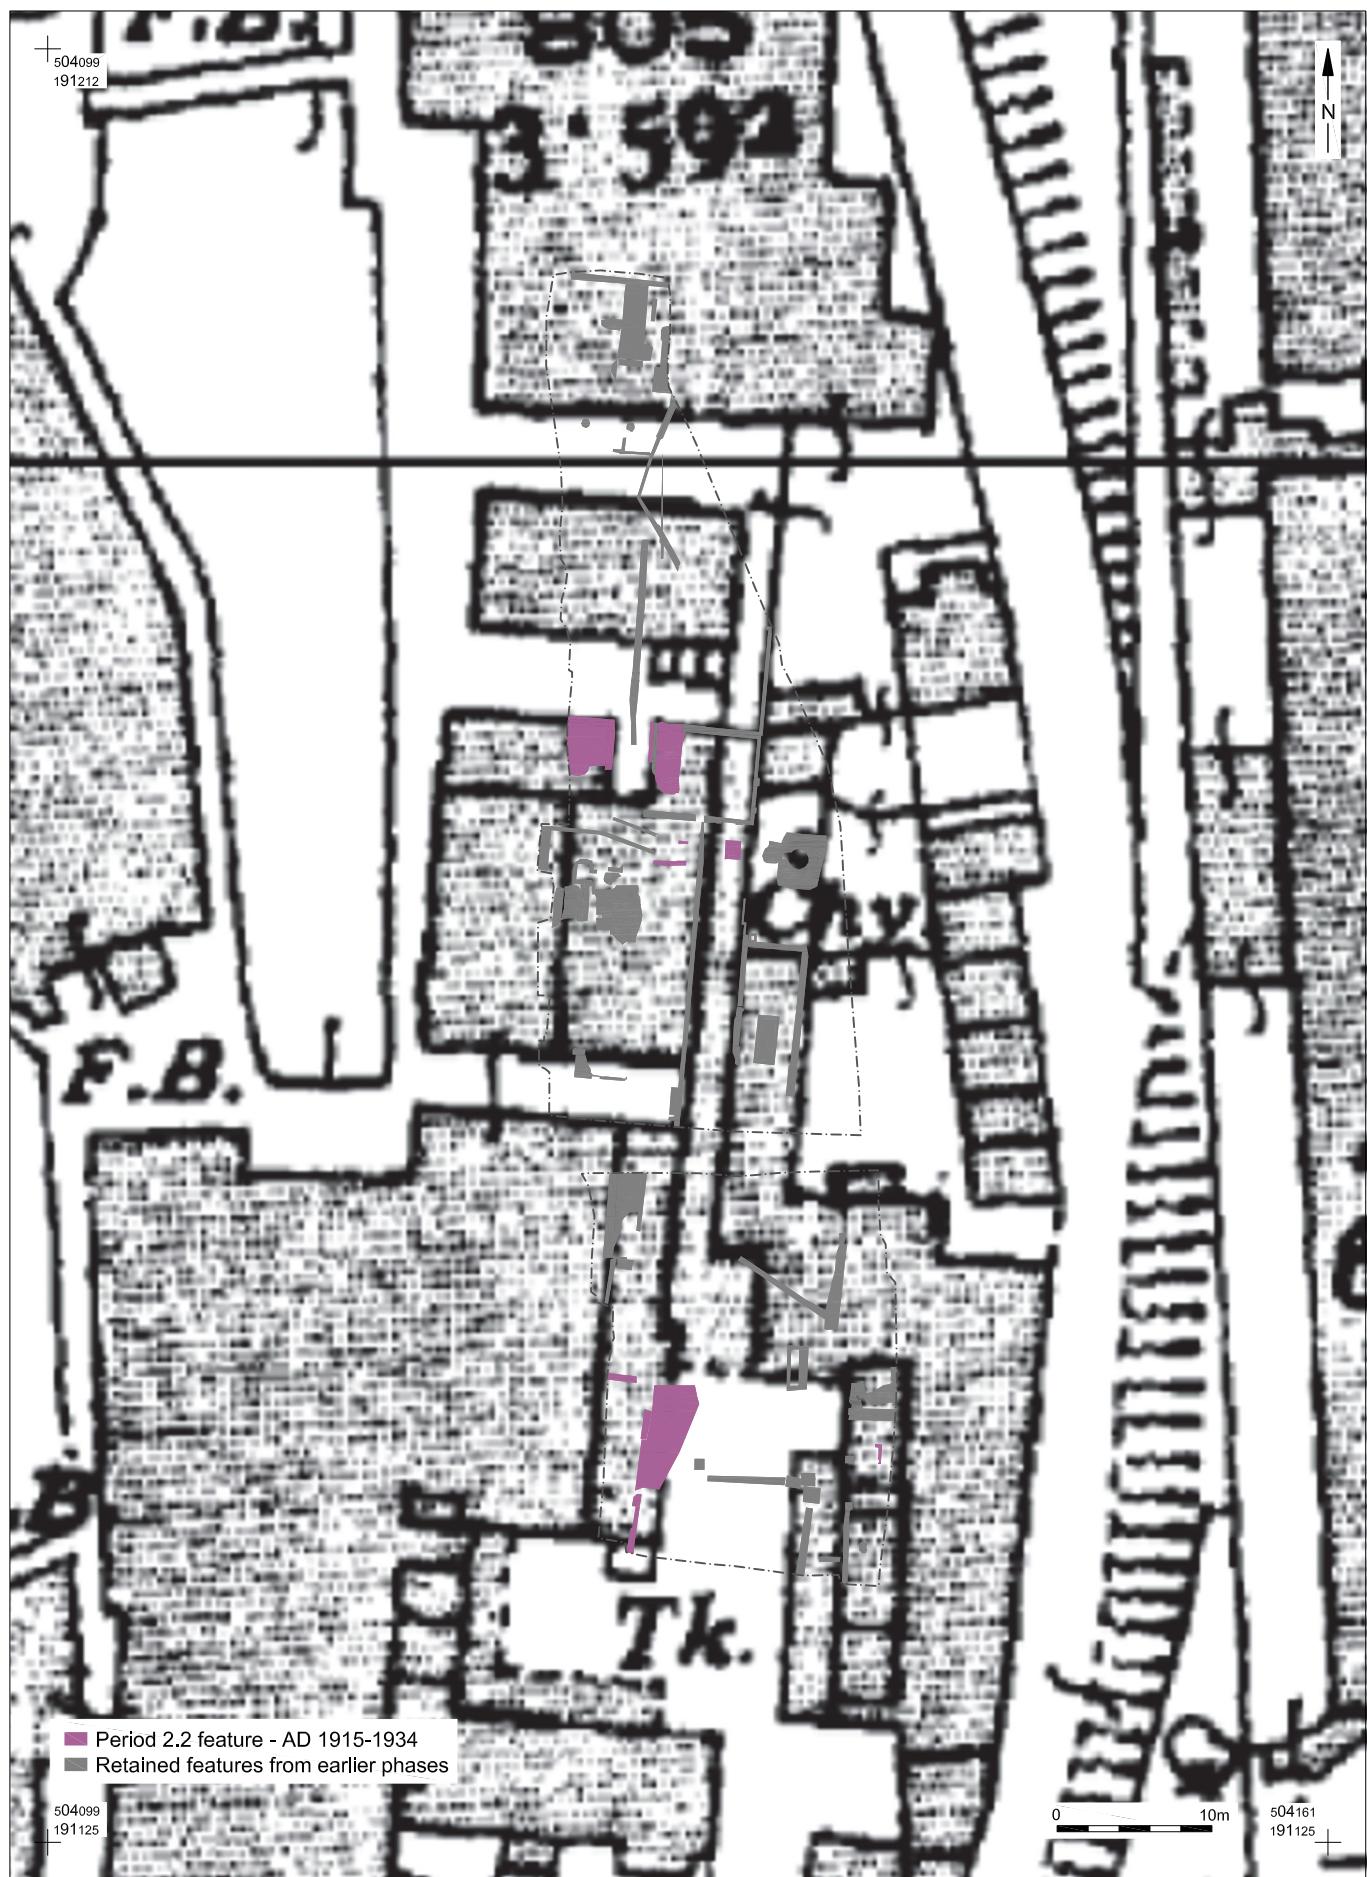
Fig. 18

Figure 18: Period 2.2 remains and the 1934 Ordnance Survey map

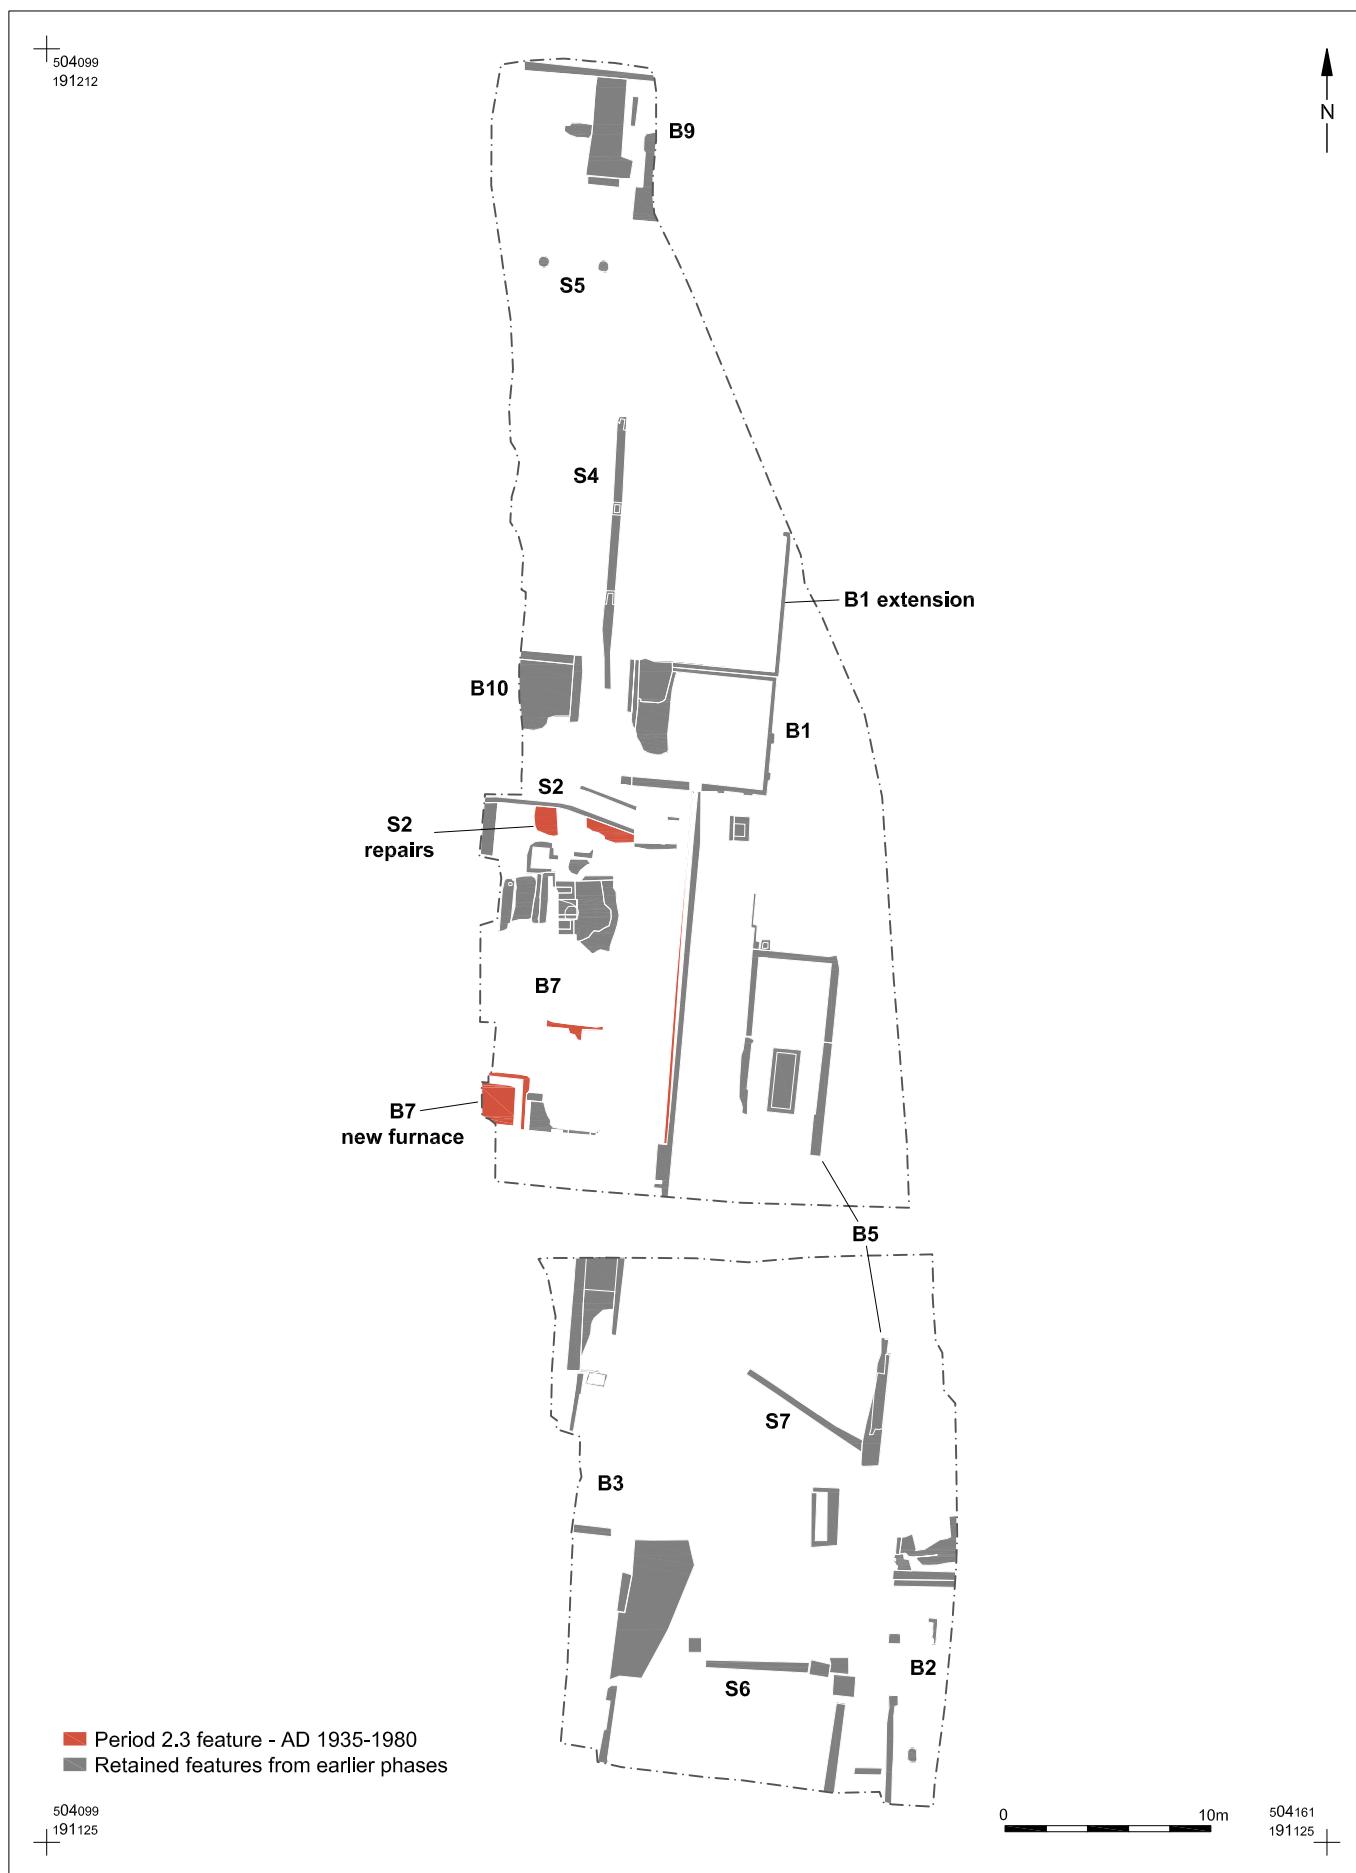
Fig. 19

Figure 19: Period 2.3 plan
